## APPENDIX D

### TREE CONSTRAINTS PLAN (12072 TCP 01)

TITLE  
New Place Farm, Pulborough  
Tree Constraints Plan

CLIENT  
David Wilson Homes, Southern Counties

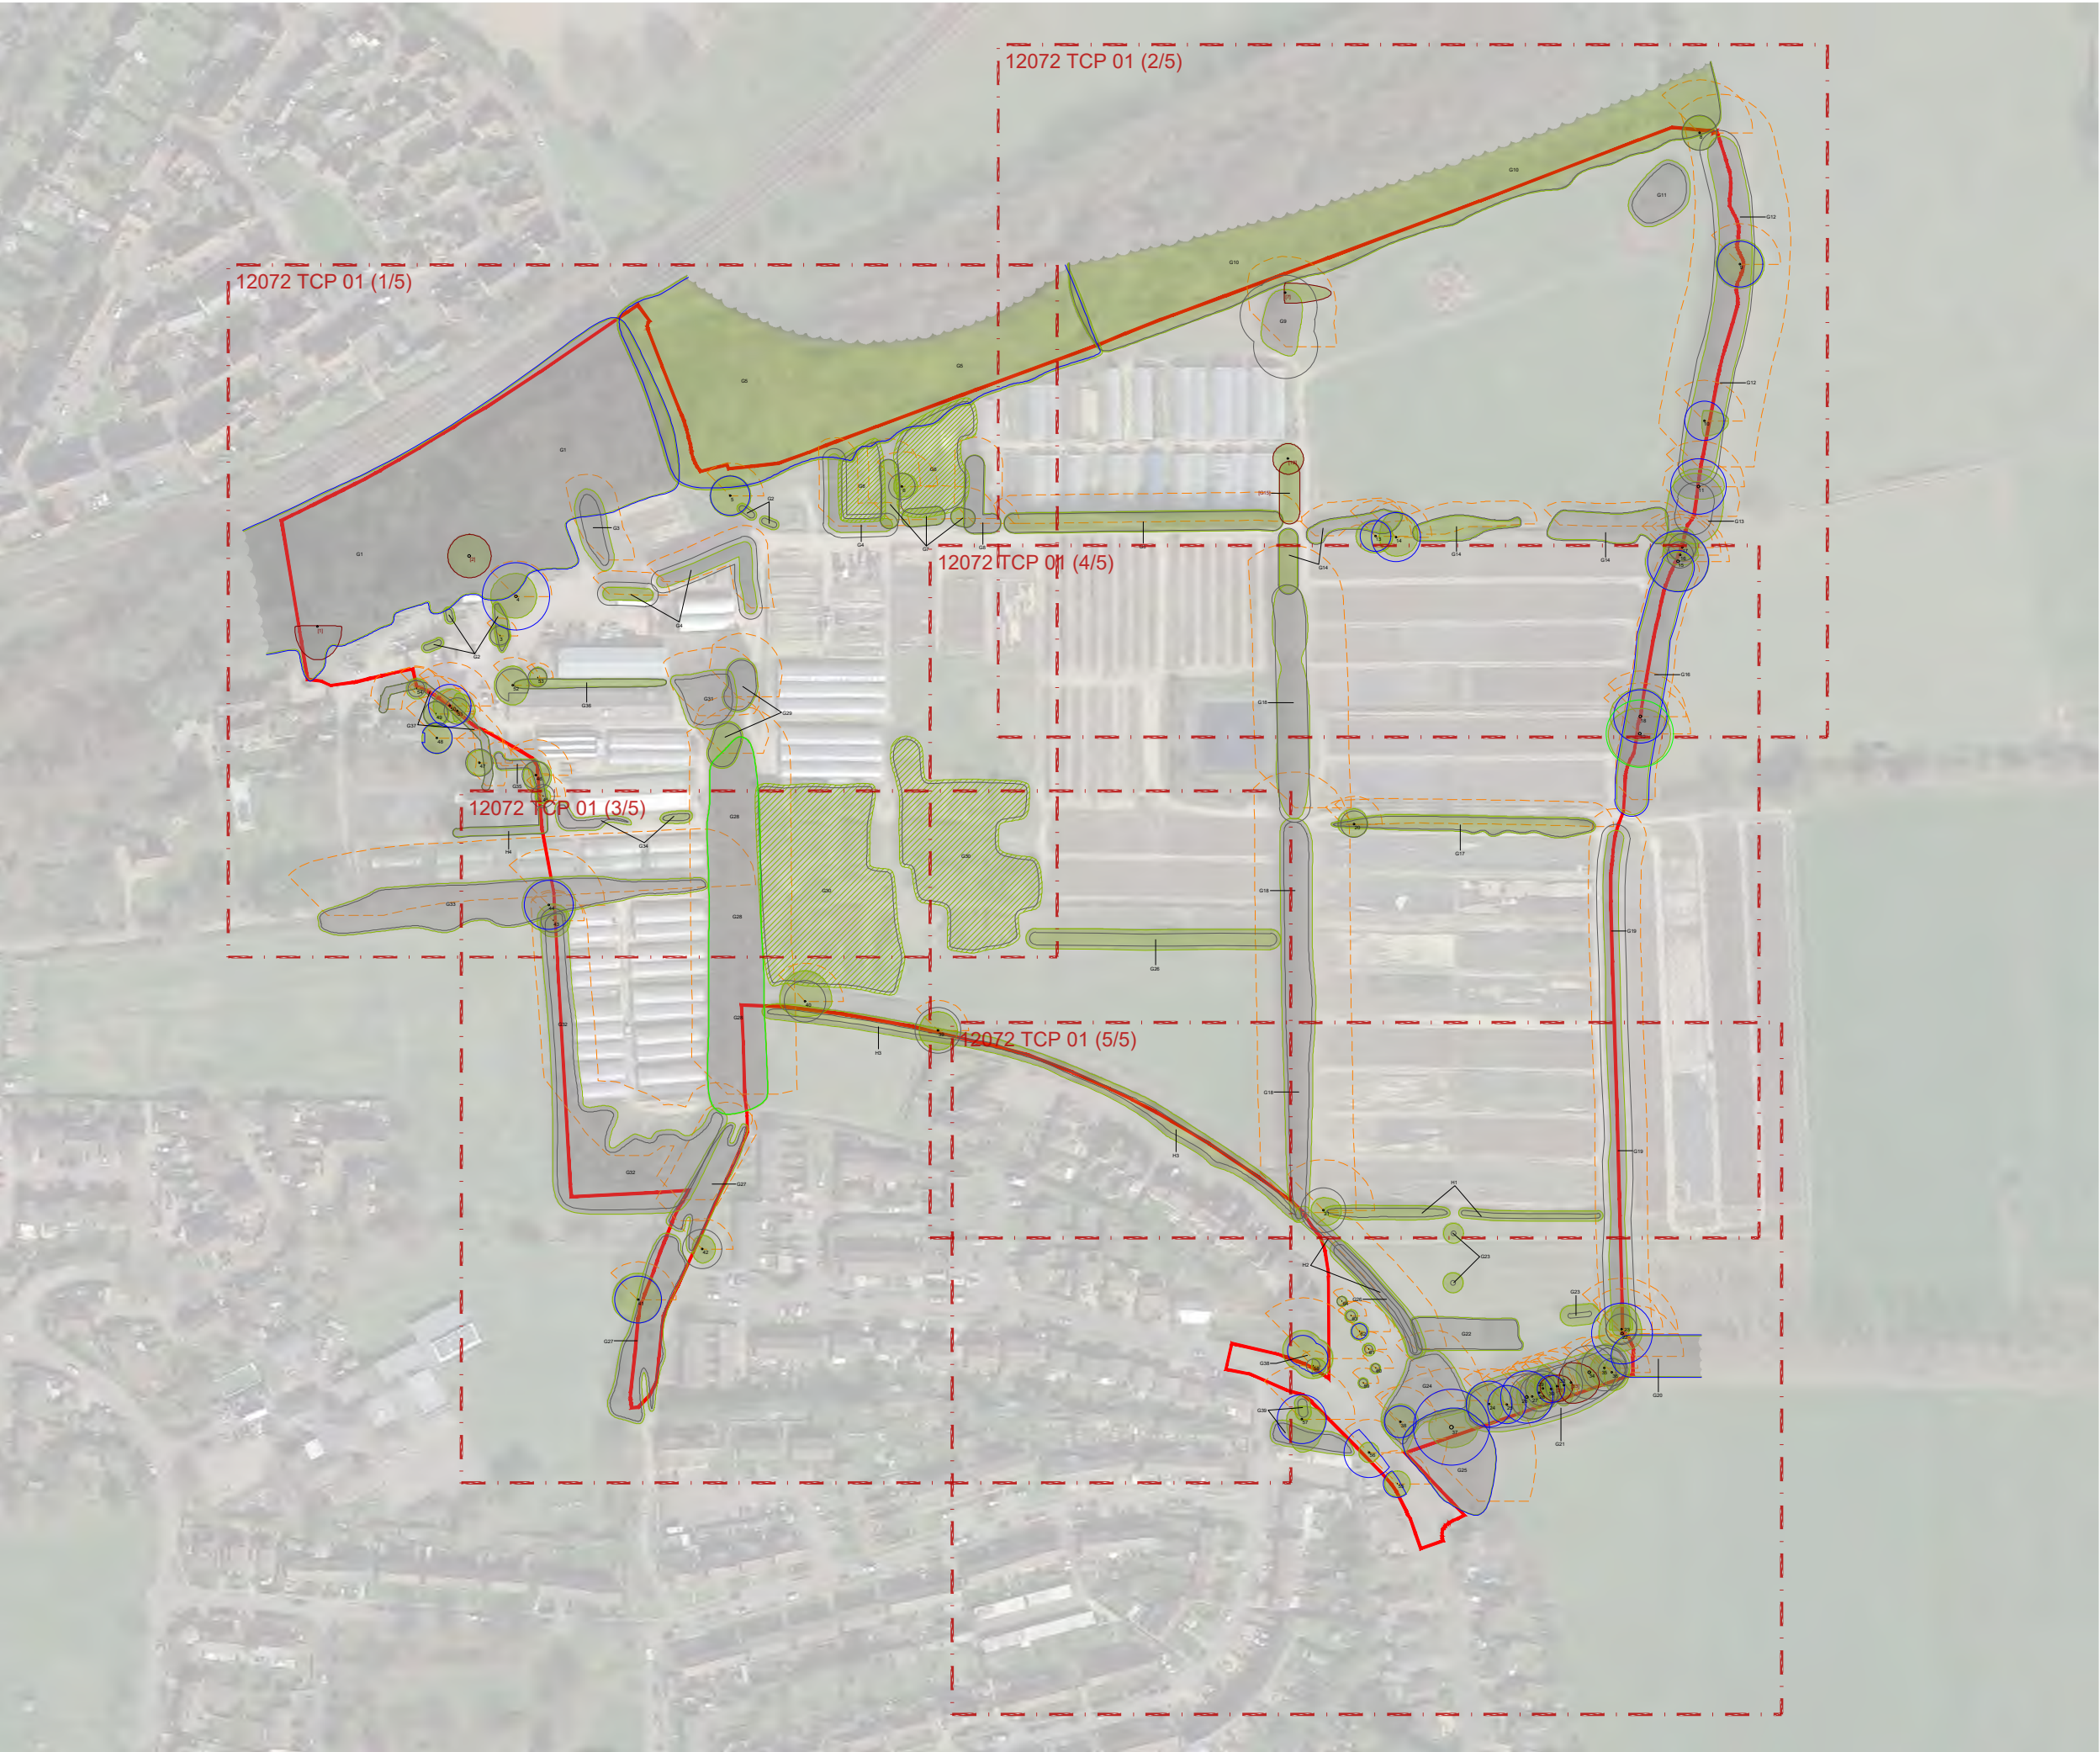
| DRAWING NUMBER<br>12072 TCP 01 (Overview) | REVISION | |

Note: Trees 1, 16, 17, 23, 32, 36-39, 41, 42, Groups G1-G3, G5-G7, G10, G11, G14, G16, G17, G19-G21, G23-G27, G30, G32-G34 and Hedgerows H1-H3 have been plotted using measurements onsite in conjunction with aerial imagery. Their locations were not recorded on the topographical survey of the site.

Note: The RPA footprint for Trees 48, 52, 55 & 56 have been displaced to allow for the effect of the adopted highway. The surface area of the RPA has not been reduced.

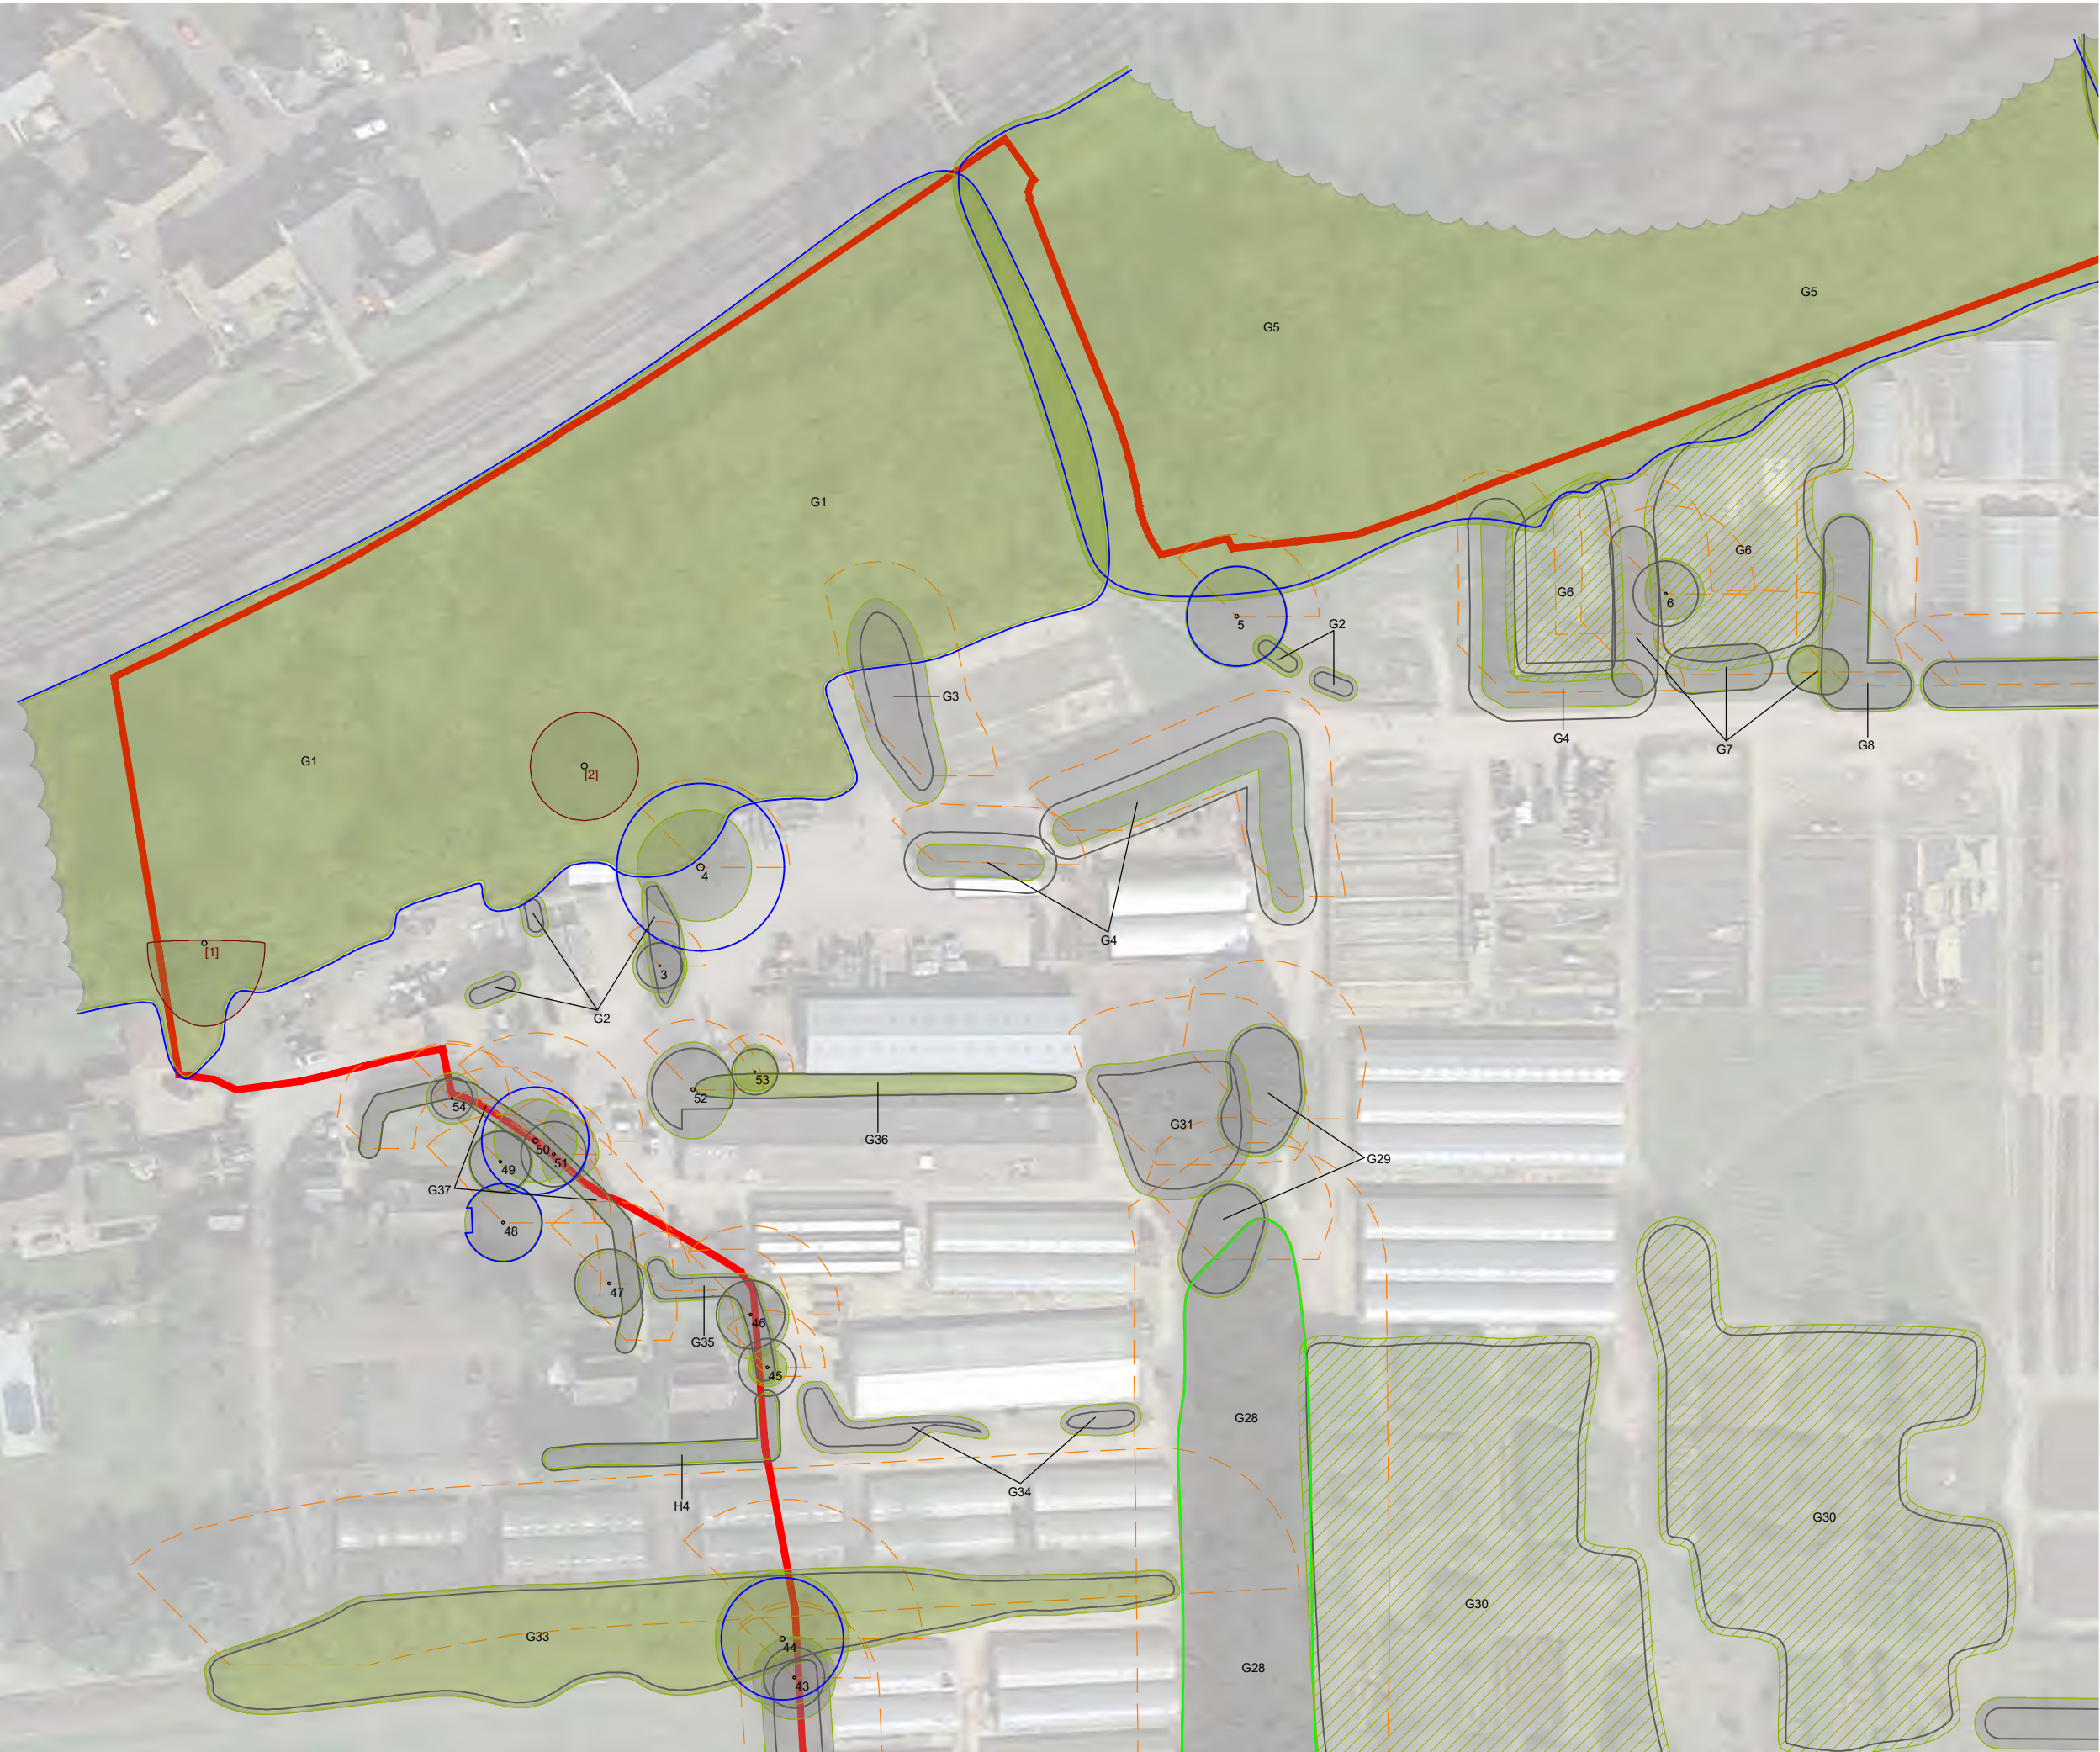
12072 TCP 01 (1/5)

Note: Trees 1, 16, 17, 23, 32, 36-39, 41, 42, Groups G1-G3, G5-G7, G10, G11, G14, G16, G17, G19-G21, G23-G27, G30, G32-G34 and Hedgerows H1-H3 have been plotted using measurements onsite in conjunction with aerial imagery. Their locations were not recorded on the topographical survey of the site.

Note: The RPA footprint for Trees 48, 52, 55 & 56 have been displaced to allow for the effect of the adopted highway. The surface area of the RPA has not been reduced.

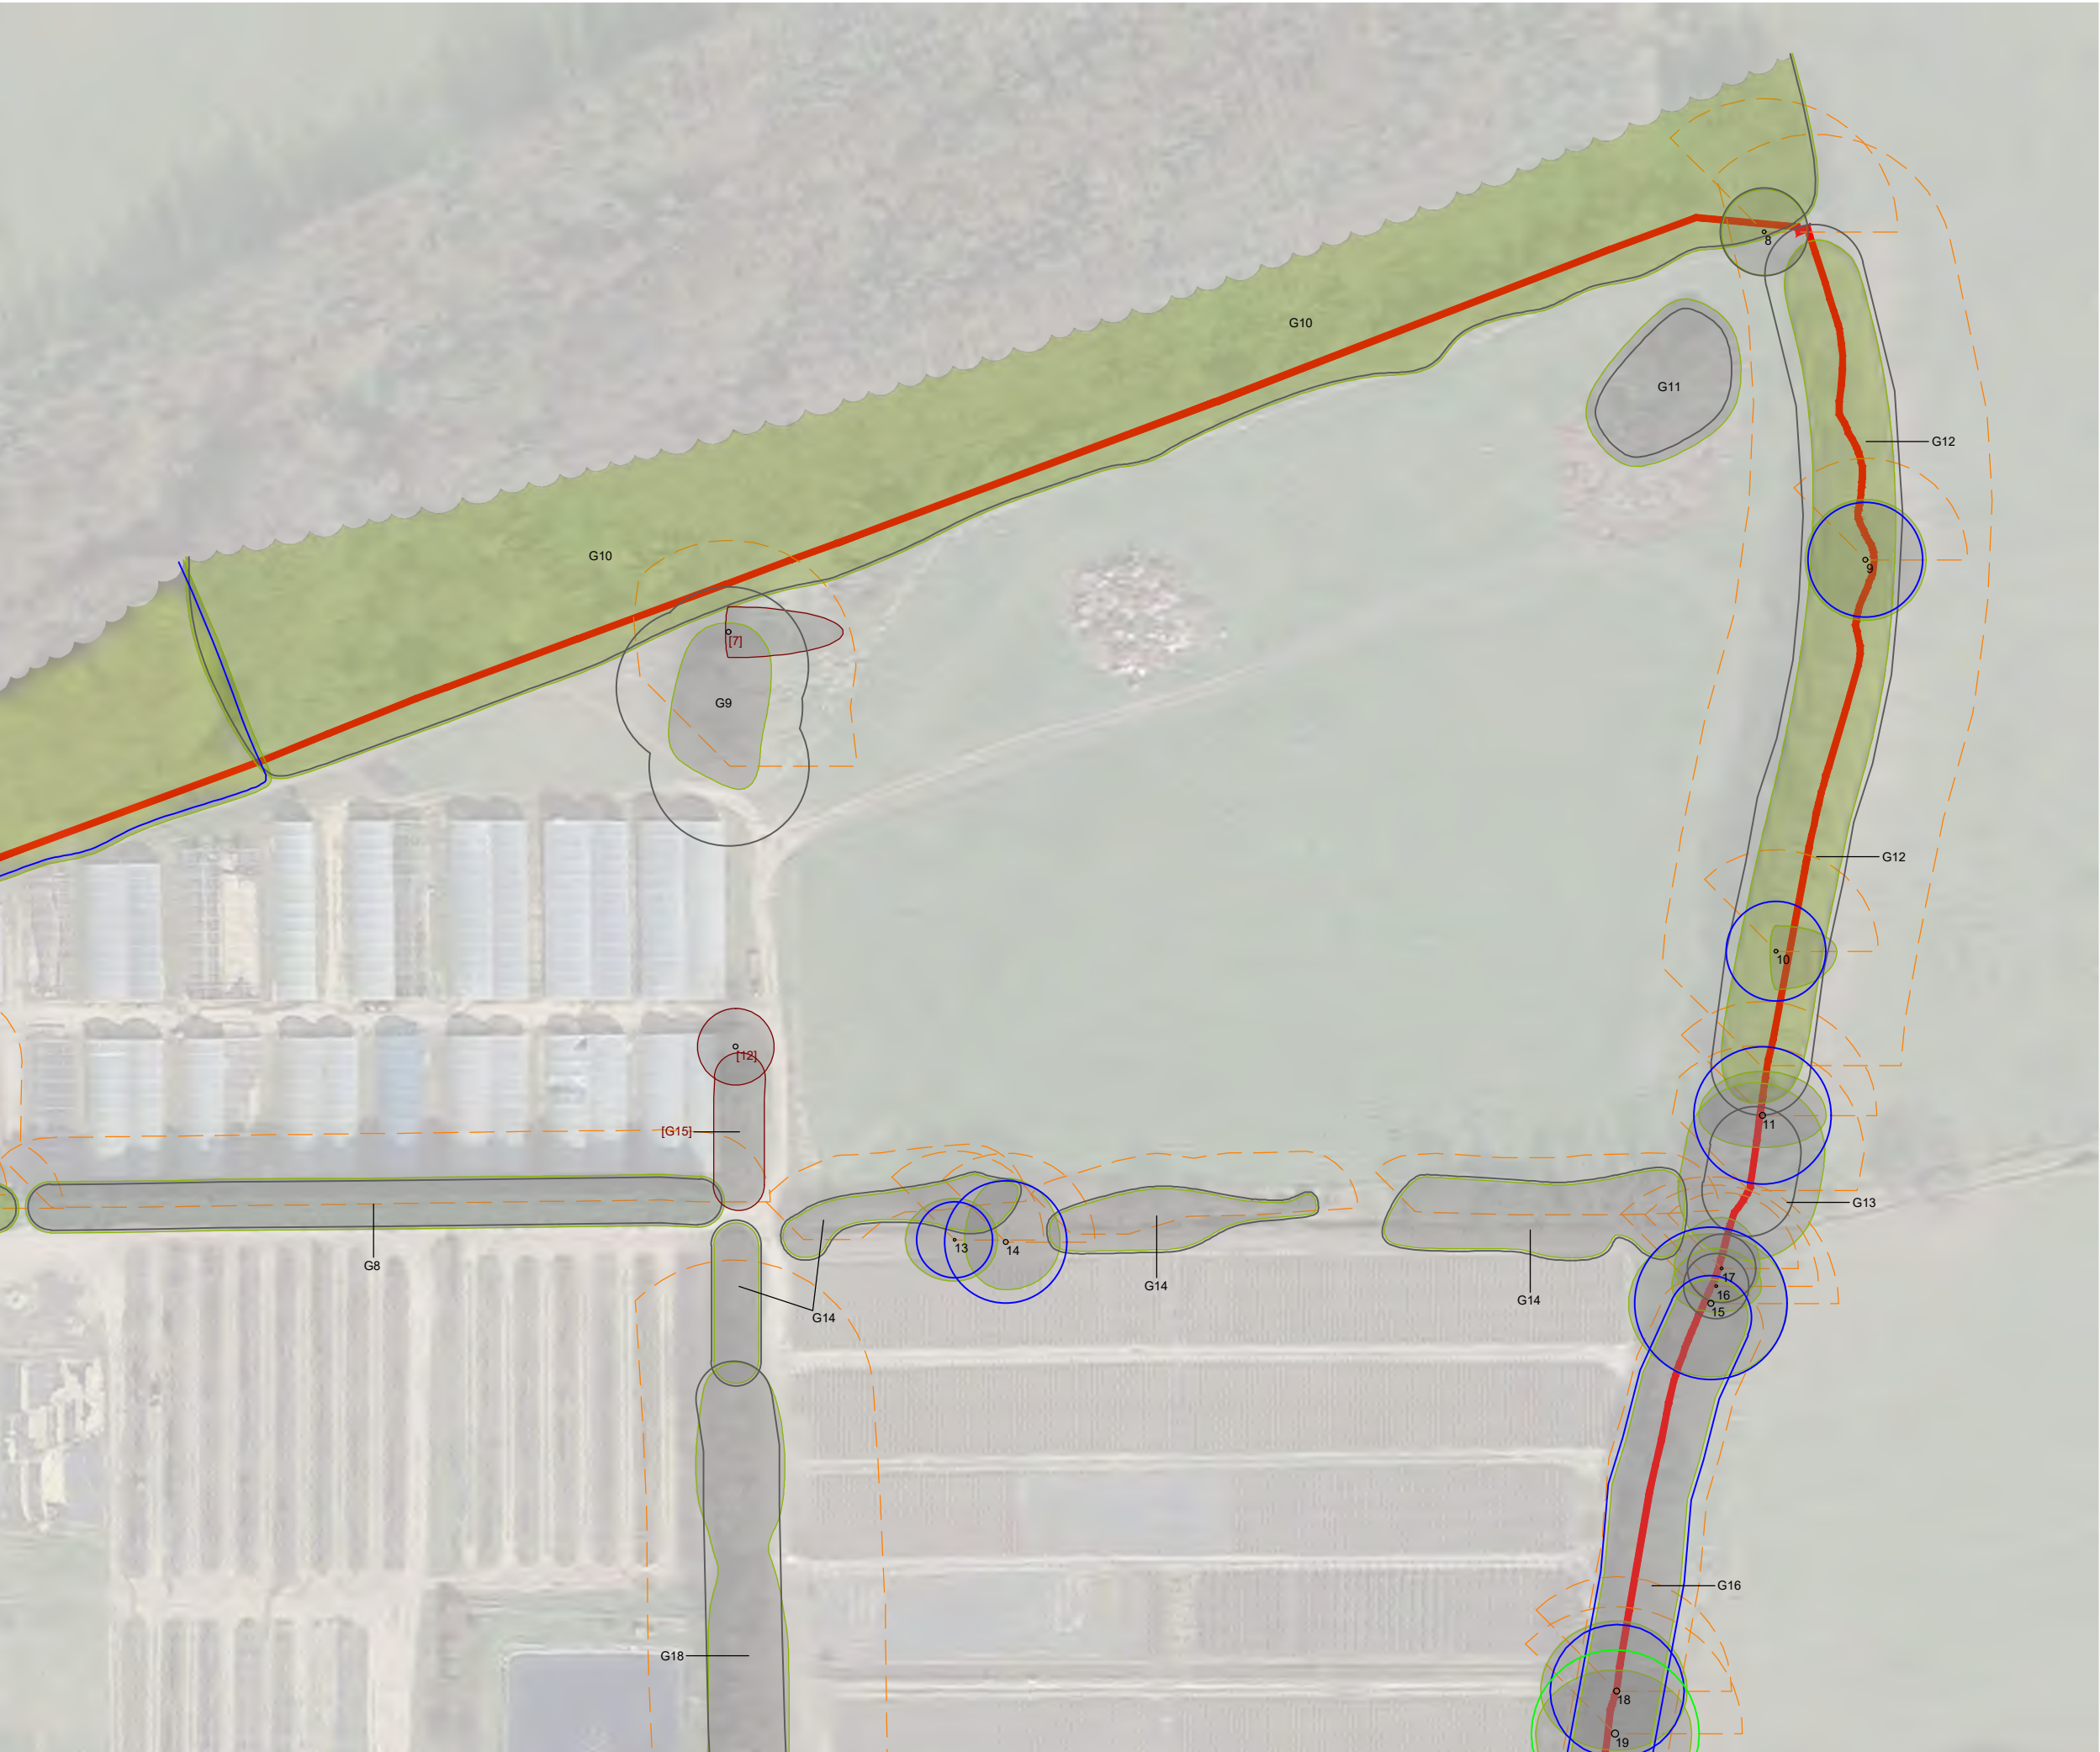
| 12072 TCP 01 (2/5) | | |

Note: Trees 1, 16, 17, 23, 32, 36-39, 41, 42, Groups G1-G3, G5-G7, G10, G11, G14, G16, G17, G19-G21, G23-G27, G30, G32-G34 and Hedgerows H1-H3 have been plotted using measurements onsite in conjunction with aerial imagery. Their locations were not recorded on the topographical survey of the site.

Note: The RPA footprint for Trees 48, 52, 55 & 56 have been displaced to allow for the effect of the adopted highway. The surface area of the RPA has not been reduced.

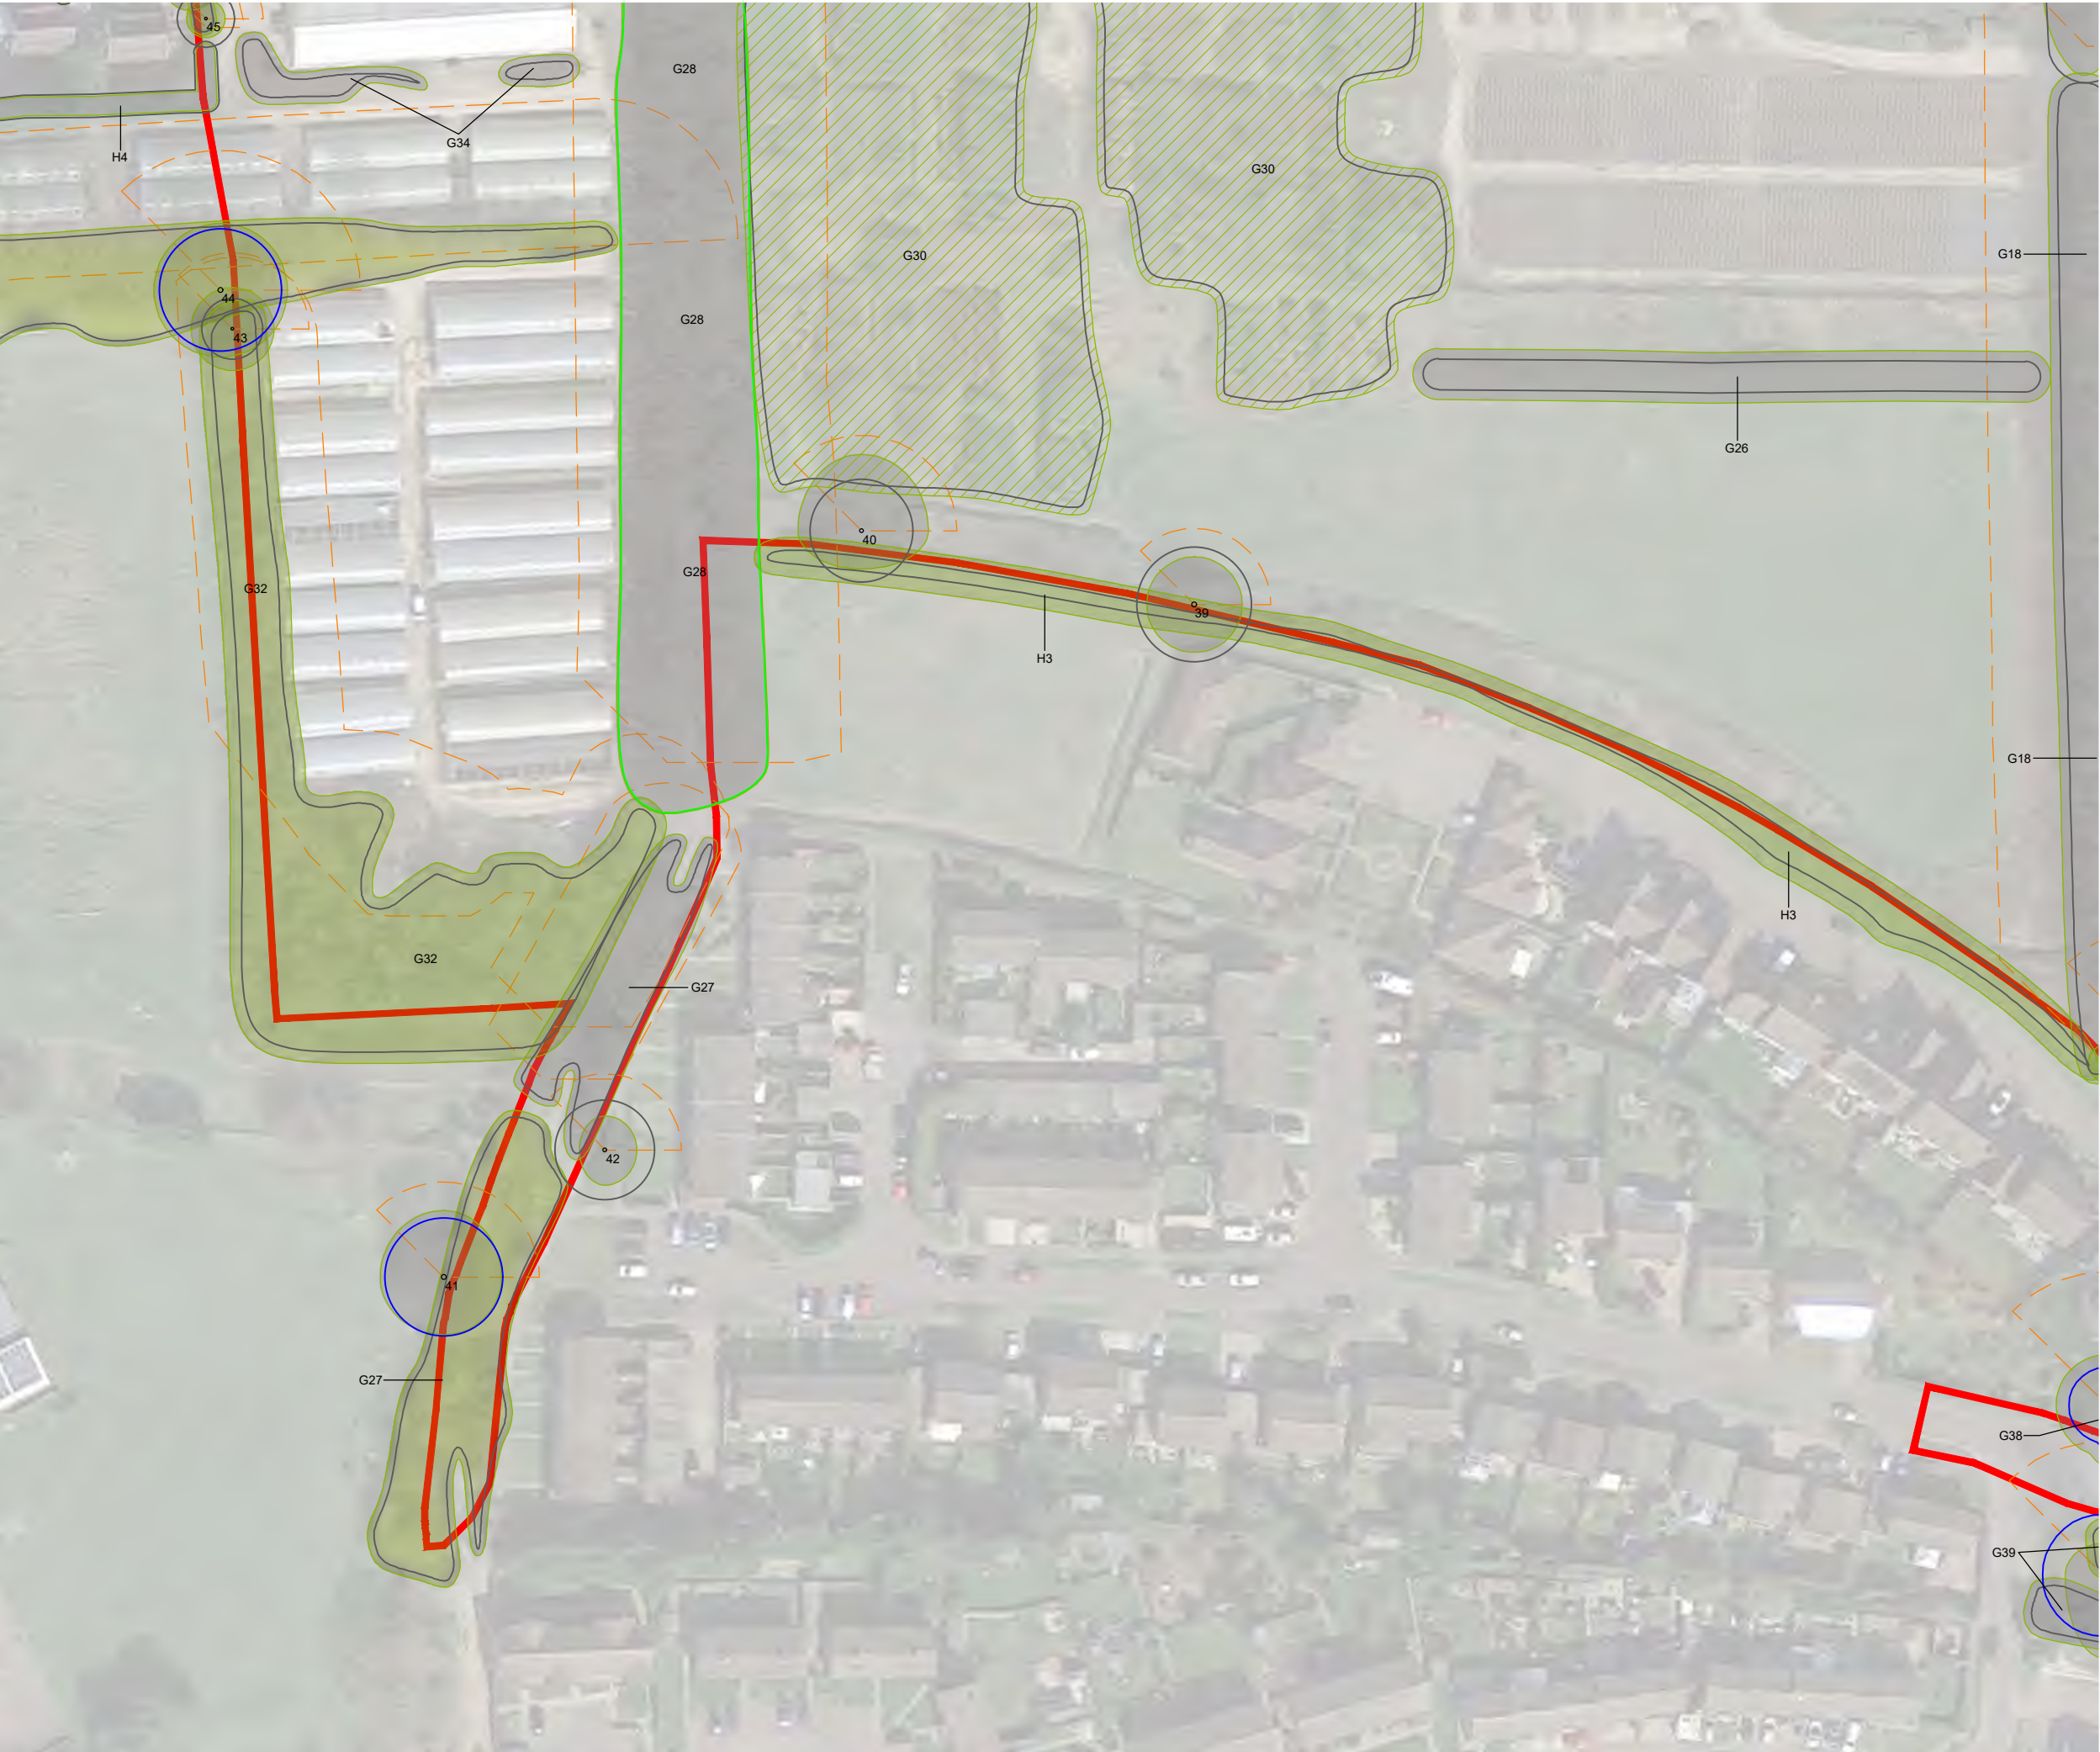
| SCALE | DATE | DRAWN |
|---|---|---|
| 12072 TCP 01 (3/5) | | |

Note: Trees 1, 16, 17, 23, 32, 36-39, 41, 42, Groups G1-G3, G5-G7, G10, G11, G14, G16, G17, G19-G21, G23-G27, G30, G32-G34 and Hedgerows H1-H3 have been plotted using measurements onsite in conjunction with aerial imagery. Their locations were not recorded on the topographical survey of the site.

Note: The RPA footprint for Trees 48, 52, 55 & 56 have been displaced to allow for the effect of the adopted highway. The surface area of the RPA has not been reduced.

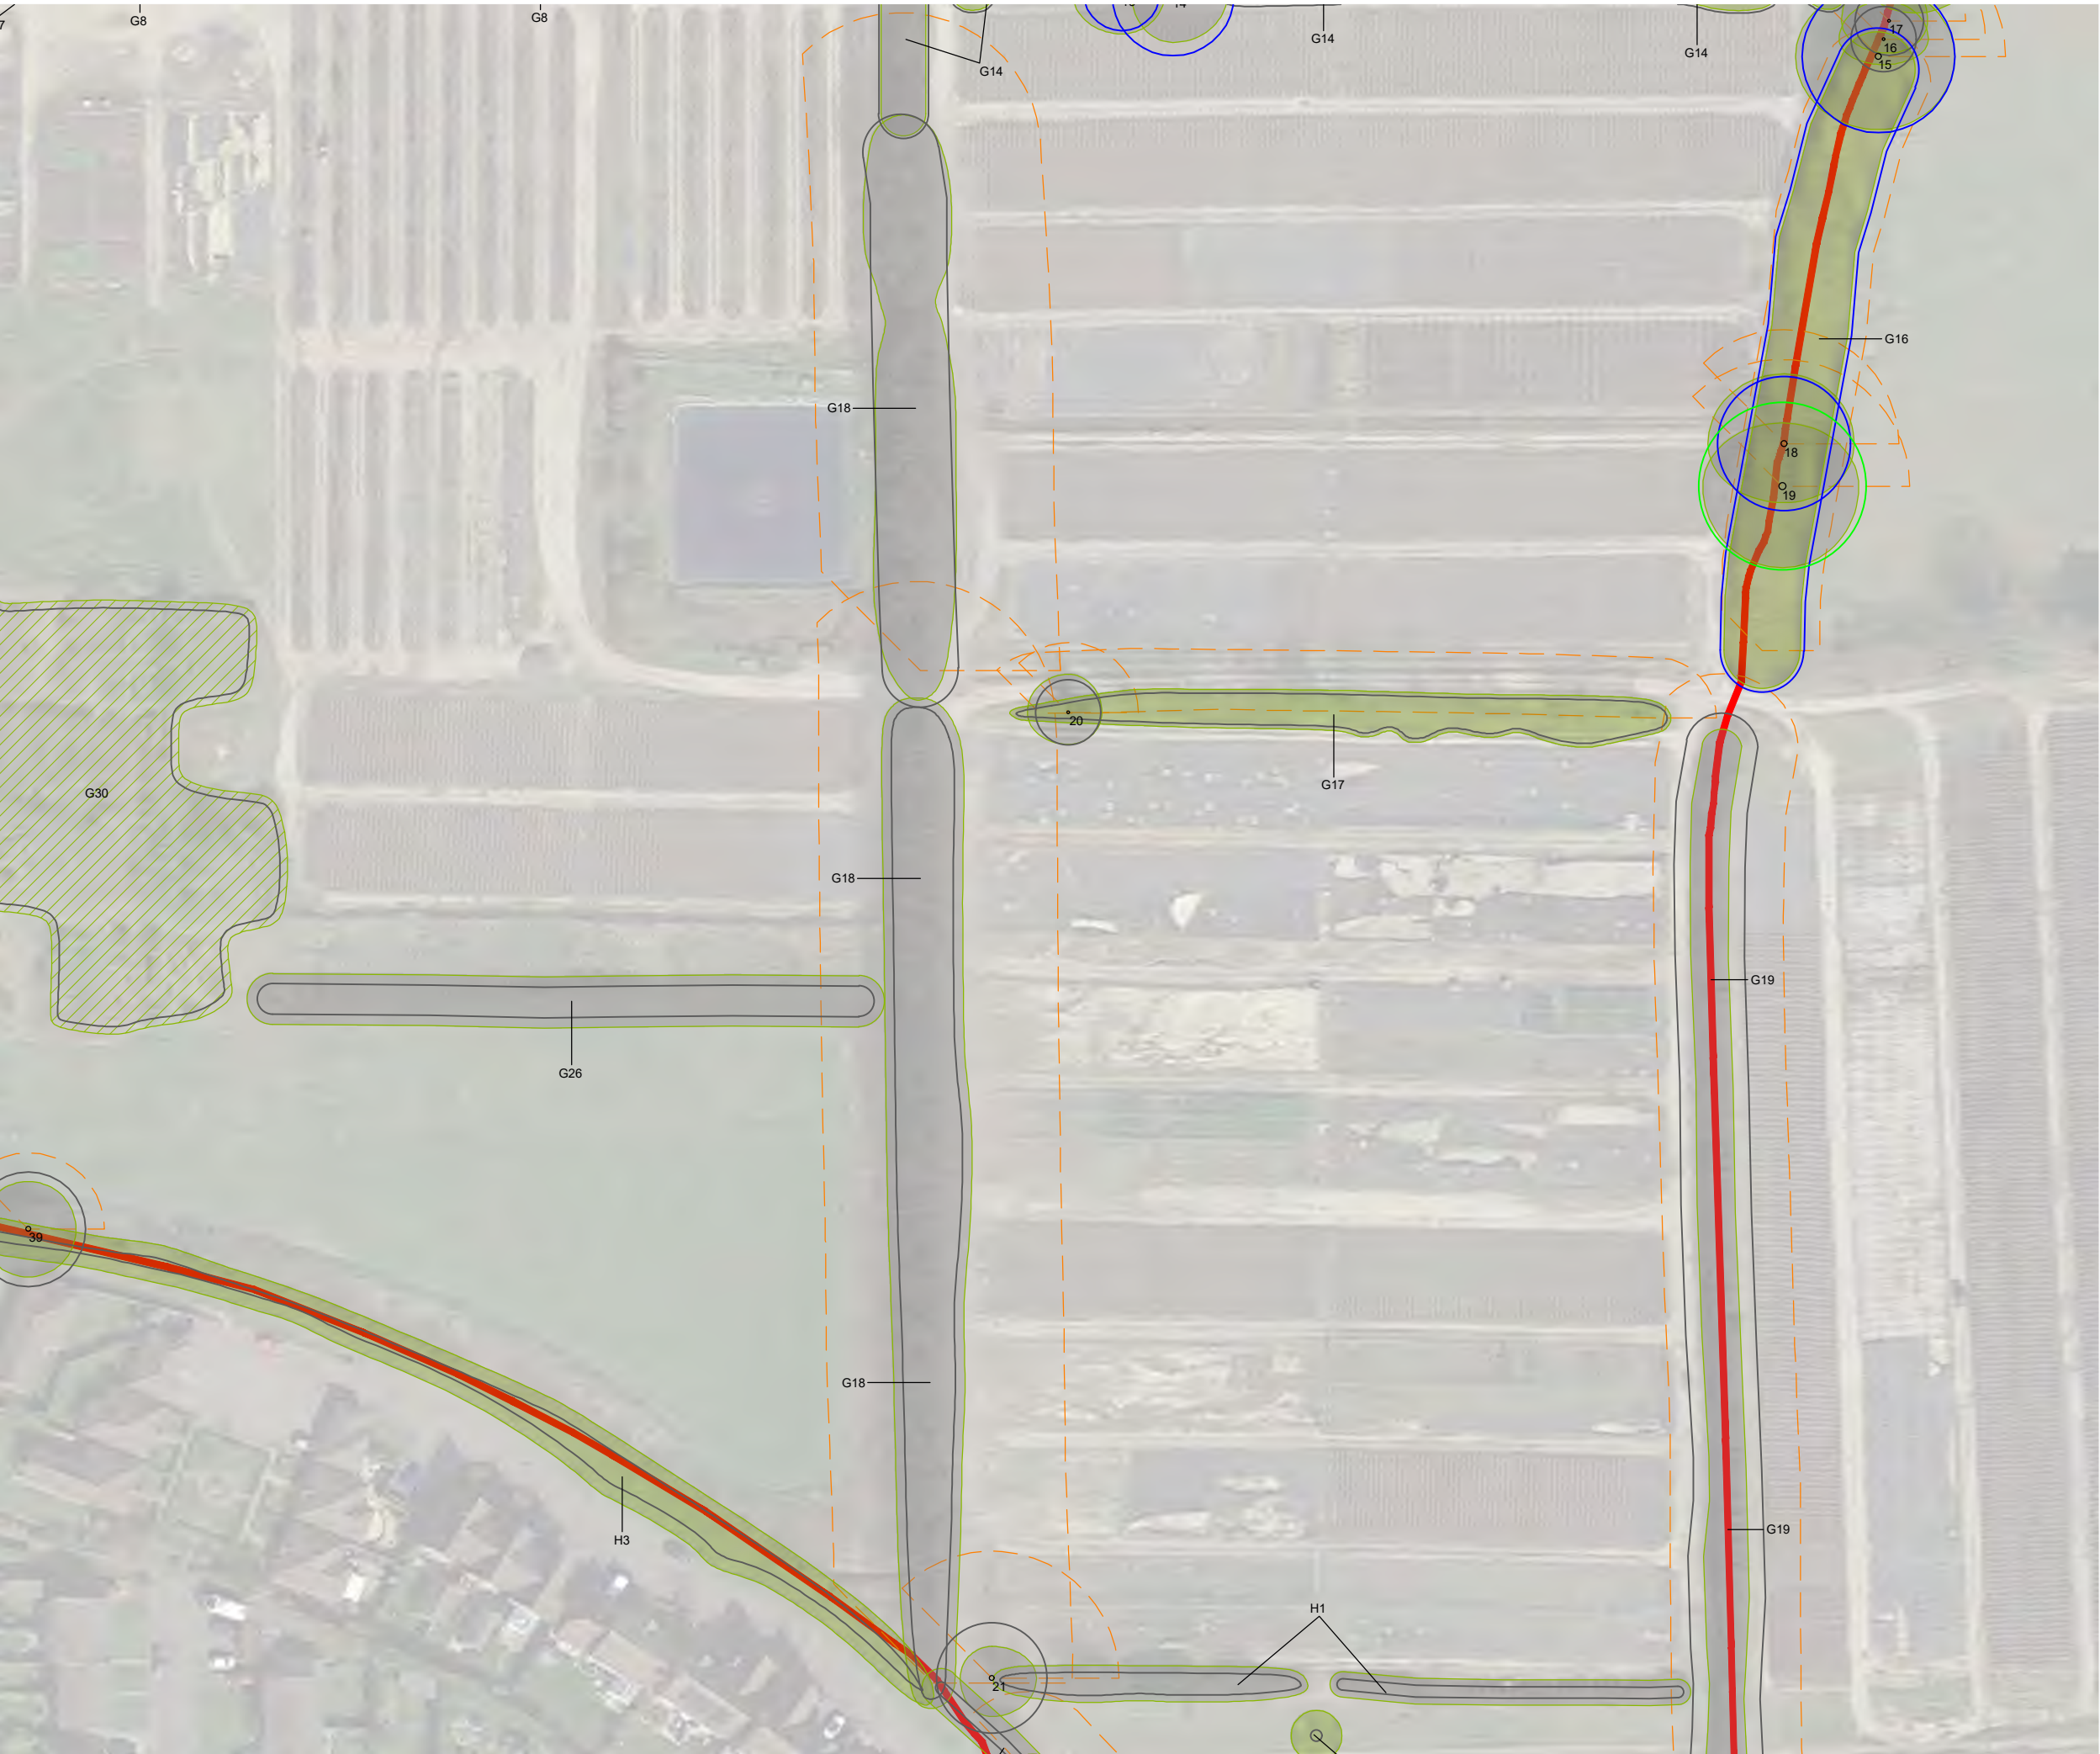
| 12072 TCP 01 (4/5) | | |

Note: Trees 1, 16, 17, 23, 32, 36-39, 41, 42, Groups G1-G3, G5-G7, G10, G11, G14, G16, G17, G19-G21, G23-G27, G30, G32-G34 and Hedgerows H1-H3 have been plotted using measurements onsite in conjunction with aerial imagery. Their locations were not recorded on the topographical survey of the site.

Note: The RPA footprint for Trees 48, 52, 55 & 56 have been displaced to allow for the effect of the adopted highway. The surface area of the RPA has not been reduced.

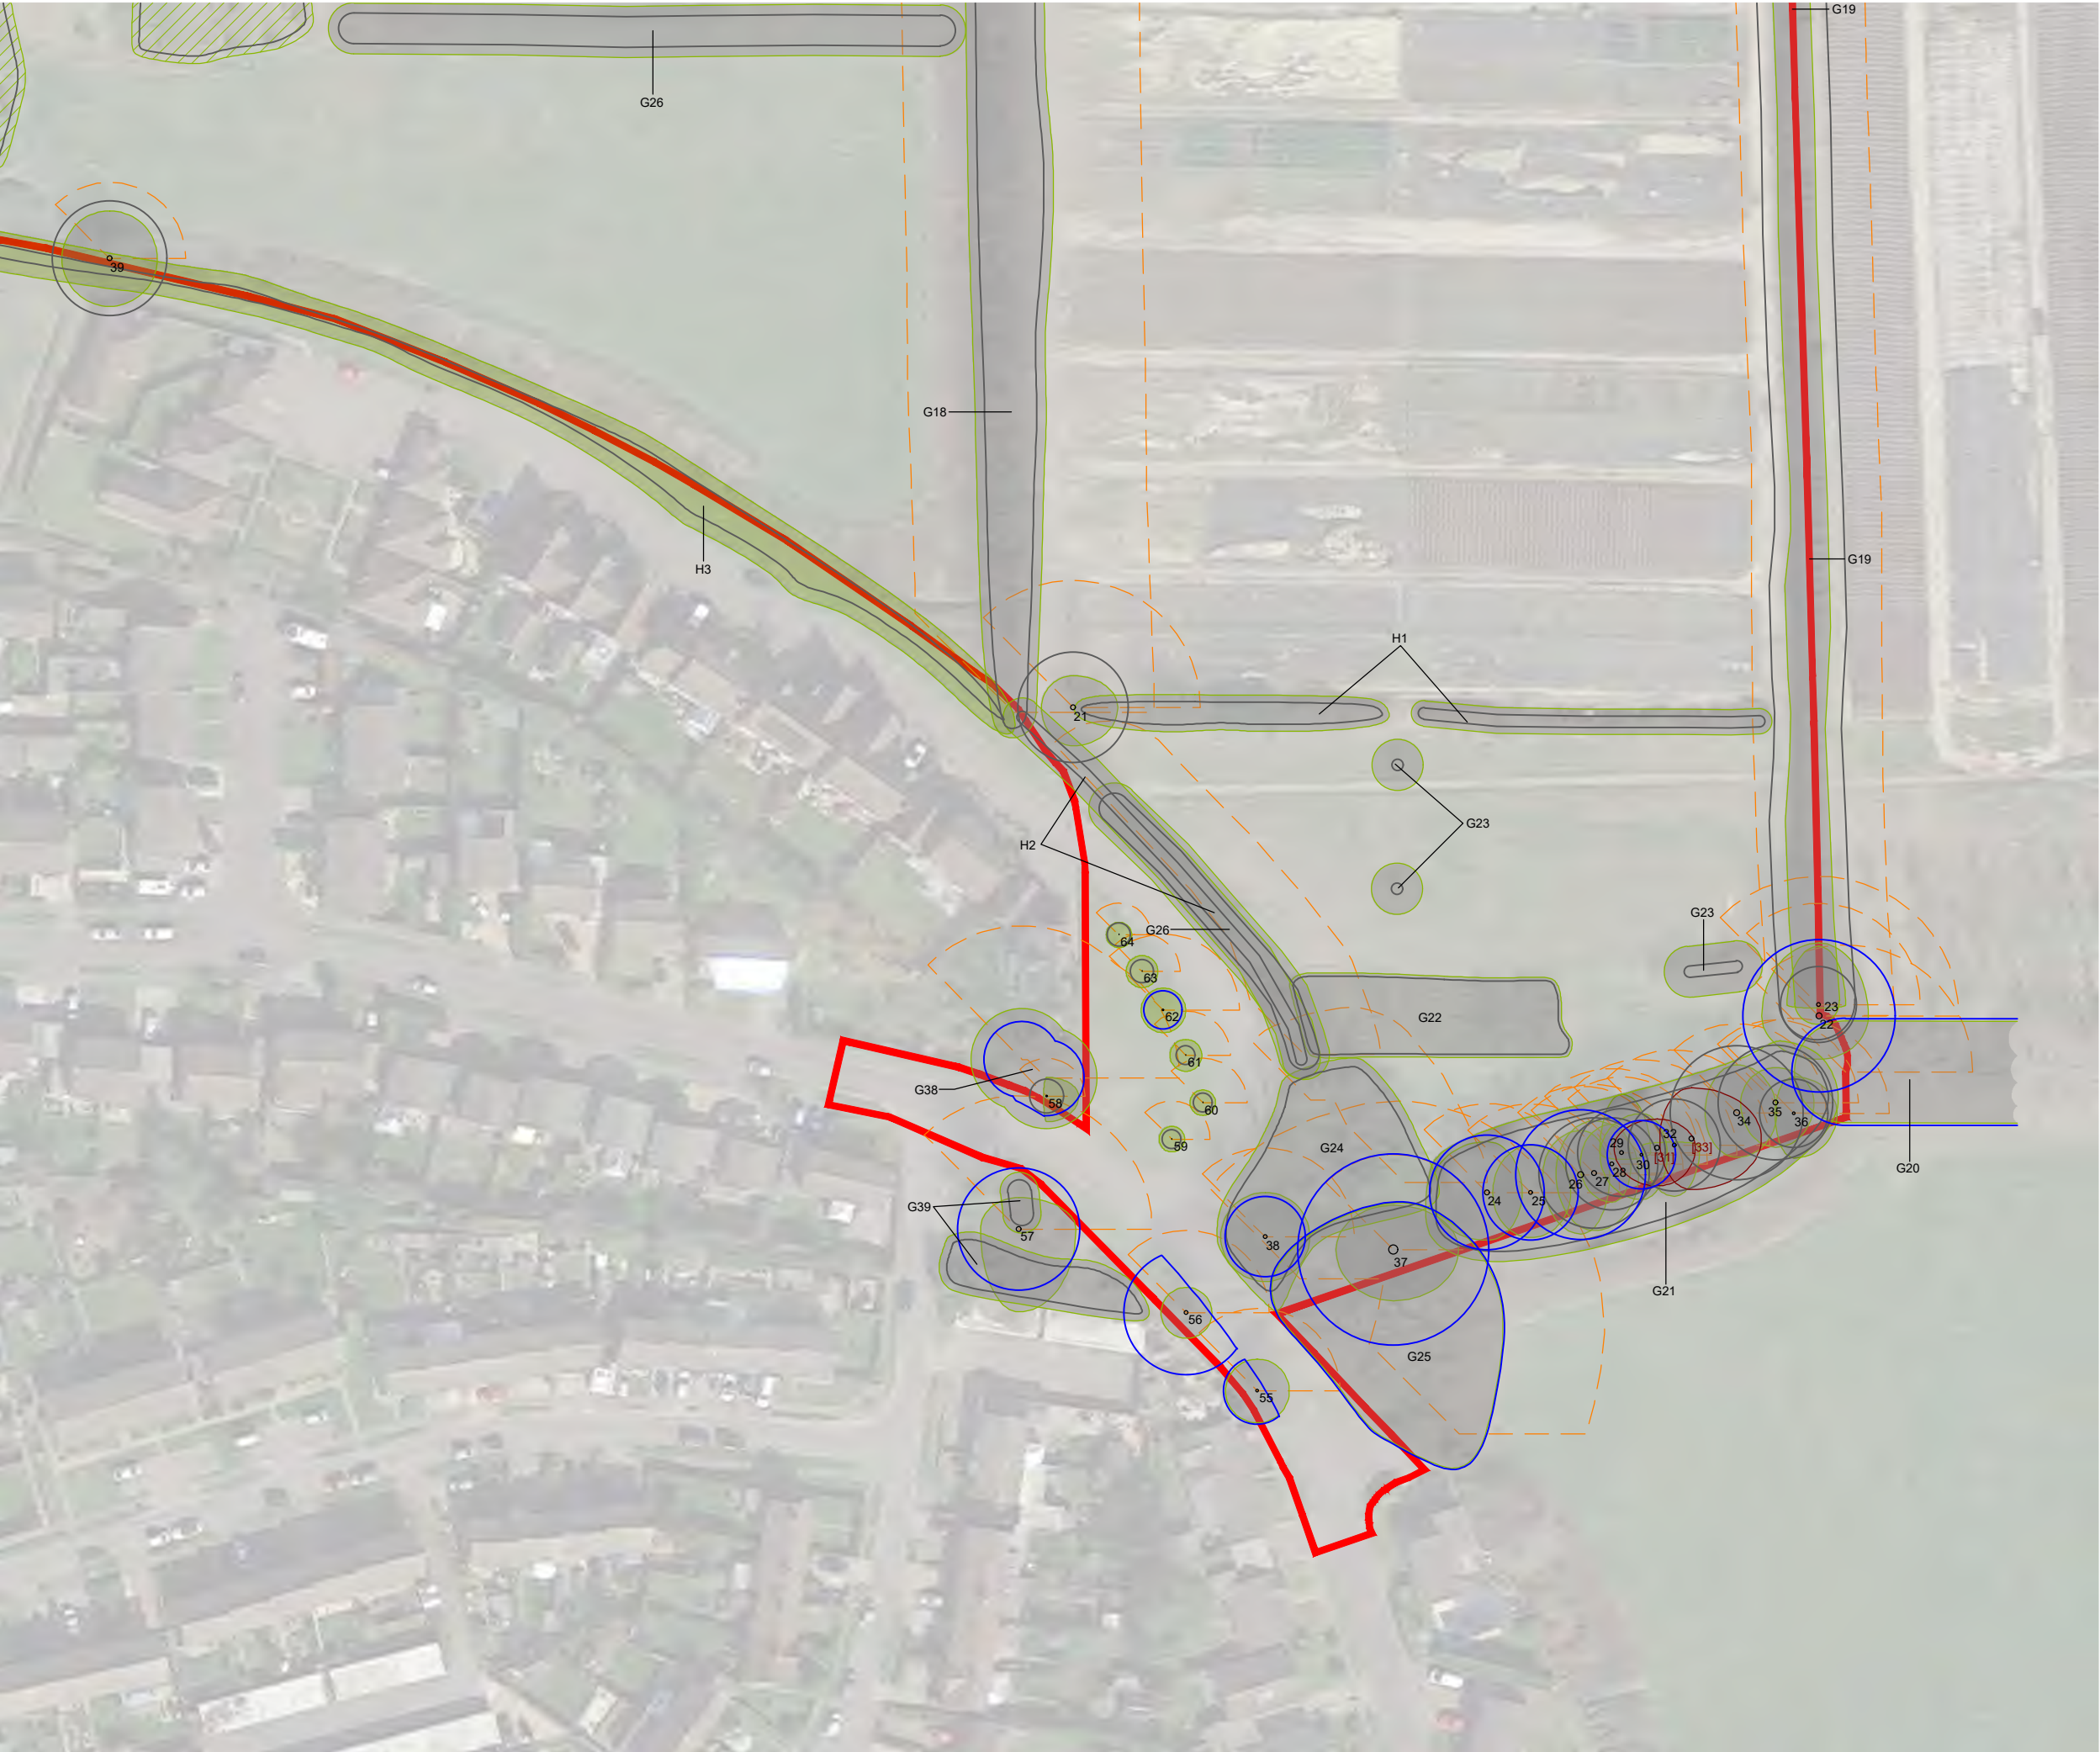
12072 TCP 01 (5/5)

Note: Trees 1, 16, 17, 23, 32, 36-39, 41, 42, Groups G1-G3, G5-G7, G10, G11, G14, G16, G17, G19-G21, G23-G27, G30, G32-G34 and Hedgerows H1-H3 have been plotted using measurements onsite in conjunction with aerial imagery. Their locations were not recorded on the topographical survey of the site.

Note: The RPA footprint for Trees 48, 52, 55 & 56 have been displaced to allow for the effect of the adopted highway. The surface area of the RPA has not been reduced.
