# Bat Emergence and Re-Entry Survey

**119 High Street, Steyning  
BN443RE**

This report is prepared to inform a planning application for the proposal described as a conversion of the existing ground floor shop and bakery and 4-bed self-contained residential on first floor to 4 x 2-bed flats. The only physical change to the external building envelope is the addition of 2 roof dormers to the High Street and one to the side street.

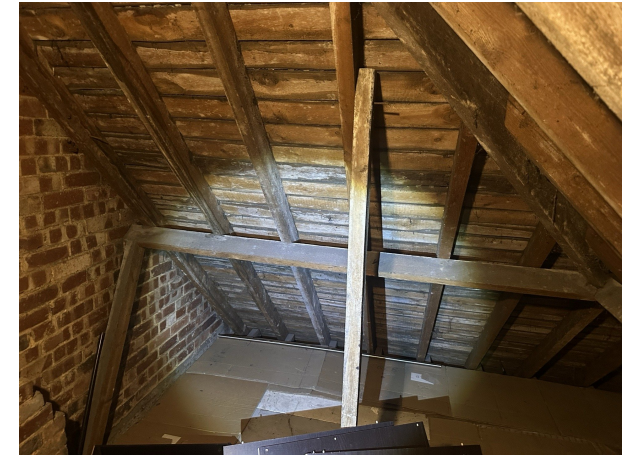
**Figure 1a:** Internal void of B1

An updated loft inspection was undertaken by Charlotte Hall (BSc) on 30/06/26 as part of the BERS survey. The inspection identified no evidence of bats. No changes were noted since the previous inspection, with no alterations to the structure, access points, or suitability for roosting bats identified. The conclusions of the original Preliminary Roost Assessment by Arbtech Consulting Ltd on 18/03/26 are therefore considered to remain valid.

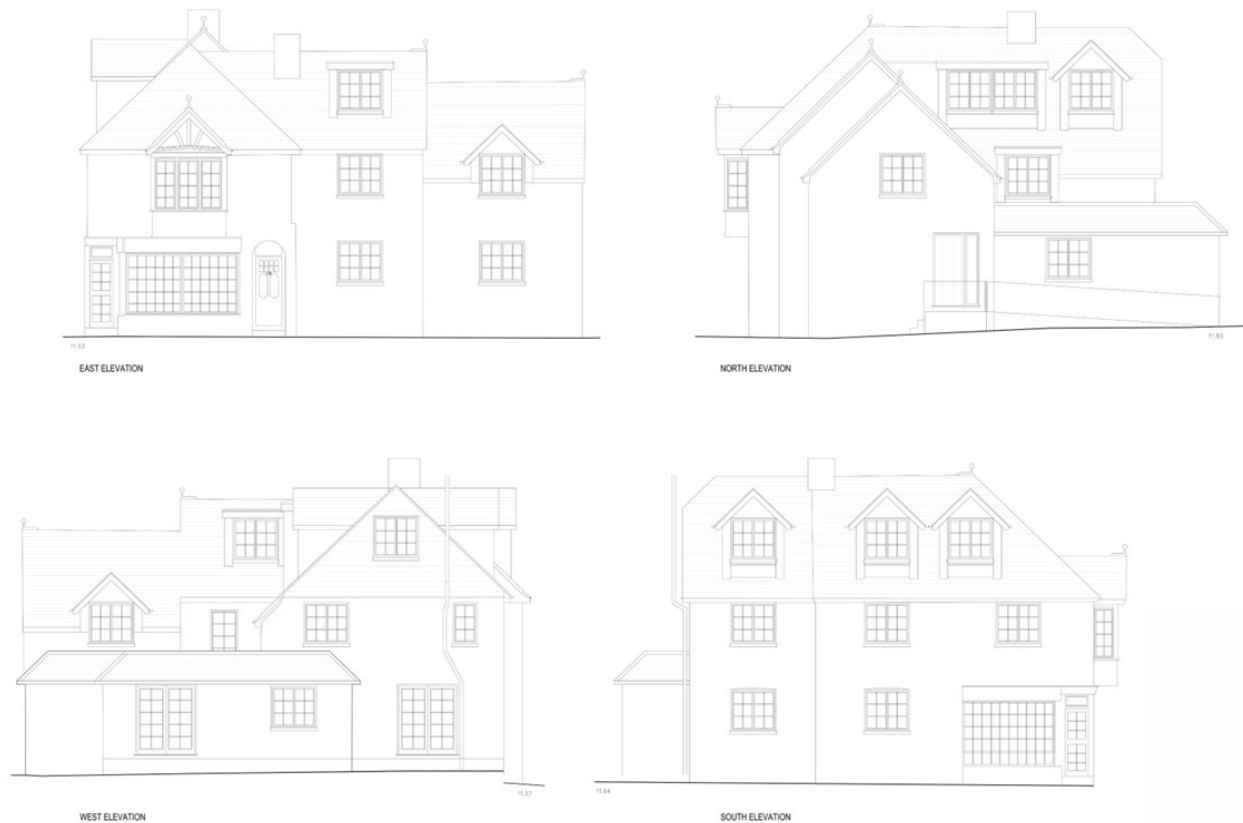
Figure 2: The proposed plans

Addition of 2 roof dormers to the High Street and one to the side street.

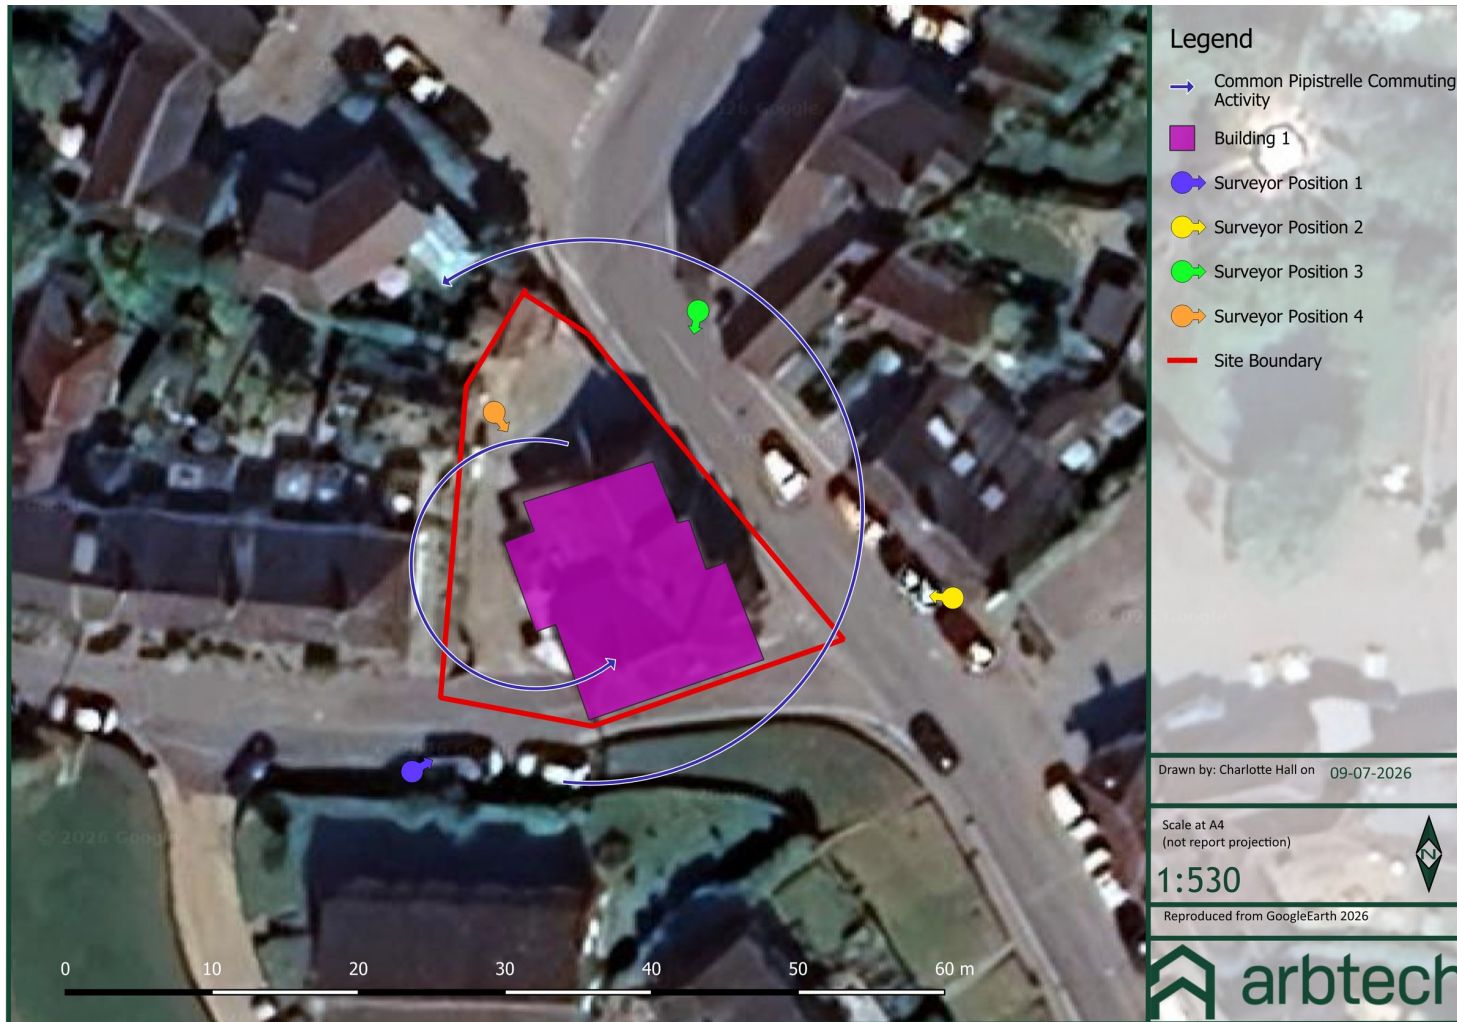
## Appendix 1: BERS plan

A diagram of the positions on site can be found in Appendix 1 along with the position images.

The arrangement of surveyors and equipment was informed by the Preliminary Roost Assessment (structures) and/or tree assessment (PRFs/GLTA) so that identified roosting features and likely access points were the focus of coverage, while recognising that bats may emerge from unexpected locations (BCT 7.2.12). Where NVAs were deployed, a still image or screenshot was captured from the darkest point of the survey from each NVA to demonstrate field of view and adequacy of illumination; these are provided in 3 (BCT 7.2.10). Surveyor and equipment positions for each survey visit are shown on Appendix 1.

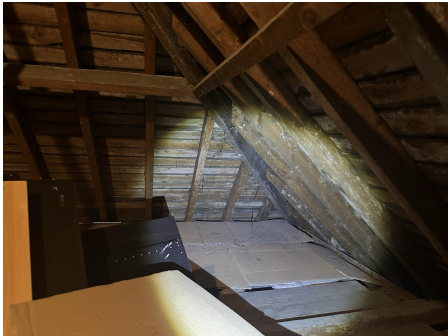
Internal void of B1
