**LEONARD AND PENELOPE WARNER**

WAPPINGTHORN LODGE, HORSHAM ROAD, STEYNING, BN44 3AA

**Contamination Risk Assessment**

June 2026

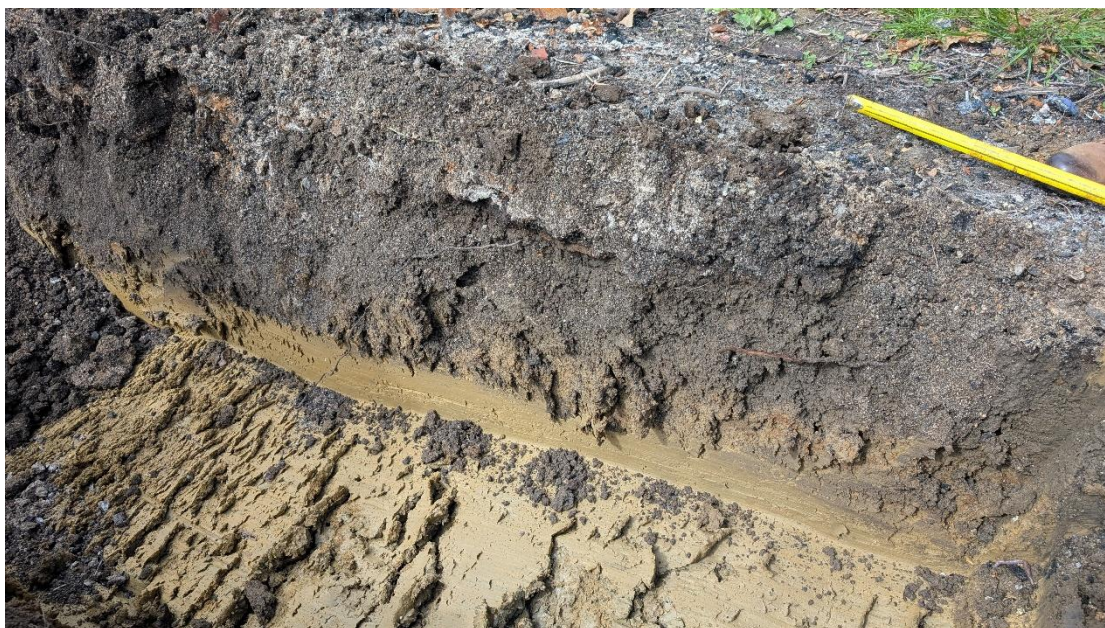
Trial pit 1

| TP1 | TP2 | TP3 |
|---|---|---|
| <i>Bonfire location</i><br>Surface bare ground with ash residues from green waste bonfire to 0.08 m bgl.<br>Dark brown clay subsoil to 0.28 m bgl.<br>Light brown clay natural ground to 0.5 m bgl. | <i>Rear of shed</i><br>Surface brambles down to 0.05 m bgl.<br>Mid-dark brown clayey topsoil to 0.20 m bgl.<br>Northside of trial pit consists of fill material chalk down to 0.40 m bgl.<br>South side of pit is natural ground consisting of light brown clay to 0.45 m bgl. | <i>Rear of stables</i><br>Disturbed topsoil ground with roots down to 0.25 m bgl.<br>Light brown clay fading to a mottled light brown/grey clay to 0.5 m bgl. |

- 7.1.1. Oil staining, unusual colouring, odour and other superficial indications of significant contamination were not noted in the trial pits. However, it was immediately apparent that the upper soil in TP1 contained ash residues from a green waste bonfire.
- 7.1.2. Photographs taken at the site during the current investigation are provided in Appendix B.

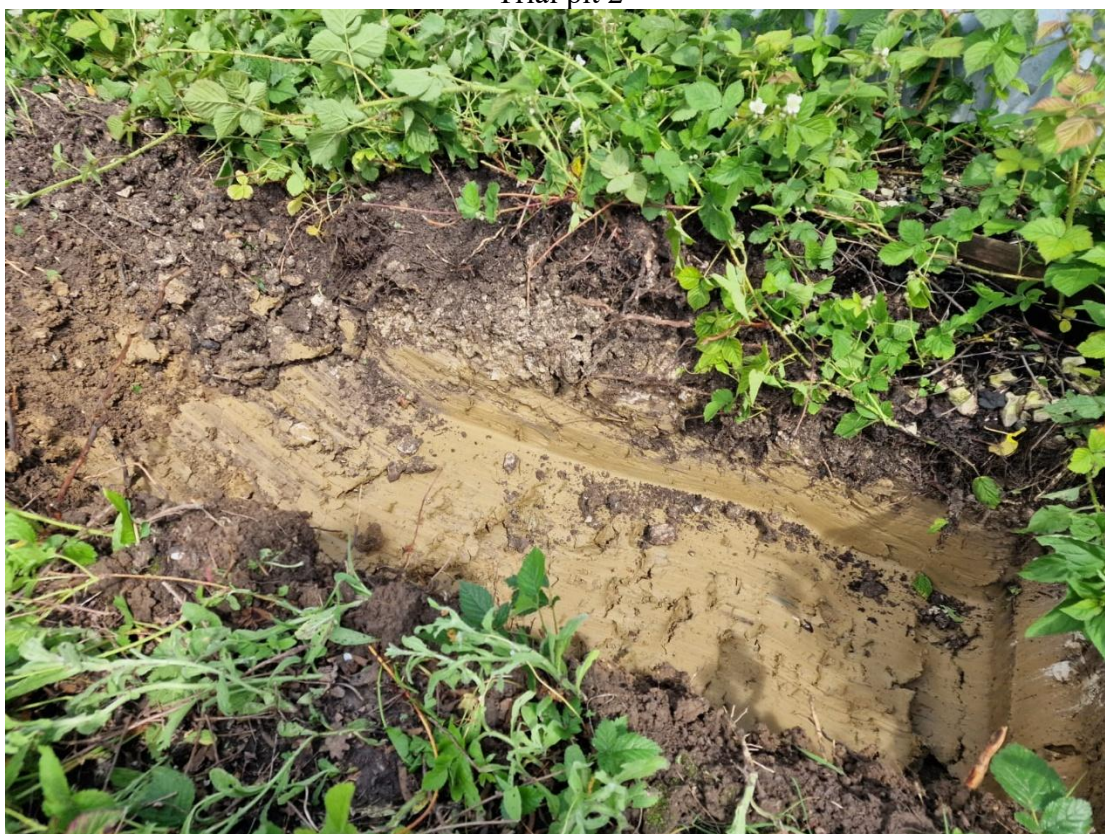
Trial pit 2

| Standpipe | Sampling | | | Strata | | | | |
|---|---|---|---|---|---|---|---|---|
| | | | | | 0.2 m | | Surface brambles<br>Mid-dark brown clayey topsoil<br><br>North side chalk fill<br>South side light brown natural clay ground | |

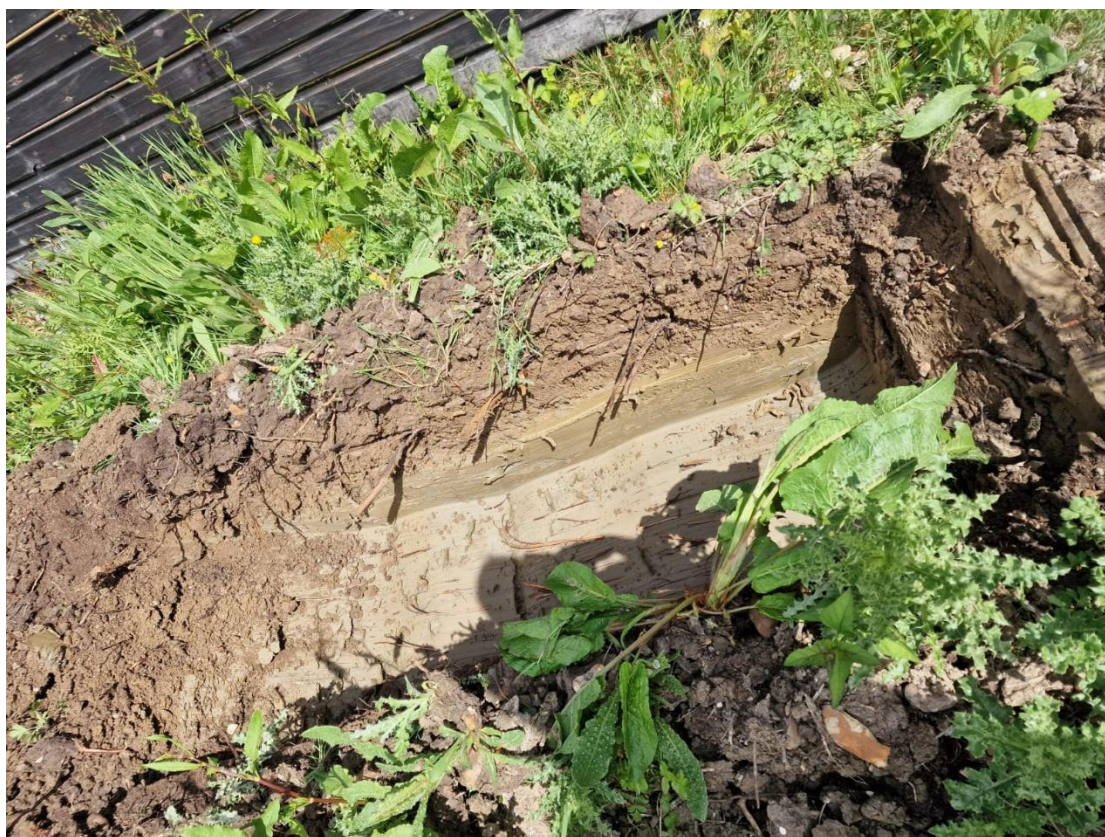
Trial pit 3

| | | <p>Disturbed ground, topsoil with roots.</p> <p>Light brown clay fading to mottled light brown/grey clay.</p> | | | | | | | | | | |
| Remarks | | | | | | |

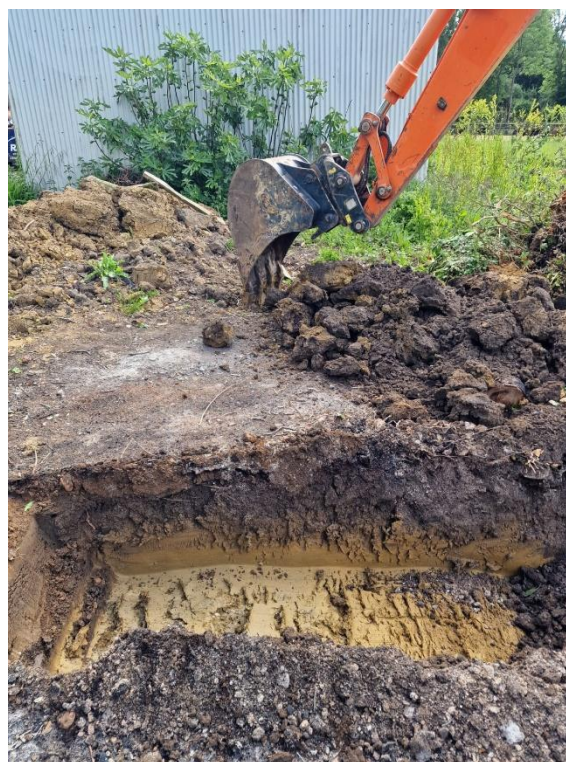
Trial pit 4

| Standpipe | Sampling | | | Strata | | | | |
|---|---|---|---|---|---|---|---|---|
| | | | | | 0.15 m<br>0.25 m<br>0.5 m | | Topsoil<br><br>Chalk<br><br>Light brown clay | |

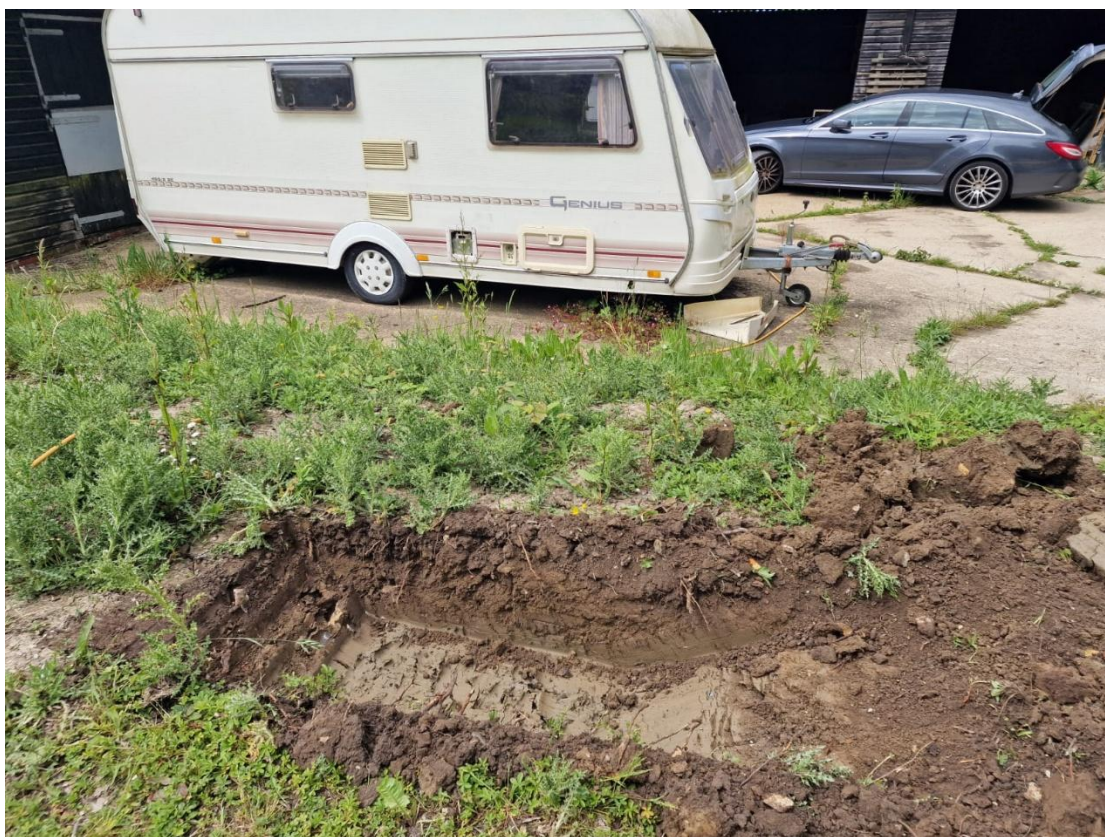
Trial pit 5

| Standpipe | Sampling | | | Strata | | | | |
|---|---|---|---|---|---|---|---|---|
| | | | | <br>0.25 m<br><br>0.35 m | | Clayey midbrown topsoil<br><br>Light brown clay fading to mottled light brown/grey clay. | | |

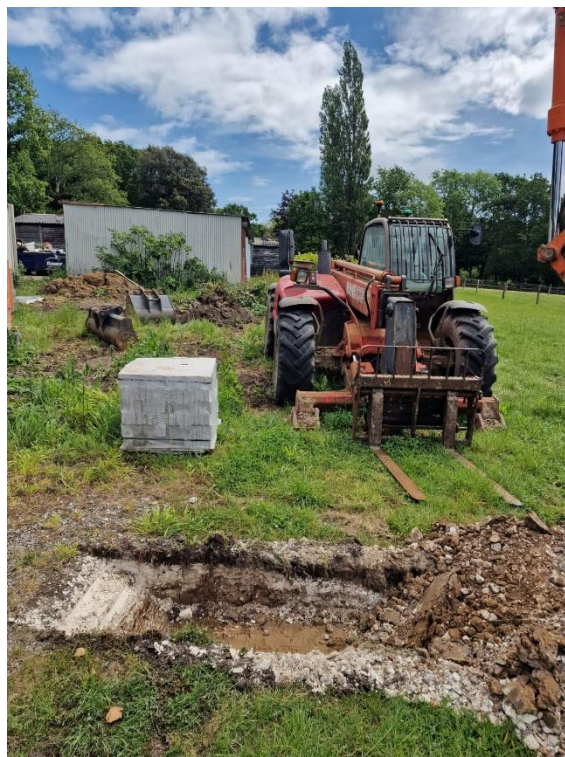
Trial pit 6

| TP1 | TP2 | TP3 |
|---|---|---|
| <i>Immediate east of yard area</i><br>Topsoil to 0.15 m bgl.<br>Chalk to 0.25 m bgl.<br>Light brown clay to 0.5 m bgl. | <i>East of yard area</i><br>Clayey brown topsoil to 0.25 m bgl.<br>Light brown clay fading to a mottled light brown/grey clay to 0.35 m bgl. | <i>West of existing driveway</i><br>Ground check revealed shallow topsoil chalk over clay. |
