## Bat Emergence and Re-Entry Surveys (BERS)

Cedar Cottage, Lower Beeding. RH13 6LR

14<sup>th</sup> April 2026

“The construction of ~24 dwellings.”

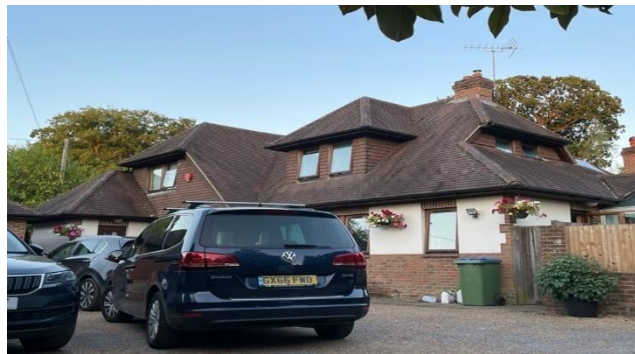
| Results | | | | | | |
|---|---|---|---|---|---|---|
| Surveyor 1 | | <b>Emergences observed - None</b><br><b>Species</b> – Common pipistrelle, soprano pipistrelle, Myotis<br><b>Summary of general activity:</b> Bat activity was recorded between 21:52 and 22:41, comprising Common Pipistrelle, Soprano Pipistrelle, and Myotis species. Most of the activity was attributed to Common Pipistrelle, with intermittent heard not seen recordings from Soprano Pipistrelle and Myotis species.<br><b>Flight paths</b> – Common pipistrelle seen circling the house and then travelling east<br><b>Foraging areas</b> – No Foraging behaviour observed | | | | |

Figure 1: Full elevation photo showing surveyors view.

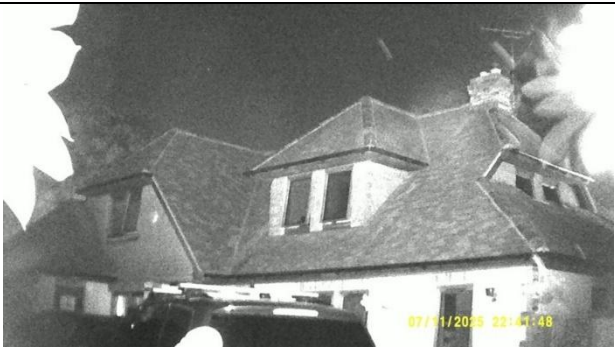
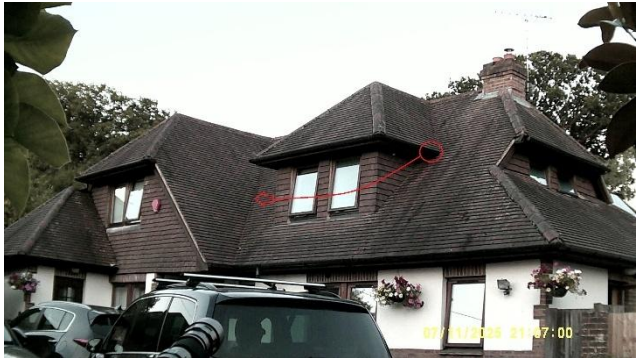
| <p><i>IR position 1</i><br/><i>Nightfox Whisker +</i><br/><i>Nightfox Torch XB5</i></p> | <p>Camera position: observing the northern elevation of B1<br/>Emergences observed: Yes</p> <p><b><u>Common pipistrelle day roost: Roost 1</u></b><br/>Number: 1<br/>Time: 21:07<br/>Location of access point: Junction between the dormer window and the main roof slope on northern elevation<br/>Direction of travel on emergence: North<br/>Species ID confirmed on site by sound analysis</p> <p>No other notable activity recorded</p> | <p>Figure 2: Darkest point</p> <p>Figure 3: Annotated image showing the place of common pipistrelle emergence from roost 1 and direction of travel</p> |

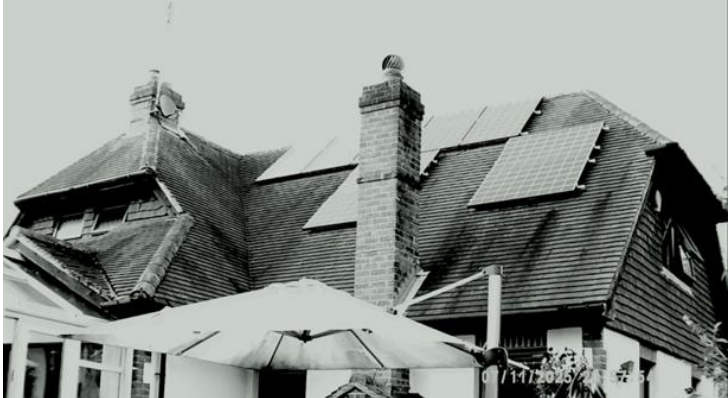
| <p><i>Surveyor 2</i></p> | <p><b>Emergences observed - None</b></p> <p><b>Species</b> – common pipistrelle, soprano pipistrelle, Myotis</p> <p><b>Summary of general activity:</b> frequent Common Pipistrelle foraging within the southern and western gardens, with additional observations near the northern chimney. Occasional activity by Noctule, Soprano Pipistrelle, and Myotis species was also recorded.</p> <p><b>Flight paths</b> - Common Pipistrelles were frequently recorded commuting around the building, particularly near the northern chimney and to the west of the property, with occasional passes by Noctule and Myotis species.</p> <p><b>Foraging areas</b> – Sustained foraging activity by Common Pipistrelles was concentrated within the gardens to the south of the building, with additional activity noted to the west.</p> | <p>Figure 4: Full elevation photo showing surveyors view</p> |

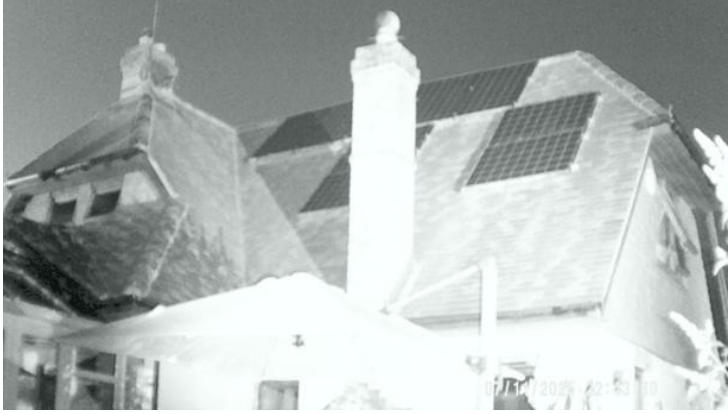
| <p><i>IR position 2</i><br/><i>Nightfox Whisker +</i><br/><i>Nightfox Torch XB5</i></p> | <p>Camera position: observing the western elevation of B1</p> <p>Emergences observed: Yes</p> <p><b><u>Common pipistrelle day roost: Roost 2</u></b></p> <p>Number: 1</p> <p>Time: 21:53</p> <p>Location of access point: Gap beneath roof tiles beneath the junction of the dormer roof and the conservatory roof.</p> <p>Direction of travel on emergence: North</p> <p>Species ID confirmed on site by sound analysis</p> <p>No other notable activity recorded</p> | <p>Figure 5: Darkest point</p> |

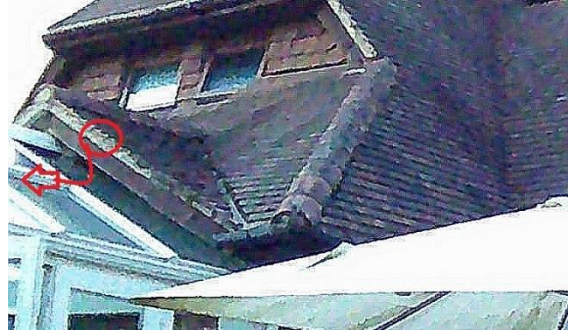
| | | <p>Figure 6: Annotated image showing the place of common pipistrelle emergence from roost 2 and direction of travel</p> |

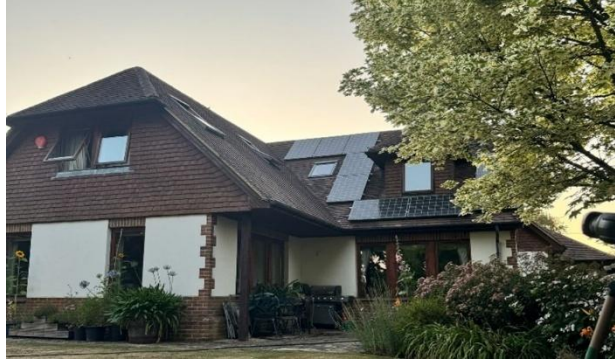
| Surveyor 3 | <p><b>Emergences observed - None</b></p> <p><b>Species</b> – common pipistrelle</p> <p><b>Summary of general activity:</b></p> <p><b>Flight paths</b> – A Common Pipistrelle at 21:44 flew southeast over surveyors head going northwest.</p> <p><b>Foraging areas</b> – Common pipistrelle where observed circling and foraging around the garden at 22:18</p> | <p>Figure 7: Full elevation photo showing surveyors view</p> |

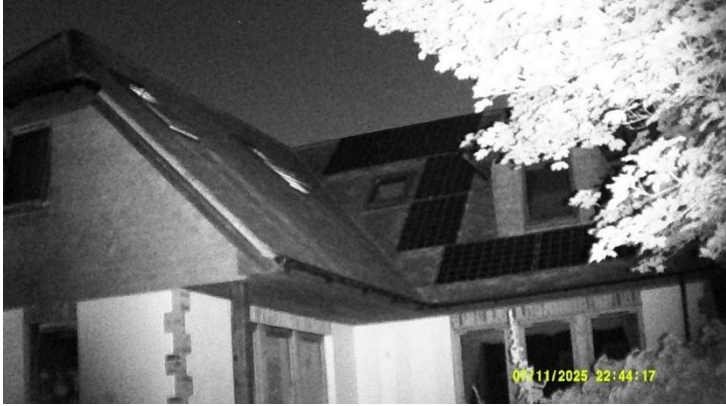
| <i>IR position 3</i><br><i>Nightfox Whisker +</i><br><i>Nightfox Torch XB5</i> | Camera position: observing southern elevation of B1<br>Emergences observed: None<br>No additional observations or bat activity recorded upon review | |

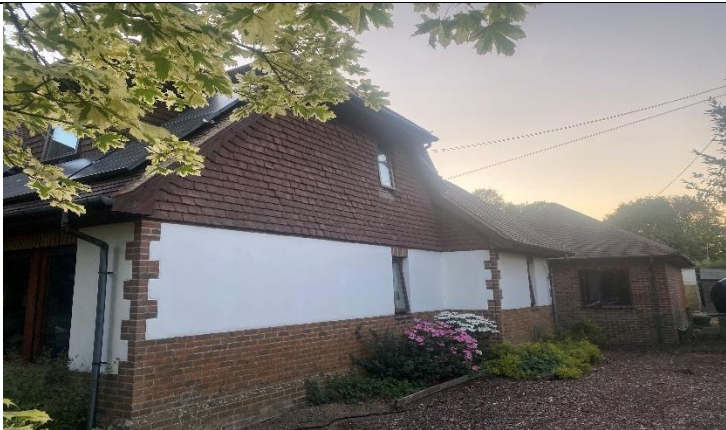
| <i>Surveyor 4</i> | <b>Emergences observed - None</b><br><b>Species</b> – Common pipistrelle, soprano pipistrelle<br><b>Summary of general activity:</b> Common pipistrelle commuting and foraging behaviour observed between 21:45 and 21:18. One soprano pipistrelle was heard not seen at 22:33<br><b>Flight paths</b> – Frequent common pipistrelle passes seen travelling north to south along western elevation<br><b>Foraging areas</b> – Common pipistrelle feeding activity was observed throughout the and was concentrated along the western elevation | |

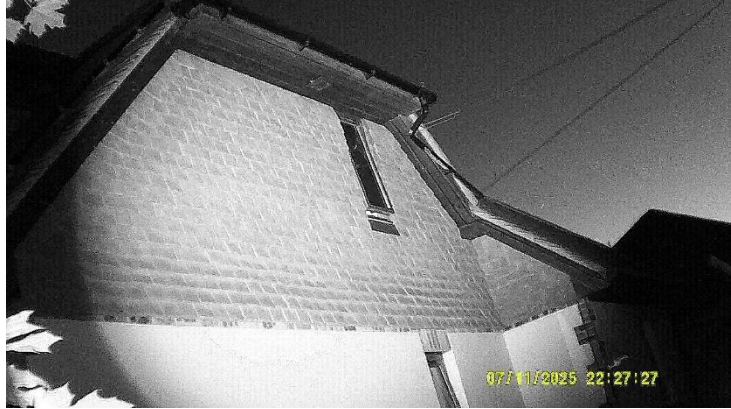
| <i>IR position 4</i><br><i>Nightfox Whisker +</i><br><i>Nightfox Torch XB5</i> | Camera position: observing western elevation of B1<br>Emergences observed: None<br>No additional observations or bat activity recorded upon review | <p>Figure 10: Darkest point</p> |

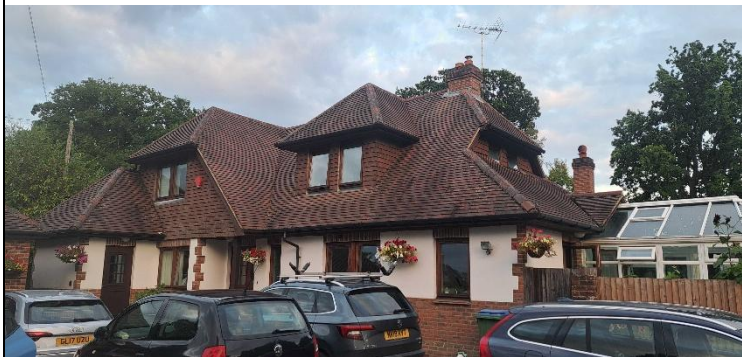
| Results | | | | | | |
|---|---|---|---|---|---|---|
| Surveyor 1 | | <b>Emergences observed - None</b><br><b>Species</b> – Common pipistrelle, soprano pipistrelle, Myotis, serotine, noctule<br><b>Summary of general activity:</b> The survey recorded Common Pipistrelle, Soprano Pipistrelle, Noctule, Serotine, Myotis (including Daubenton's), and long-eared bats. Foraging was noted over the driveway and along a southeast–north flight line.<br><b>Flight paths</b> – Bats were observed commuting along the southern elevation, across the northwest boundary hedgerow, and repeatedly along a southeast–north axis through the site.<br><b>Foraging areas</b> - Foraging activity was concentrated over the driveway (long-eared species) and along the southeast–north flight path, with Daubenton's Myotis actively foraging on multiple occasions. | | | <p>Figure 11: Full elevation photo showing surveyors view.</p> | |

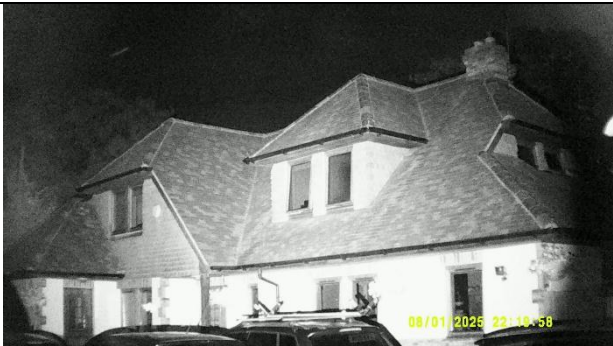
| <p><i>IR position 1</i><br/> <i>Nightfox Whisker +</i><br/> <i>Nightfox Torch XB5</i></p> | <p>Camera position: observing the northern elevation of B1<br/> Emergences observed: Yes</p> <p>No other notable activity recorded</p> | <p>Figure 12: Darkest point</p> |

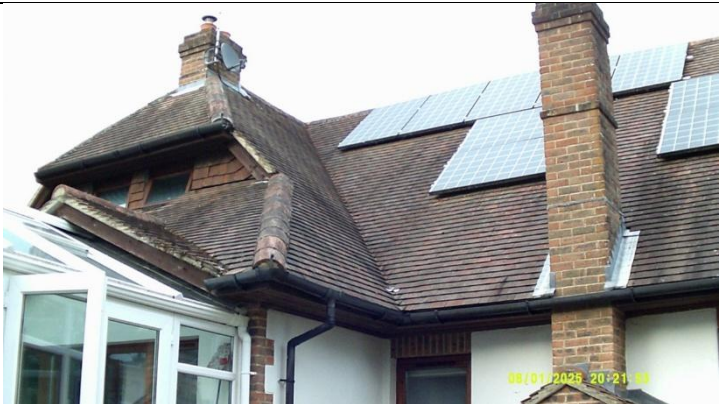
| <p><i>Surveyor 2</i></p> | <p><b>Emergences observed – Yes</b><br/> <b><u>Common pipistrelle day roost: Roost 3</u></b><br/> Number: 1<br/> Time(s): 20:58<br/> Location of access point(s): Lead flashing at the base of the northern most chimney<br/> Direction(s) of travel on emergence: South<br/> Species ID confirmed on site by sound analysis.<br/> <b>Species</b> – Common pipistrelle, soprano pipistrelle, myotis<br/> <b>Summary of general activity:</b> One emergence observed. At 21:06 there was constant foraging in the southern garden. Myotis and soprano pipistrelle calls were recorded but were heard not seen<br/> <b>Flight paths</b> – Common pipistrelle were observed to be flying north over the building between 21:28 and 21:42<br/> <b>Foraging areas</b> – Foraging behaviour was observed in the garden to the south of B1.</p> | <p>Figure 13: Full elevation photo showing surveyors view</p> |

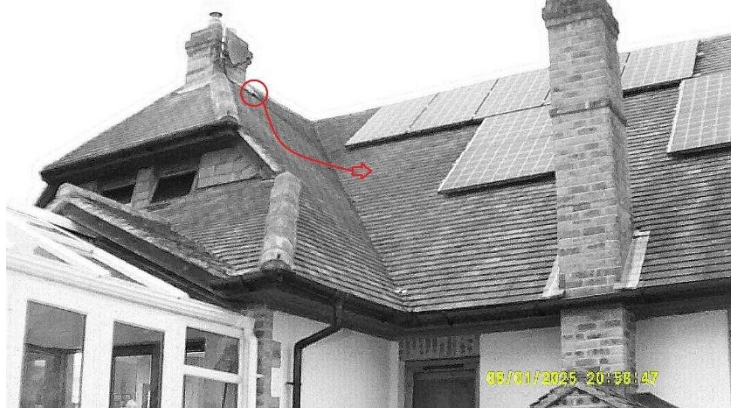
| | | <p>Figure 14: Annotated image showing the place of common pipistrelle emergence from roost 3 and direction of travel</p> |

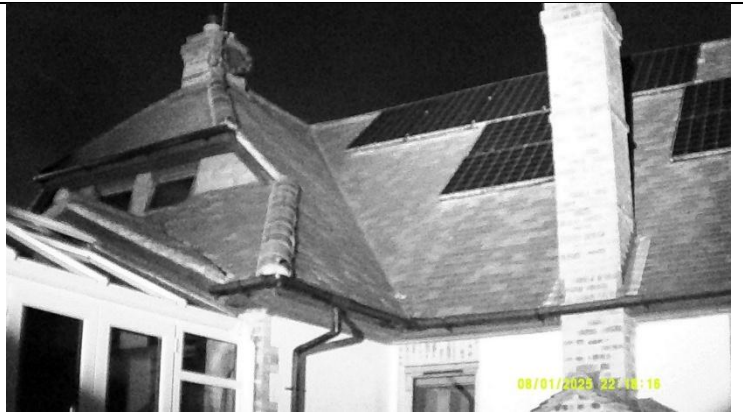
| <i>IR position 2</i><br><i>Nightfox Whisker +</i><br><i>Nightfox Torch XB5</i> | Camera position: observing the western elevation of B1<br>Emergences observed: None<br><br>No other notable activity recorded | <p>Figure 15: Darkest point</p> |

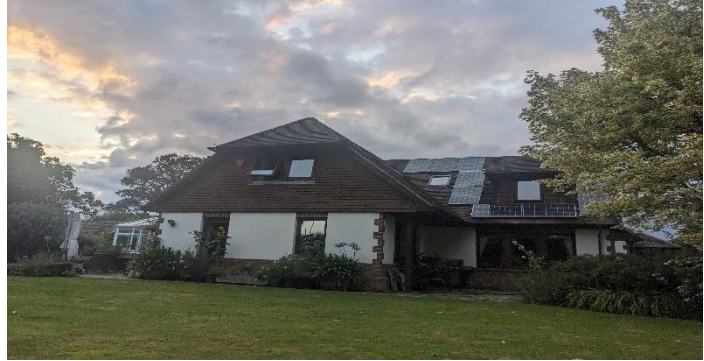
| <i>Surveyor 3</i> | <p><b>Emergences observed - None</b></p> <p><b>Species</b> – Common pipistrelle, noctule</p> <p><b>Summary of general activity:</b> Constant common pipistrelle activity throughout the evening as well as a noctule heard not seen</p> <p><b>Flight paths</b> – A common Pipistrelle at 21:00 flew southwest from the dormer window</p> <p><b>Foraging areas</b> – Common pipistrelle where observed circling and foraging around the garden at 21:06</p> | |

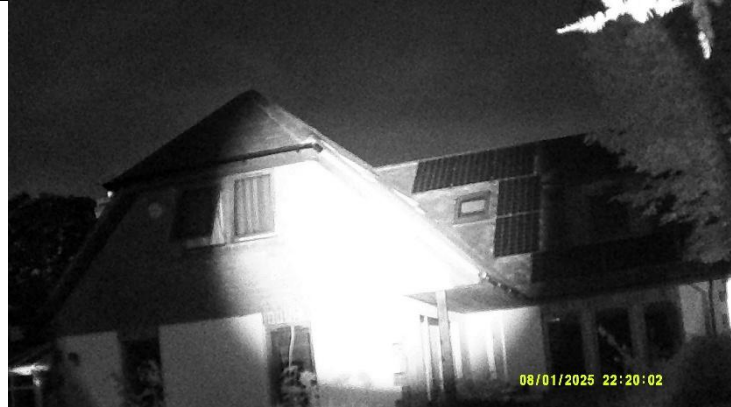
| <i>IR position 3</i><br><i>Nightfox Whisker +</i><br><i>Nightfox Torch XB5</i> | <p>Camera position: observing southern elevation of B1</p> <p>Emergences observed: None</p> <p>No additional observations or bat activity recorded upon review</p> | |

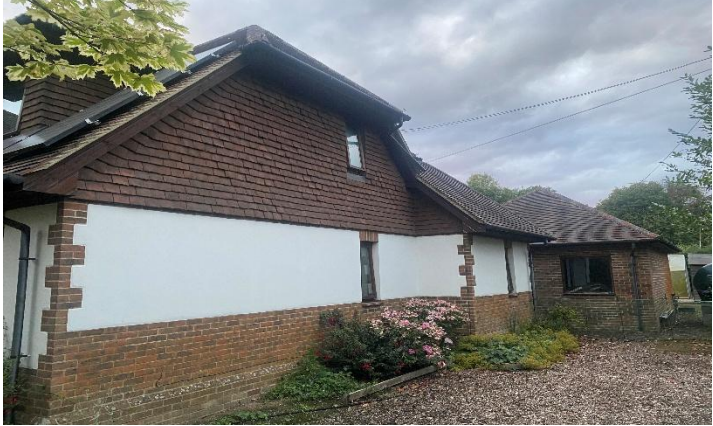
| <i>Surveyor 4</i> | <b>Emergences observed - None</b><br><b>Species</b> – common pipistrelle,<br><b>Summary of general activity:</b> Constant common pipistrelle activity between 21:06 and 22:04 consisting of foraging behaviour.<br><b>Flight paths</b> – Frequent common pipistrelle passes seen travelling north to south along western elevation<br><b>Foraging areas</b> – Common pipistrelle feeding activity was observed throughout the and was concentrated along the western elevation. | <p>Figure 18: Full elevation photo showing surveyors view</p> |

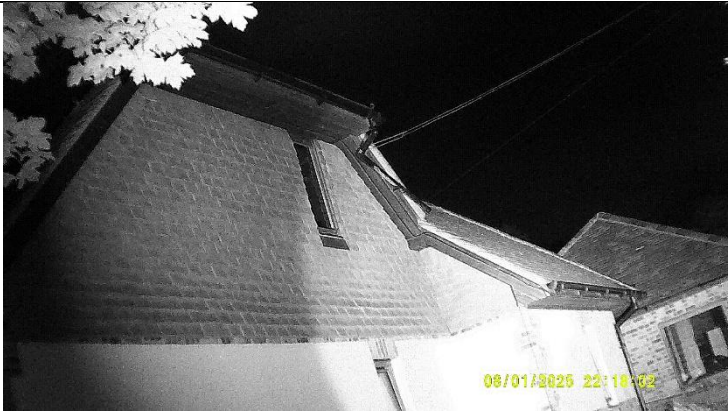
| <i>IR position 4</i><br><i>Nightfox Whisker +</i><br><i>Nightfox Torch XB5</i> | Camera position: observing western elevation of B1<br>Emergences observed: None<br>No additional observations or bat activity recorded upon review | <p>Figure 19: Darkest point</p> |

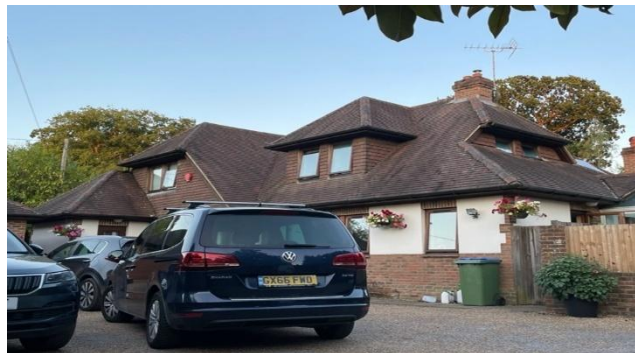
| Results | | | | | | |
|---|---|---|---|---|---|---|
| Surveyor 1 | | <b>Emergences observed – Yes</b><br><b><u>Common pipistrelle day roost:</u></b> Roost 4<br>Number: 3<br>Time(s): 20:20,20:32,20:42<br>Location of access point (s): lifted lead flashing to the bottom left of the westerly chimney stack on the north facing elevation.<br>Direction(s) of travel on emergence:<br>1 <sup>st</sup> – Northwestern<br>2 <sup>nd</sup> – West<br>3 <sup>rd</sup> – West<br>Species ID confirmed on site by sound analysis<br><b>Summary of general activity:</b> Common pipistrelles emerged from the western chimney at 20:20 and 20:32 and 20:42 with continuous activity including foraging, passes, and social calls recorded until 21:38. A noctule was heard in flight at 20:36 and a brown long-eared bat was recorded at 21:13. | | | <p>Figure 20: Full elevation photo showing surveyors view.</p> | |

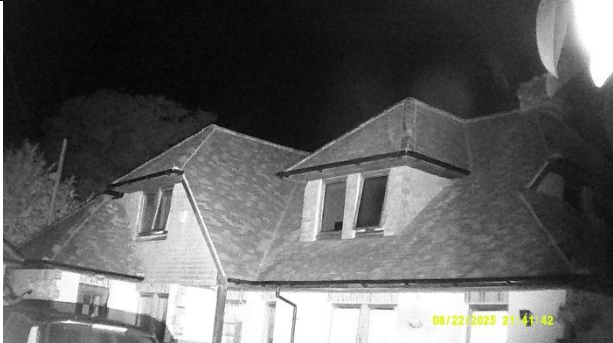
| <p><i>IR position 1</i><br/> <i>Nightfox Whisker +</i><br/> <i>Nightfox Torch XB5</i></p> | <p>Camera position: observing the northern elevation of B1</p> <p>Emergences observed: None</p> <p>No other notable activity recorded</p> | <p>Figure 22: Darkest point</p> |

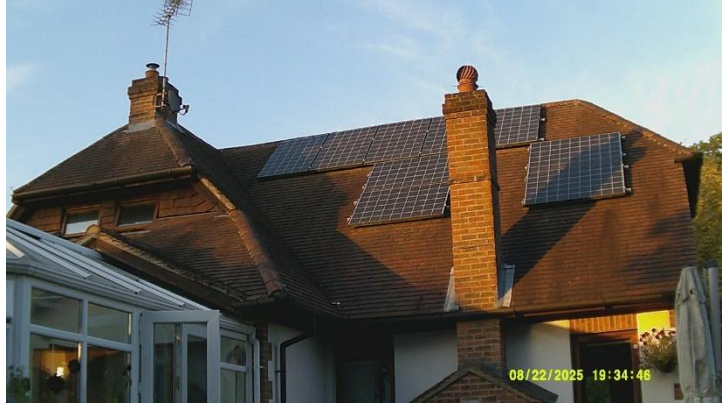
| <i>Surveyor 2</i> | <p><b>Emergences observed - None</b></p> <p><b>Species</b> – Common pipistrelle, noctule, soprano pipistrelle, brown long-eared, myotis</p> <p><b>Summary of general activity:</b> Noctules were recorded at 20:16, 20:28, 20:35, 21:14 and 21:19. A pipistrelle was seen near the northern chimney at 20:20, with common pipistrelles active from 20:33 and foraging continuously 21:02–21:36. A myotis species (likely Daubenton's) was heard at 21:15, brown long-eared bats foraged 21:26–21:35, and a soprano pipistrelle was heard at 21:37.</p> <p><b>Flight paths</b> – Common pipistrelles were recorded following flight paths around the NW elevation, including pipistrelle activity moving north–south at 20:33 and eastward over head of surveyor at 20:49.</p> <p><b>Foraging areas</b> – Foraging activity was concentrated around the NW elevation, with common pipistrelles active between 21:02 and 21:36 and brown long-eared bats foraging between 21:26 and 21:35.</p> | <p>Figure 23: Full elevation photo showing surveyors view</p> |

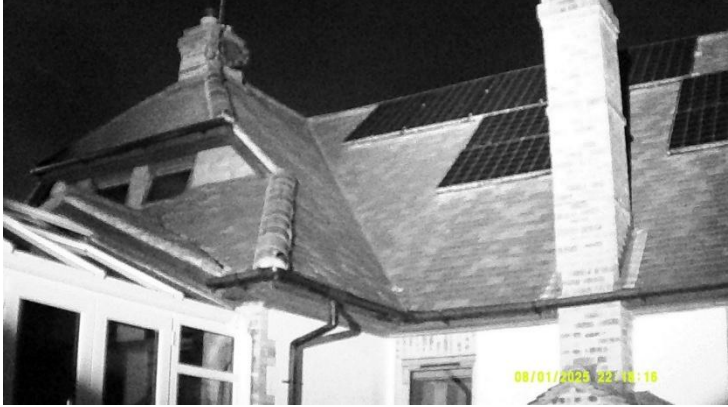
| <p><i>IR position 2</i><br/> <i>Nightfox Whisker +</i><br/> <i>Nightfox Torch XB5</i></p> | <p>Camera position: observing the western elevation of B1<br/> Emergences observed: Yes</p> <p>No other notable activity recorded</p> | <p>Figure 24: Darkest point</p> |

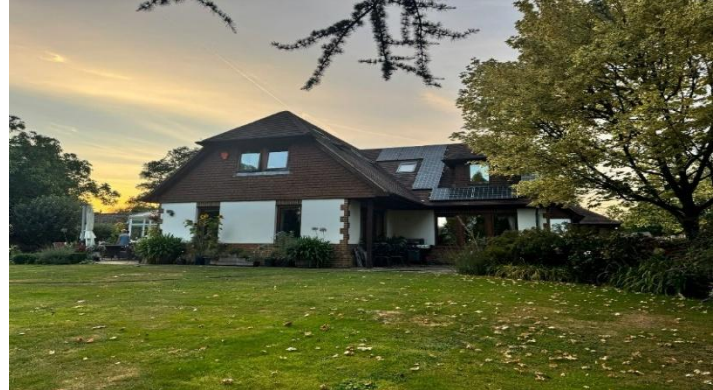
| <p><i>Surveyor 3</i></p> | <p><b>Emergences observed - None</b><br/> <b>Species</b> – Common pipistrelle<br/> <b>Summary of general activity:</b><br/> <b>Flight paths</b> – Common pipistrelles were observed flying west at 20:22, southwest to northeast at 20:45, and north to south between 21:04 and 21:08.<br/> <b>Foraging areas</b> – Foraging activity by common pipistrelles was concentrated in the garden between 21:04 and 21:08.</p> | <p>Figure 25: Full elevation photo showing surveyors view</p> |

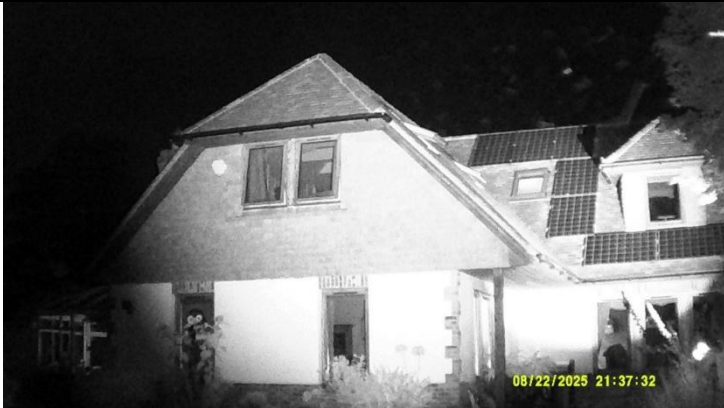
| <p><i>IR position 3</i><br/> <i>Nightfox Whisker +</i><br/> <i>Nightfox Torch XB5</i></p> | <p>Camera position: observing southern elevation of B1<br/> Emergences observed: None<br/> No additional observations or bat activity recorded upon review</p> | <p>Figure 26: Darkest point</p> |

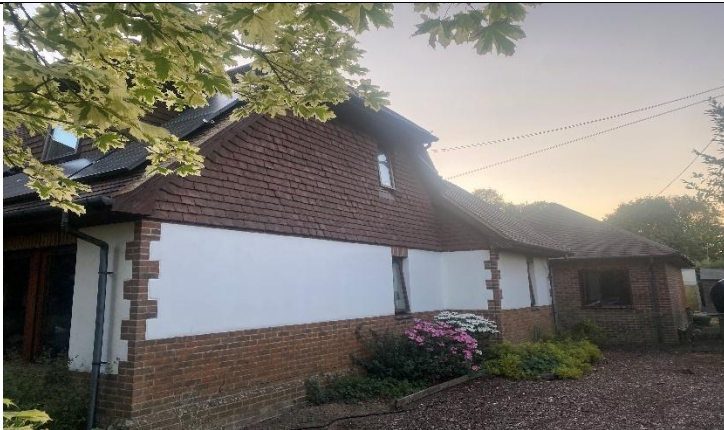
| <p><i>Surveyor 4</i></p> | <p><b>Emergences observed - None</b><br/> <b>Species</b> – Common pipistrelle, soprano pipistrelle, noctule, myotis<br/> <b>Summary of general activity:</b> constant pipistrelle feeding and commuting behaviour from 20:40 to 21:29. One noctule was heard not seen at 20:31 and one myotis was heard not seen at 21:09<br/> <b>Flight paths</b> – common pipistrelle and soprano pipistrelle passes where observed between 20:40 and 21:29 flying north to south and south to north.<br/> <b>Foraging areas</b> – Common pipistrelle foraging behaviour was observed between 21:09 and 21:29 long the eastern elevation</p> | <p>Figure 27: Full elevation photo showing surveyors view</p> |

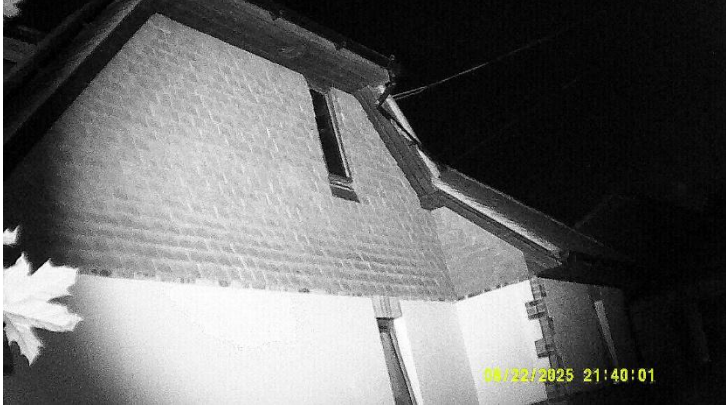
| <i>IR position 4</i><br><i>Nightfox Whisker +</i><br><i>Nightfox Torch XB5</i> | Camera position: observing western elevation of B1<br>Emergences observed: None<br>No additional observations or bat activity recorded upon review | <br>Figure 28: Darkest point |

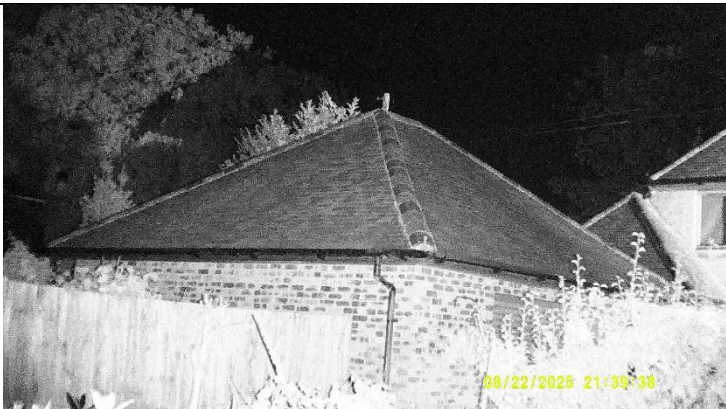
| <i>IR position 5</i><br><i>Nightfox Whisker +</i><br><i>Nightfox Torch XB5</i> | Camera position: Observing western and northern elevation of B2<br>Emergences observed: None<br>No additional observations or bat activity recorded upon review | <br>Figure 29: Darkest point |
