WS17  
GE20724

| Unit 7, Danworth Farm<br>Hurstpierpoint<br>BN6 9GL<br>www.gesl.net | | | | <h1>Borehole Log</h1> | | | | Borehole No.<br><b>WS19</b><br>Sheet 1 of 1 | |
|---|---|---|---|---|---|---|---|---|---|
| Project Name: North Horsham II | | | | Project No. GE20724 | | Co-ords: 519850E - 133227N | | Hole Type<br>WLS | |
| Location: Horsham | | | | Level: 64.41 | | Scale<br>1:25 | | | |
| Client: Legal & General | | | | Dates: 12/05/2022 | | Logged By<br>KO | | | |

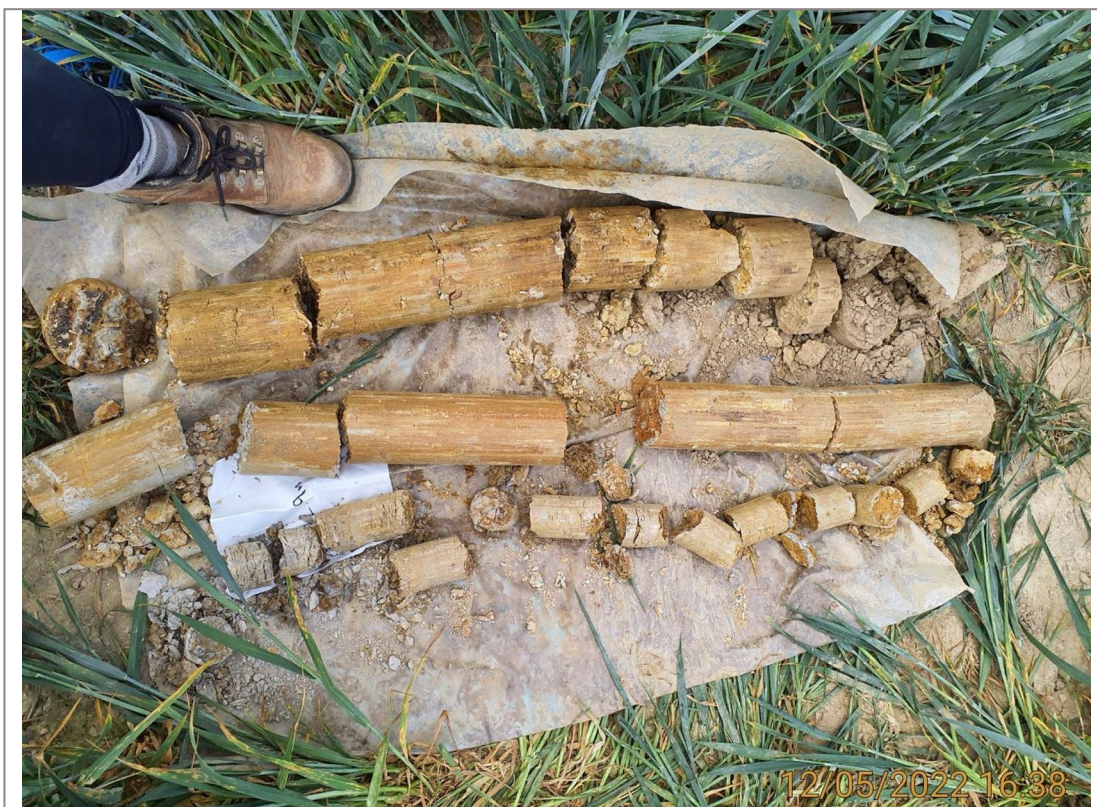
**Image 1.** 1652369838473.jpg:  
WindowSamplerPhoto

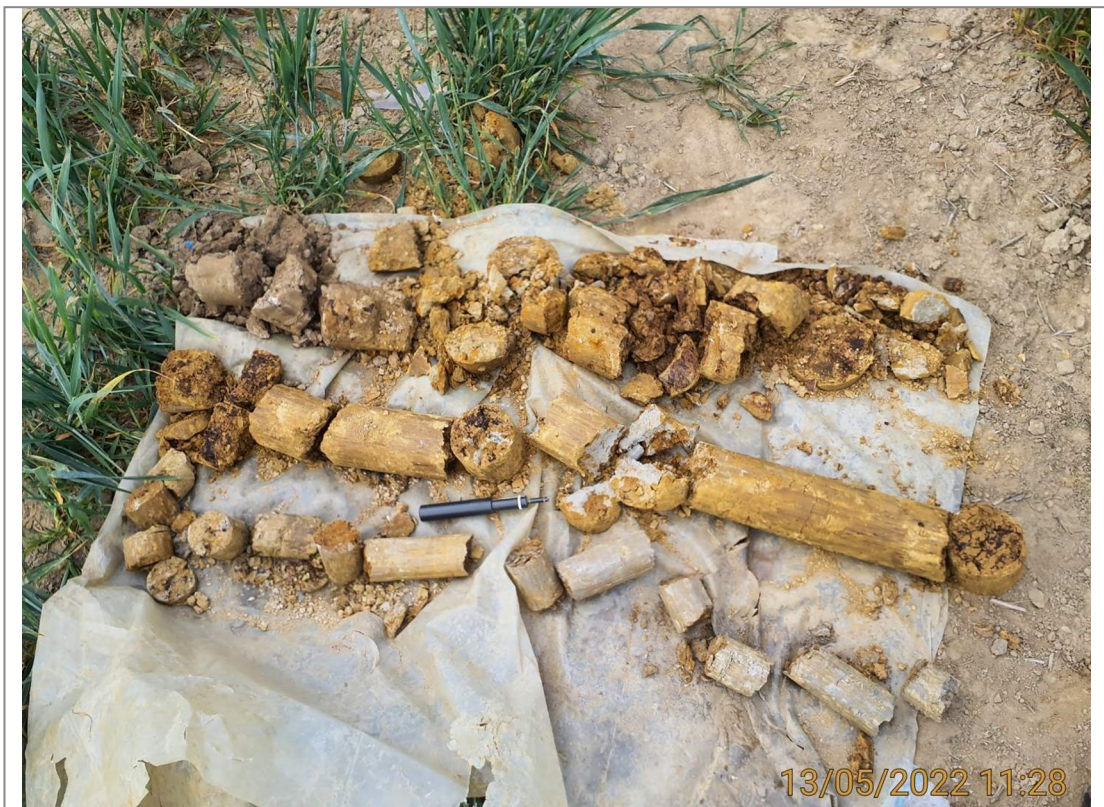
WS18  
GE20724

**Image 1.** 1652437658710.jpg:  
WindowSamplerPhoto

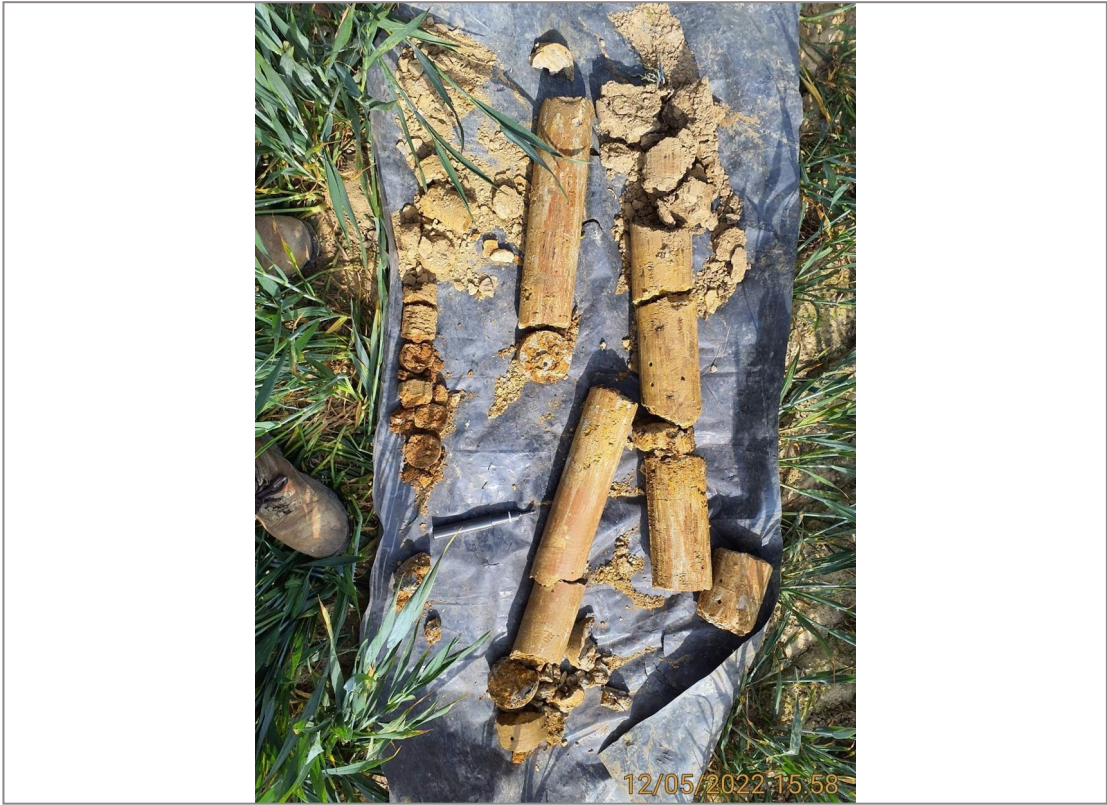
Image 1. 1652367507790.jpg:  
WindowSamplerPhoto

| Unit 7, Danworth Farm<br>Hurstpierpoint<br>BN6 9GL<br>www.gesl.net | | | | <h1>Borehole Log</h1> | | | | Borehole No.<br><b>WS19</b><br>Sheet 1 of 1 | |
|---|---|---|---|---|---|---|---|---|---|
| | | 0.10 | ES | 4.4kg/cm2 | 0.30 | 64.10 | | Brown silty clay with abundant rootlets.<br>TOPSOIL | |
| | | 0.50 | D | | | | 4.3kg/cm2 | | Very stiff orangish brown and pale grey silty CLAY with black ferruginous fragments.<br>TUNBRIDGE WELLS SAND |
| | | 1.00 | D | 3.9kg/cm2 | | Very stiff reddish orange silty sandy CLAY with frequent siltstone inclusions.<br>TUNBRIDGE WELLS SAND | | | |

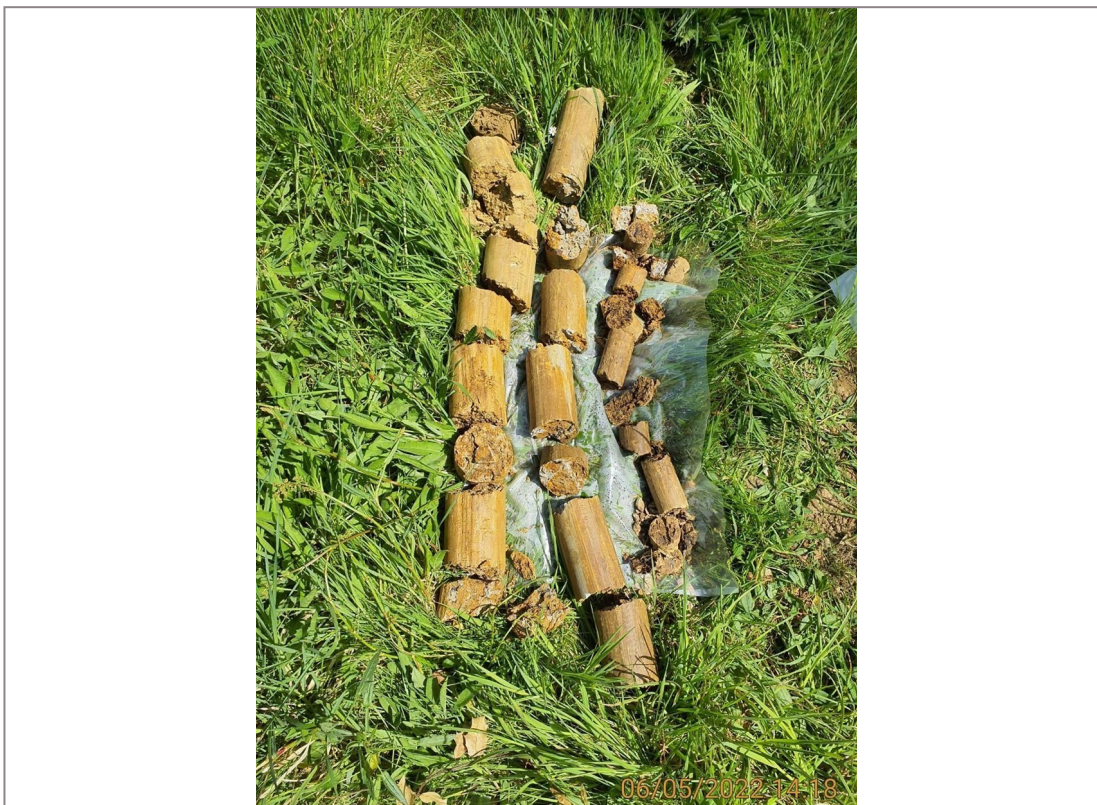
WS20  
GE20724

**Image 1.** 1651843094460.jpg:  
WindowSamplerPhoto

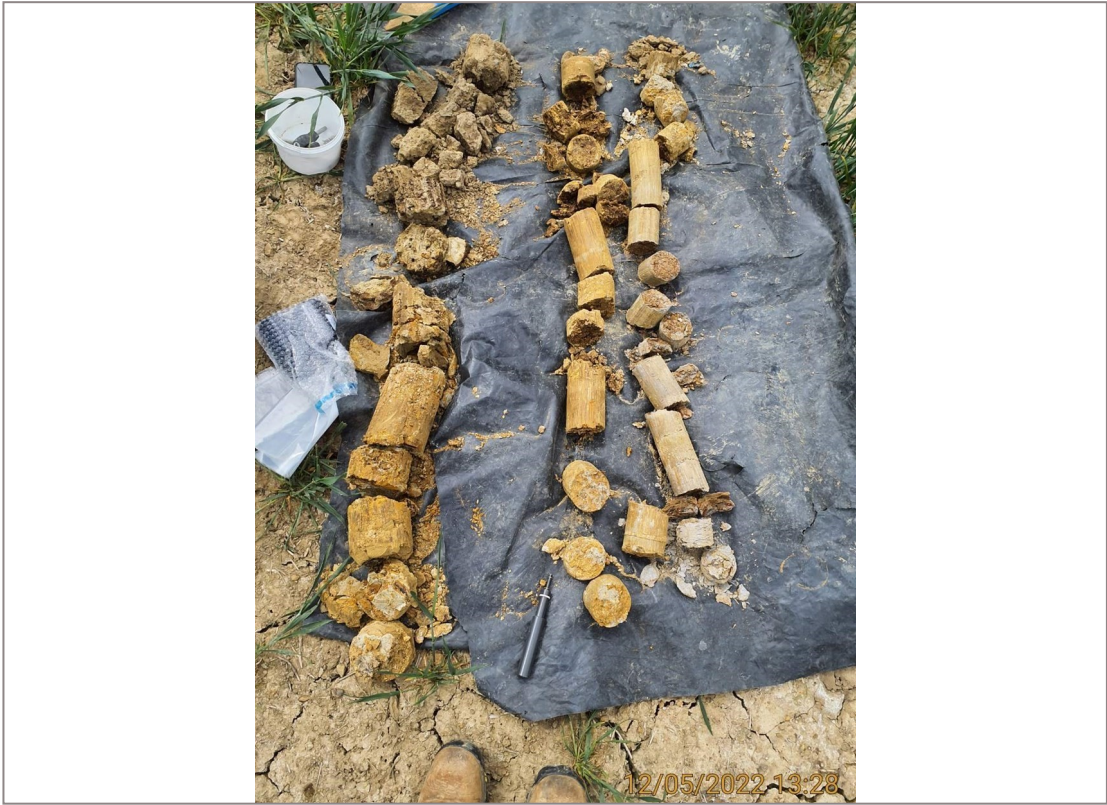
Image 1. 1652358488929.jpg:  
WindowSamplerPhoto

| Well | Water Strikes | Sample and In Situ Testing | | | Depth (m) | Level (m) | Legend | Stratum Description | |
|---|---|---|---|---|---|---|---|---|---|
| | | 0.10 | ES | 4.0kg/cm2 | 0.30 | 66.45 | | Brown silty CLAY with black flecking. TOPSOIL | 1 |
| | | 0.50 | D | | 1.10 | 65.65 | | Orangish brown and grey sandy gravelly CLAY with black ferruginous fragments. Sand is fine. Gravel is fine to coarse sub angular sandstone. TUNBRIDGE WELLS SAND | |
| | | 1.00 | D | 5.0kg/cm2 | 1.70 | 65.05 | | Brown and black silty clayey iron stained weakly cemented sandstone gravel. TUNBRIDGE WELLS SAND | 2 |
| | | 2.00 | D | | 2.30 | 64.45 | | Stiff orangish brown and pale grey silty CLAY with black ferruginous fragments. TUNBRIDGE WELLS SAND | |
| | | 2.00 | PP | | | | | Grey and reddish brown clayey weakly cemented SILT. TUNBRIDGE WELLS SAND | |

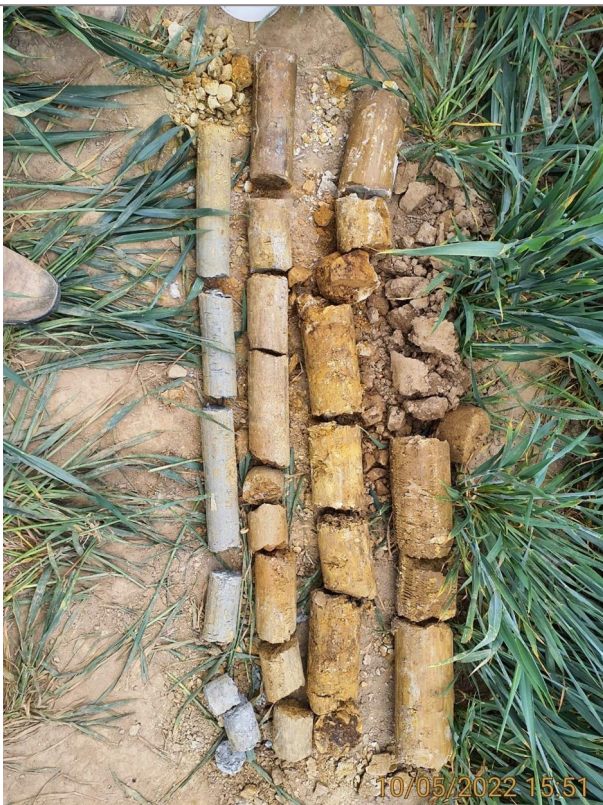
Image 1. 1652194299098.jpg:  
WindowSamplerPhoto

| Well | Water Strikes | Sample and In Situ Testing | | | Depth (m) | Level (m) | Legend | Stratum Description | |
|---|---|---|---|---|---|---|---|---|---|
| | | 0.20 | ES | | 0.30 | 58.63 | | Brown silty clay with abundant rootlets. TOPSOIL | |
| | | 0.50<br>0.50 | D<br>PP | 3.4kg/cm2 | | | | Very stiff pale grey and orangish brown silty CLAY with orange staining. WEALD CLAY<br><i>Some rootlets and roots 1-2mm.</i> | |
| | | 0.80 | ES | | 1.20 | 57.73 | | Stiff orangish brown and pale grey silty gravelly CLAY with black ferruginous fragments. Gravel is fine to coarse of siltstone and sandstone.. WEALD CLAY | |
| | | 2.50<br>2.50 | D<br>PP | 4.9kg/cm2 | 3.10 | 55.83 | | Very stiff bluish grey silty CLAY with some siltstone inclusions. WEALD CLAY | |

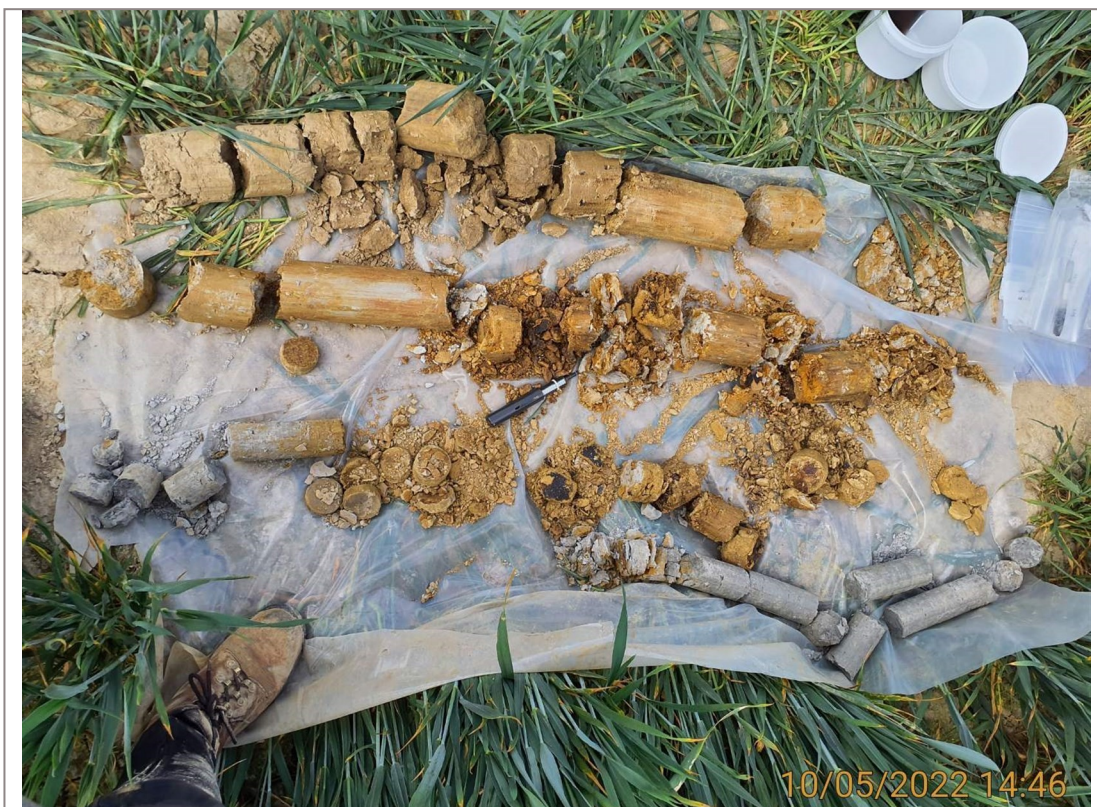
WS23  
GE20724

**Image 1.** 1652190360419.jpg:  
WindowSamplerPhoto

| Well | Water Strikes | Sample and In Situ Testing | | | Depth (m) | Level (m) | Legend | Stratum Description | |
|---|---|---|---|---|---|---|---|---|---|
| | | 0.30 | ES | 3.9kg/cm2 | 0.60 | 57.82 | Crop overlying brown silty clay with abundant rootlets and some orange staining.<br>TOPSOIL | | |
| | | 0.65<br>0.70 | D<br>ES | | | | | | Very stiff pale grey and orangish brown silty CLAY with orange and black ferruginous staining and some black fragments<br>WEALD CLAY<br><i>Some rootlets</i> |
| | | 1.00<br>1.00<br>1.00 | D<br>D<br>PP | | 1.40 | 57.02 | Pale grey and orange silty CLAY with occasional weakly cemented siltstone gravel.<br>WEALD CLAY | | |
| | | 2.00 | D | | 2.80 | 55.62 | Pale grey slightly clayey weakly cemented SILT.<br>WEALD CLAY | | |

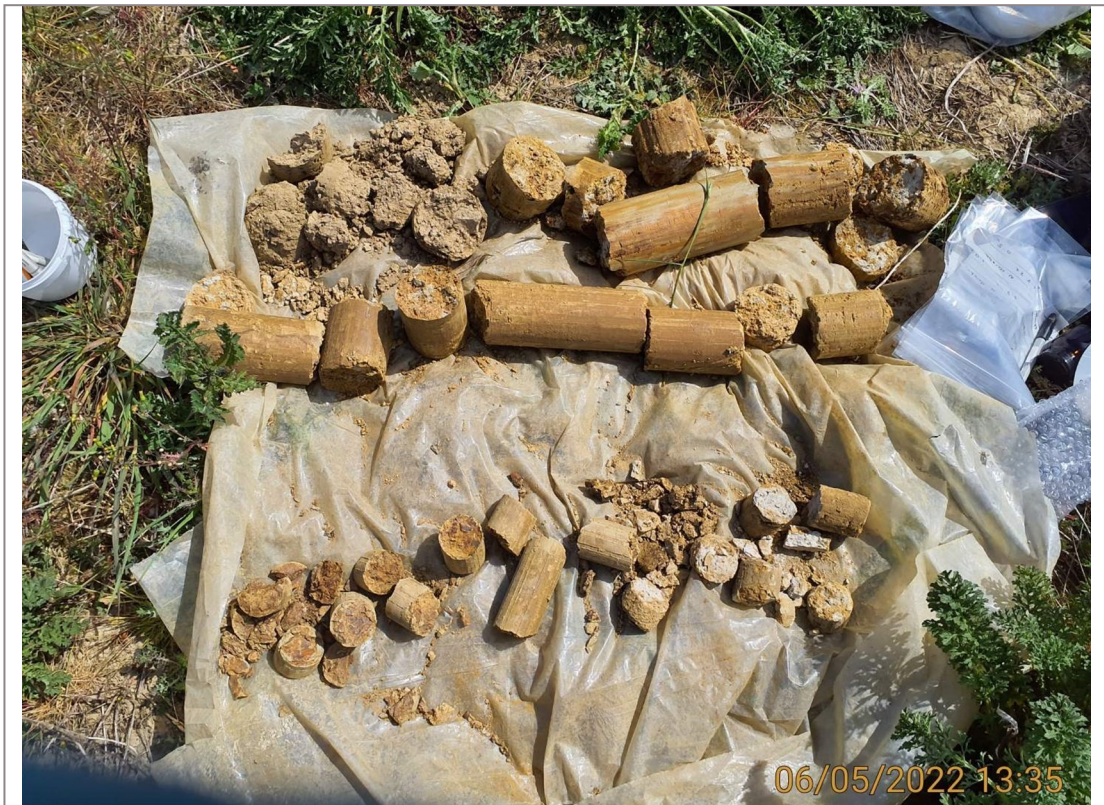
WS26  
GE20724

**Image 1.** 1651840545452.jpg:  
WindowSamplerPhoto

| Well | Water Strikes | Sample and In Situ Testing | | | Depth (m) | Level (m) | Legend | Stratum Description | |
|---|---|---|---|---|---|---|---|---|---|
| | | 0.10 | ES | | 0.30 | 55.69 | | Grass overlying brown silty clay with abundant rootlets.<br>TOPSOIL | 1 |
| | | 0.40 | ES | | | | | Very stiff orangish brown and pale grey silty CLAY with orange staining and black ferruginous fragments.<br>WEALD CLAY | |
| | | 1.00 | D | | | 2.10 | 53.89 | Orange and brown slightly sandy CLAY with rare fine to medium sub-angular iron stained weakly cemented silt.<br>WEALD CLAY | 2 |
| | | 2.50 | D | | 2.60 | 53.39 | | Very stiff pale grey silty CLAY with orange staining and siltstone inclusions.<br>WEALD CLAY | 3 |

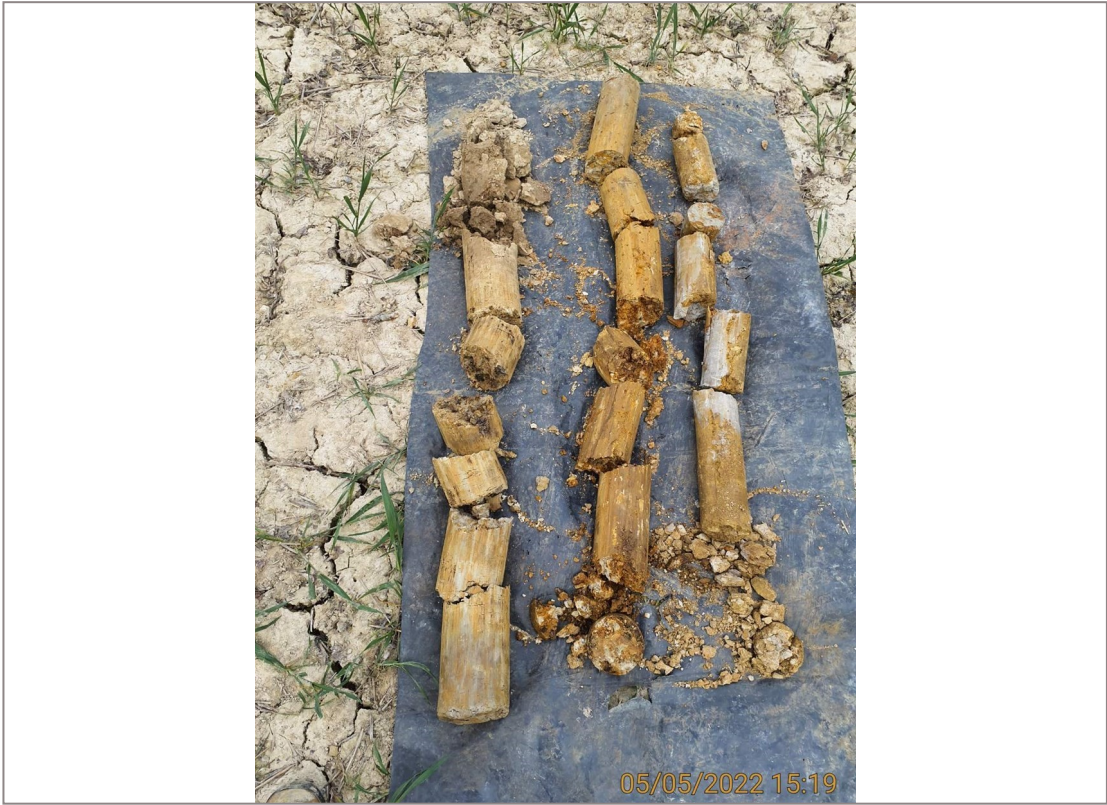
Image 1. 1651760341785.jpg:  
WindowSamplerPhoto

| Well | Water Strikes | Sample and In Situ Testing | | | Depth (m) | Level (m) | Legend | Stratum Description | |
|---|---|---|---|---|---|---|---|---|---|
| | | 0.50 | D | | | | | Stiff pale grey and orangish brown silty CLAY with frequent black ferruginous fragments and orange staining. WEALD CLAY | |
| | | 1.00 | D | | 1.20 | 54.84 | | Stiff pale grey, brown and orangish brown silty sandy gravelly CLAY with frequent black ferruginous fragments and orange staining. Sand is fine to coarse. Gravel is fine to coarse sub angular ironstone/ sandstone. WEALD CLAY | 2 |
| | | 2.40 | ES | | 2.10 | 53.94 | | Very stiff pale grey and orangish brown silty CLAY with orange staining. WEALD CLAY | 3 |
| | | | | | | | | End of Borehole at 2.90m | |

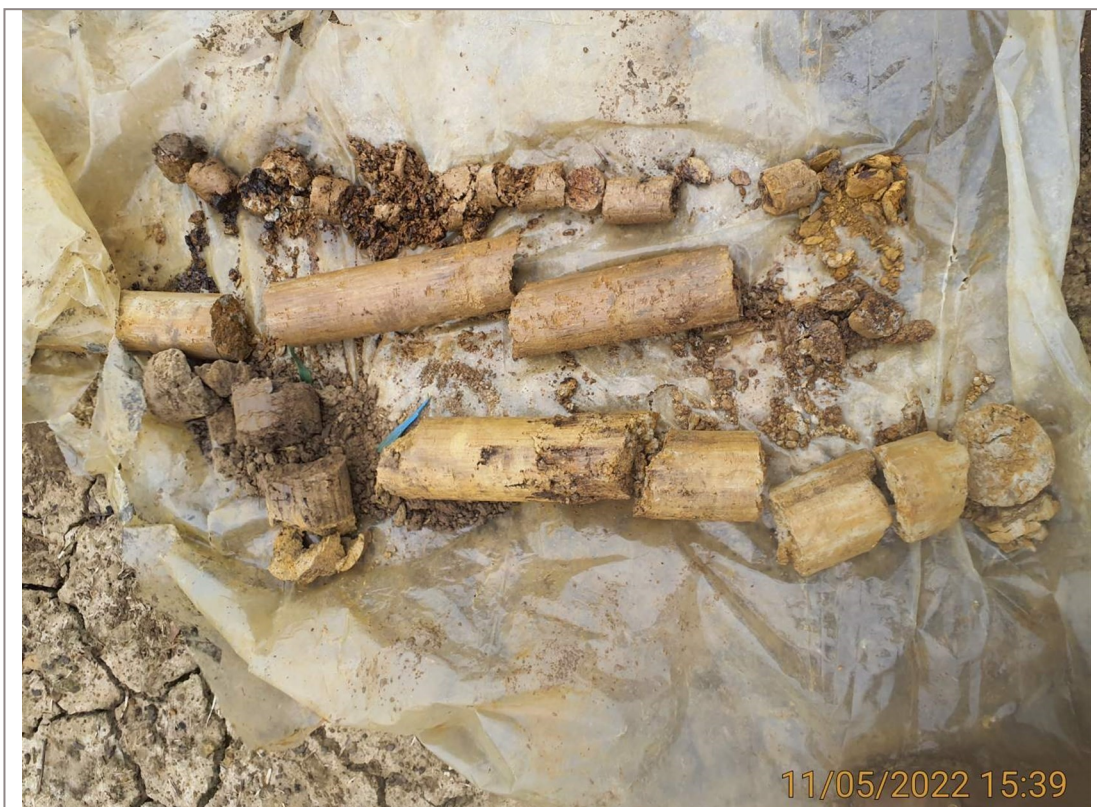
WS29  
GE20724

**Image 1.** 1652279920562.jpg:  
WindowSamplerPhoto
