# Borehole: Photos

WS30  
GE20724

| Project Name: North Horsham II | | | | Project No. GE20724 | | Co-ords: 519700E - 133525N | | Hole Type<br>WLS | |
| Client: Legal & General | | | | Dates: 09/05/2022 | | Logged By<br>KO | | | |

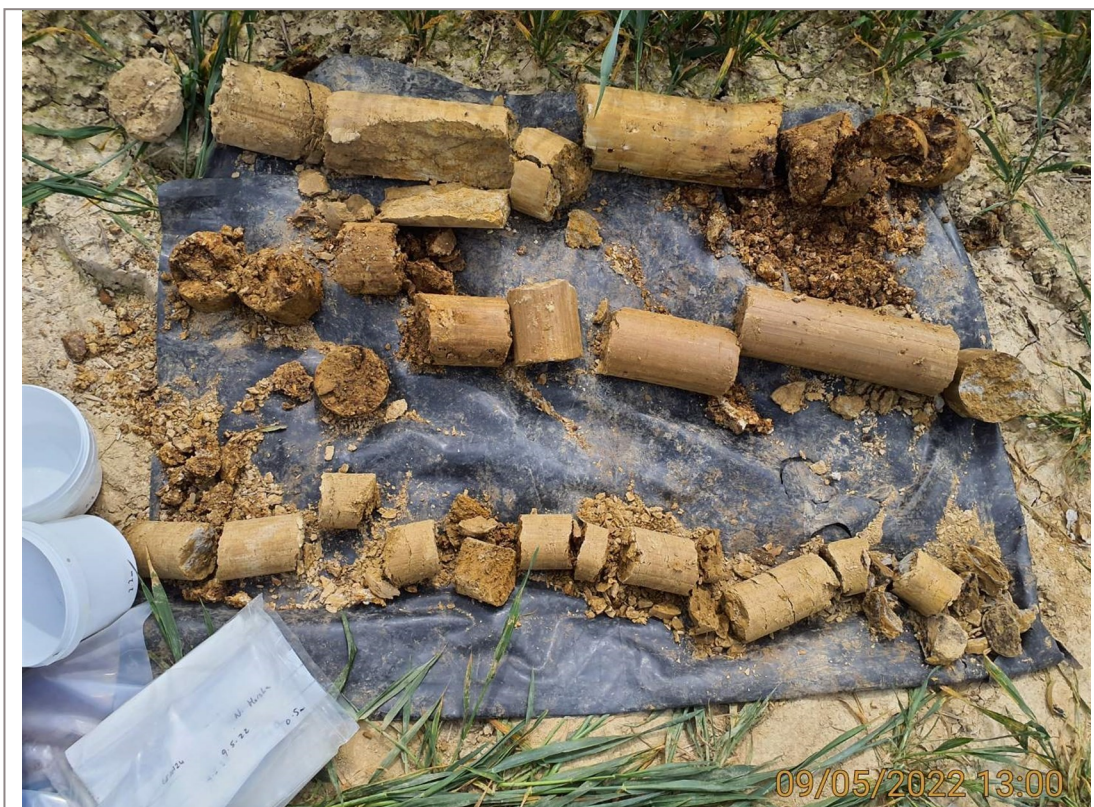
**Image 1.** 1652097606679.jpg:  
WindowSamplerPhoto

WS32  
GE20724

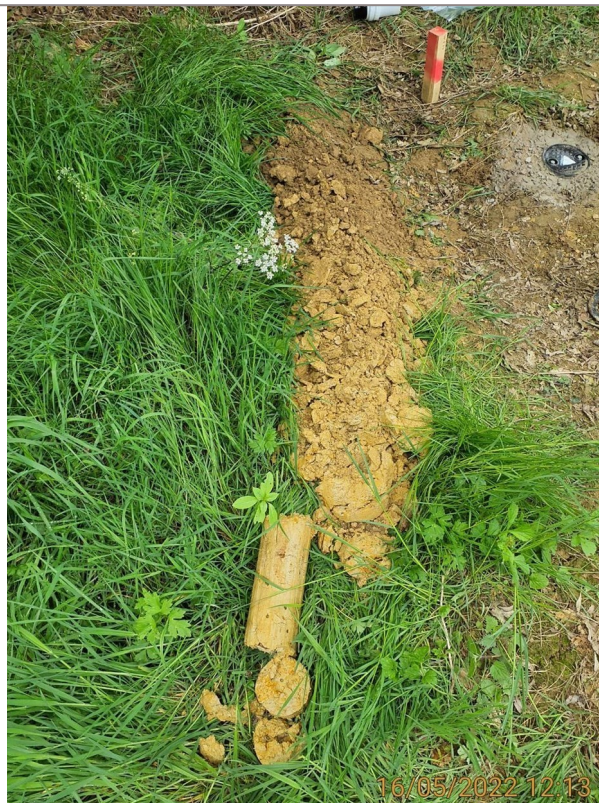
**Image 1.** 1652699613206.jpg:  
WindowSamplerPhoto

WS34  
GE20724

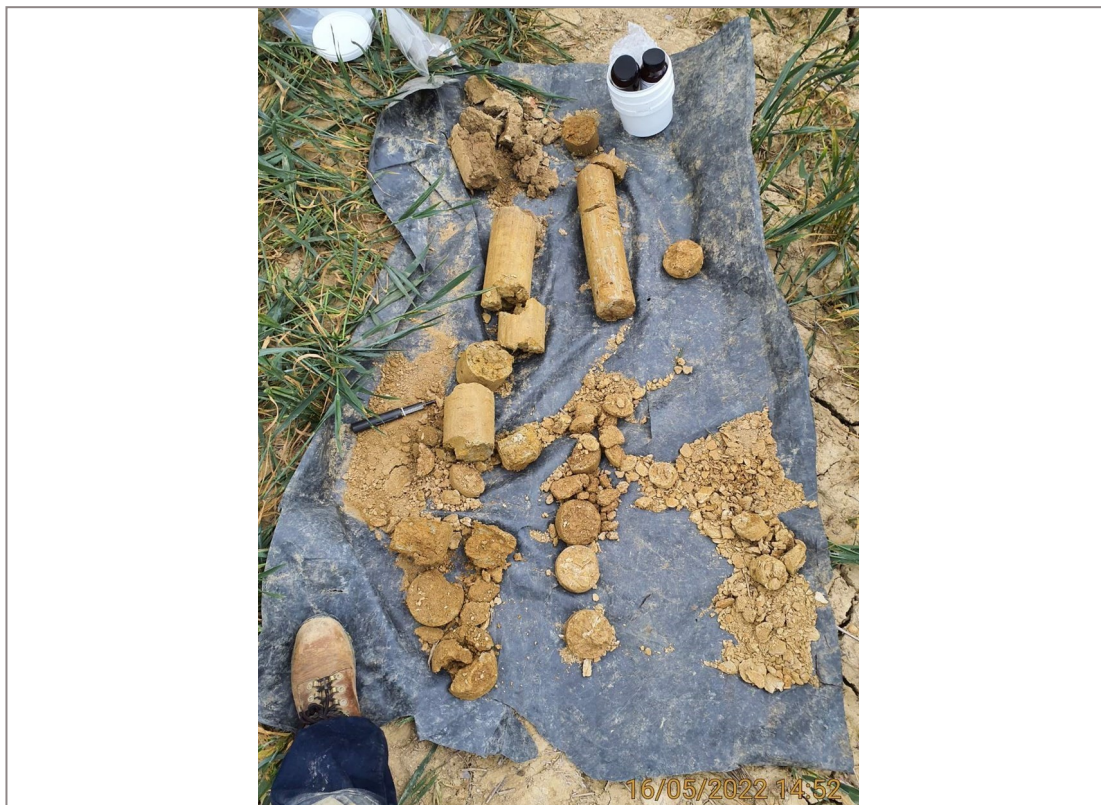
**Image 1.** 1652709158246.jpg:  
WindowSamplerPhoto

WS38  
GE20724
