| <div> Unit 7, Danworth Farm<br/> Hurstpierpoint<br/> BN6 9GL<br/> <a href="http://www.gesl.net">www.gesl.net</a> </div> | | | | <div>Borehole Log</div> | | | | Borehole No.<br><b>WS69</b><br>Sheet 1 of 1 | | |
| Project Name: North Horsham II | | | | Project No.<br>GE20724 | | Co-ords: 520151E - 134082N | | Hole Type<br>WLS | | |
| Location: Horsham | | | | Level: 62.73 | | Scale<br>1:25 | | | | |
| Client: Legal & General | | | | Dates: 18/05/2022 | | Logged By<br>KO | | | | |

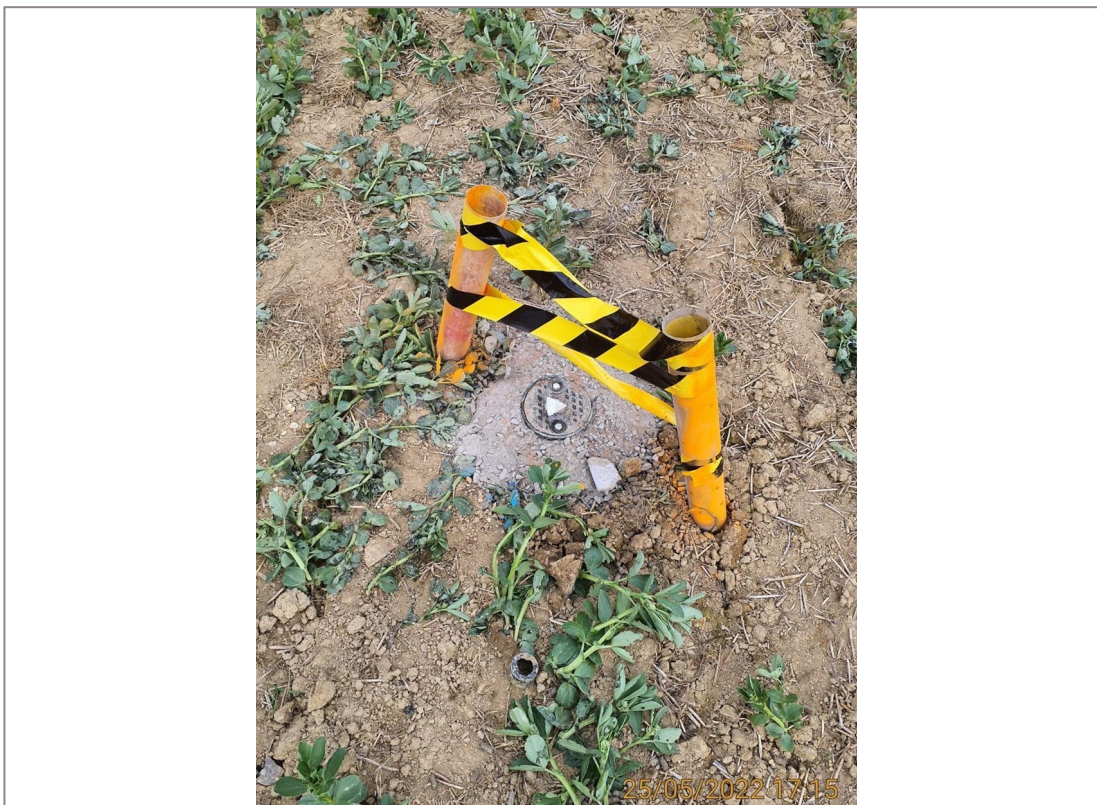
**Image 1.** 1653495330857.jpg:  
WindowSamplerPhoto

| Well | Water Strikes | Sample and In Situ Testing | | | Depth (m) | Level (m) | Legend | Stratum Description | | |
|---|---|---|---|---|---|---|---|---|---|---|
| | | 0.10 | ES | 4.2kg/cm2 | 0.20 | 62.68 | Crop overlying brown silty clay with frequent rootlets. TOPSOIL | | | |
| | 0.50 | D | 5.0kg/cm2 | | | | 1.10 | | 61.78 | Very stiff orangish brown and pale grey silty CLAY with orange staining and black ferruginous fragments WEALD CLAY |
| | 0.70 | ES | | | | Orangish brown and pale grey silty CLAY with rare weakly cemented siltstone gravel. WEALD CLAY | | | | |
| | 1.00 | D | | | | Brown clayey weakly cemented SILT. WEALD CLAY | | | | |

| | | | | | Collapse to 2.4m bgl. |

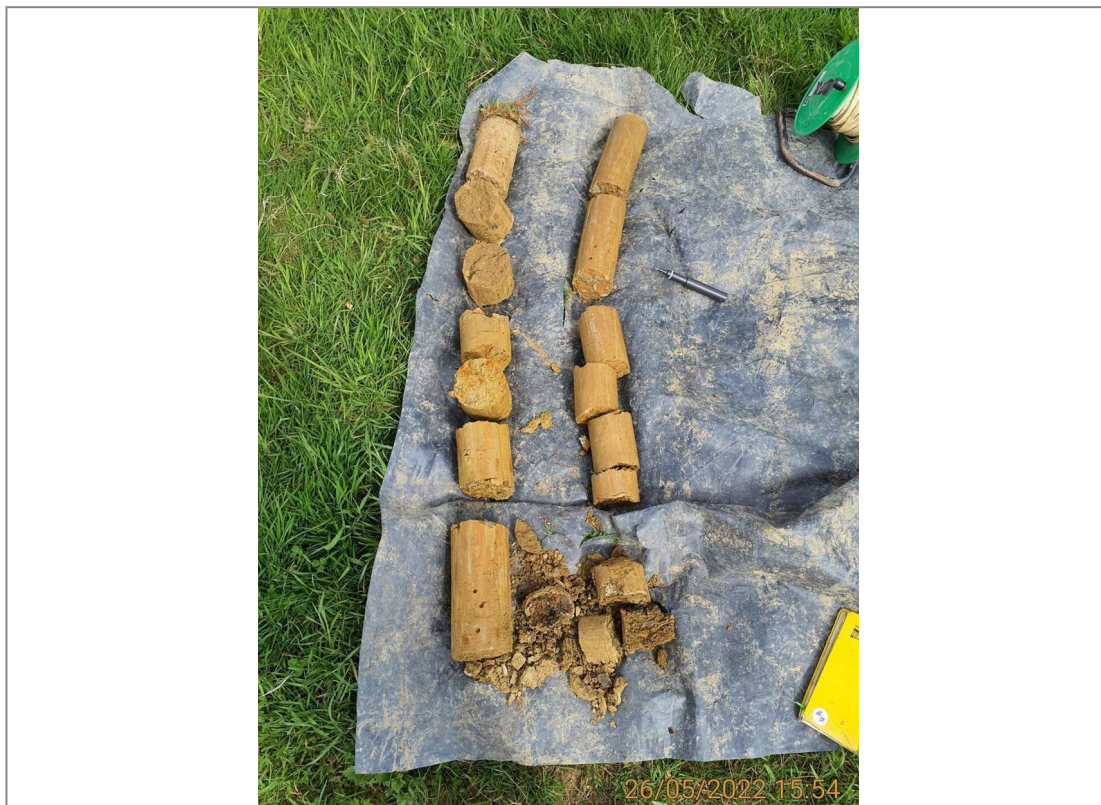
**Image 1.** 1653576878620.jpg:  
WindowSamplerPhoto

| Well | Water Strikes | Sample and In Situ Testing | | | Depth (m) | Level (m) | Legend | Stratum Description | | | |
|---|---|---|---|---|---|---|---|---|---|---|---|
| | | 0.10 | ES | | 0.40 | 63.73 | | Grass overlying brown silty clay with black ferruginous fragments and abundant rootlets.<br>TOPSOIL | | | |
| | | 0.50 | D | | | | | 3.2kg/cm2 | | | Very stiff orangish brown and pale grey silty CLAY with orange staining<br>WEALD CLAY<br><i>Some rootlets</i> |
| | | | | 1.70 | 62.43 | | Brown with reddish brown stained slightly clayey weakly cemented SILT.<br>WEALD CLAY | | | | |

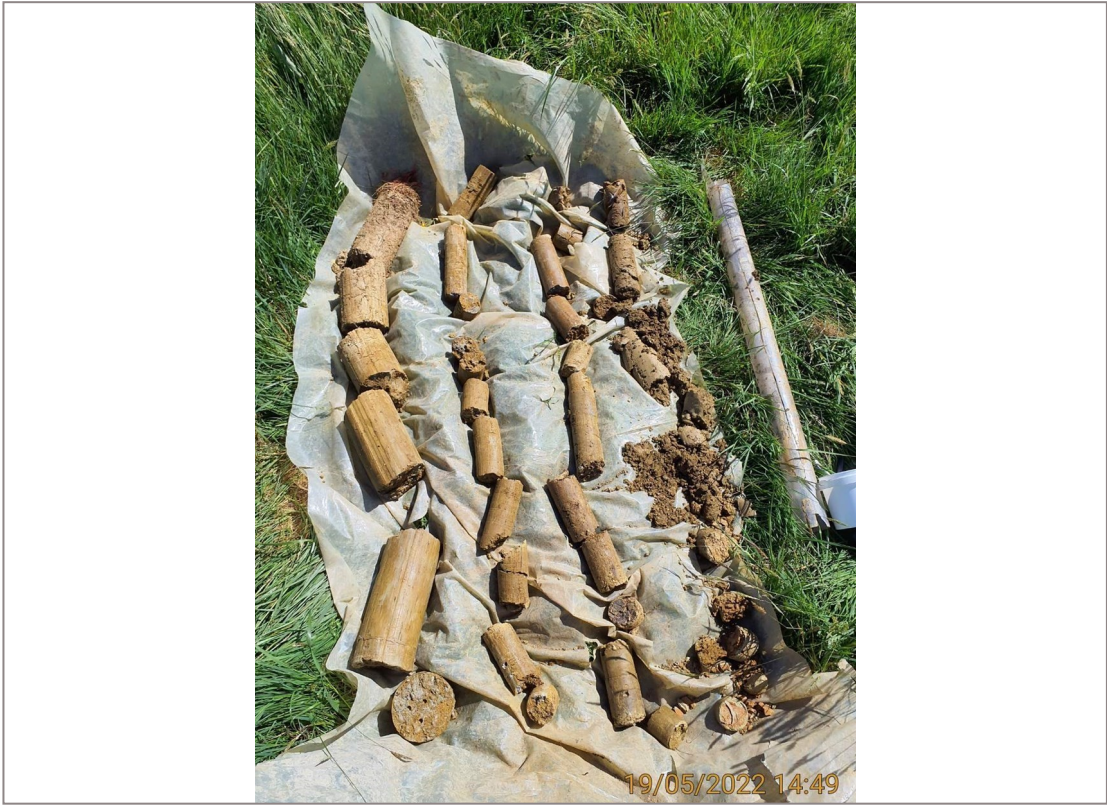
Image 1. 1652968159221.jpg:  
WindowSamplerPhoto

| Well | Water Strikes | Sample and In Situ Testing | | | Depth (m) | Level (m) | Legend | Stratum Description | |
|---|---|---|---|---|---|---|---|---|--|
| | | 0.20 | ES | | 0.40 | 62.66 | Brown silty sandy clay with abundant rootlets and orange staining.<br>TOPSOIL | | |
| | 0.50 | D | 3.2kg/cm2 | Stiff to very stiff silty CLAY with orange staining and some black ferruginous fragments.<br>WEALD CLAY<br><i>Some rootlets</i> | | | | | |
| | 1.00 | D | 3.5kg/cm2 | Very stiff silty sandy gravelly CLAY with black ferruginous fragments. Gravel is fine to coarse ironstone.<br>WEALD CLAY | | | | | |
| 2.90 | ES | 5.0kg/cm2 | 3.10 | | 59.96 | Dark brown clayey gravelly fine to coarse SAND. Gravel is fine sandstone.<br>WEALD CLAY | | | |
| 3.50 | D | | 3.60 | 59.46 | Orangish brown clayey weakly cemented SILT.<br>WEALD CLAY | | | | |

| Dynamic Sampling Run Details | | | Water Strike Details (mbgl) | | Remarks |
|---|---|---|---|---|---|
| | | | | | Water standing at 1.65m bgl |

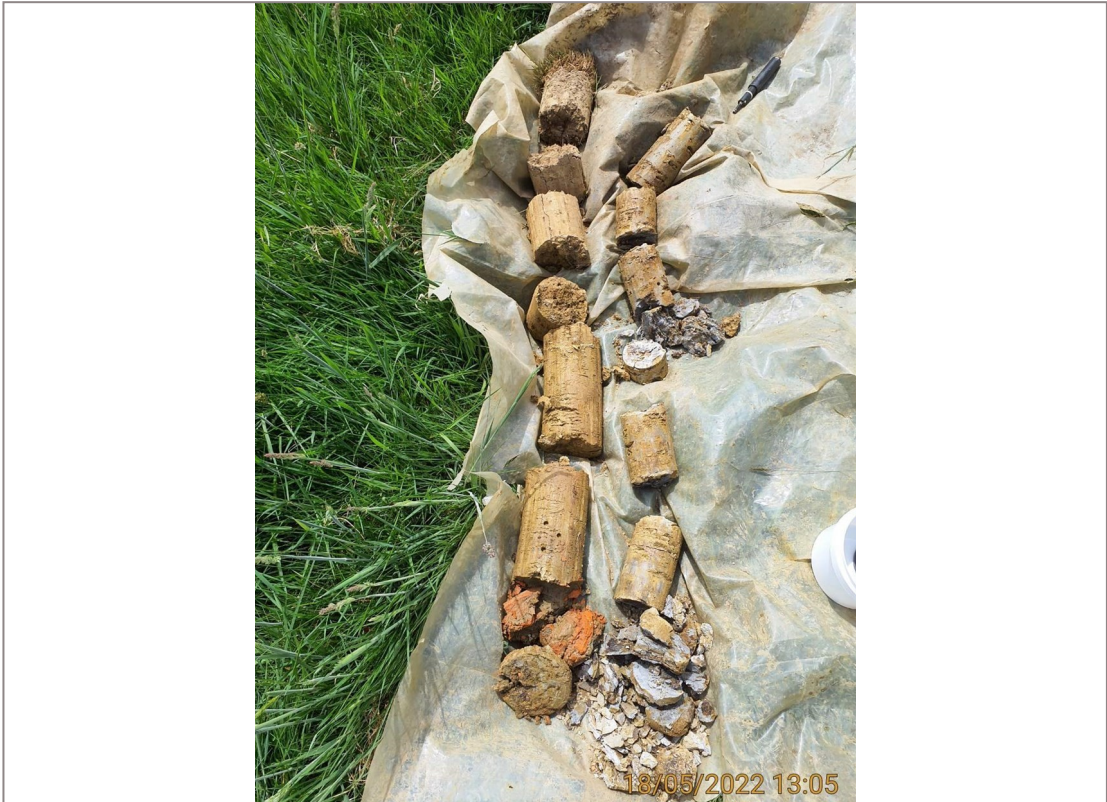
Image 1. 1652875531272.jpg:  
WindowSamplerPhoto

| Well | Water Strikes | Sample and In Situ Testing | | | Depth (m) | Level (m) | Legend | Stratum Description | | |
|---|---|---|---|---|---|---|---|---|---|---|
| | | 0.10 | ES | | 0.30 | 61.43 | | Grass overlying silty gravelly clay with abundant rootlets and roots 1-3mm.<br>TOPSOIL | | |
| | | 0.50 | D | | | | | | | Very stiff brown silty CLAY with black ferruginous fragments and some rootlets.<br>WEALD CLAY |
| | | 0.70 | ES | | 1.10 | 60.63 | | Clay land drain | | |
| | | 1.00 | D | | | | | Stiff bluish grey silty CLAY with interbedded siltstone, orange and decomposed rootlets.<br>WEALD CLAY | | |

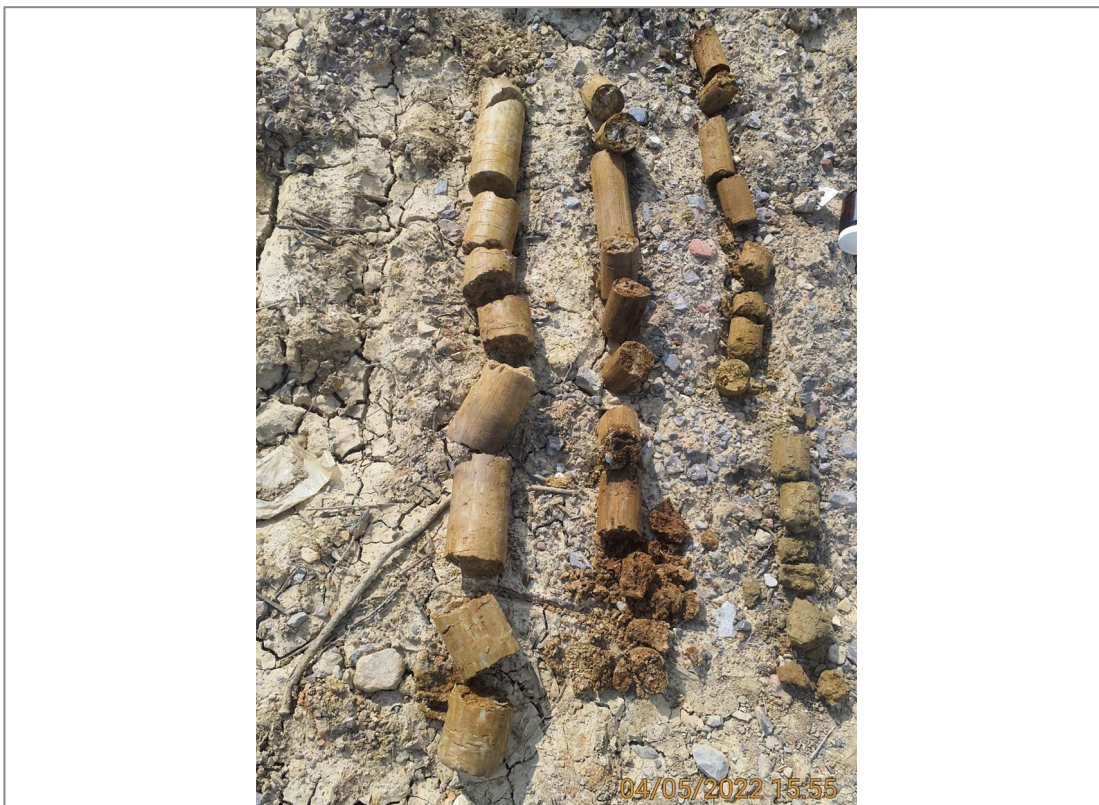
**Image 1.** 1651676078006.jpg:  
WindowSamplerPhoto

| Unit 7, Danworth Farm<br>Hurstpierpoint<br>BN6 9GL<br>www.gesl.net | | <h1 style="text-align: center;">Borehole Log</h1> | | | | Borehole No.<br><b>WS81</b><br>Sheet 1 of 1 | | | | |
|---|---|---|---|---|---|---|---|---|---|---|
| | | 0.20 | ES | | 0.60 | 52.92 | | Very stiff orangish brown and pale grey mottled silty CLAY with some rootlets<br>TOPSOIL | 1 | |
| | | 2.50 | D | | 2.60 | 50.92 | | Brown and dark grey mottled slightly sandy silty CLAY with rare fine to medium weakly cemented silt.<br>WEALD CLAY | 3 | |

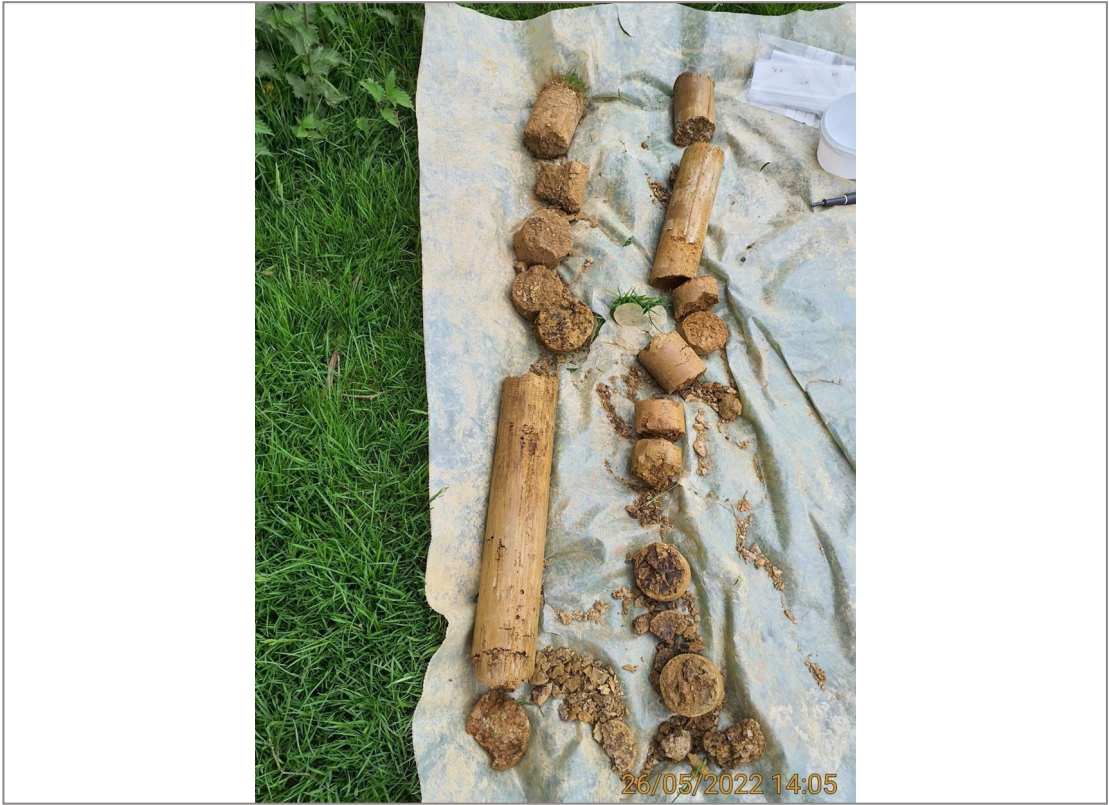
Image 1. 1653570257050.jpg:  
WindowSamplerPhoto

| <div> Unit 7, Danworth Farm<br/> Hurstpierpoint<br/> BN6 9GL<br/> <a href="http://www.gesl.net">www.gesl.net</a> </div> | | | | <div>Borehole Log</div> | | | | Borehole No.<br><b>WS82</b><br>Sheet 1 of 1 | | | | |
|---|---|---|---|---|---|---|---|---|---|---|---|---|
| | | 0.10 | ES | 3.7kg/cm2 | 0.40 | 66.08 | | Grass overlying brown silty sandy clay with abundant rootlets.<br>TOPSOIL | 1 | | | |
| | | 0.50 | D | | | | | 2.8kg/cm2 | | 65.18 | | Very stiff greyish brown silty sandy CLAY with black ferruginous fragments, orange staining and some rootlets.<br>WEALD CLAY |
| | | 1.00 | D | 4.1kg/cm2 | 1.30 | | Very stiff orangish brown silty CLAY with abundant weak siltstone inclusions.<br>WEALD CLAY | | | | | |
| 1.50 | D | 2.00 | 1.70 | | Brown silty CLAY with rare weakly cemented siltstone gravel and reddish brown staining on faces.<br>WEALD CLAY | | | | | | | |

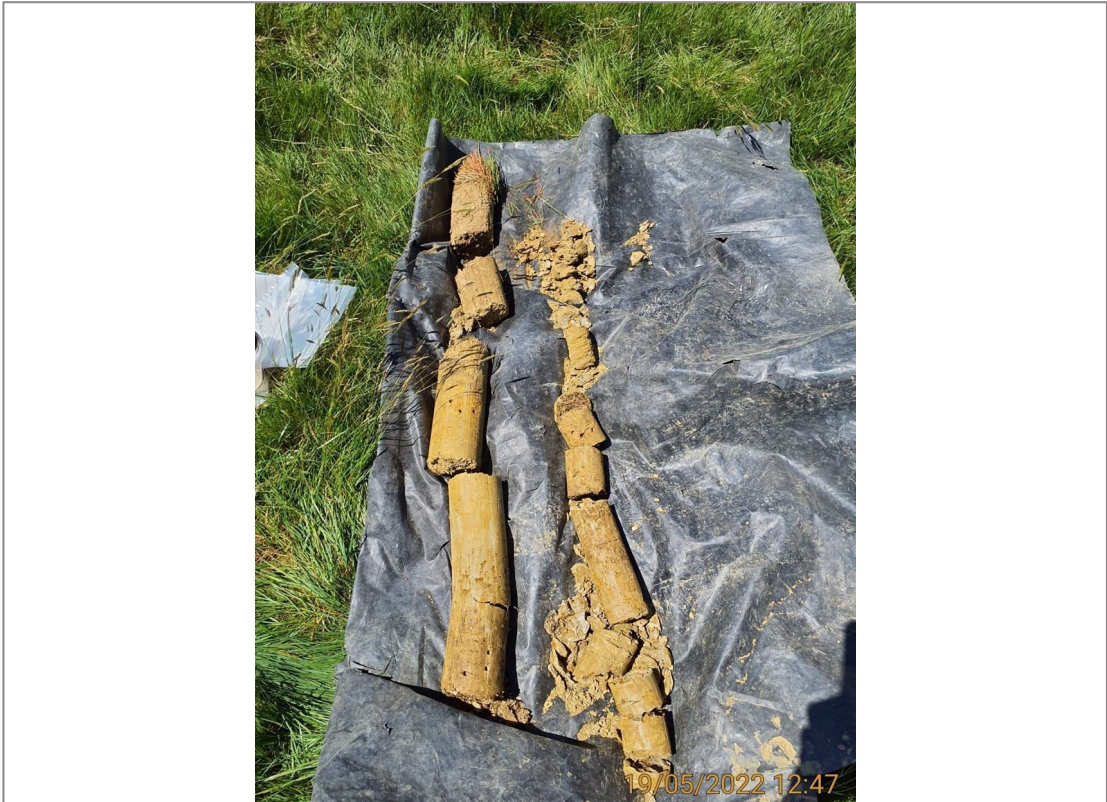
**Image 1.** 1652960781582.jpg:  
WindowSamplerPhoto

| Well | Water Strikes | Sample and In Situ Testing | | | Depth (m) | Level (m) | Legend | Stratum Description | |
|---|---|---|---|---|---|---|---|---|---|
| | | 0.50 | D | | | | | Stiff orangish brown and grey mottled silty CLAY with frequent rootlets and orange staining.<br>WEALD CLAY | |
| | | 0.60 | ES | 3.8kg/cm2 | 0.80 | 63.63 | | Stiff orangish brown and grey mottled silty sandy CLAY with abundant black ferruginous fragments, some rootlets and orange staining.<br>WEALD CLAY | |
| | | 1.40 | ES | 4.2kg/cm2 | 1.30 | 63.13 | | Brown and reddish brown and black ferruginous stained clayey weakly cemented SILT.<br>WEALD CLAY | |
