# Borehole: Photos

WS84  
GE20724

Project Name: North Horsham II

Project No.  
GE20724

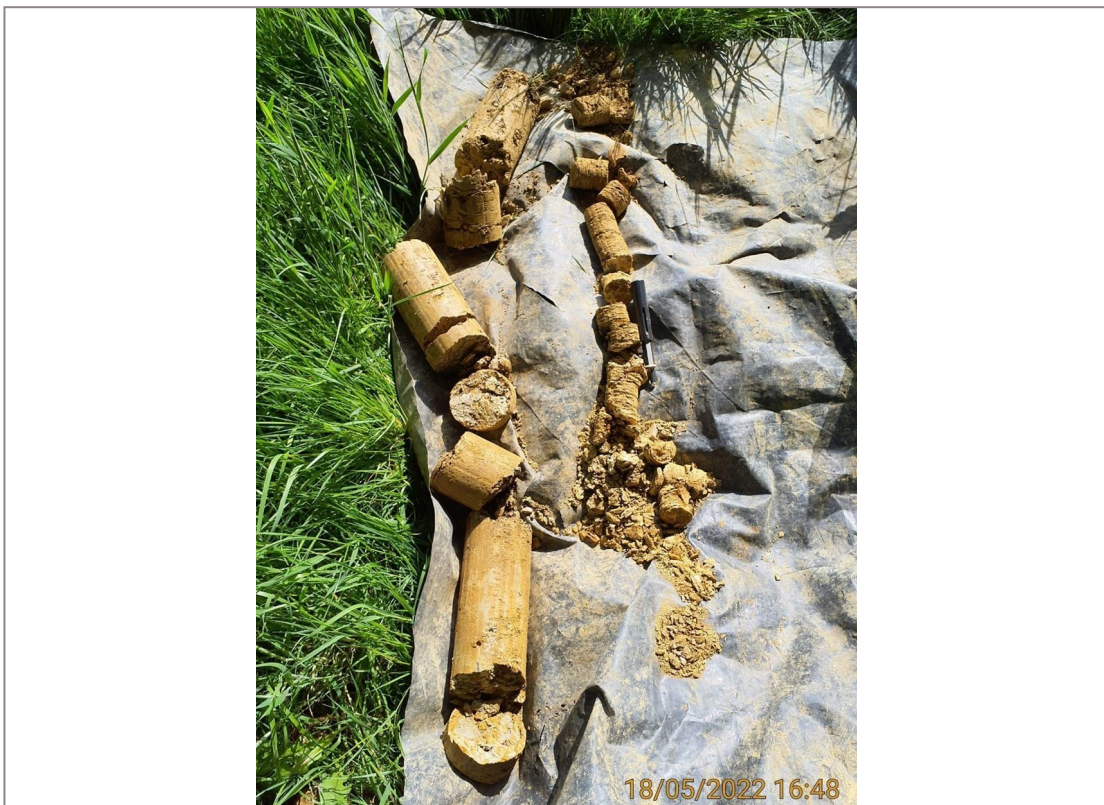
**Image 1.** 1652888905667.jpg:  
WindowSamplerPhoto

WS86  
GE20724

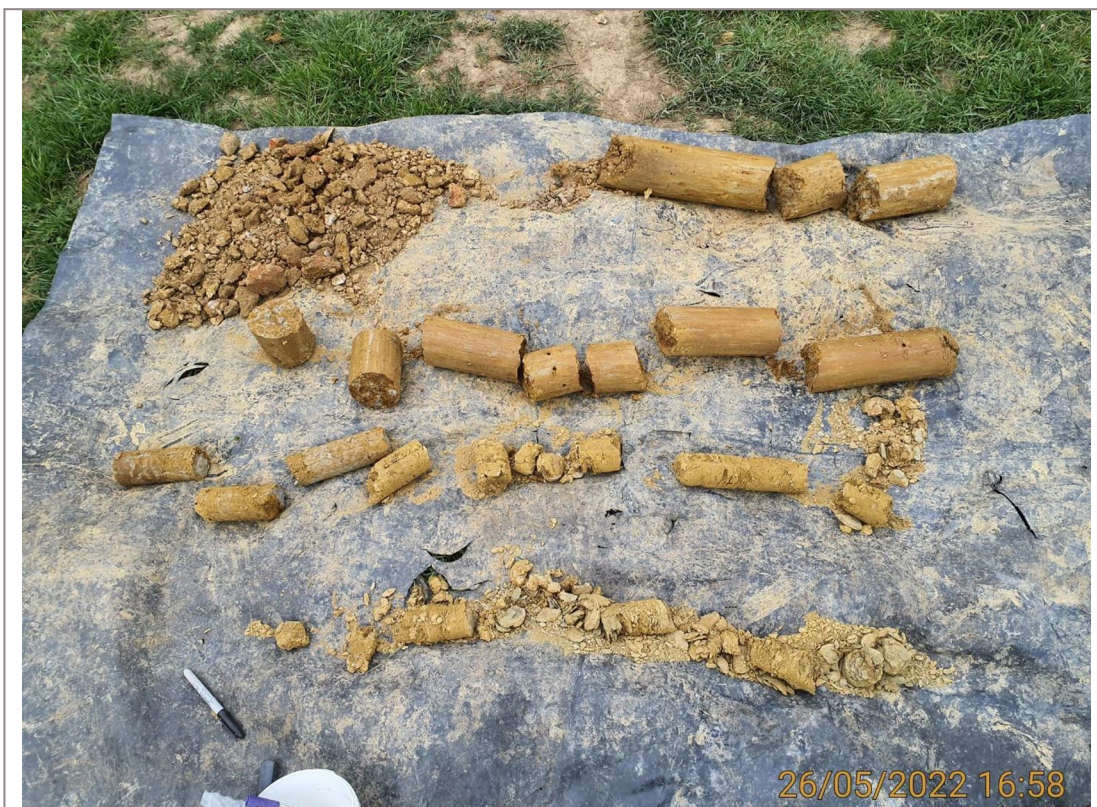
**Image 1.** 1653580690478.jpg:  
WindowSamplerPhoto

WS90  
GE20724

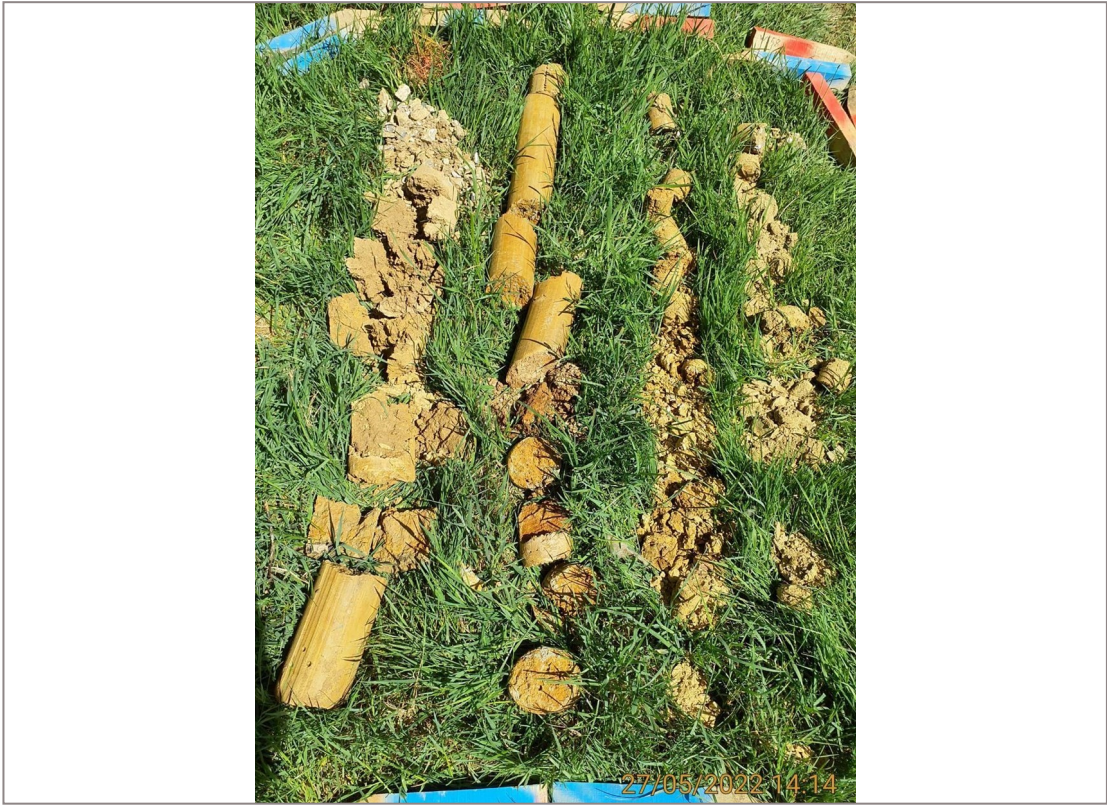
Image 1. 1653657276066.jpg:  
WindowSamplerPhoto

WS91  
GE20724

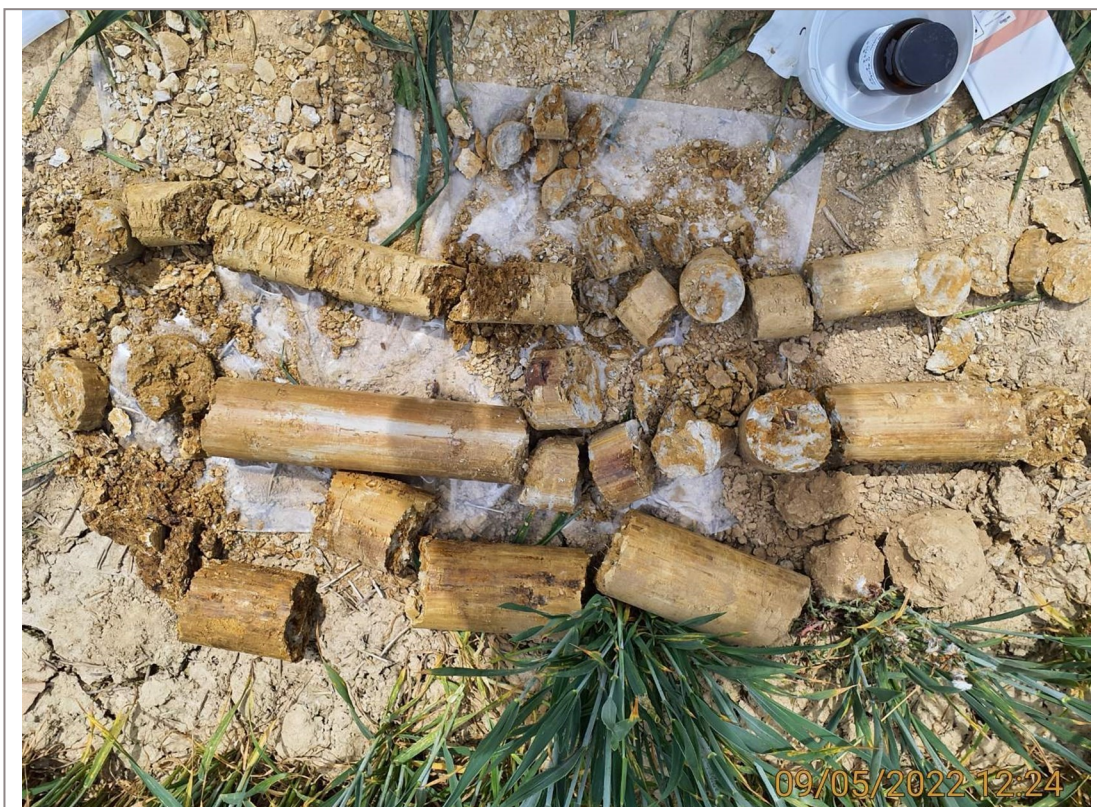
**Image 1.** 1652095476395.jpg:  
WindowSamplerPhoto

WS93  
GE20724
