# The Ecology Co-op

**Ref: P11100 Barn Conversion at Morlands Farm.**

The Ecology Co-op undertook a bat scoping assessment at Morlands Farm on the 10<sup>th</sup> of February 2026 at the request of Pauline & Paul McBride. This assessment was undertaken further to a proposal to convert a barn to create one dwelling. The survey was undertaken in accordance with best practice guidance produced by the Bat Conservation Trust<sup>1</sup>.

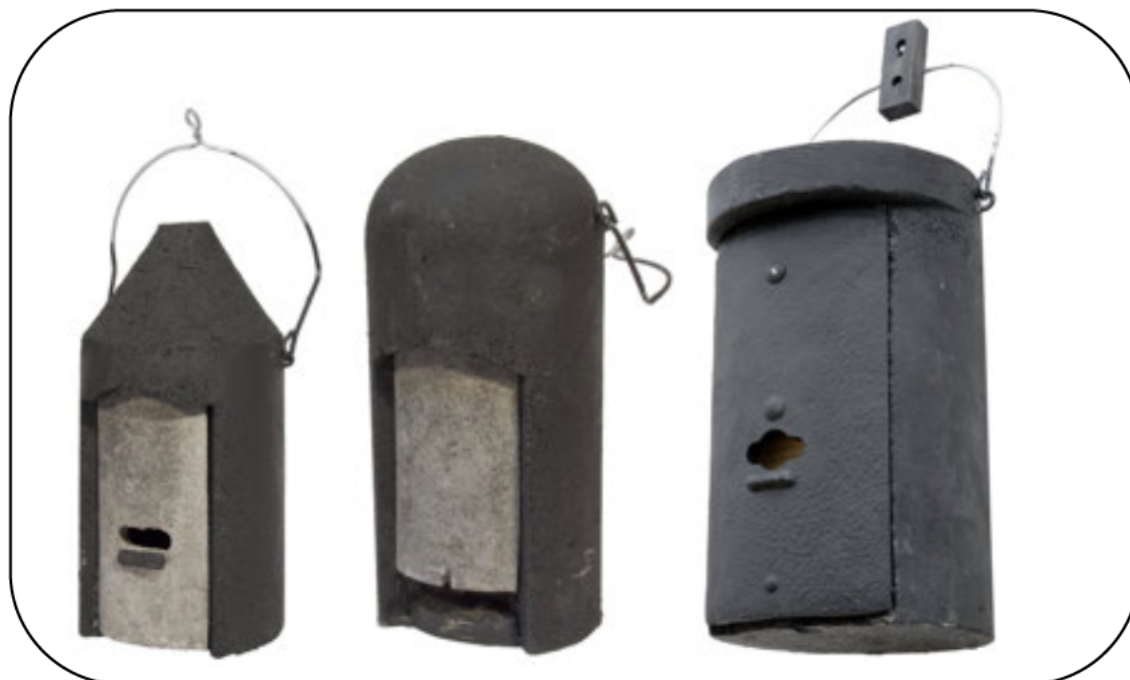
**Figure 2.** Left to right, the 2F, 2FN and the 1FS bat boxes produced by Schwegler. These and other brands are available at many on-line wildlife stores. These are constructed of 'woodcrete' (a mixture of cement and woodchip) and are designed to be durable and replicate the stable thermal properties of trees and buildings. They may be attached to trees or buildings.

The site can be enhanced for bats by placing bat boxes on nearby trees or buildings at a height of 3m or higher, and preferably on a south-facing aspect (examples in Appendix 1, Figure 2).

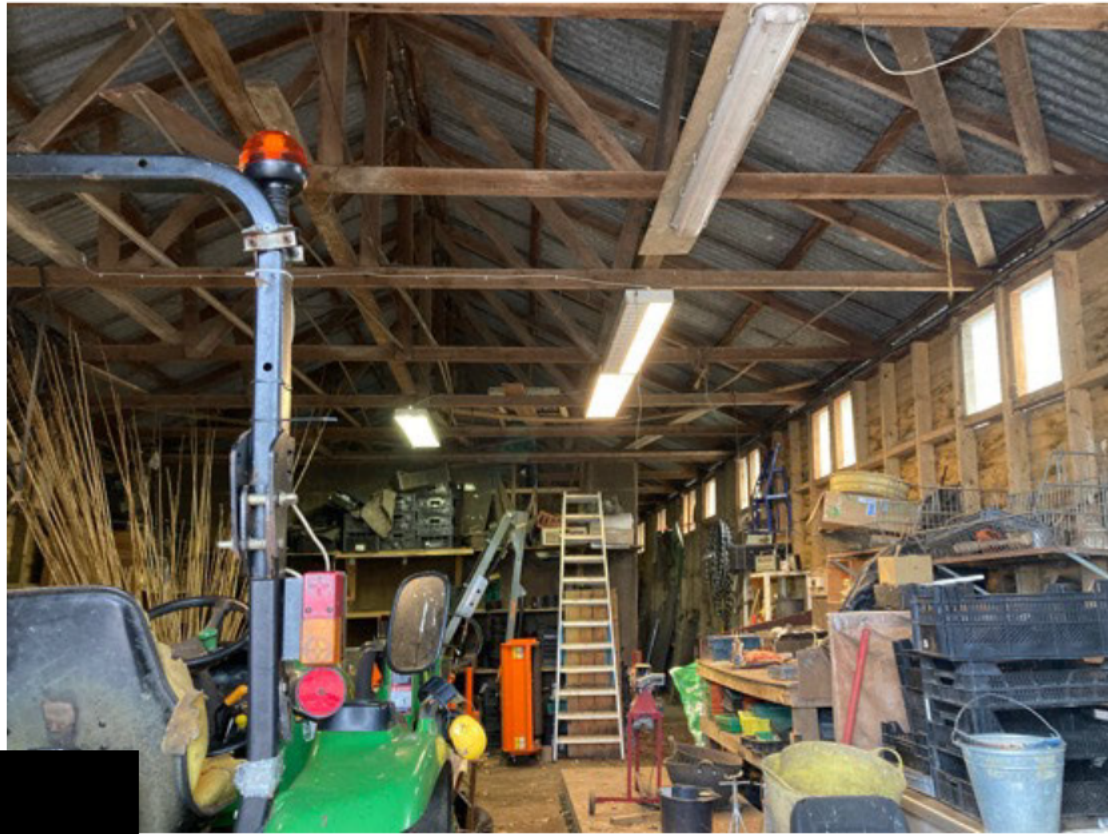
**Photograph 5.** Internal view

| Building section | Description of features | Assessment of suitability<br>(Collins 2023) |
|---|---|---|
| | roosting features inside the barn. No cracks or gaps in chipboard or wooden beams. There was no internal void space. | |
