**LAND AT GORELANDS FARM,  
NORTH HEATH, HORSHAM,  
RH20 1DN  
PHASE I GEO-ENVIRONMENTAL  
ASSESSMENT  
GEORGINA MERRISON  
13TH JANUARY 2026  
LS9050**

| <b>Title:</b> | PHASE I GEO-ENVIRONMENTAL ASSESSMENT | |
| <b>Project:</b> | RESIDENTIAL DEVELOPMENT | |
| <b>Reference:</b> | LS9050 | |

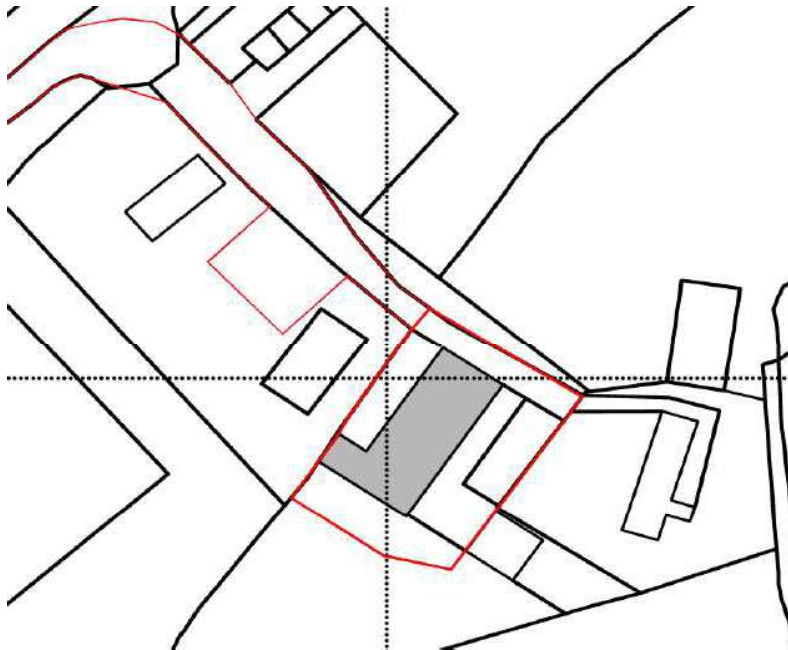
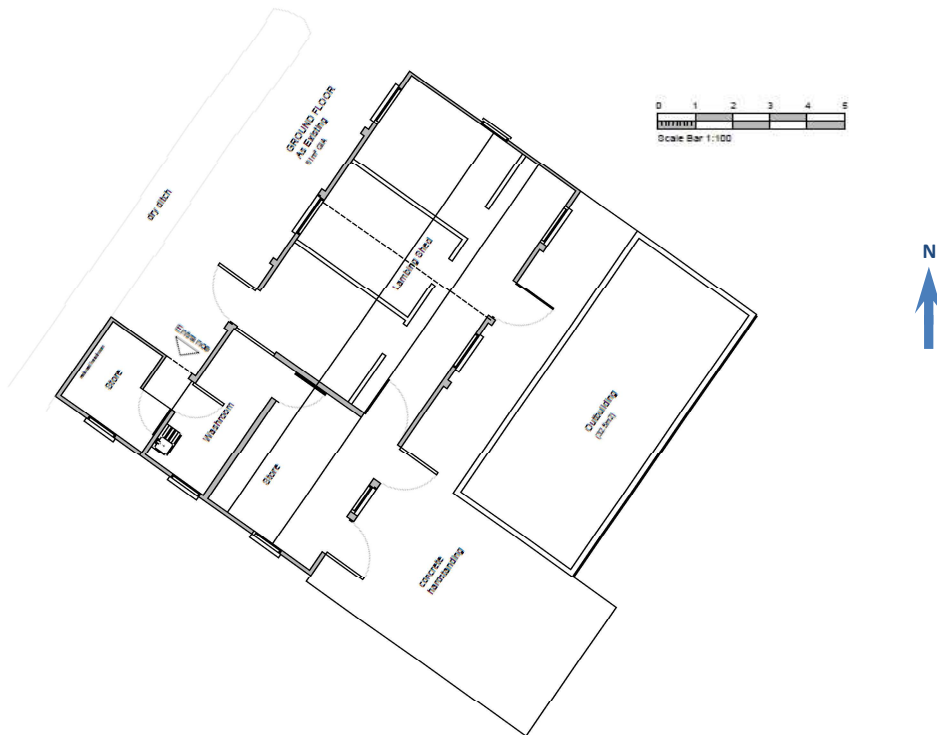
| <b>TITLE:</b> Existing layout | | | <b>REF:</b> LS9050 |

In summary, the area under investigation comprised a single storey brick-built farm building understood to be used as a lambing shed / stable, small central concrete yard area and a separate single storey wooden stable / outbuilding.

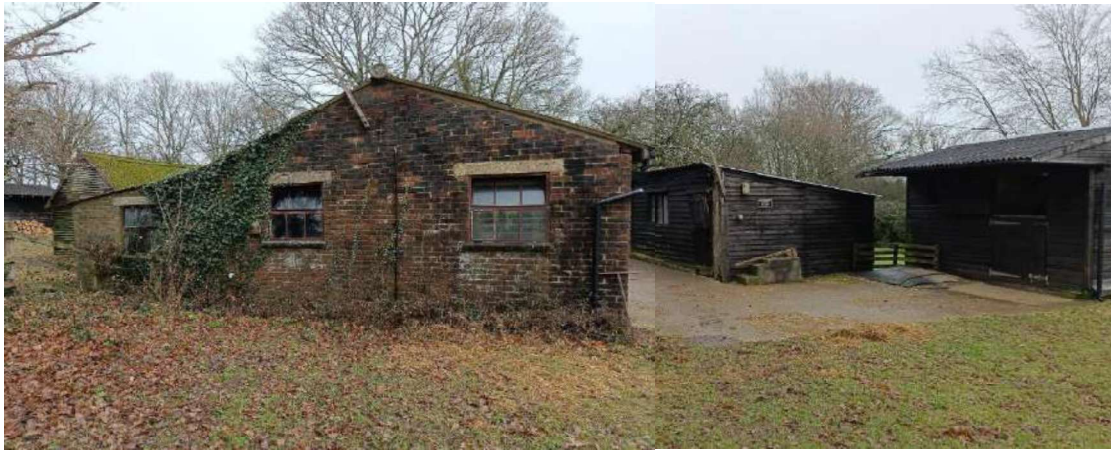
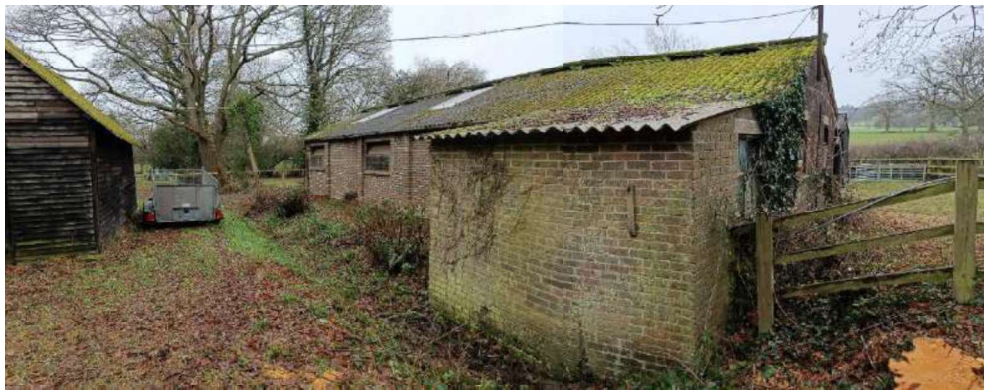
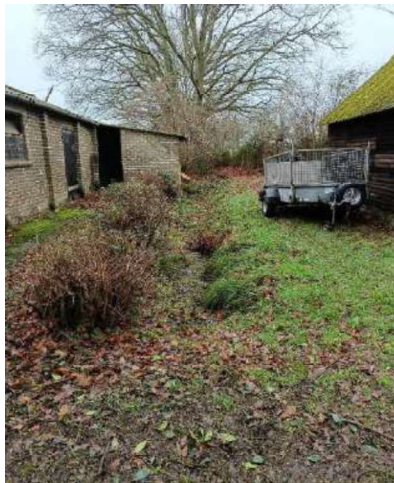
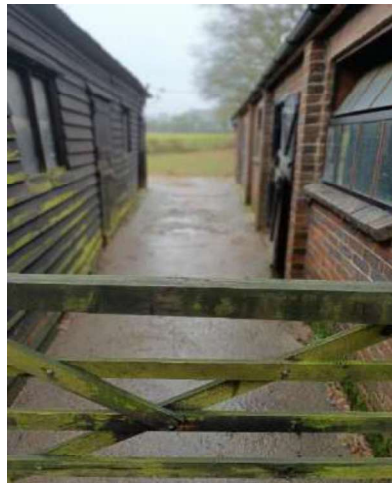
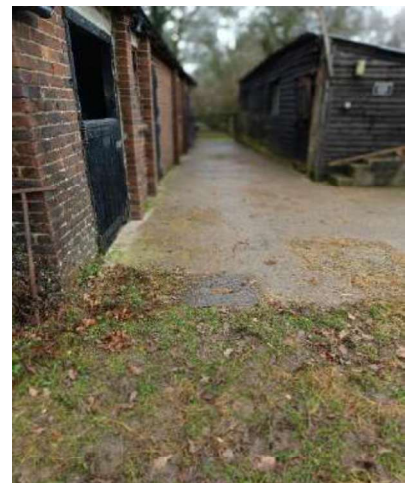
| <b>TITLE:</b> Site Photographs | | | <b>REF:</b> LS9050 |

Three lambing pens / stables were noted in the northern end of the main agricultural building with two storerooms and a washroom in the southern end. The roof of the building was noted to be corrugated cement sheeting; given the age of the structure this is assumed to be asbestos. A drainpipe on the north western elevation was also noted to be made of potentially asbestos containing materials. The south western elevation was noted to partially covered with ivy.

The building had a concrete floor; no staining or cracks were noted. Two of the pens had hay/straw along the north western ends and were separated by wooden panelling, the southernmost pen contained several hay bales. Two Ronseal spray applicators were noted inside adjacent to the northern end of the building along with a water hose. A pile of sheared sheep's fleeces was noted in the southern end of the pens. The southern storeroom contained a hand operated rotavating tool, and fertiliser applicator shovels, and rolls of metal fencing. The other store room contained several wooden shelves, these were noted to be empty with the exception of two large tins of matt paint.
