**PLOT 6, ANGEL HEIGHTS, STORRINGTON, WEST SUSSEX**

**SLOPE STABILITY ASSESSMENT**

**APRIL 2026**

| Project No. | J26-026 |

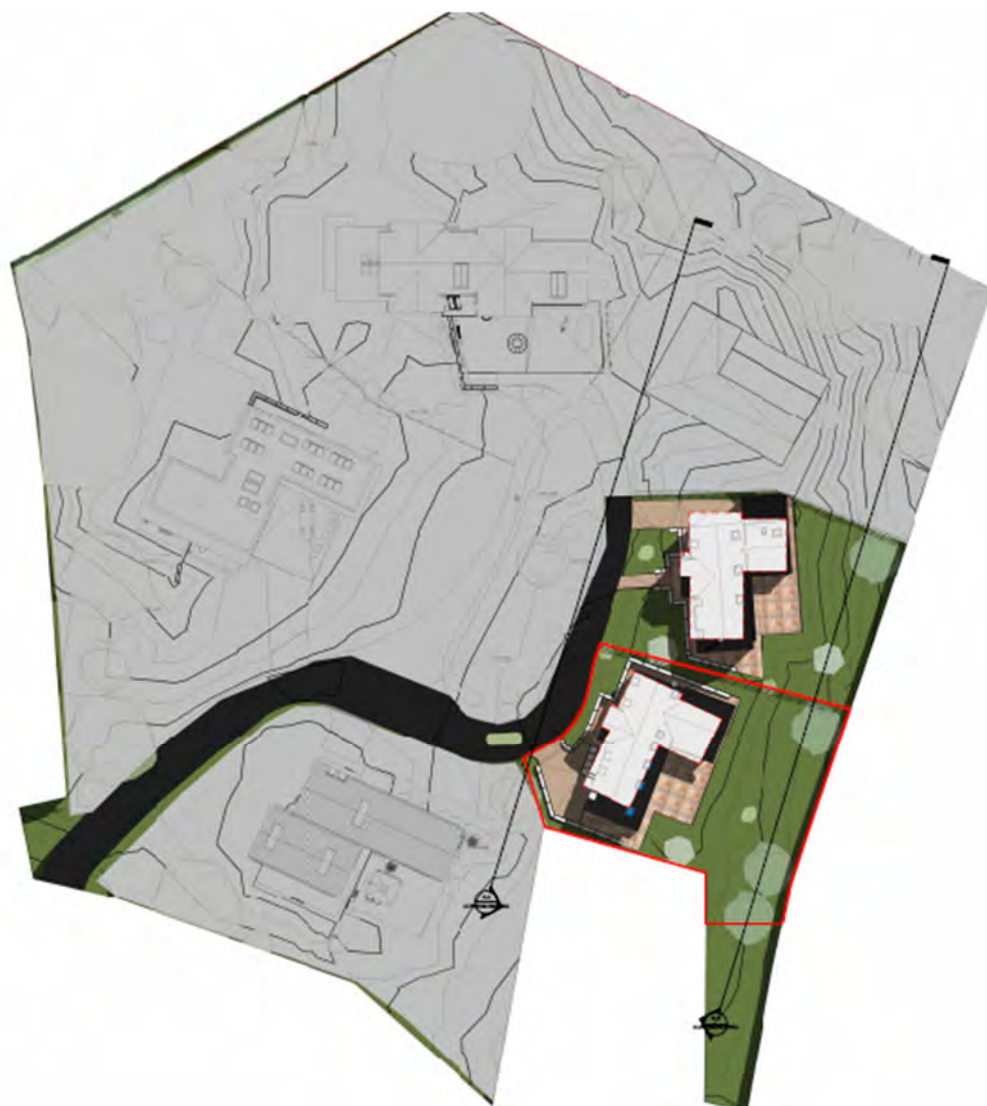
**Figure 2.2. Site Layout Plan**

Plot 6 is situated towards the east of the site

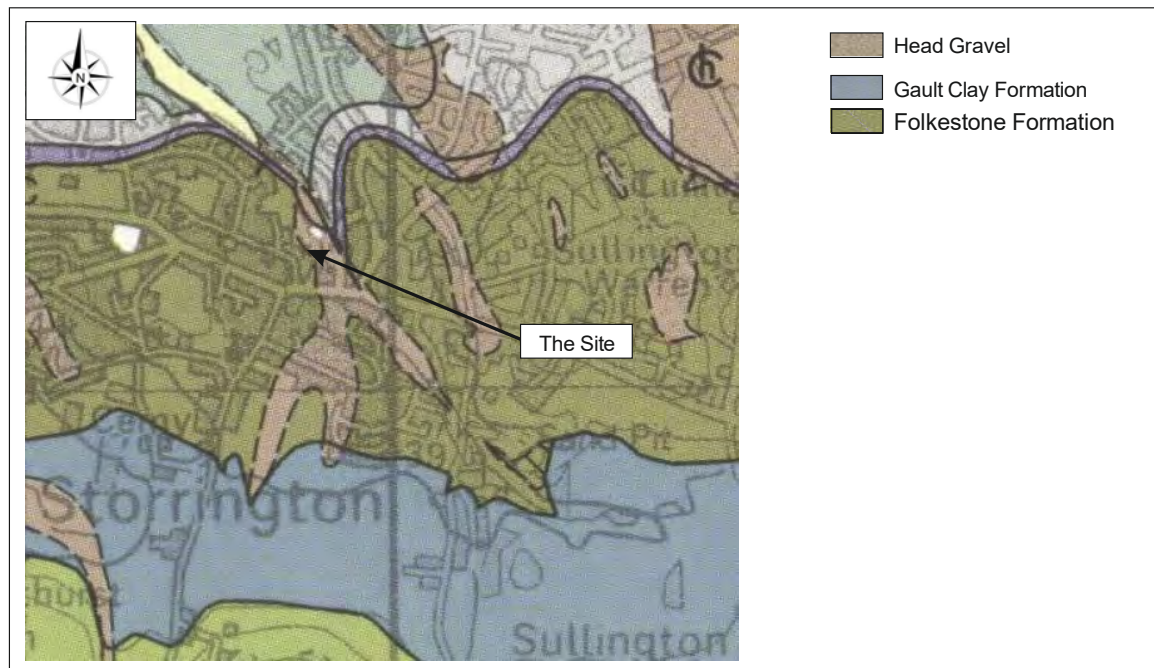
**Figure 2.3. Regional geology of the area around Angels Sandpit**

With reference to British Geological Survey Sheet 317/332 Chichester and Bognor 1:50000 Solid and Drift (1996) the site is underlain by the Folkestone Formation of the Lower Greensand Group (Figure 2.3).

The BGS Lexicon of Named Rock Units describes the Folkestone Formation as medium- and coarse-grained, well-sorted cross-bedded sands and weakly cemented sandstones. Whilst the Gault Formation is a pale to dark grey or blue-grey clay or mudstone, glauconitic in part, with a sandy base.

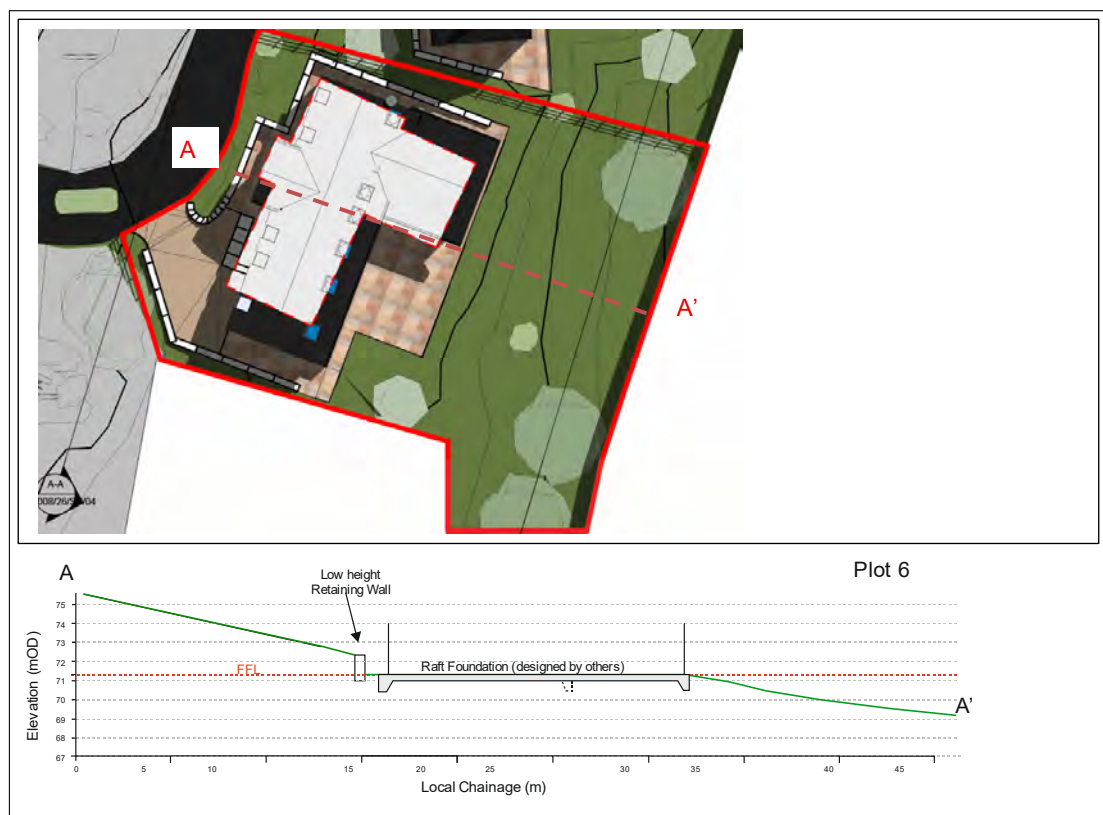
**Figure 4.1. Section through Plot 6**

The stability of the revised Plot 6 has been undertaken in accordance with EC7, as detailed earlier in this Report. It should be noted that the Plot numbering has changed from the earlier Report in which the current Plot 6 was identified as Plot 1. Where any of the individual construction platforms require a retaining structure, it is assumed that the internal stability (sliding and overturning) of any such structure will be considered during the retaining wall design.

| Plot No | SlopeW Run | Stress Conditions | Degree of Utilisation (%) | | Notes |
|---|---|---|---|---|---|
| Plot 6 | Slope1 | Total | 0.63 | | Section as Figure 4.1 |

The stability analyses of construction plot 6 returned degrees of utilisation of less than 1.00 under both total and long term effective stress conditions. The degree of utilisation decreases from short term total to long term effective stress conditions. This is most likely due to the effect of the surcharge loading increasing the shear strength of the Inert Waste Material under effective stress conditions ( $\sigma_n \tan \phi$ ).

Therefore, it is concluded that the construction plot 6 is stable in the form set out in cross-sections supplied by the Client (Appendix 2).

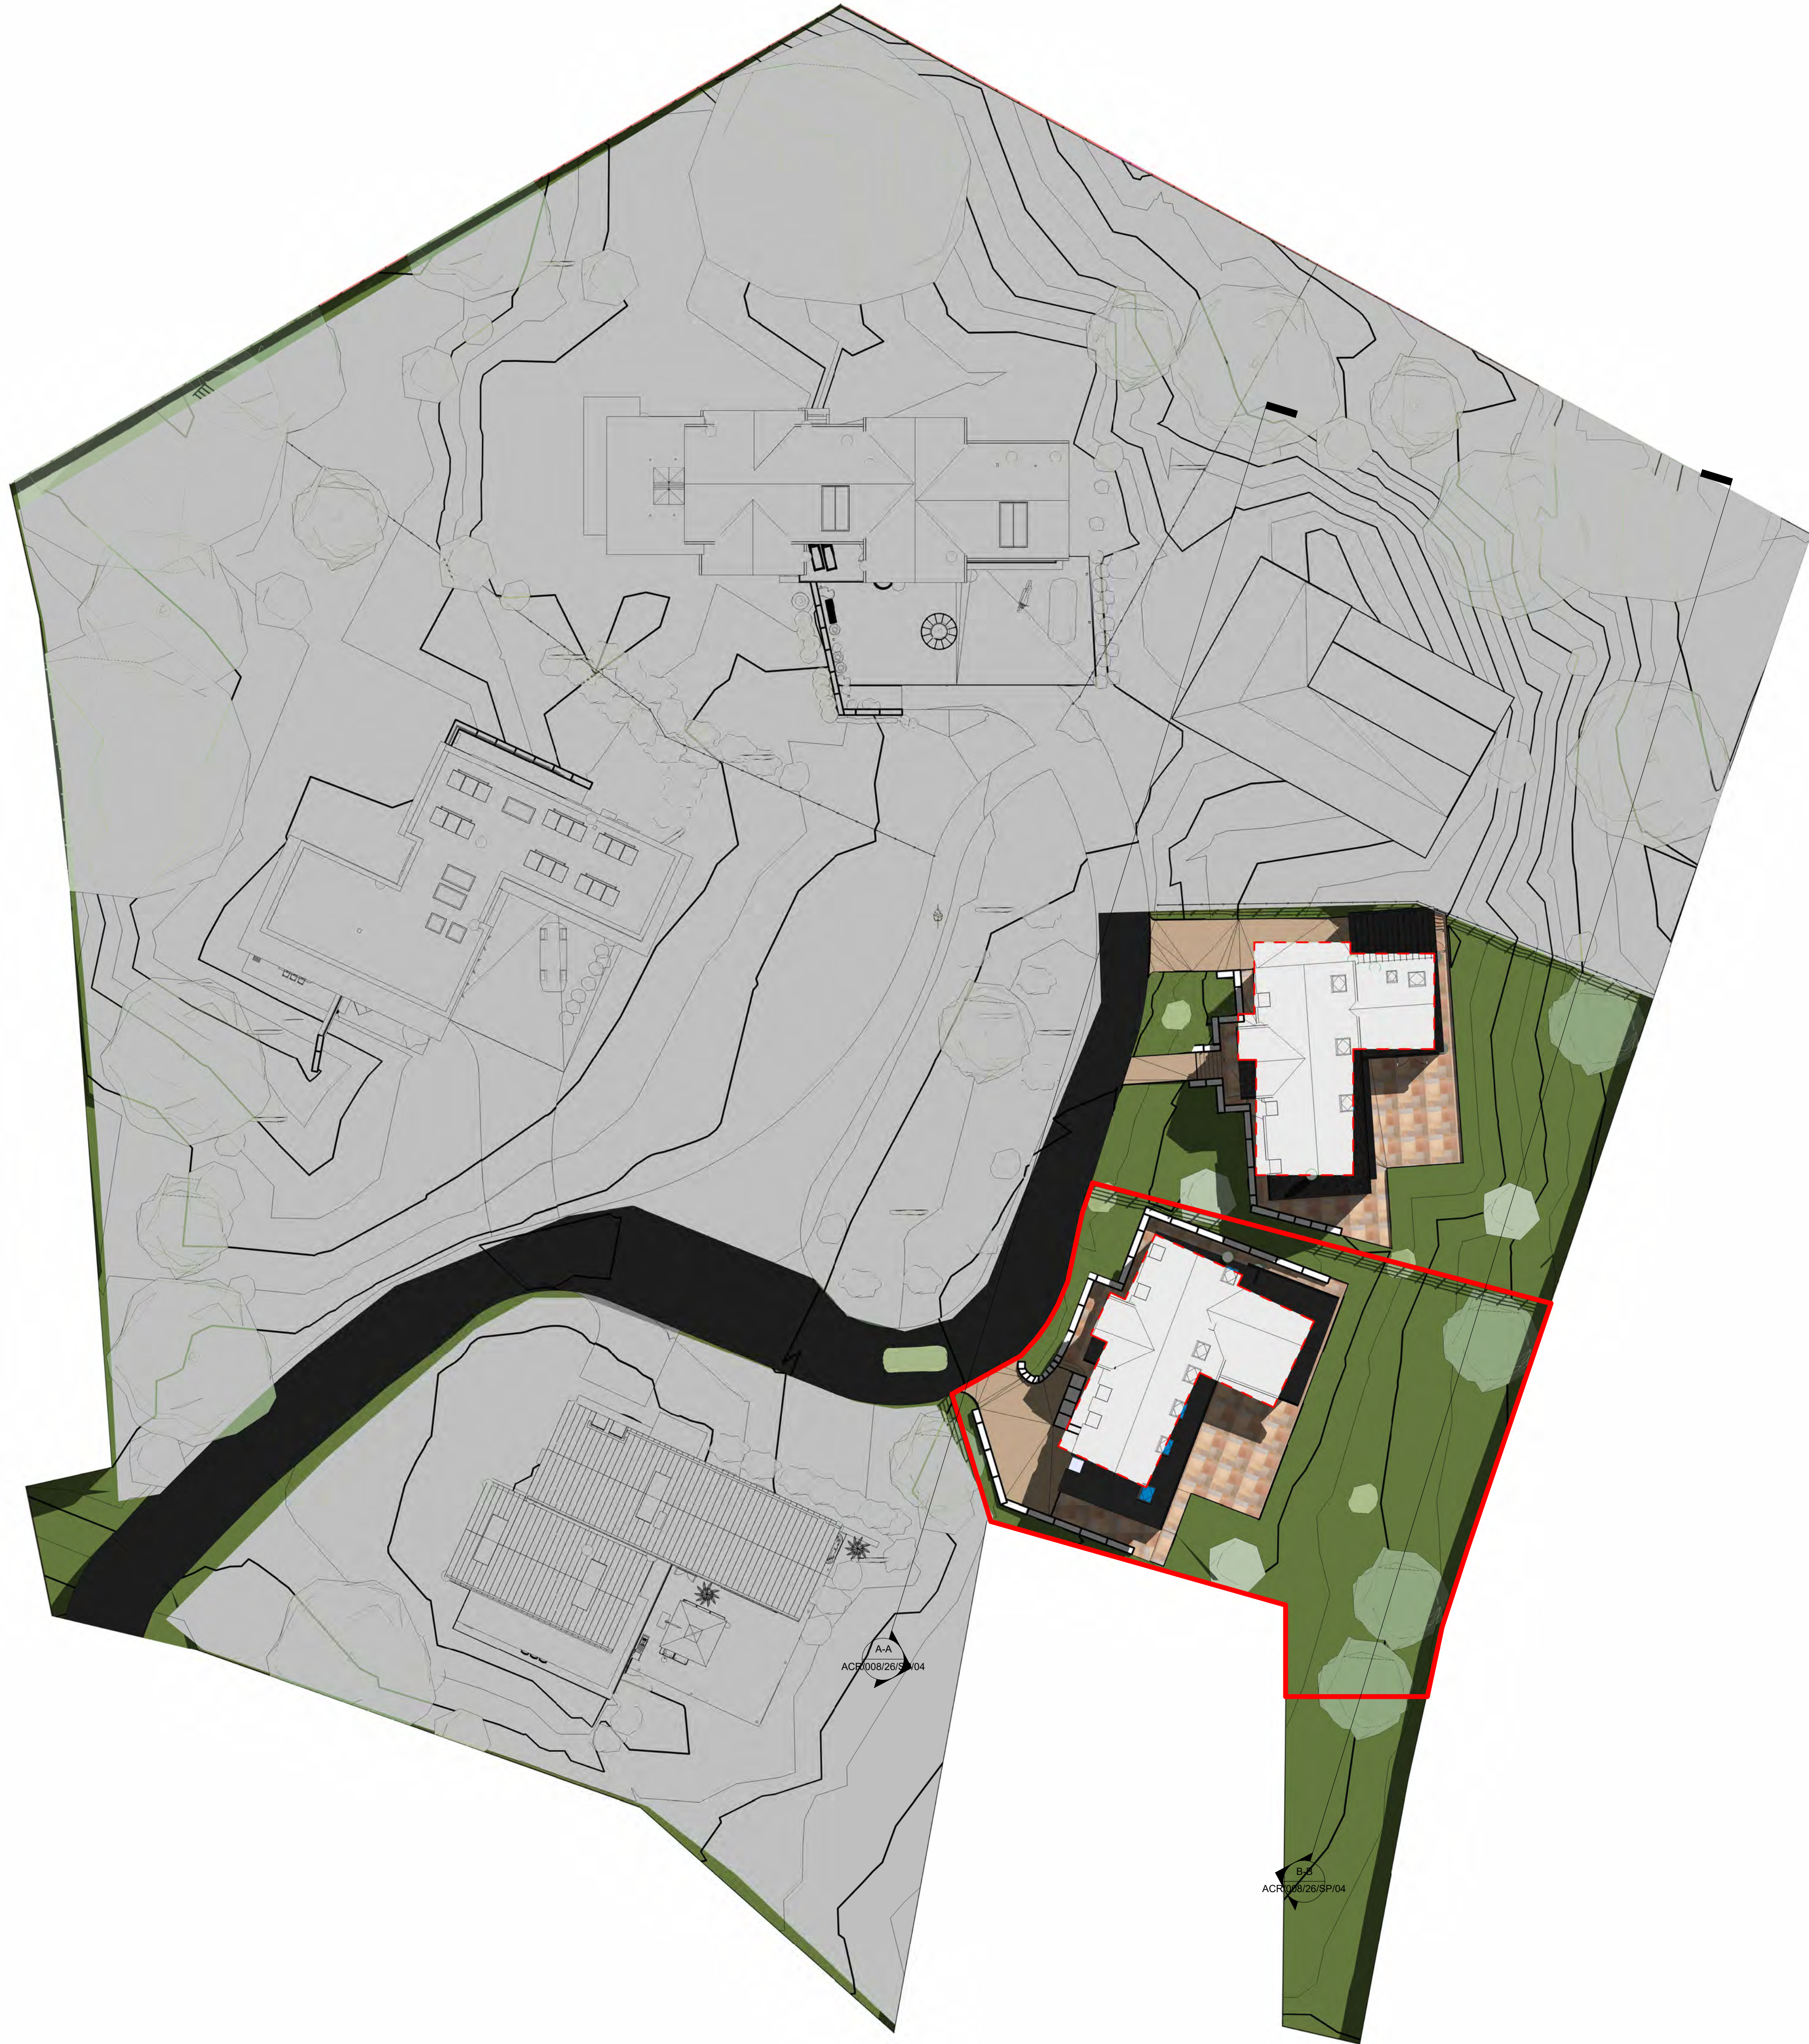
PLOT CROSS SECTIONS  
SHEET 2 OF 5

Cross sections across Plot 6 have been drawn and are presented with the sections designated Section B-B and E-E from the earlier PBA Drawing 120.05844.0251-P01 in Appendix 2 of this Report.

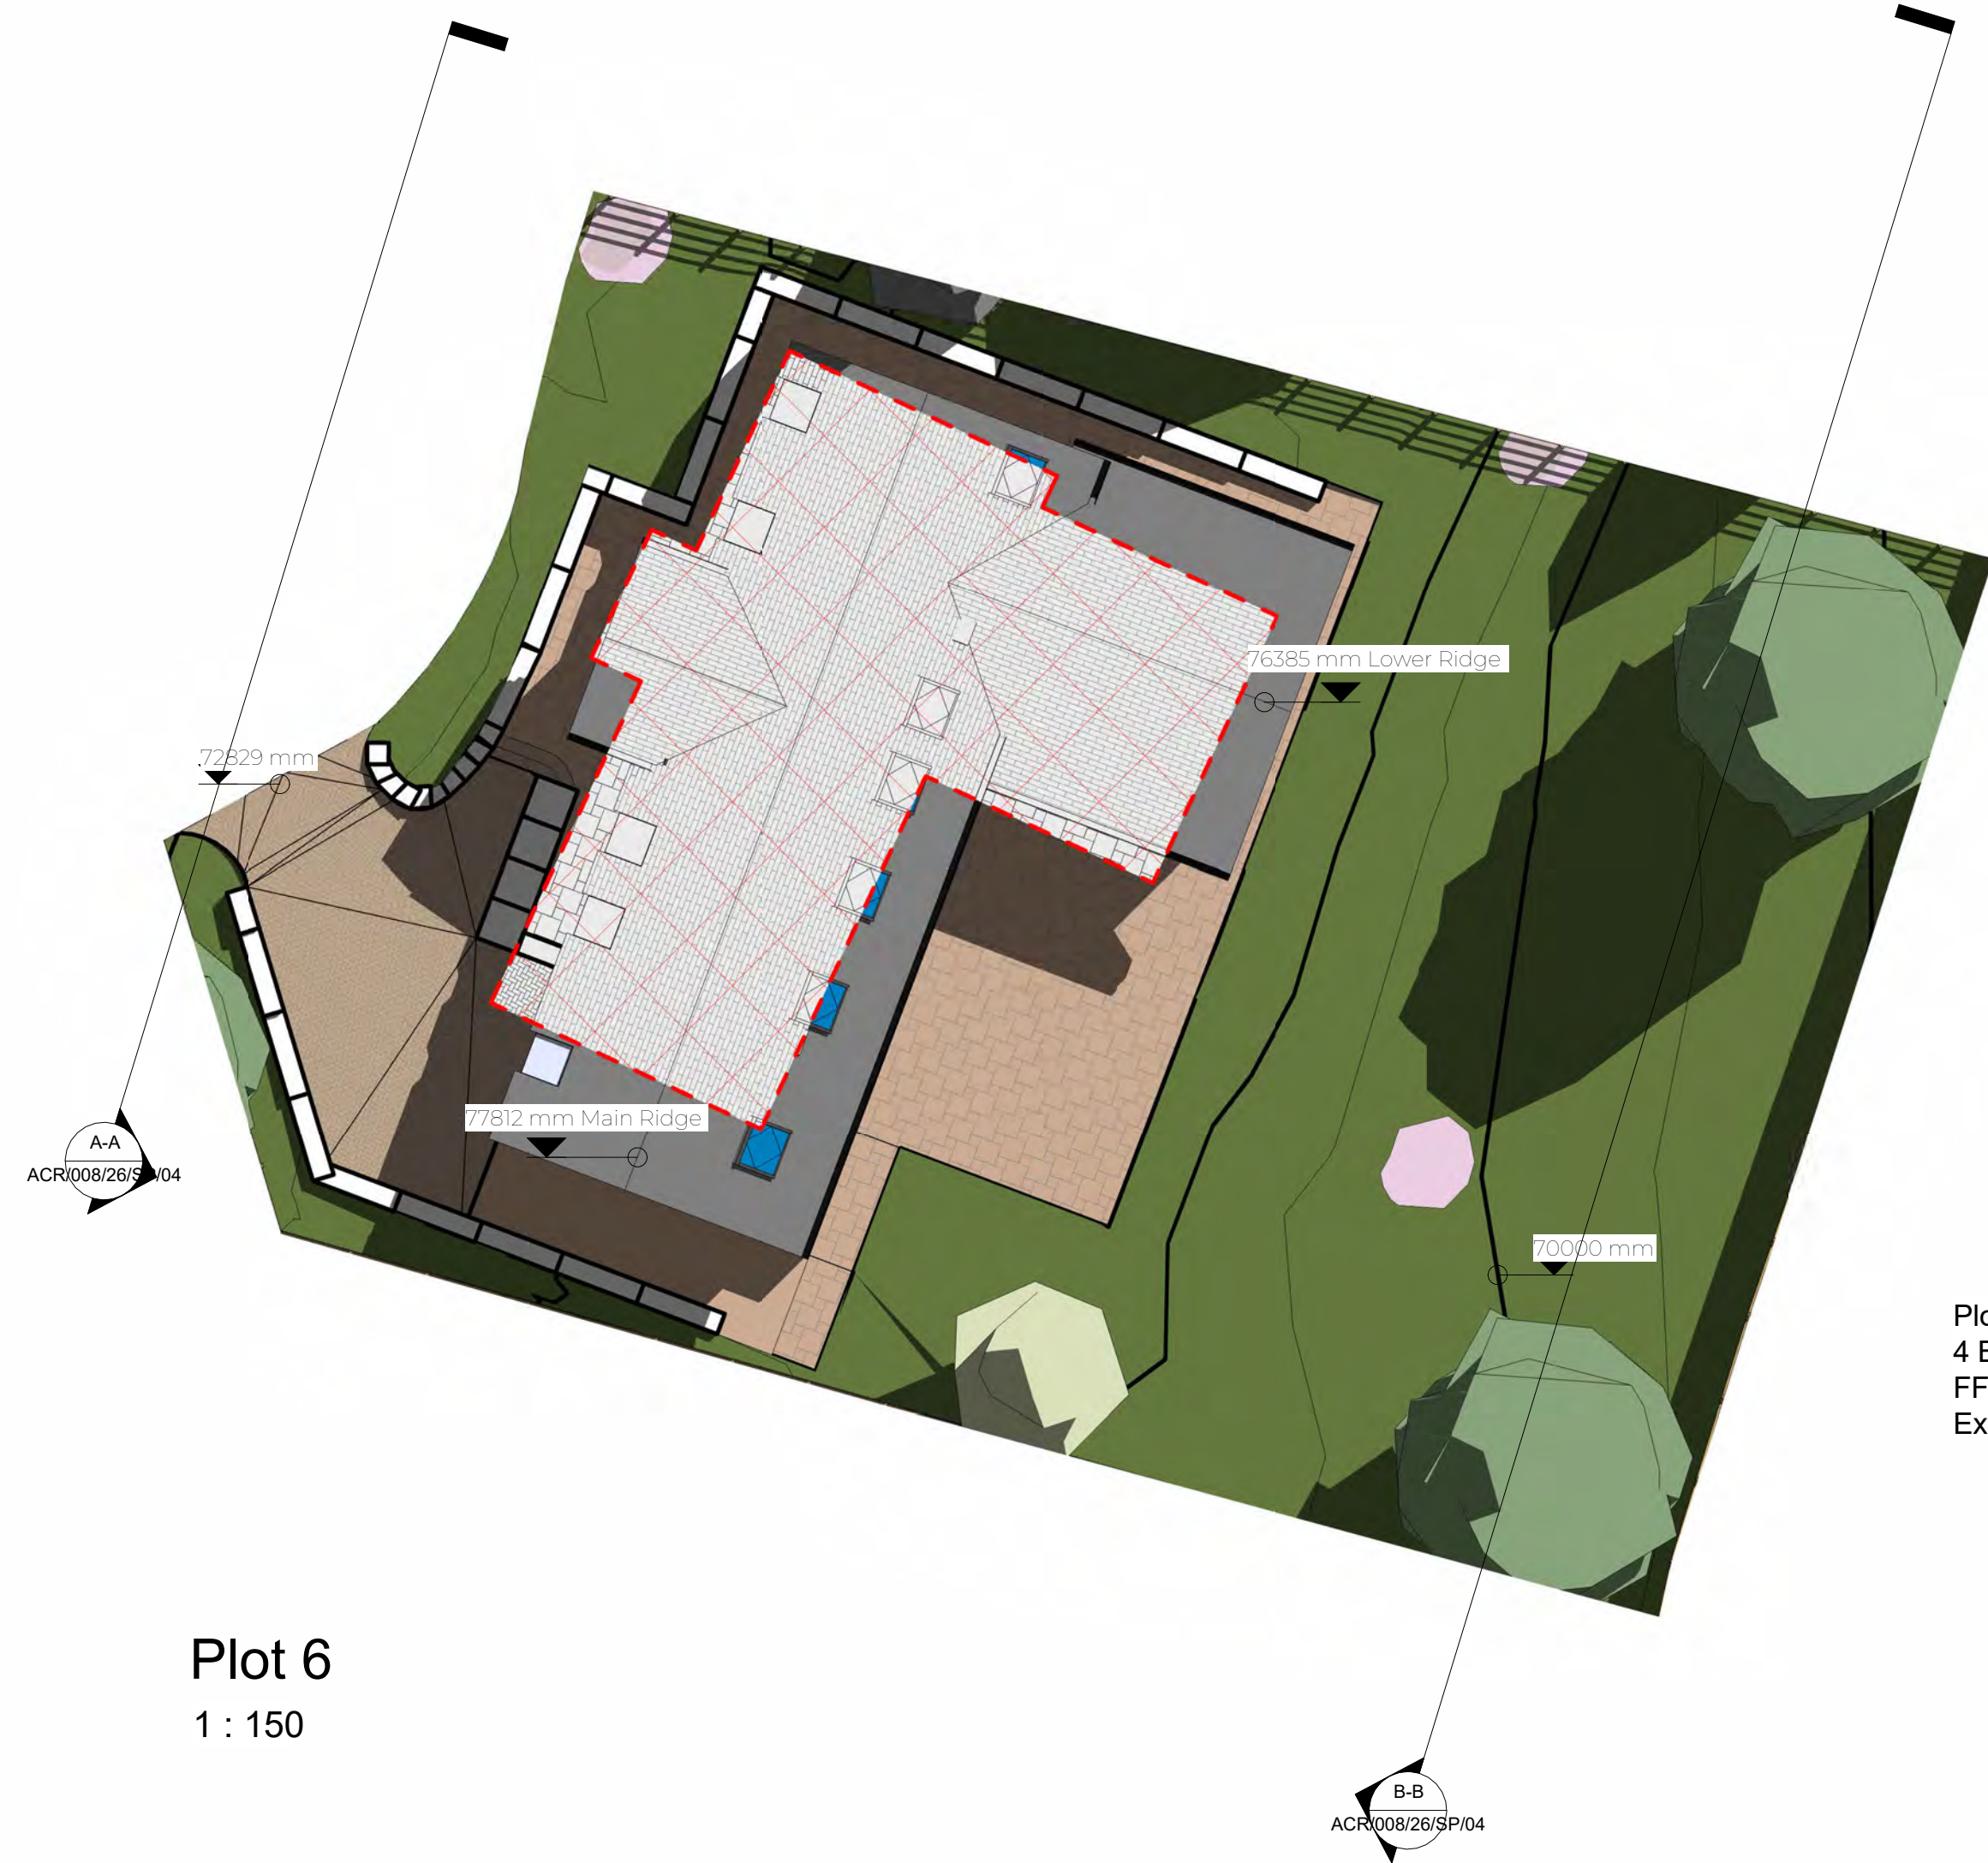
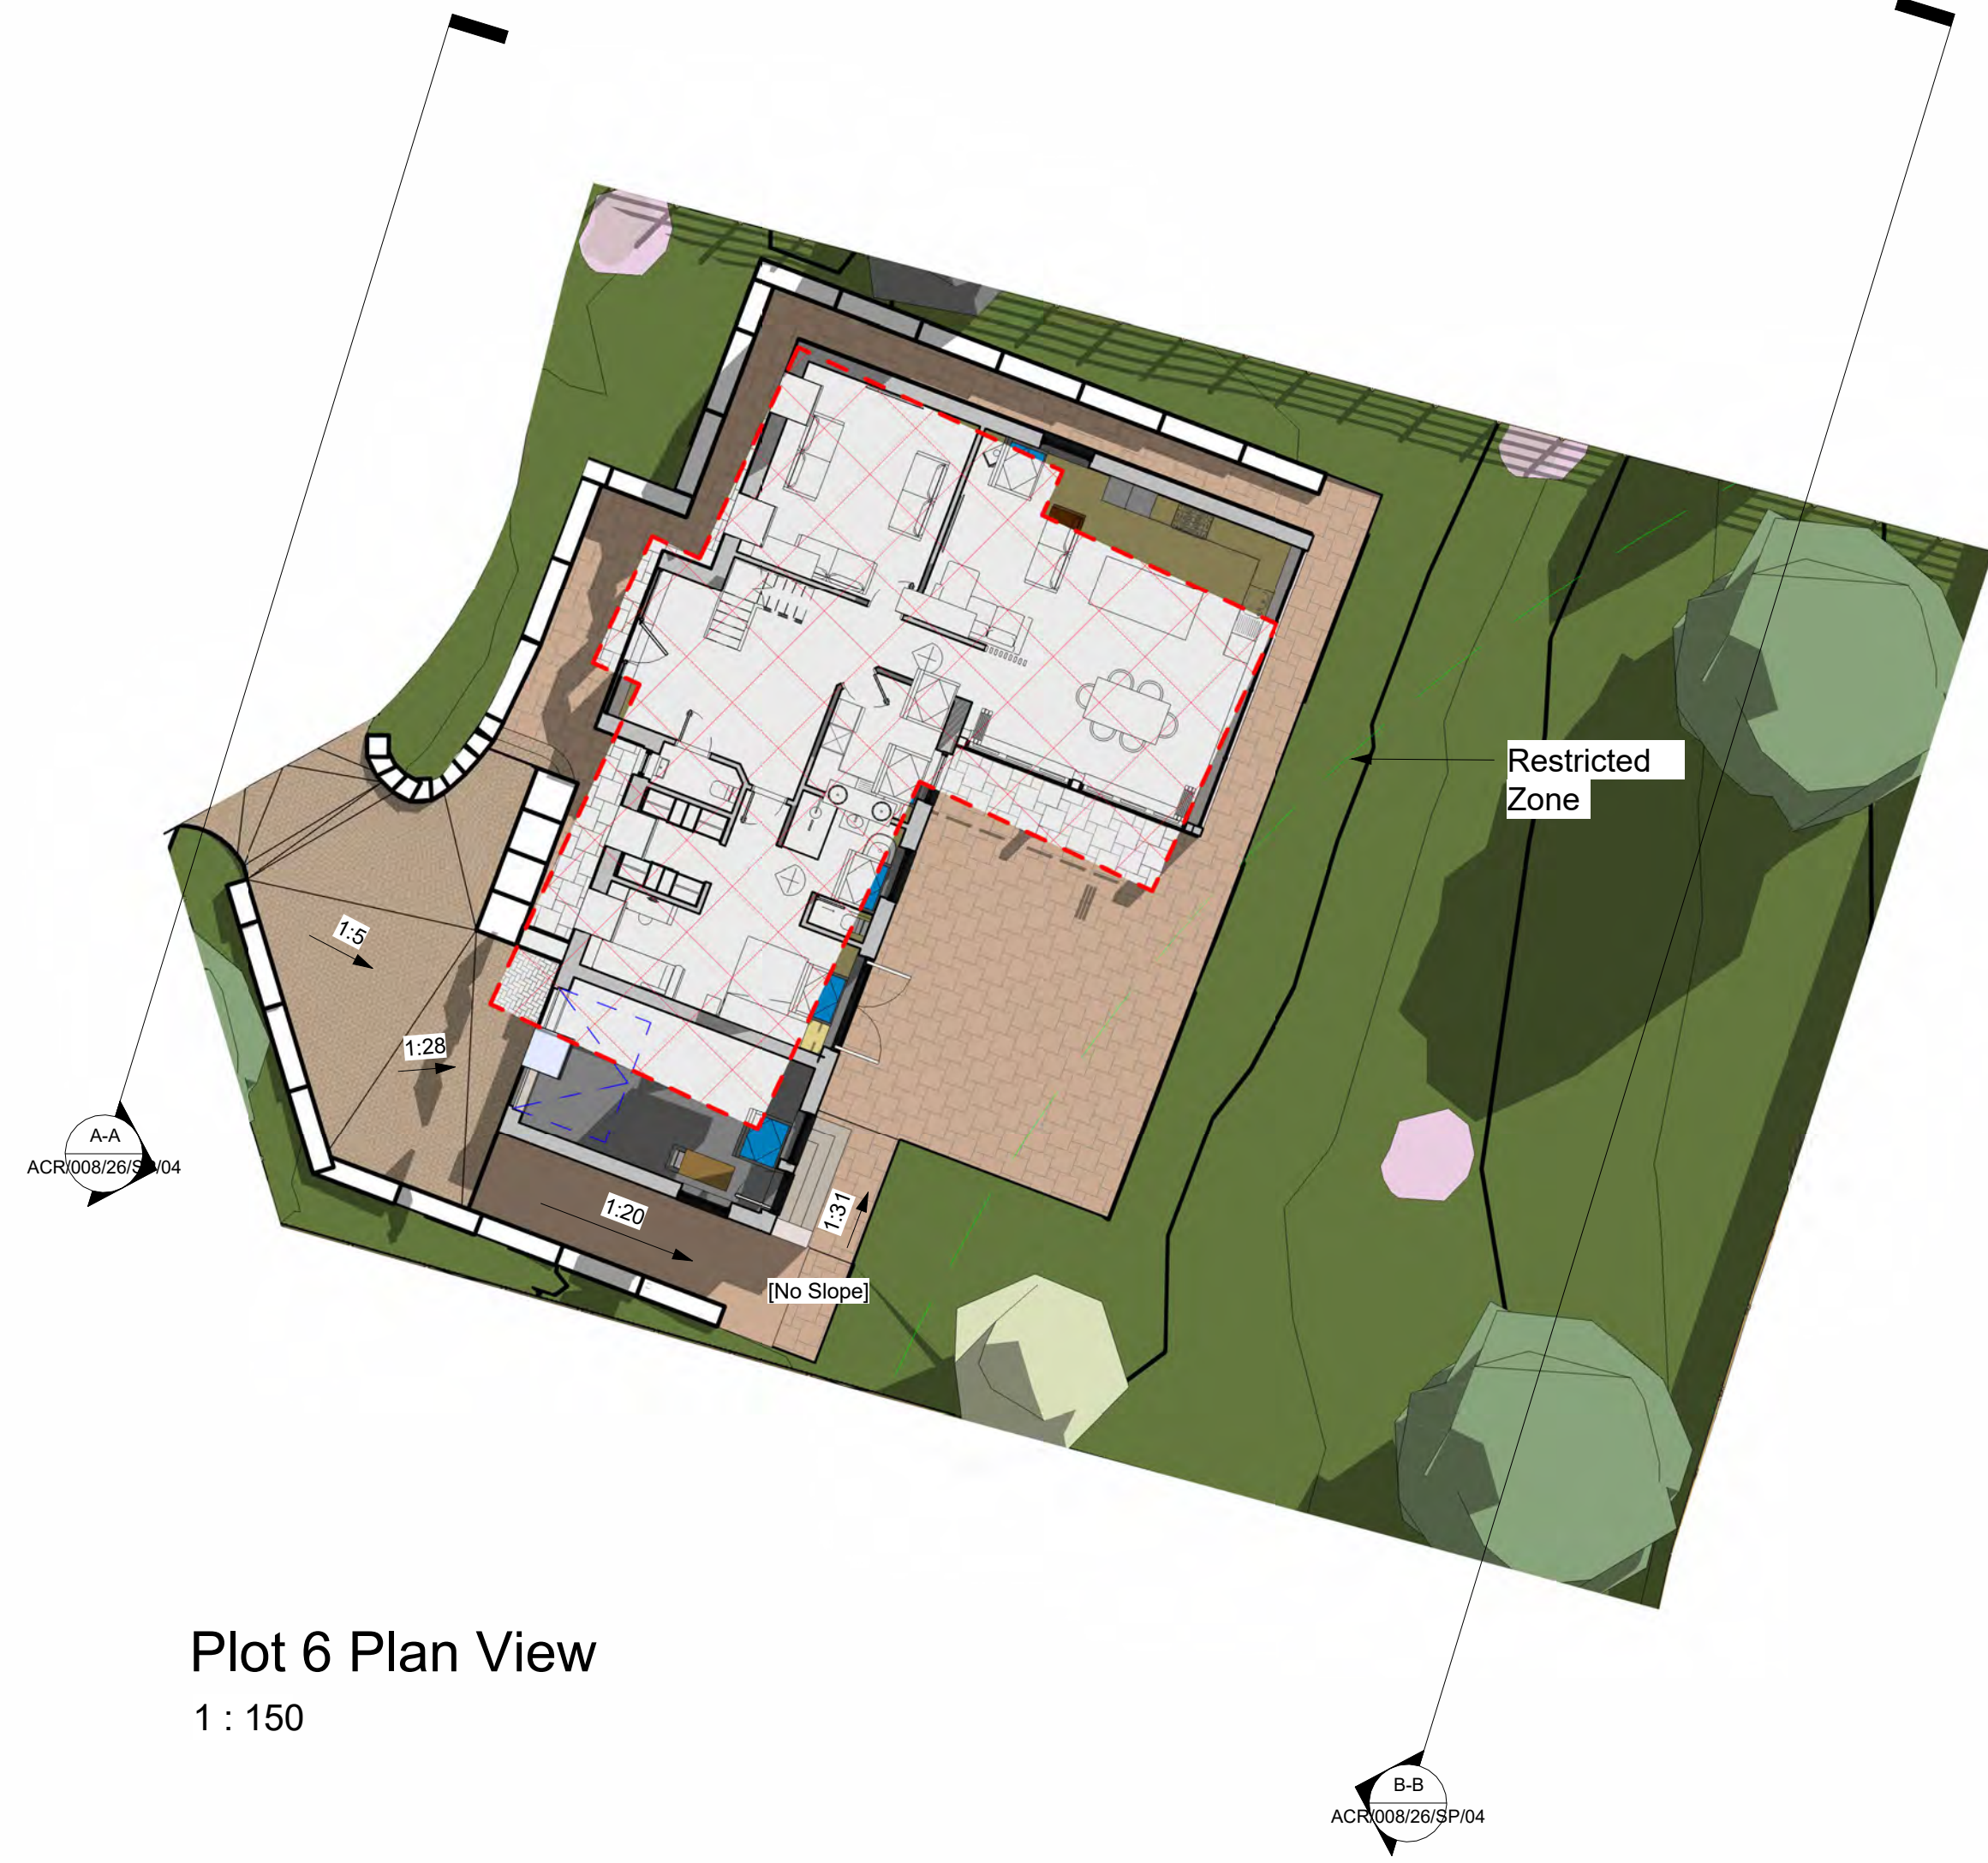
Plot 6  
1 : 150

Plot 6  
4 Bed  
FFL - 71.29  
External FFL - 71.29

Subsequent changes in design levels for the structure designated Plot 6 has meant that a new “Plot Specific” slope stability assessment is now required and this was instructed by ECE Planning on behalf of Nick and Sally Kayworth in March 2026. This slope stability assessment will use the results of the GCC ground investigation (GCC Report No. J20-022/R06 dated September 2023) and the development levels provided by the Client (Drawing No. ARC/008/24/P6/105).

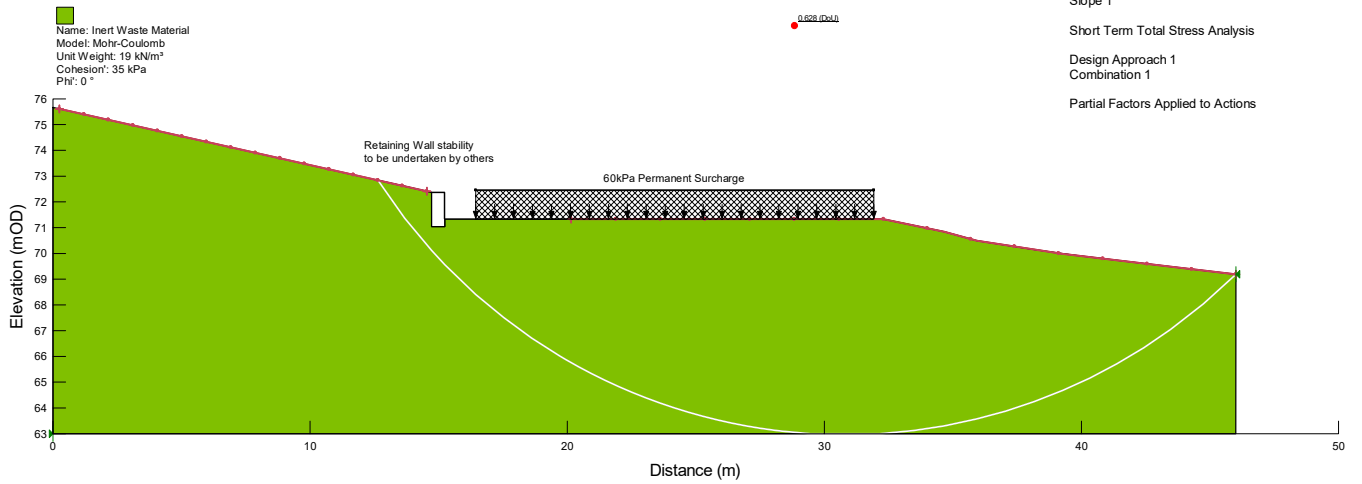
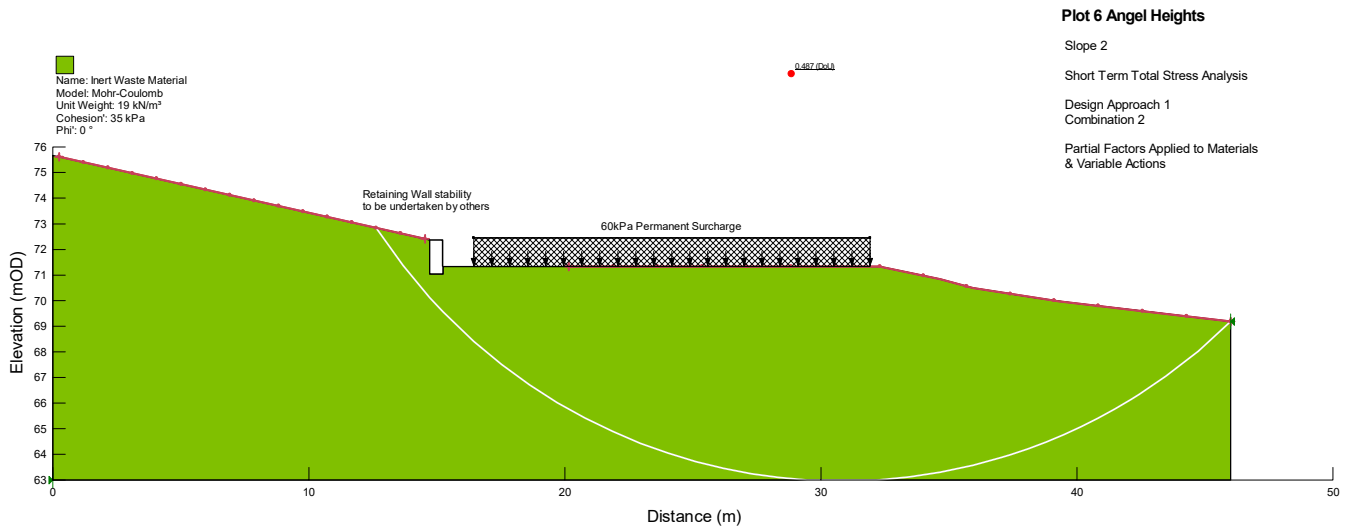
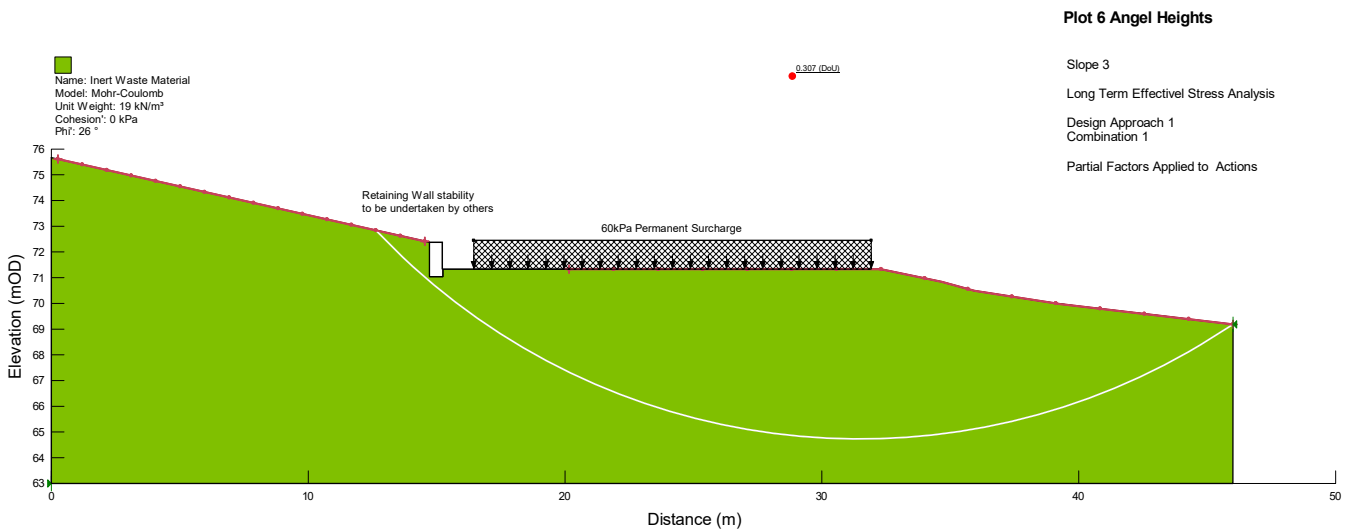
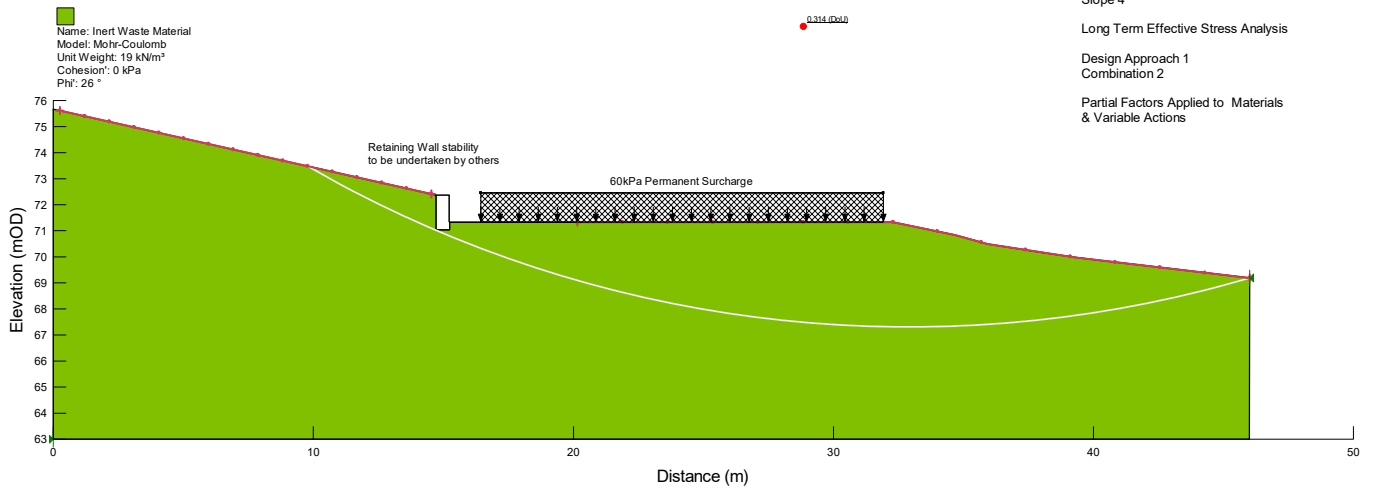
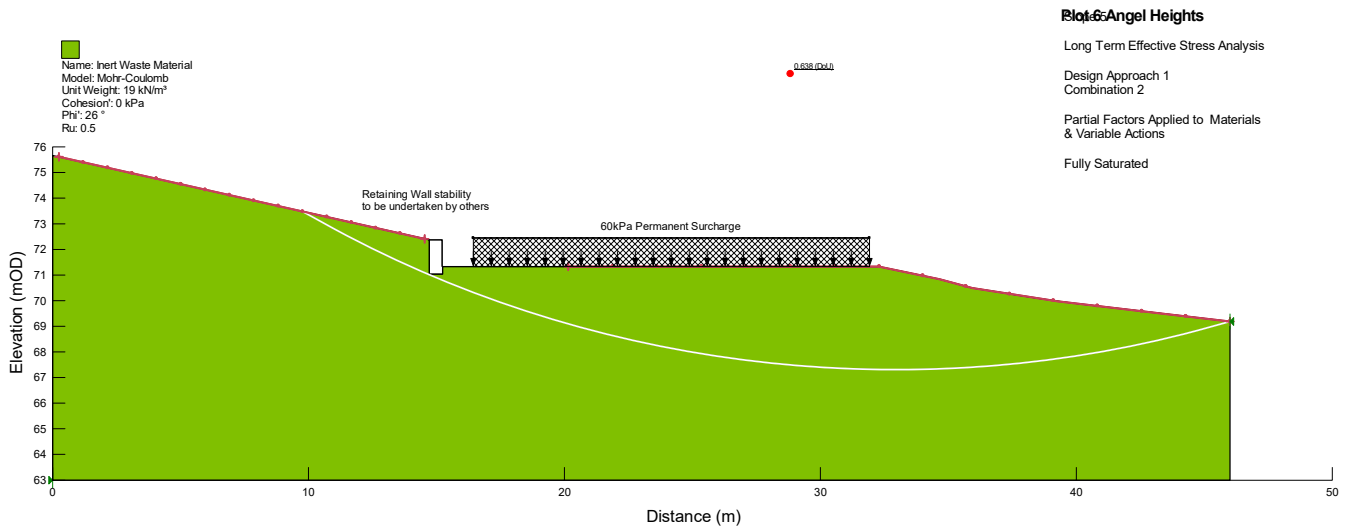
### **APPENDIX 3: SLOPEW WORKSHEETS - PLOT 6**

The results of the individual construction plot stability analysis are presented in Table 4.2., whilst the SlopeW worksheets are located in Appendix 3.
