**Land East of Henfield Road, Cowfold**

**Minerals Safeguarding Assessment**

**May 2026**

| Reference: | GE23858/MSA/MAY26 |

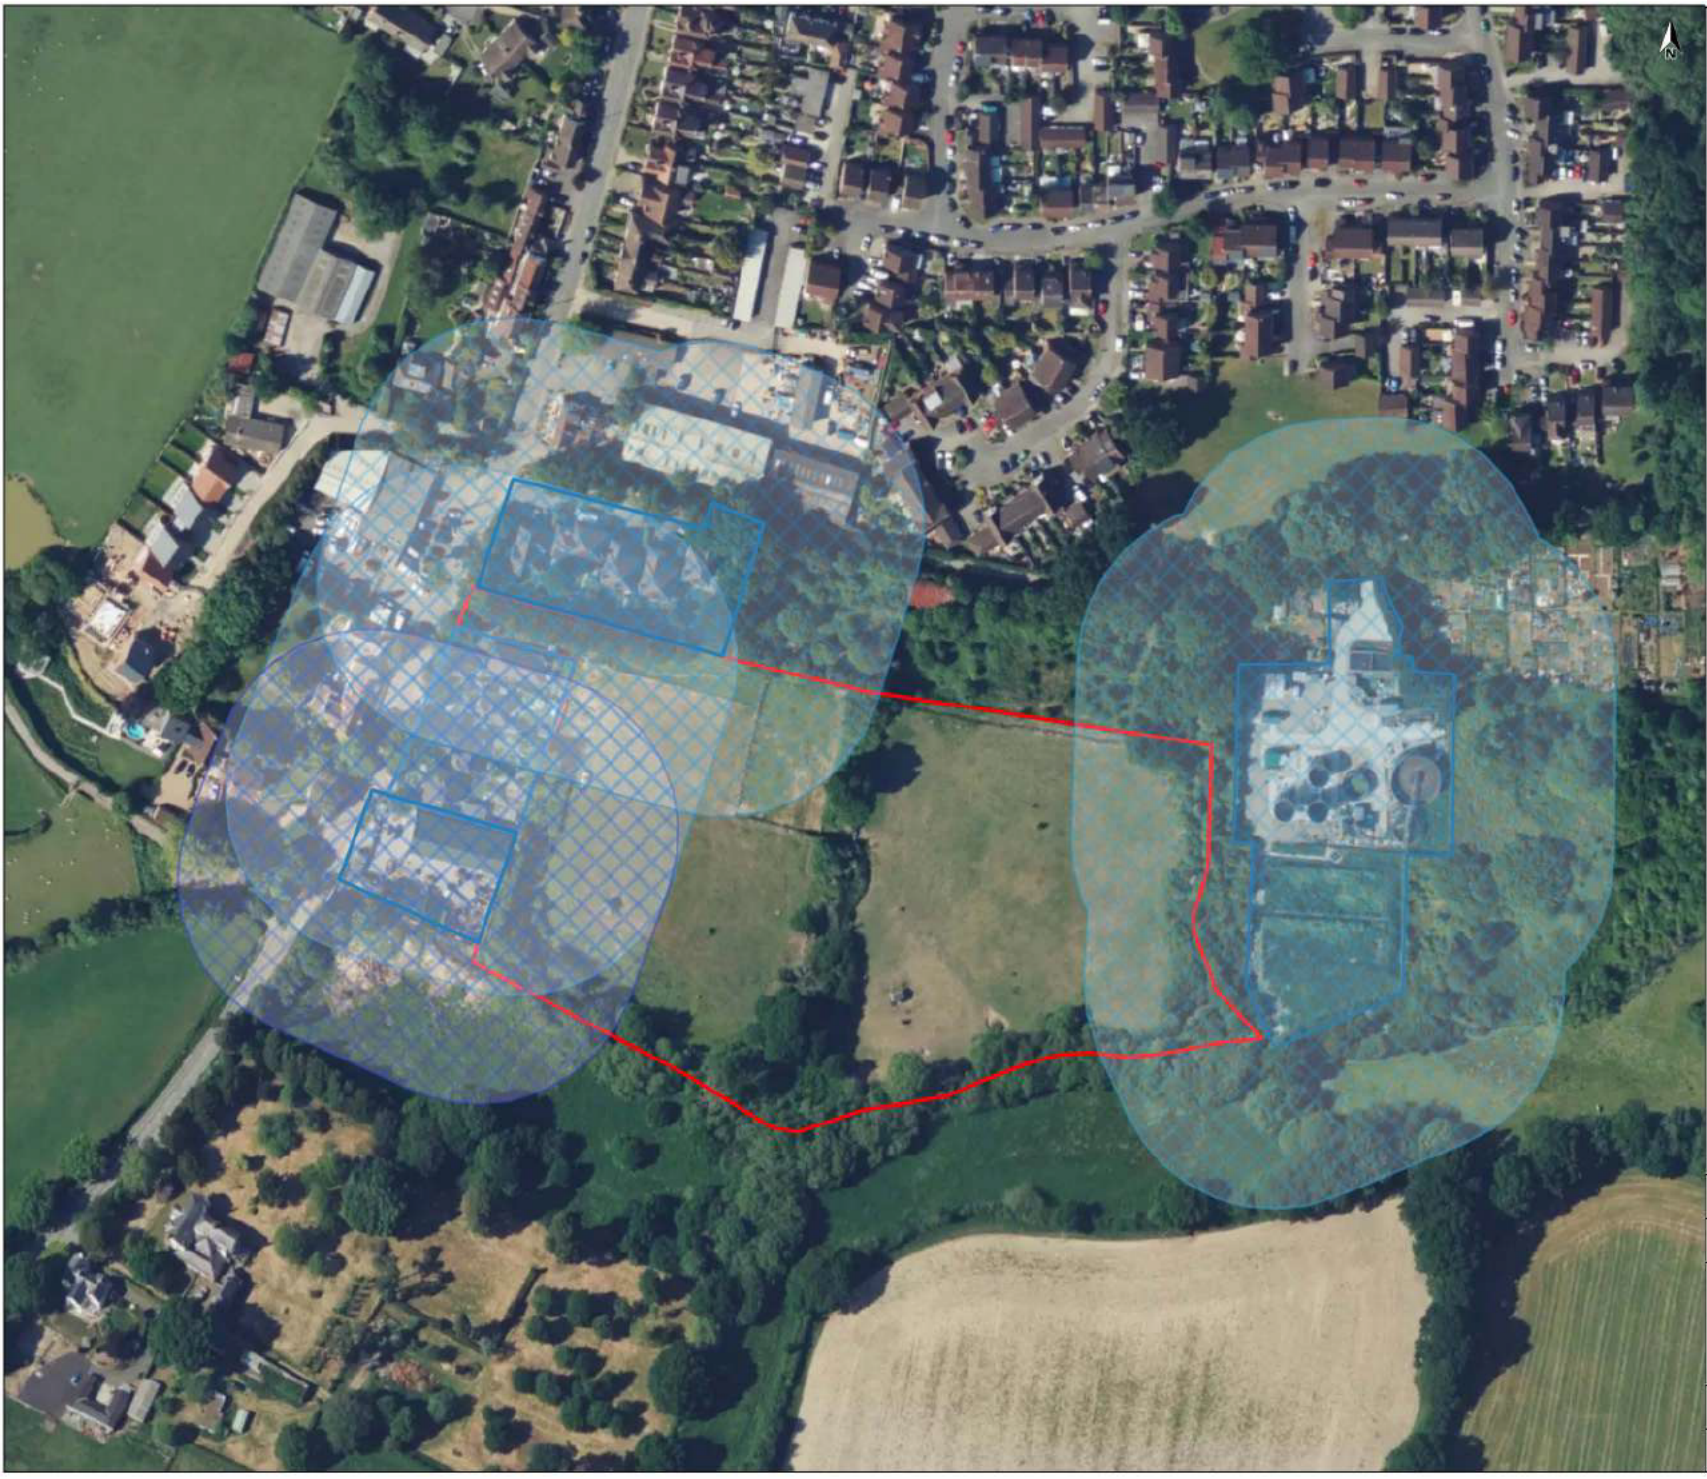
- Legend**
- 50m buffer around Residential Properties to the North
  - Residential Properties to the North
  - 50m buffer around Sewage Works to the East
  - Sewage Works to the East
  - 50m buffer around Commercial Property to the West
  - Commercial Property to the West
  - 50m buffer around Residential Properties to the West
  - Residential Properties to the West
  - Site Boundary

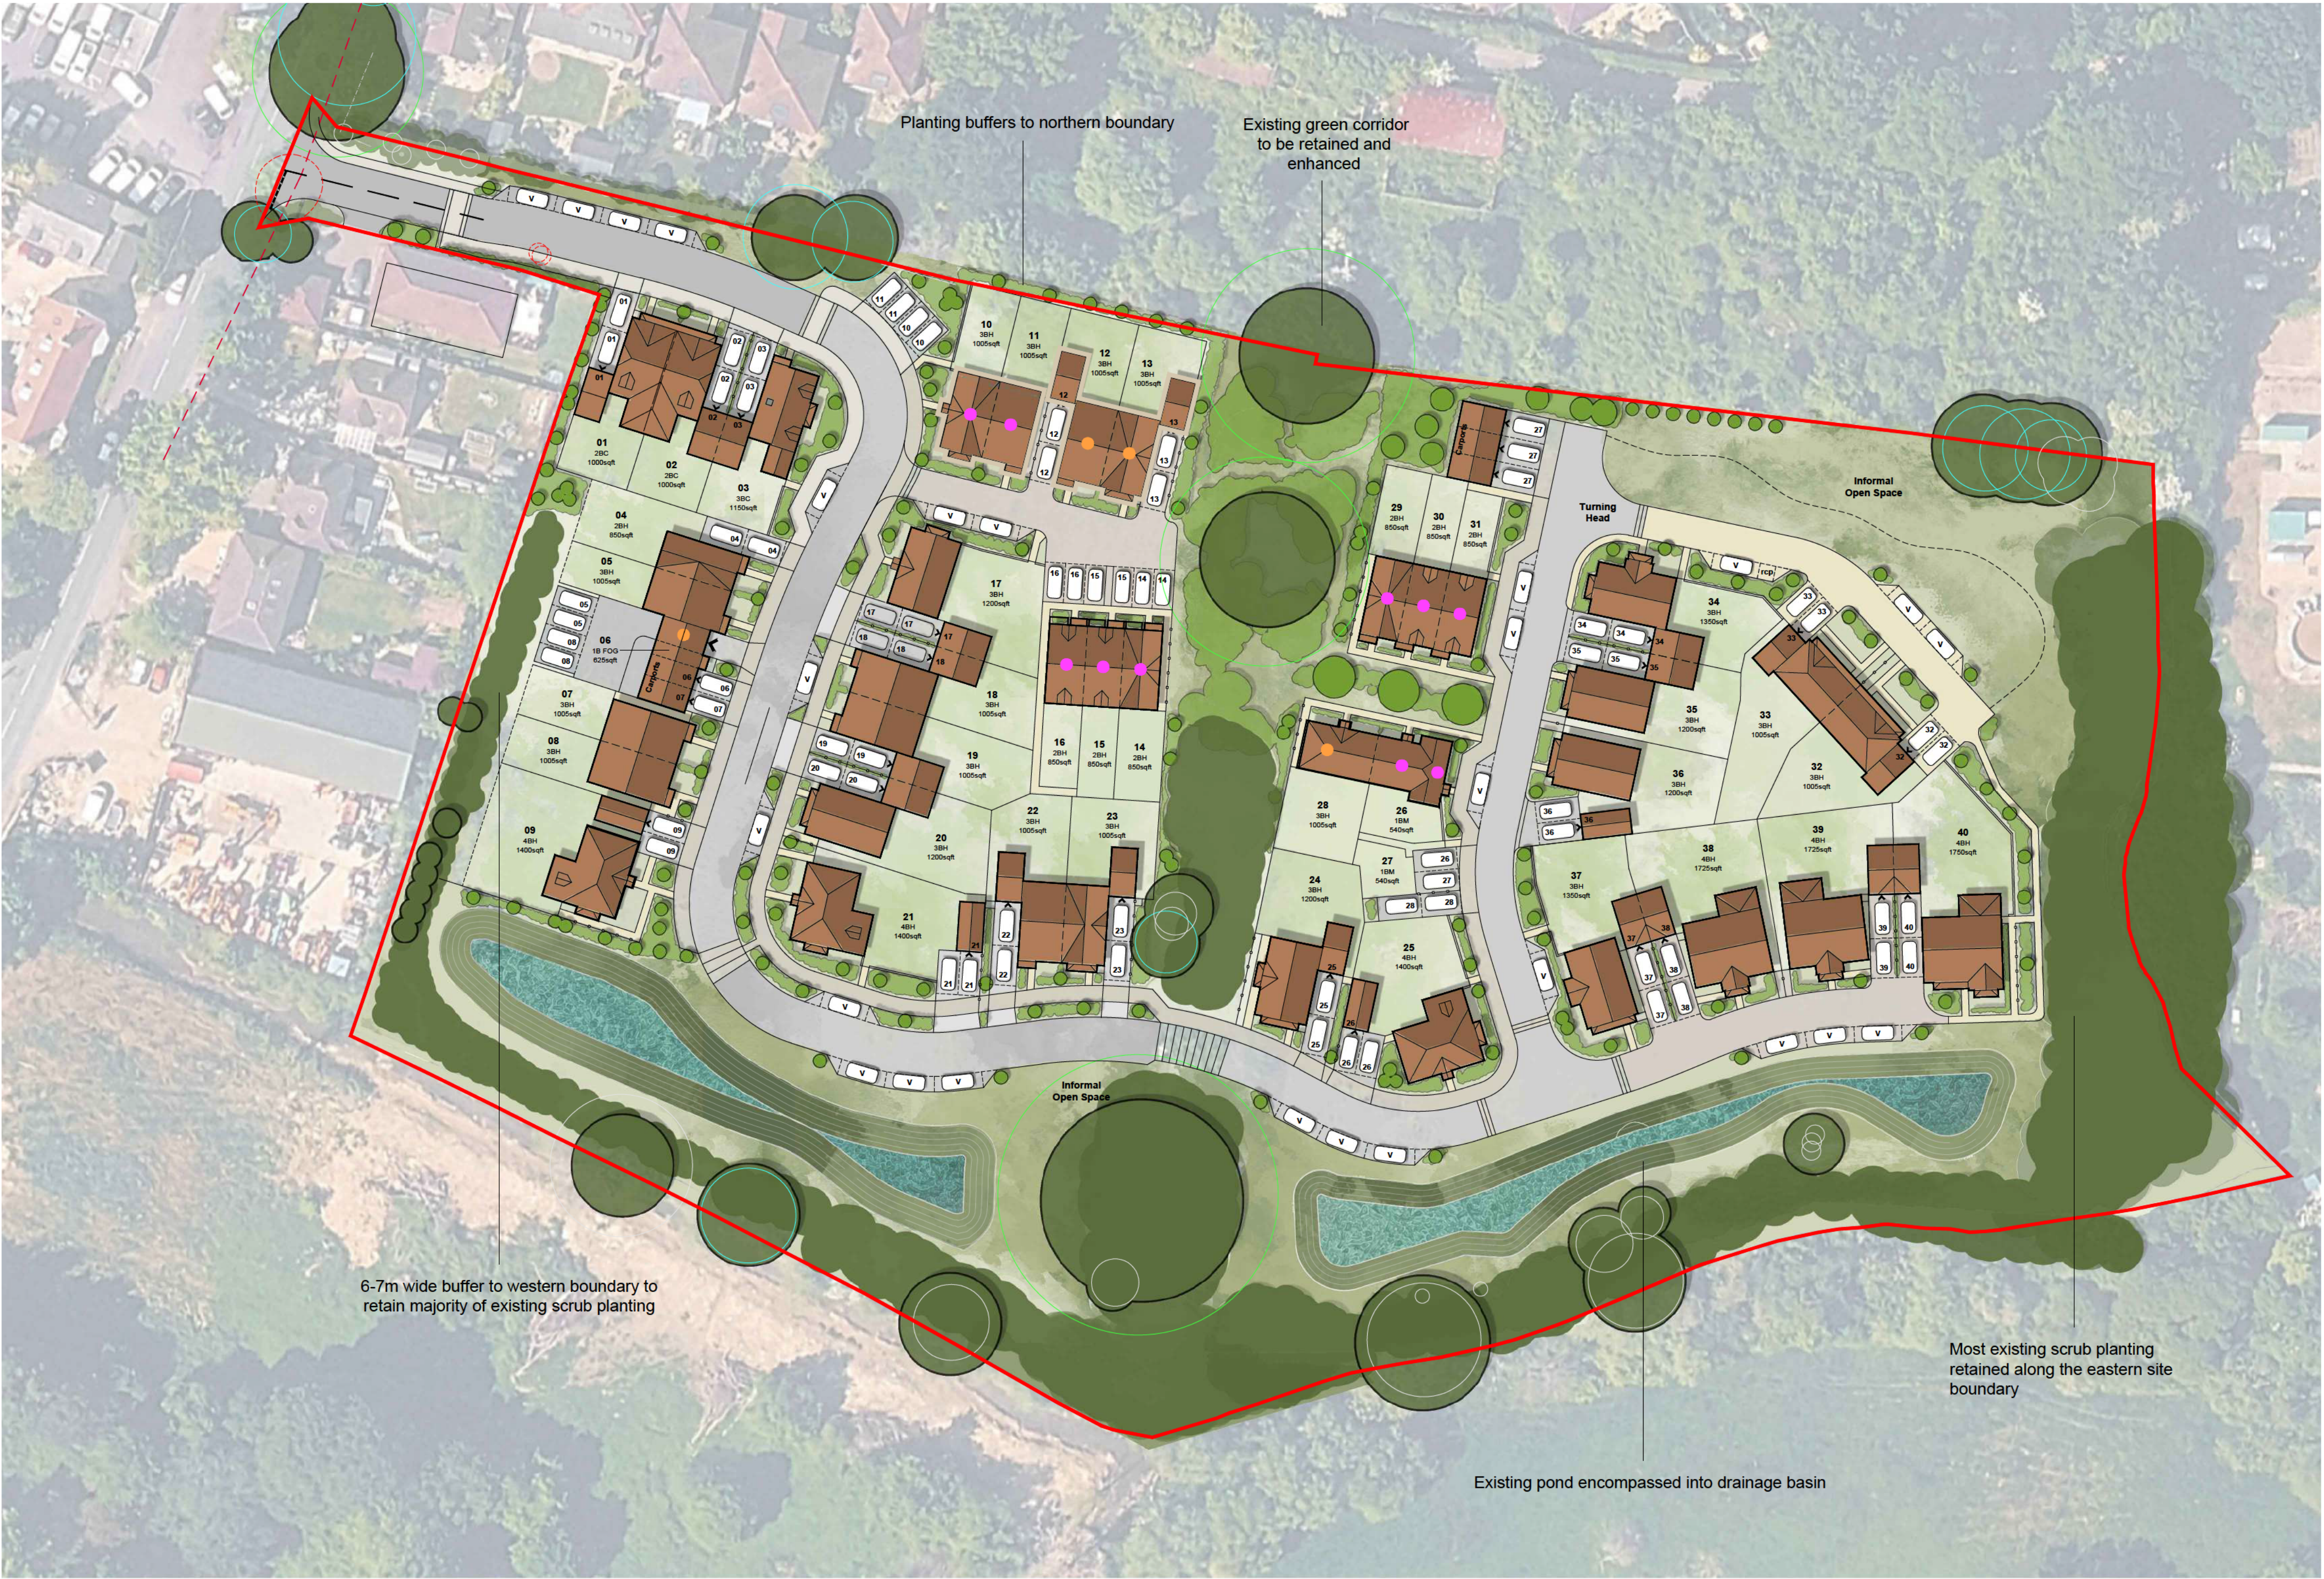
| FIGURE 3 | Proposed Site Plan |

- Site Boundary [2.59 Ha approx]
- Category A Tree Root Protection Area
- Category B Tree Root Protection Area
- Category C Tree Root Protection Area
- Removed Tree Root
- Existing Trees Retained
- Existing Tree / Shrub Groups Retained

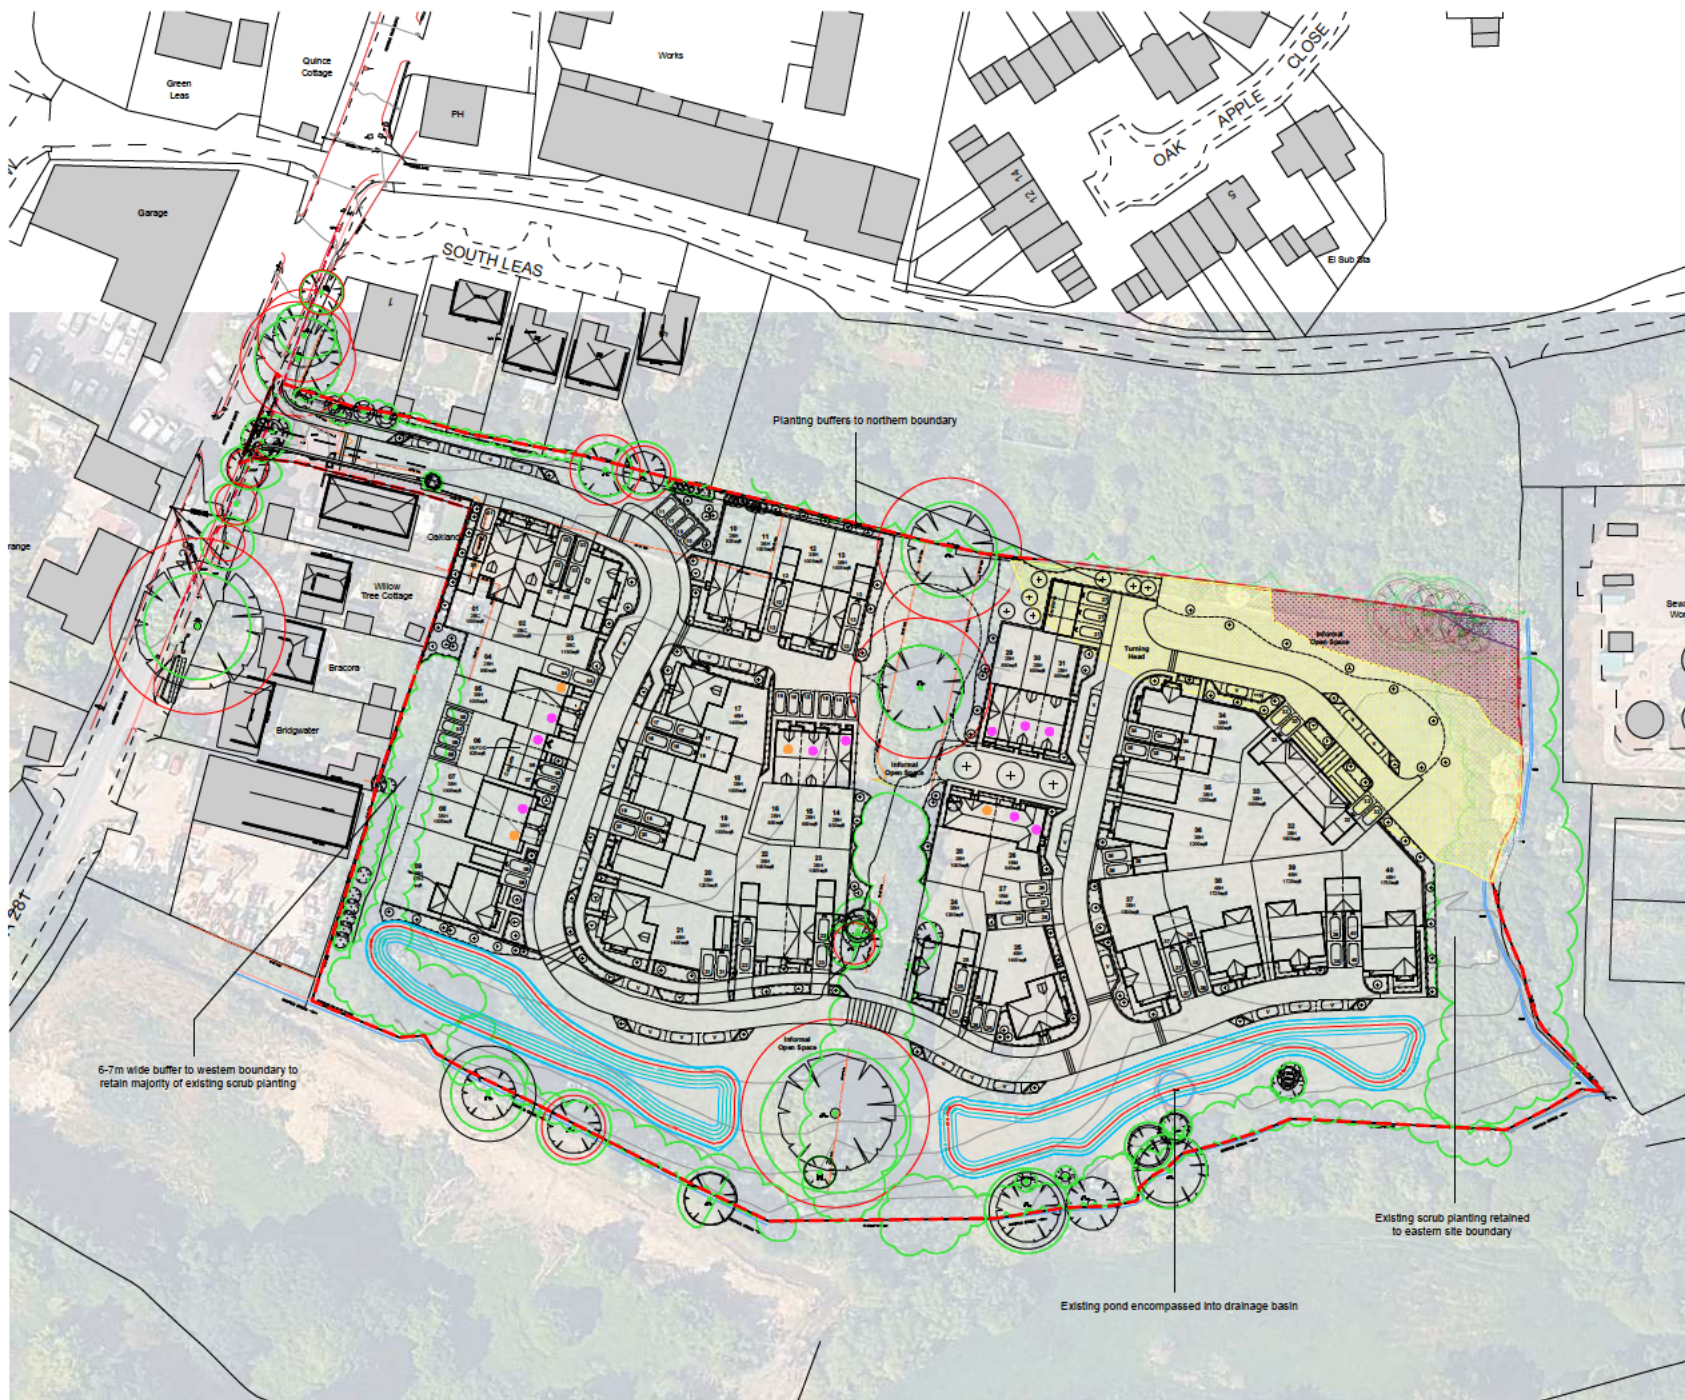
**FIGURE 1**

**PROPOSED LAYOUT**

| Key: | |
|---|---|
| <span style="border: 2px solid red; display: inline-block; width: 10px; height: 10px;"></span> | Site Boundary [2.53 Ha approx] |

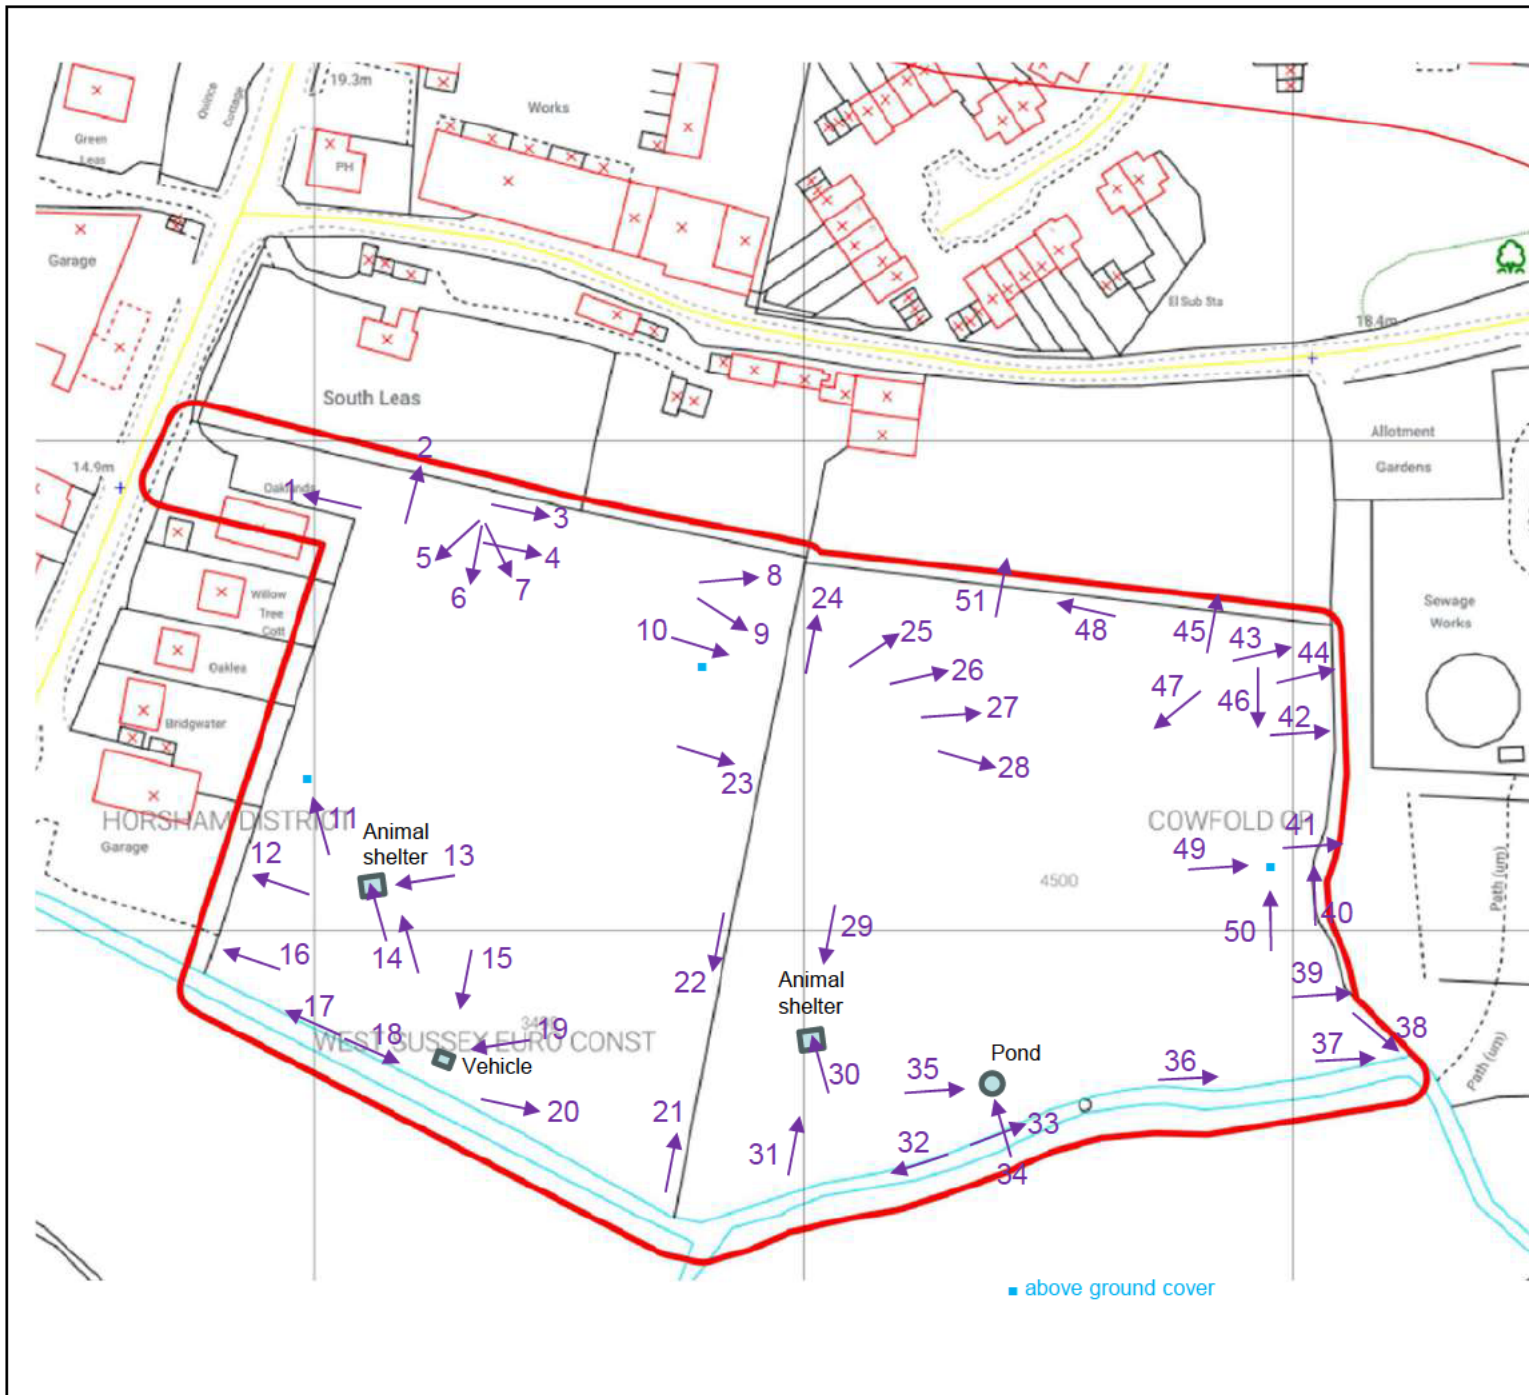
**FIGURE 2**

**PHOTOGRAPH INDEX**
