## Preliminary Ecological Appraisal & Preliminary Roost Assessment

9 Montpelier Gardens, Washington, Pulborough RH203BW

This report is prepared to inform a planning application with Horsham District Council. This proposal can be described as "Construction of two semi-detached dwellings".

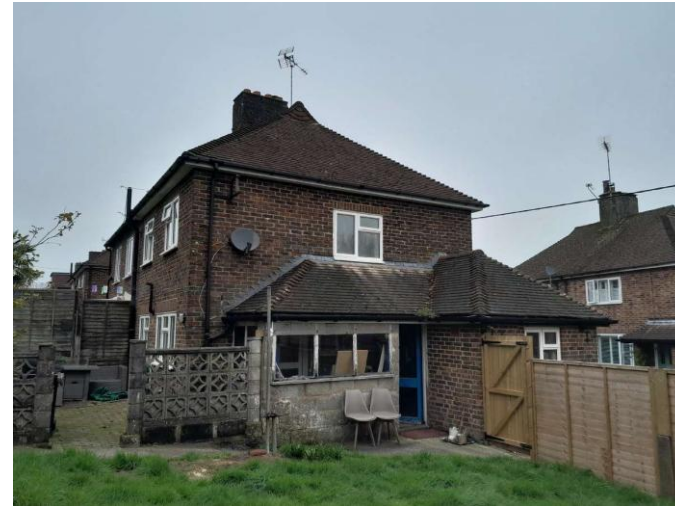
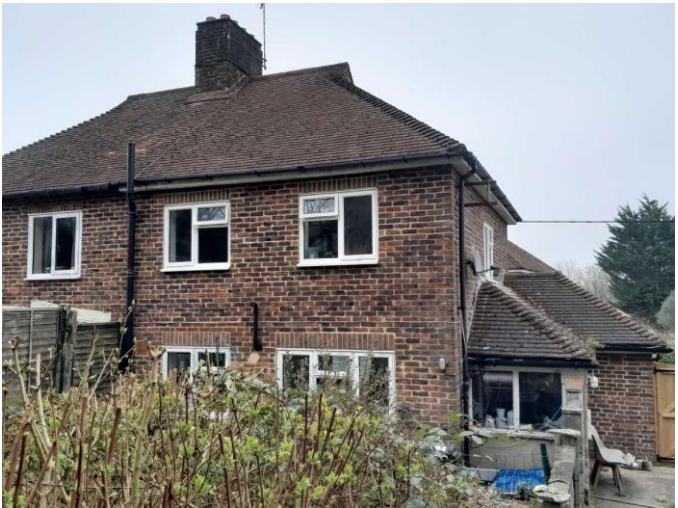
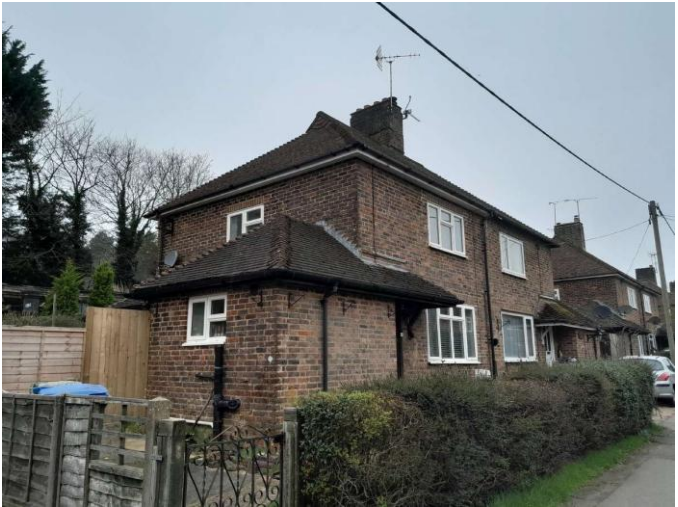
B1 is a two-storey, brick-built, semi-detached, residential dwelling. The main roof is hipped and constructed of clay tiles. The brickwork appears in good condition and the windows and doors are tight fitted. There is a single storey extension on the south elevation with half a cross-hipped roof area which protrudes from the exterior wall. No bat evidence was found during the survey.

In line with Good Practice Guidelines (Collins, J (Ed) 2023), B1 is assessed to have low habitat value for roosting bats due to a small number of suitable roosting features, such as gaps under roof tiles and gap between soffit and wall.

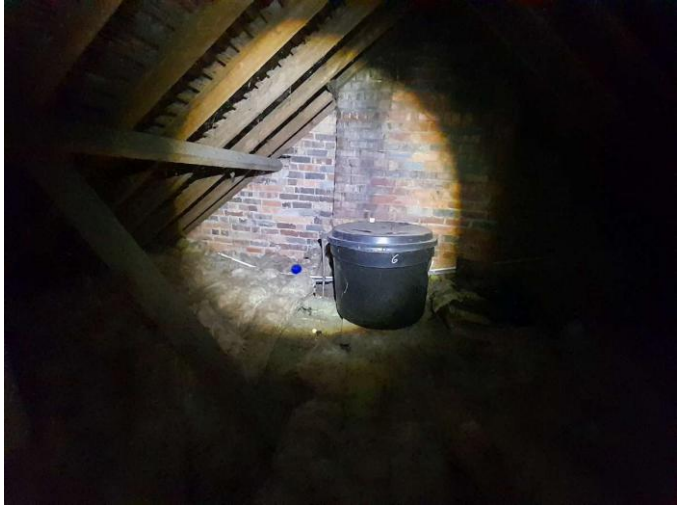
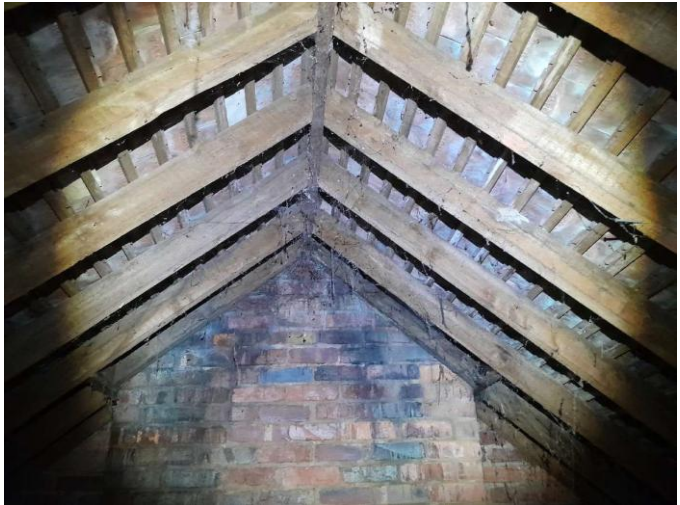
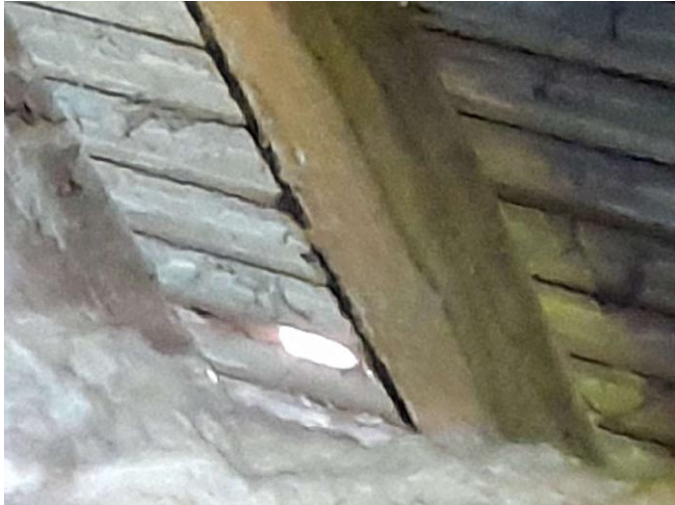
*Loft*

| Feature | Materials | Condition/Suitability | Photographs |
|---|---|---|---|
| Voids | None | <p>A loft void was recorded within B1. This void was accessible and measured approximately 4m in length, 4m in width, and 2.2m in height, with an area of 16m<sup>2</sup>. The temperature within the void was recorded at 9.2°C with a humidity of 68%. The loft is unlined. There are roosting opportunities between the timber ridge and rafters and a small number of gaps under roof tiles were visible, allowing an ingress of light. No bat evidence were noted within this void.</p> | <p><i>Loft</i></p> <p><i>Loft</i></p> |

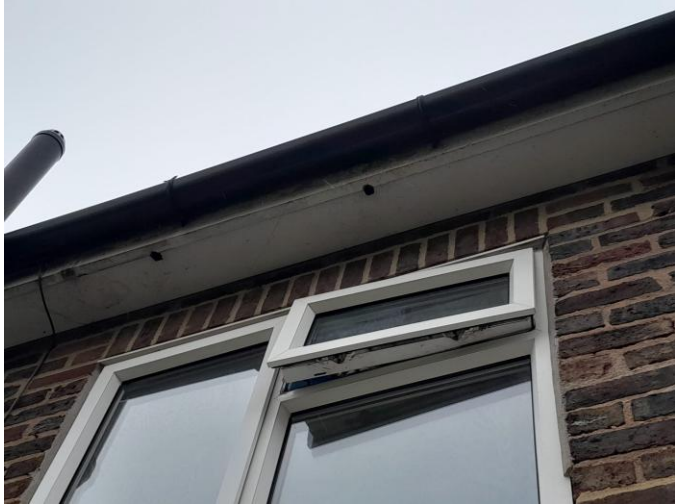
*Soffit and wall gap*

| | Soffit | uPVC | The soffit appears in good general condition. There is a gap between the soffit and the wall and two small holes in the soffit which provide suitable roosting features for crevice-dwelling bats. | | |

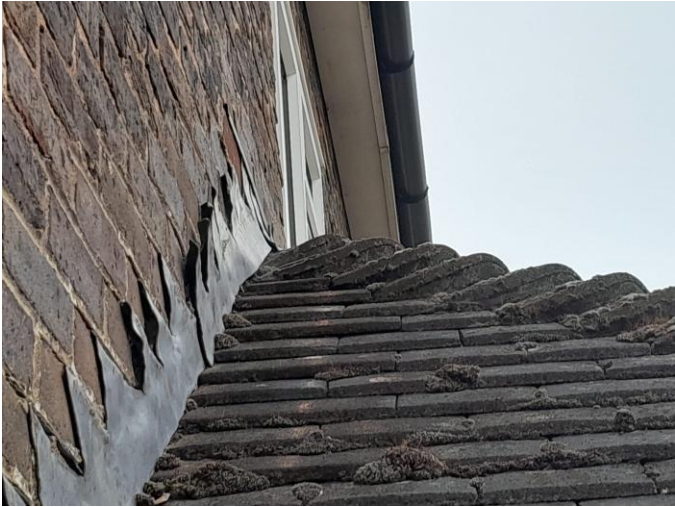
| | Lead flashing | Lead | Gaps between the loose lead flashing and the wall provide sub-optimal roosting features for crevice-dwelling bats. | <p><i>Lead flashing</i></p> | |

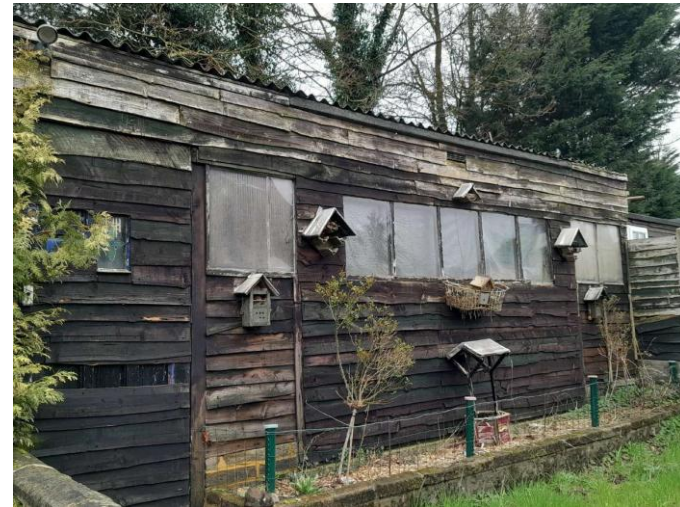
*B2*

B2 and B3 are single-storey, detached, timber-framed out-buildings. The structures are covered by flat roofs comprised of corrugated metal sheeting. No bat evidence was found anywhere on the buildings.

In line with Good Practice Guidelines (Collins, J (Ed) 2023), B2 is assessed to have negligible habitat value for roosting bats due to lack of suitable roosting features.

The two outbuildings (B2 and B3) will be demolished to facilitate the development. The risk to bats is low.

It is recommended that the demolition of B2 and B3 will be timed to take place when bats are least likely to be present; November to March. As the buildings are unsuitable for hibernation due to unstable temperature and humidity regimes, this means that the likelihood of disturbing a bat is extremely low.

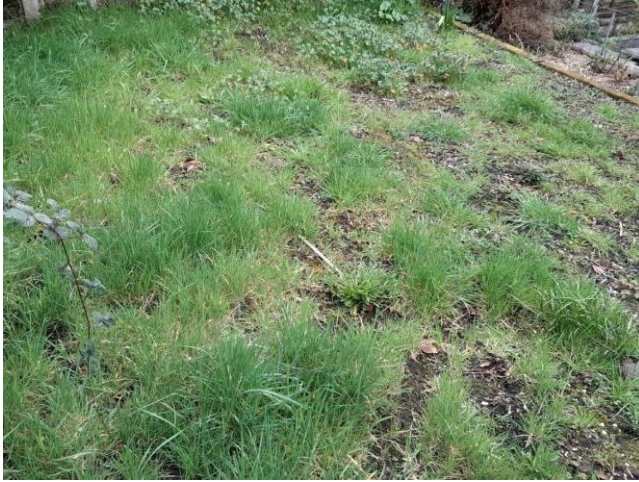
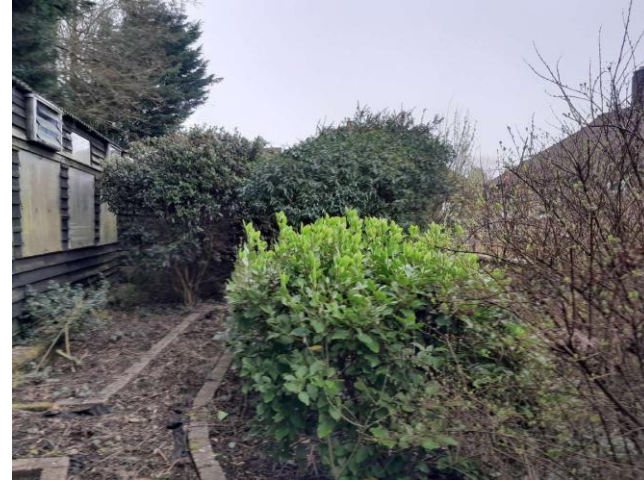
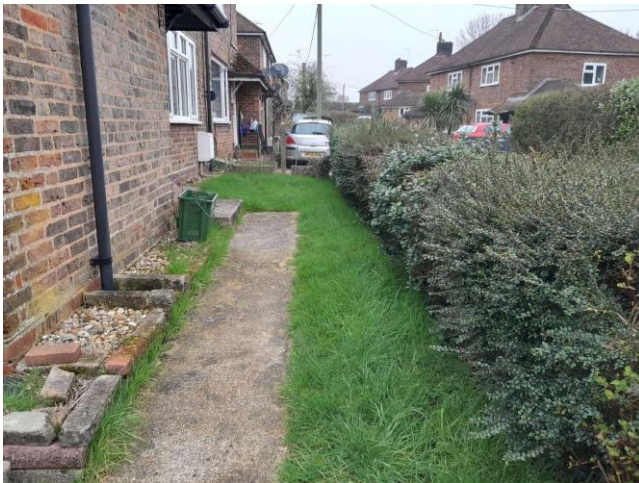
| <p><b>Summary of Survey Findings</b></p> <p><u>Vegetated garden (828)</u><br/>The rear of the site comprises vegetated garden, consisting of frequently managed modified grass lawn and introduced shrubs. The grass lawn was dominated by Yorkshire fog grass, with frequent common daisy and occasional clevers.</p> <p>In accordance with the Statutory Biodiversity Metric Condition Assessment Matrix, this habitat is not subject to a condition assessment and is automatically assigned a poor condition.</p> |

*Photo 1: Vegetated garden*

*Photo 2: Vegetated garden*

*Photo 3: Vegetated garden*

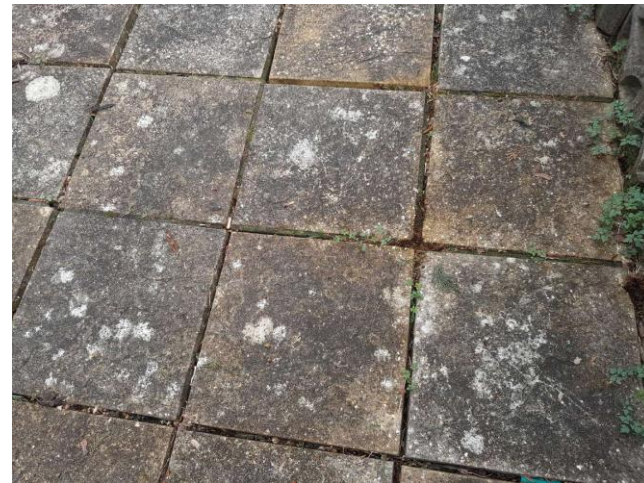
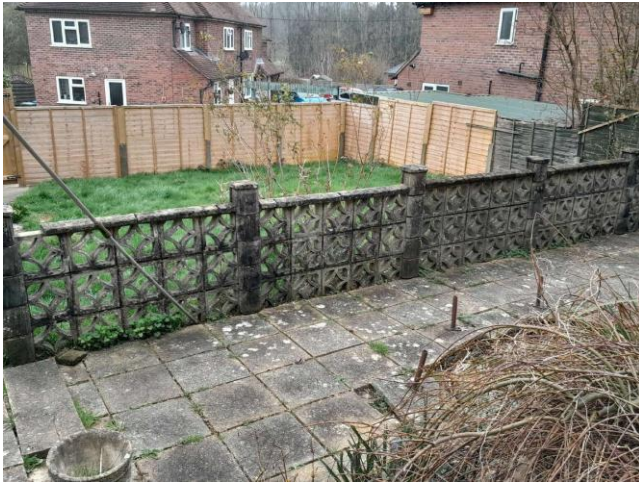
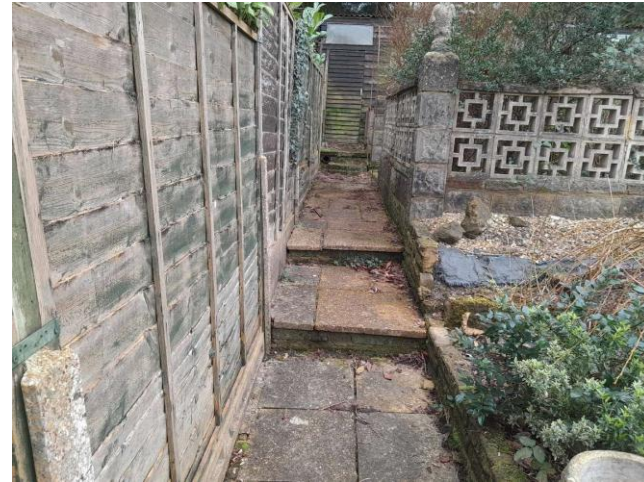
The building is surrounded by hard-standing and pathways within the garden, and the car parking area at the front of the dwelling is also comprised of hard-standing surfaces. There are areas of loose stone gravel present.

*Photo 4: Developed land; sealed surface*

*Photo 5: Developed land; sealed surface*

*Photo 6: Developed land; sealed surface*

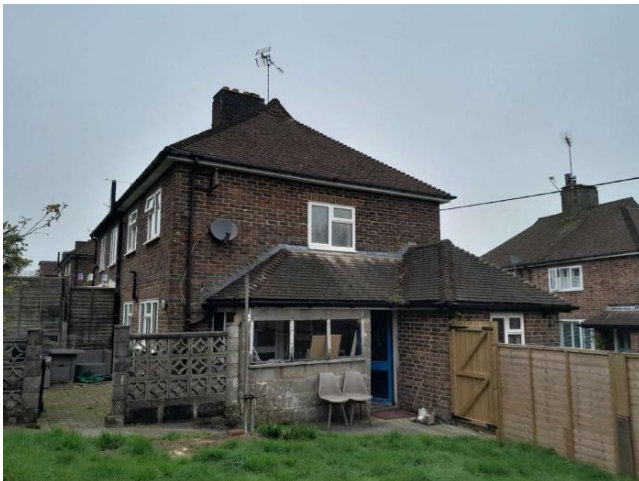
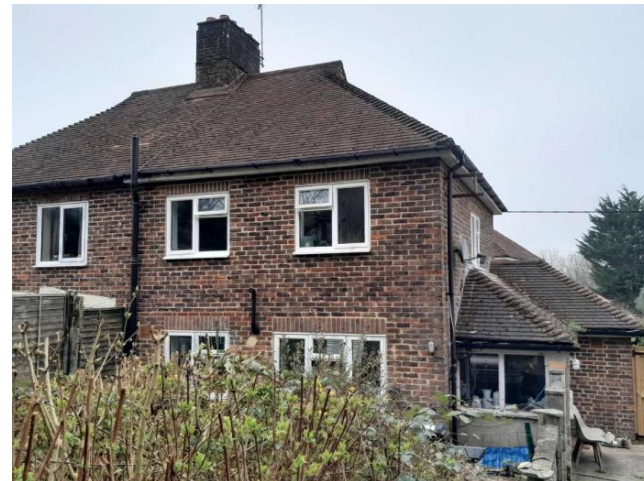
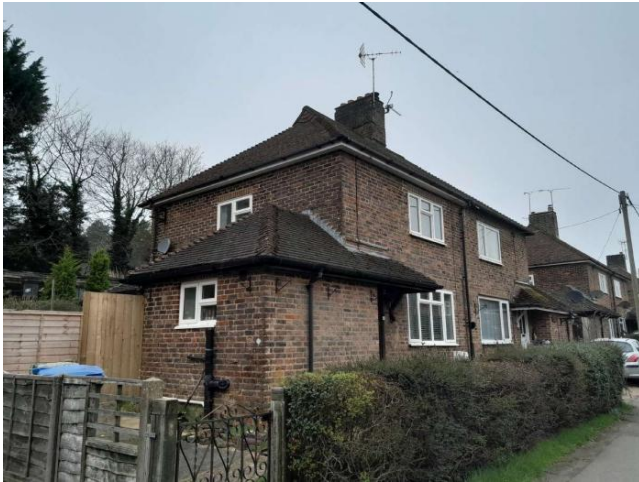
*Photo 7: B1*

*Photo 8: B1*

*Photo 9: B1*

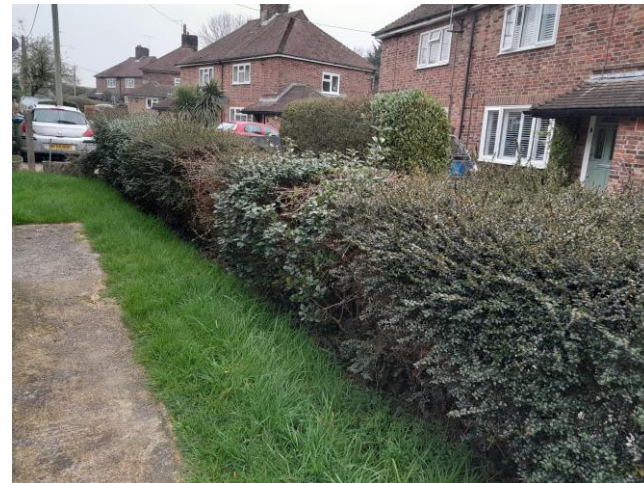
*Photo 12: Hedgerow*

There is a small strip of cotoneaster hedgerow to the front of the building. The hedgerow is <1.5m width and height and has no gaps.
