| <div> Unit 7, Danworth Farm<br/> Hurstpierpoint<br/> BN6 9GL<br/> <a href="http://www.gesl.net">www.gesl.net</a> </div> | | | | <div> <div>Project No.</div> <div>GE20724</div> </div> <div> <div>Co-ords:</div> <div>520075E - 133825N</div> </div> | | | | <div> <div>Borehole No.</div> <div>WS08</div> </div> <div> <div>Sheet 1 of 1</div> </div> | | |
| <div> <div>Project Name:</div> <div>North Horsham II</div> </div> | | | | <div> <div>Location:</div> <div>Horsham</div> </div> | | <div> <div>Level:</div> <div>60.51</div> </div> | | <div> <div>Hole Type</div> <div>WLS</div> </div> | | |

# Borehole: Photos

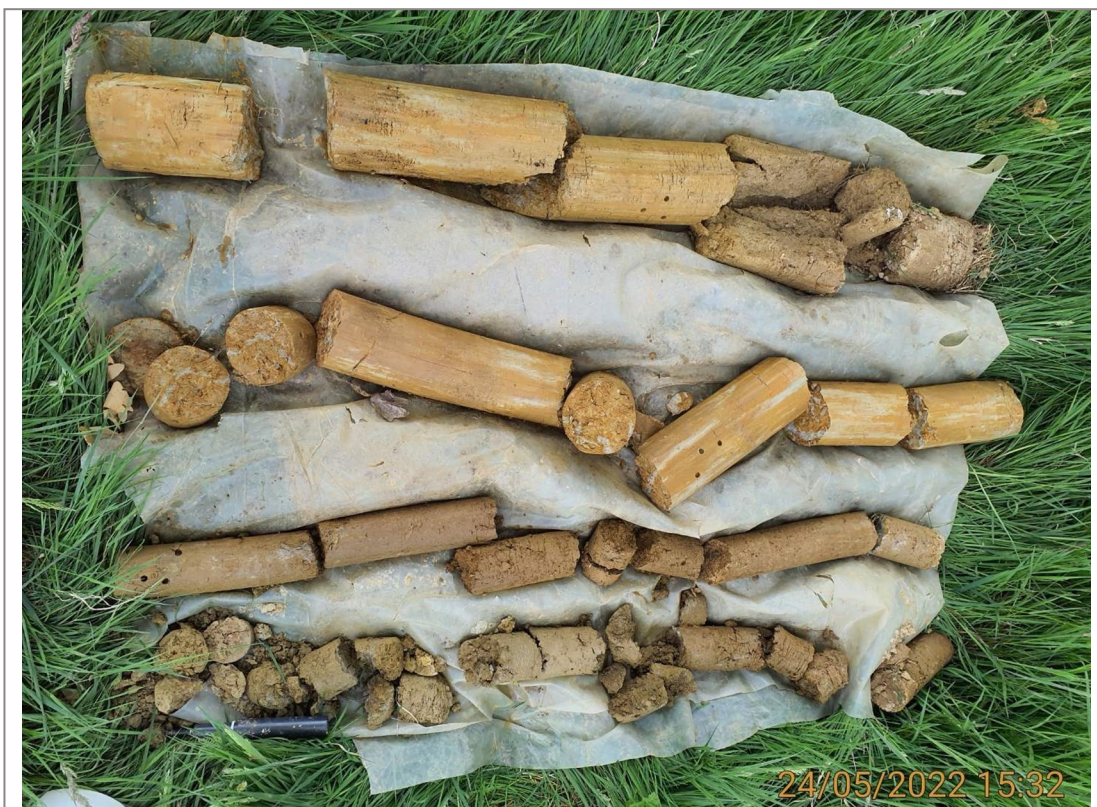
**Image 1.** 1653402739485.jpg:  
WindowSamplerPhoto

| Well | Water Strikes | Sample and In Situ Testing | | | Depth (m) | Level (m) | Legend | Stratum Description | | |
|---|---|---|---|---|---|---|---|---|---|---|
| | | 0.10 | ES | 4.5kg/cm2 | 0.30 | 55.31 | | Grass overlying brown silty clay with abundant rootlets and some black flecking.<br>TOPSOIL | 1 – | |
| | | 0.50 | D | | | | | Stiff to very stiff orangish brown and pale grey silty CLAY with black ferruginous fragments and orange staining.<br>WEALD CLAY | | |
| | | 1.00 | D | 2.4kg/cm2 | 1.10 | 54.51 | | Brown and pale grey interbedded silty CLAY with weakly cemented siltstone with some ironstone fragments and orange staining.<br>WEALD CLAY | | 2 – |

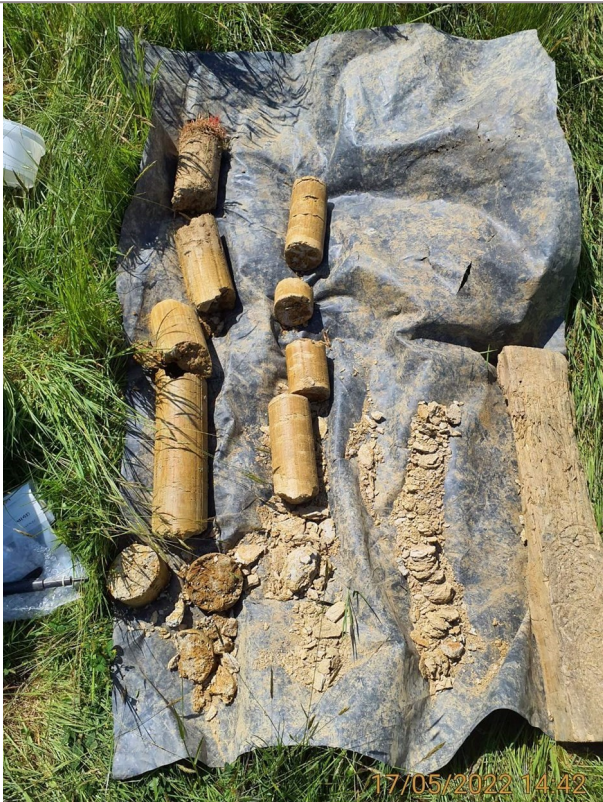
Image 1. 1652794886792.jpg:  
WindowSamplerPhoto

| <div> Unit 7, Danworth Farm<br/> Hurstpierpoint<br/> BN6 9GL<br/> <a href="http://www.gesl.net">www.gesl.net</a> </div> | | | | <h1>Borehole Log</h1> | | | | Borehole No.<br><b>WS11</b><br>Sheet 1 of 1 | | |
|---|---|---|---|---|---|---|---|---|---|---|
| | | 0.10 | ES | | 0.30 | 63.11 | | Grass overlying brown silty clay with abundant rootlets.<br>TOPSOIL | 1 | |
| | | 0.80 | ES | | | | | Stiff orangish brown and pale grey silty gravelly CLAY with rootlets and semi decomposed rootlets, frequent black ferruginous fragments and orange staining. Gravel is fine to coarse sub angular sandstone. WEALD CLAY | | |
| | | 1.80 | D | | 1.80 | 61.61 | | Brown and pale bluish grey silty CLAY with frequent siltstone inclusions. WEALD CLAY | | |

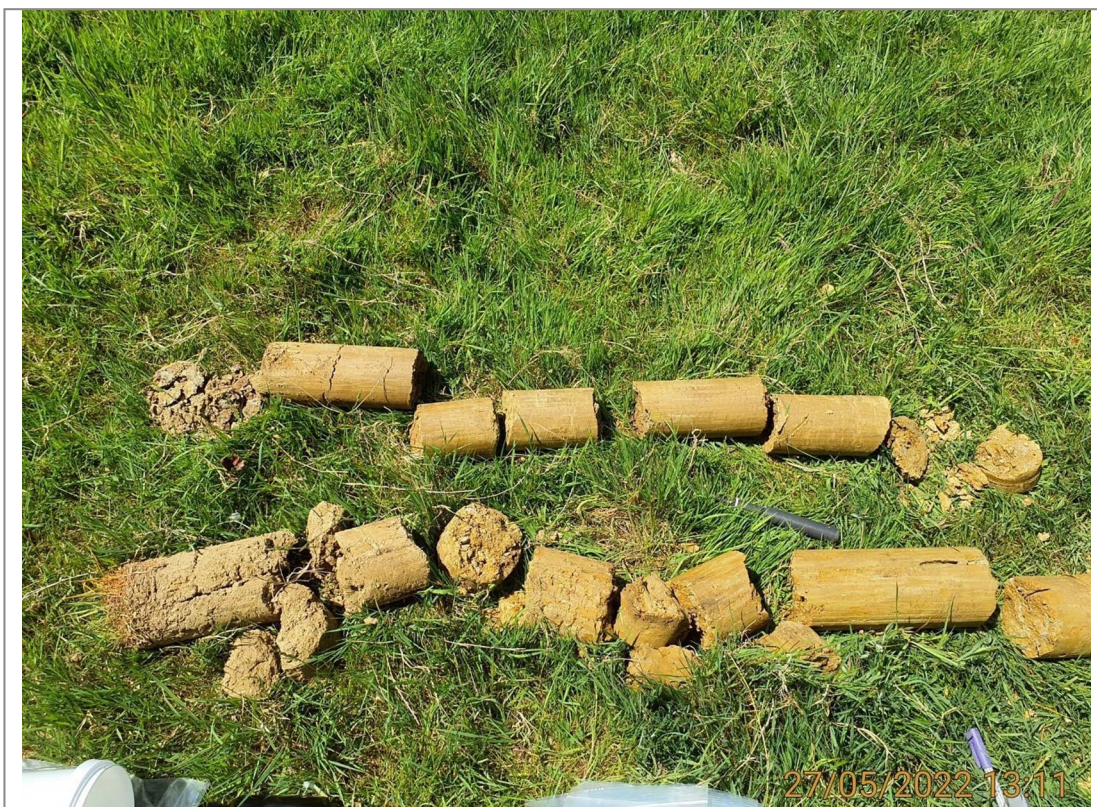
**Image 1.** 1653653501188.jpg:  
WindowSamplerPhoto

| Well | Water Strikes | Sample and In Situ Testing | | | Depth (m) | Level (m) | Legend | Stratum Description | |
|---|---|---|---|---|---|---|---|---|---|
| | | 0.10 | ES | 4.8kg/cm2 | 0.30 | 55.52 | | Brown silty clay with abundant rootlets. TOPSOIL | 1 |
| | | 0.50 | D | | | | | Very stiff brown and pale grey silty slightly gravelly CLAY with some rootlets and orange staining. Gravel is fine to coarse sub angular siltstone. WEALD CLAY | |
| | | 0.70 | ES | 1.20 | 54.62 | | Stiff orangish brown, brown and pale grey silty slightly gravelly CLAY with frequent black ferruginous fragments and orange staining. Gravel is fine to medium sub angular ironstone. WEALD CLAY | 2 | |
| | | 1.50 | D | 2.10 | 53.72 | | Brown and pale grey weakly cemented SILT with orange staining on faces. WEALD CLAY | 3 | |

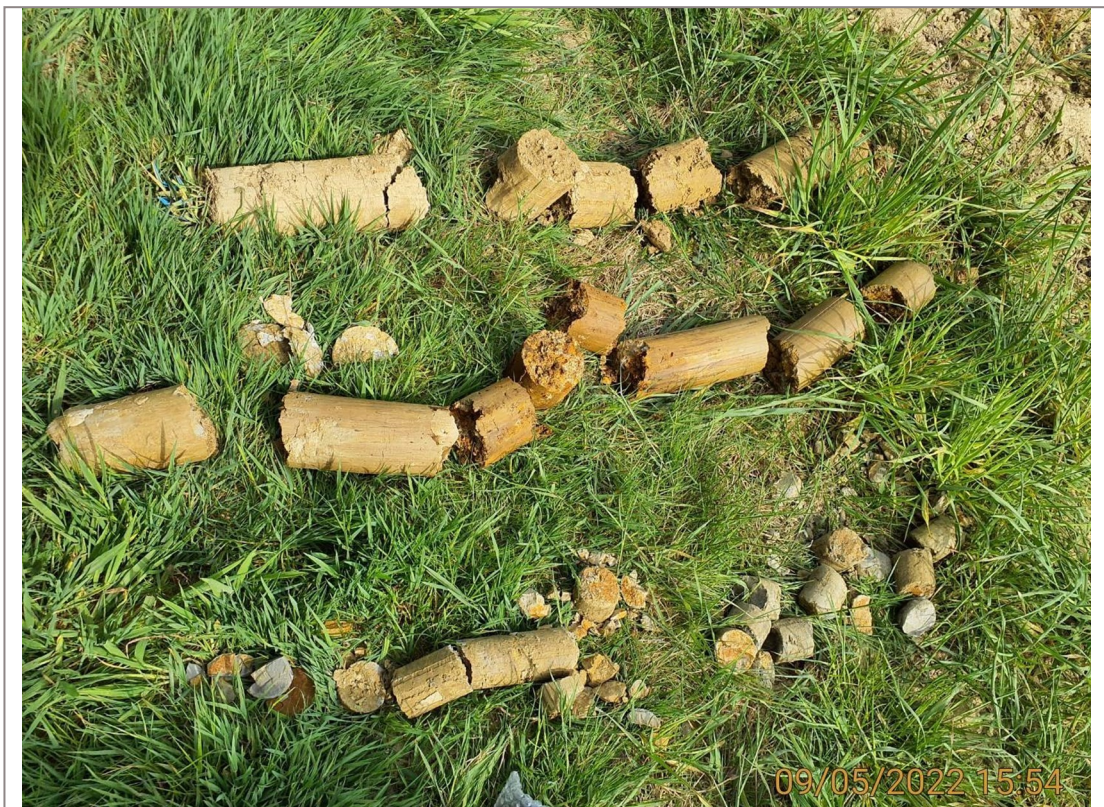
**Image 1.** 1652108051967.jpg:  
WindowSamplerPhoto

| <div> Unit 7, Danworth Farm<br/> Hurstpierpoint<br/> BN6 9GL<br/> <a href="http://www.gesl.net">www.gesl.net</a> </div> | | | | <div>Borehole Log</div> | | | | Borehole No.<br><b>WS13</b><br>Sheet 1 of 1 | | |
|---|---|---|---|---|---|---|---|---|---|---|
| | | 0.20 | ES | 5.0kg/cm2 | 0.30 | 67.36 | | Brown sandy gravelly clay with some brick fragments.<br>MADE GROUND | | |
| | 0.40 | ES | | | | | | | | Very stiff orangish brown and pale grey silty sandy CLAY with abundant black ferruginous fragments.<br>TUNBRIDGE WELLS SAND |
| | 1.00<br>1.00 | D<br>PP | 4.8kg/cm2 | 1.10 | 66.56 | | Very stiff orangish brown and pale grey silty CLAY with black flecking and some siltstone inclusions.<br>TUNBRIDGE WELLS SAND | | | |
| | 1.70<br>1.70 | D<br>PP | 3.9kg/cm2 | 1.80 | 65.86 | | Very stiff reddish brown, brown and grey clayey weakly cemented SILT<br>TUNBRIDGE WELLS SAND | | | |

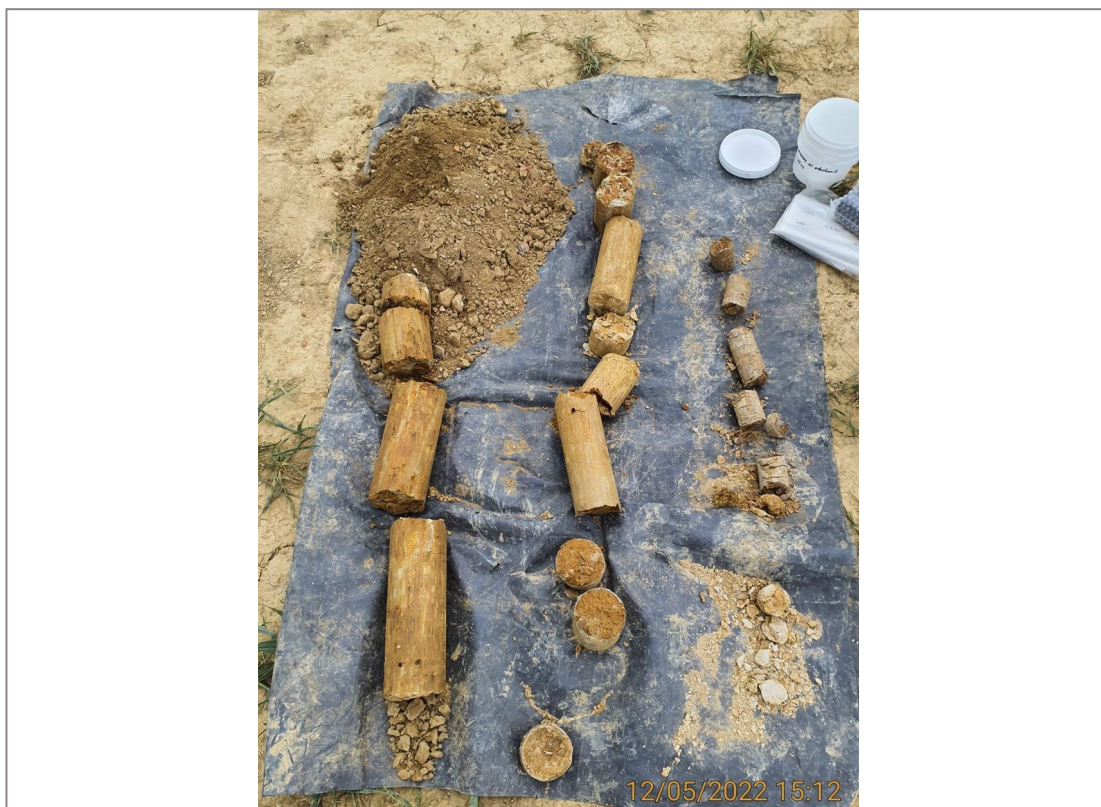
**Image 1.** 1652364760982.jpg:  
WindowSamplerPhoto

| Well | Water Strikes | Sample and In Situ Testing | | | Depth (m) | Level (m) | Legend | Stratum Description | |
|---|---|---|---|---|---|---|---|---|---|
| | | 0.10 | ES | | 0.30 | 67.14 | | Brown silty clay with abundant rootlets. TOPSOIL | 1 |
| | | 0.50 | D | | | | | Stiff orangish brown and pale grey mottled silty CLAY with black ferruginous fragments and some siltstone/ironstone. TUNBRIDGE WELLS SAND | |
| | | 1.50 | D | | 2.10 | 65.34 | | Orange and grey silty CLAY with abundant siltstone inclusions. TUNBRIDGE WELLS SAND | 2 |
| | | 2.80 | | | 2.90 | 64.64 | | Grey and orange stained clayey weakly cemented SILT. TUNBRIDGE WELLS SAND | 3 |
