# Borehole: Photos

# Borehole Log

Project Name: North Horsham II

Project No.  
GE20724

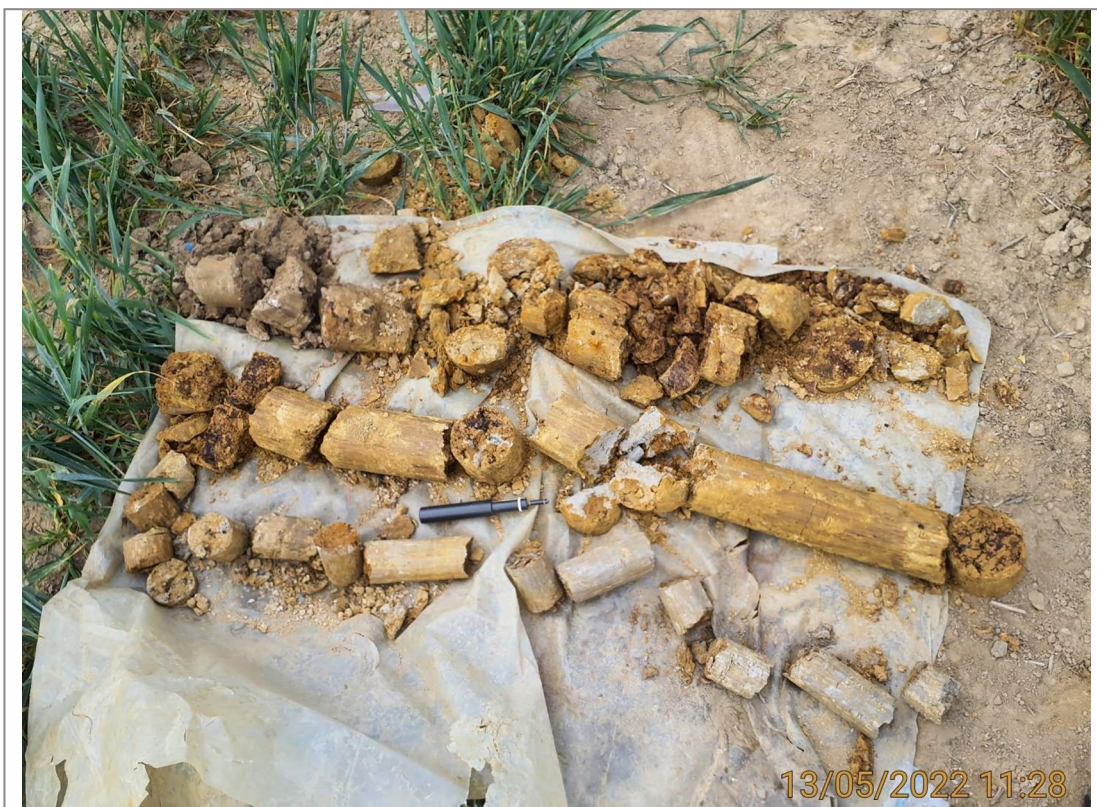
WS18  
GE20724

**Image 1.** 1652437658710.jpg:  
WindowSamplerPhoto

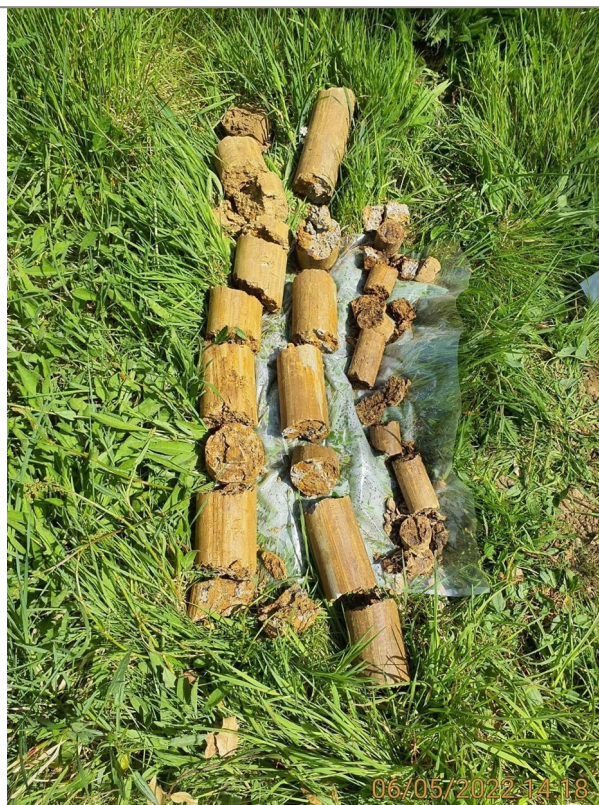
WS20  
GE20724

**Image 1.** 1651843094460.jpg:  
WindowSamplerPhoto

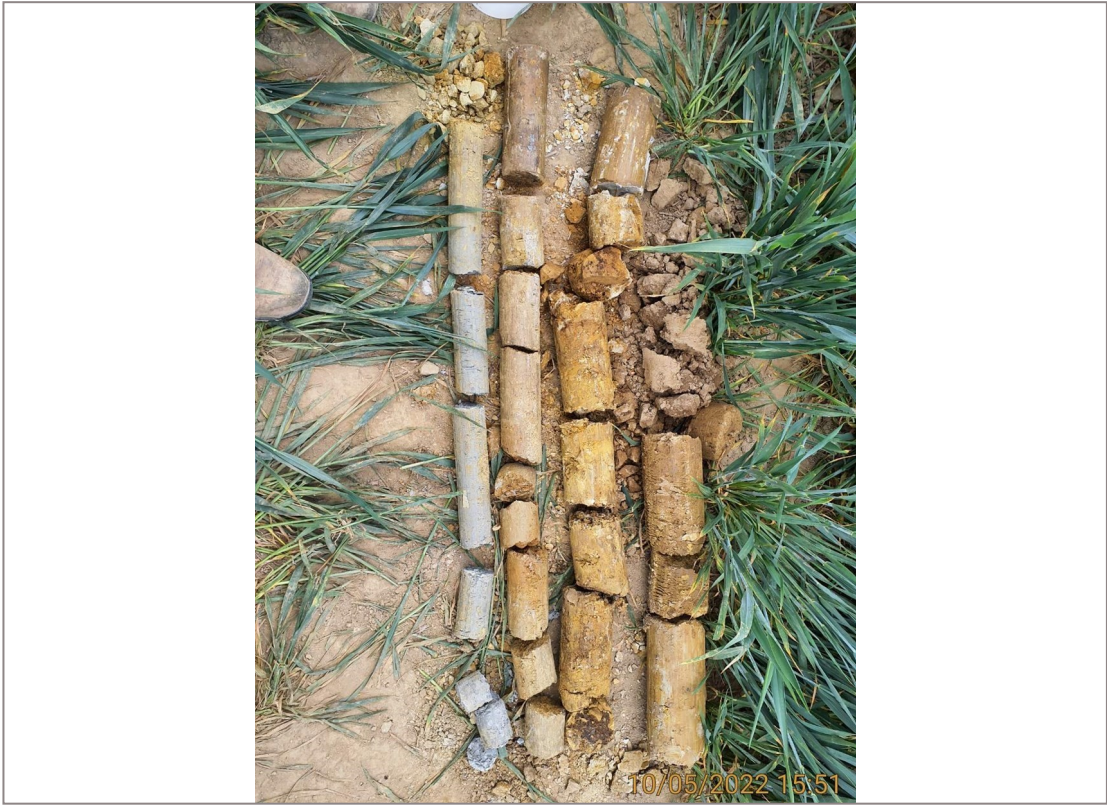
| Well | Water Strikes | Sample and In Situ Testing | | | Depth (m) | Level (m) | Legend | Stratum Description | |
|---|---|---|---|---|---|---|---|---|---|
| | | 0.20 | ES | | 0.30 | 58.63 | | Brown silty clay with abundant rootlets. TOPSOIL | |
| | | 0.50<br>0.50 | D<br>PP | 3.4kg/cm2 | | | | Very stiff pale grey and orangish brown silty CLAY with orange staining. WEALD CLAY<br><i>Some rootlets and roots 1-2mm.</i> | |
| | | 0.80 | ES | | 1.20 | 57.73 | | Stiff orangish brown and pale grey silty gravelly CLAY with black ferruginous fragments. Gravel is fine to coarse of siltstone and sandstone.. WEALD CLAY | |
| | | 2.50<br>2.50 | D<br>PP | 4.9kg/cm2 | 3.10 | 55.83 | | Very stiff bluish grey silty CLAY with some siltstone inclusions. WEALD CLAY | |

Image 1. 1652194299098.jpg:  
WindowSamplerPhoto

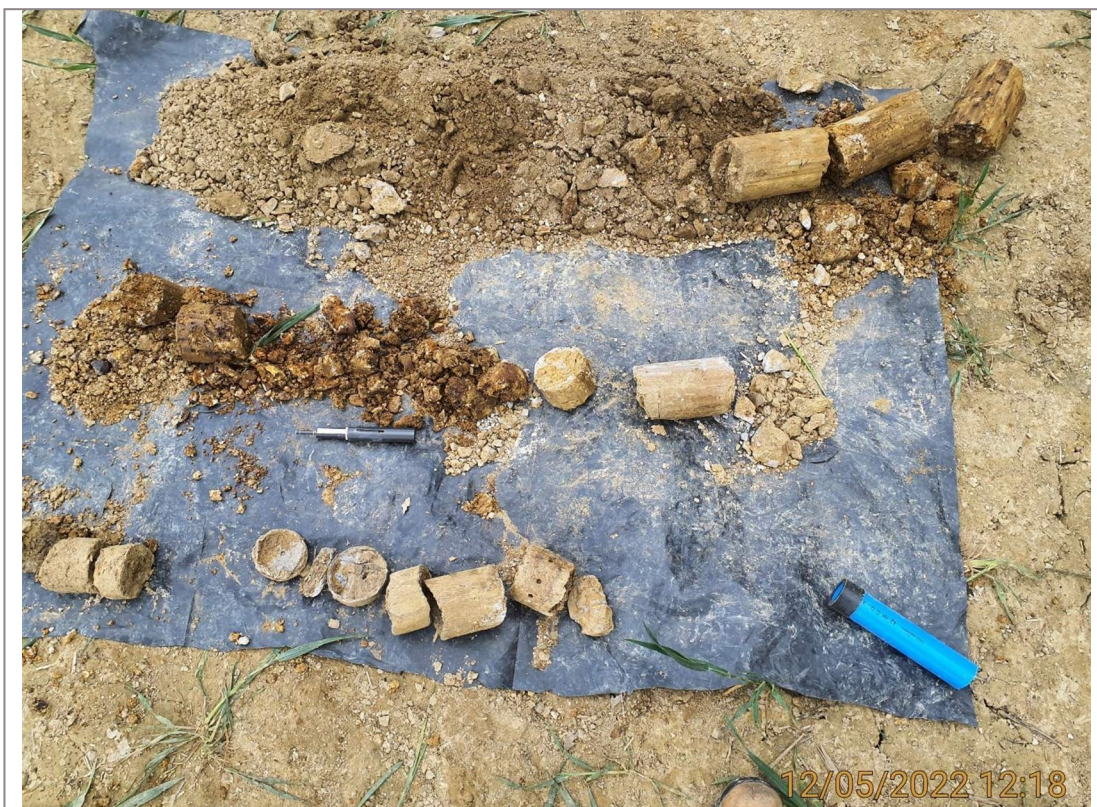
| <div> Unit 7, Danworth Farm<br/> Hurstpierpoint<br/> BN6 9GL<br/> <a href="http://www.gesl.net">www.gesl.net</a> </div> | | | | <div>Borehole Log</div> | | | | Borehole No.<br><b>WS24</b><br>Sheet 1 of 1 | | |
|---|---|---|---|---|---|---|---|---|---|--|
| | | 0.30 | ES | | 0.40 | 62.51 | | Brown silty gravelly clay with some brick fragments.<br>MADE GROUND | | |
| | 0.50 | D | | | | | | Orangish brown and pale grey sandy gravelly CLAY with frequent black ferruginous fragments. Sand is fine to coarse. Gravel is fine to coarse sub angular sandstone.<br>TUNBRIDGE WELLS SAND | | |
| | 1.00 | D | | | 1.70 | 61.21 | | Very stiff brown and pale grey silty CLAY with some black flecking.<br>TUNBRIDGE WELLS SAND | | |

**Image 1.** 1652354270296.jpg:  
WindowSamplerPhoto

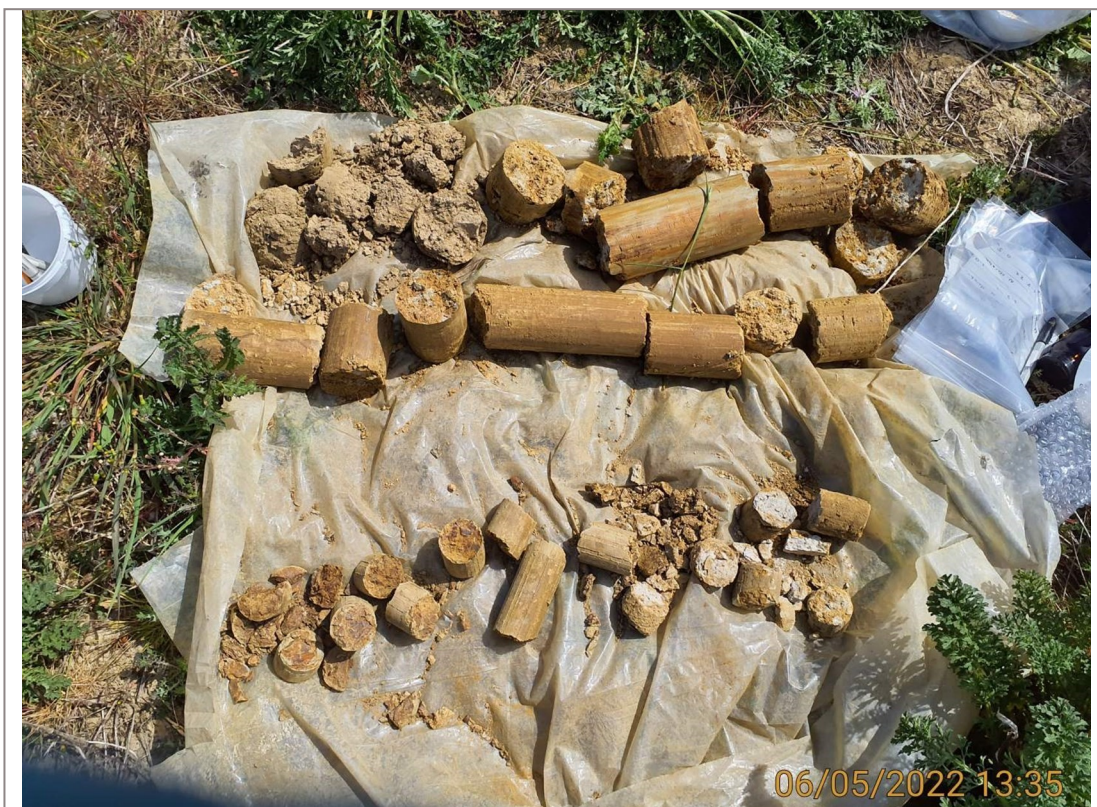
WS26  
GE20724

| Well | Water Strikes | Sample and In Situ Testing | | | Depth (m) | Level (m) | Legend | Stratum Description | | |
|---|---|---|---|---|---|---|---|---|---|--|
| | | 0.10 | ES | | 0.30 | 55.69 | | Grass overlying brown silty clay with abundant rootlets.<br>TOPSOIL | 1 | |
| | | 0.40 | ES | | | | | Very stiff orangish brown and pale grey silty CLAY with orange staining and black ferruginous fragments.<br>WEALD CLAY | | |
| | | 2.20 | ES | | | Orange and brown slightly sandy CLAY with rare fine to medium sub-angular iron stained weakly cemented silt.<br>WEALD CLAY | 3 | | | |

**Image 1.** 1651840545452.jpg:  
WindowSamplerPhoto
