# Borehole: Photos

# Borehole Log

Project Name: North Horsham II

Project No.  
GE20724

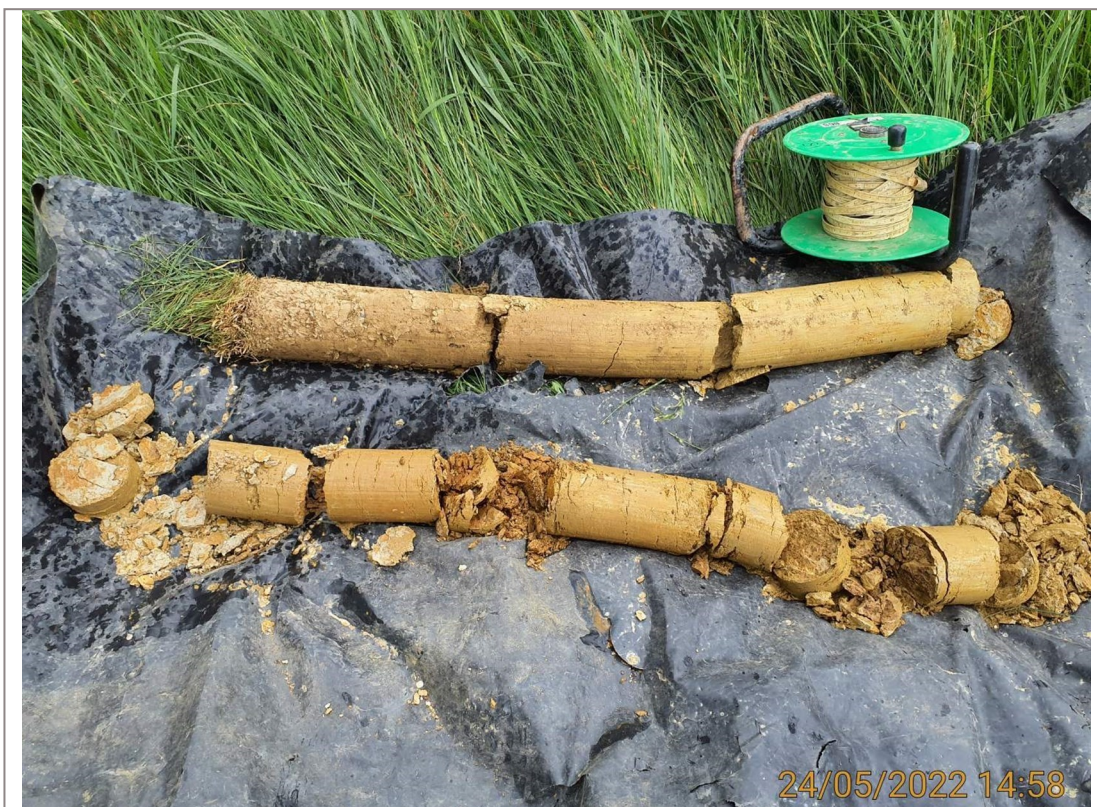
WS54  
GE20724

**Image 1.** 1653400692342.jpg:  
WindowSamplerPhoto

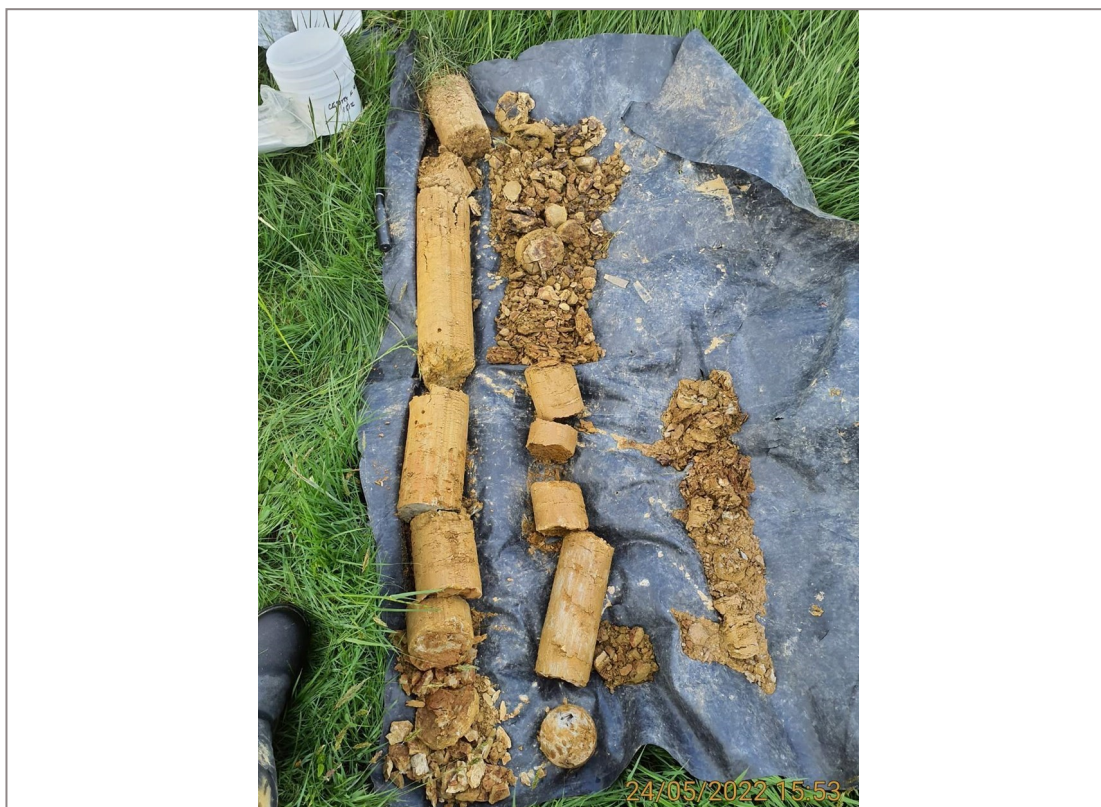
WS55  
GE20724

| Well | Water Strikes | Sample and In Situ Testing | | | Depth (m) | Level (m) | Legend | Stratum Description | |
|---|---|---|---|---|---|---|---|---|---|
| | | 0.10 | ES | 3.5kg/cm2 | 0.30 | 62.20 | | Grass overlying brown silty clay with orange staining and abundant rootlets.<br>TOPSOIL | 1 |
| | | 0.50 | D | | | | | Very stiff orangish brown and pale grey silty CLAY with orange staining and some rootlets.<br>WEALD CLAY | |
| | | 1.50 | D | | | Brown, reddish brown and black stained silty clayey weakly cemented sandstone GRAVEL.<br>WEALD CLAY | 2 | | |

**Image 1.** 1653404026849.jpg:  
WindowSamplerPhoto

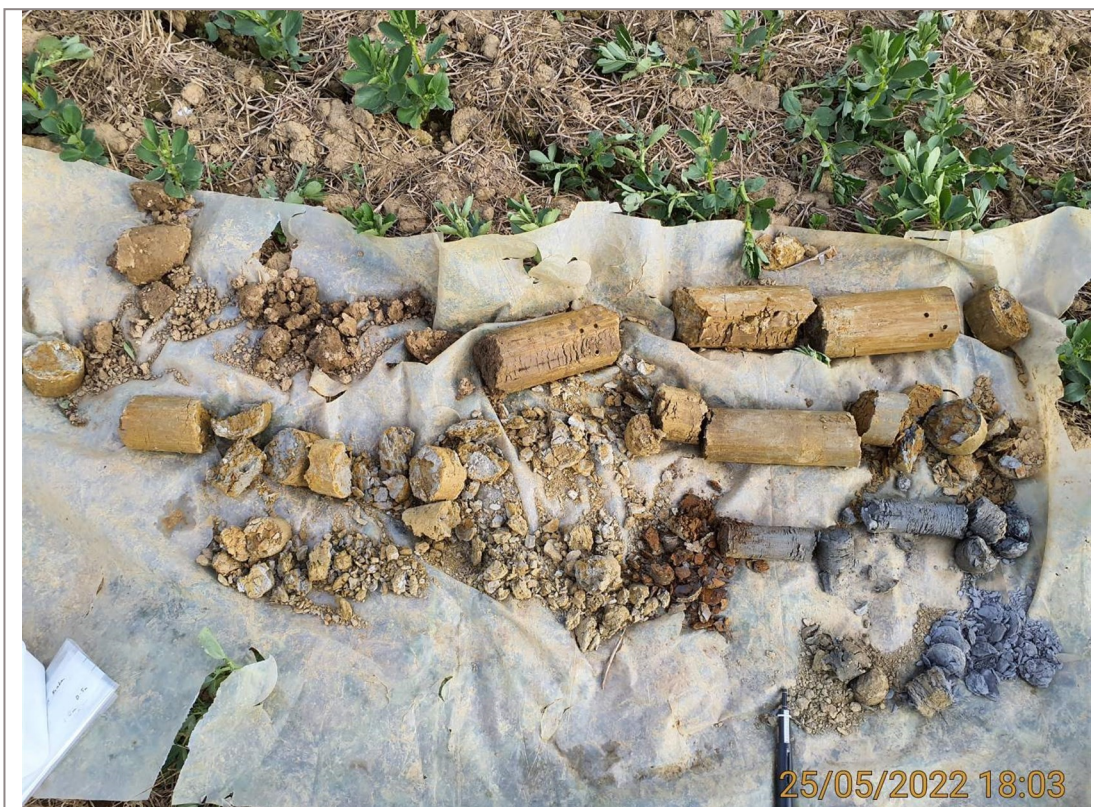
WS56  
GE20724

| <div> Unit 7, Danworth Farm<br/> Hurstpierpoint<br/> BN6 9GL<br/> <a href="http://www.gesl.net">www.gesl.net</a> </div> | | | | <div>Borehole Log</div> | | | | Borehole No.<br><b>WS56</b><br>Sheet 1 of 1 | | |
|---|---|---|---|---|---|---|---|---|---|---|
| | | 0.10 | ES | 4.2kg/cm2 | 0.30 | 57.37 | | Crop overlying brown silty clay with frequent rootlets.<br>TOPSOIL | | |
| | | 1.00<br>1.00 | D<br>PP | 2.40 | 55.27 | | Orangish brown and pale grey silty CLAY with rare weakly cemented silt.<br>WEALD CLAY | | | |

**Image 1.** 1653498177113.jpg:  
WindowSamplerPhoto

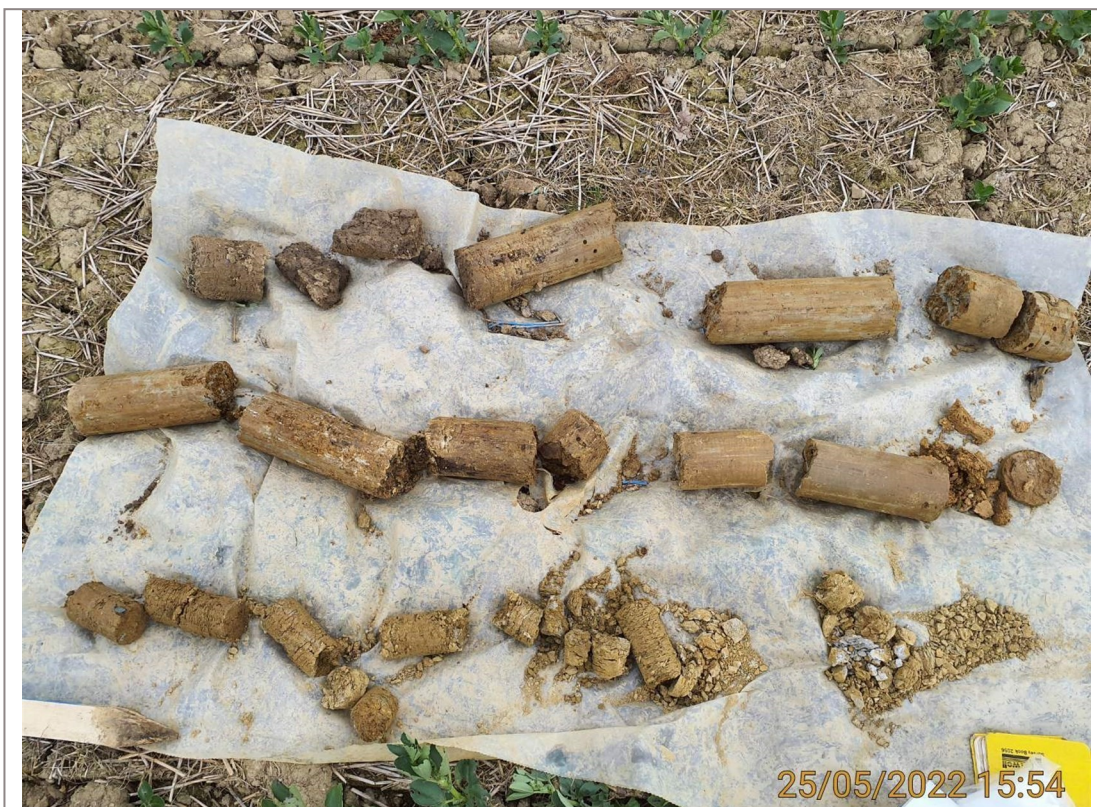
WS57  
GE20724

| Well | Water Strikes | Sample and In Situ Testing | | | Depth (m) | Level (m) | Legend | Stratum Description | | |
|---|---|---|---|---|---|---|---|---|---|---|
| | | 0.10 | ES | 3.8kg/cm2 | 0.30 | 59.60 | | Crop overlying brown silty slightly gravelly clay with frequent rootlets.<br>TOPSOIL | | |
| | | 0.50<br>0.50 | D<br>PP | | | | | Very stiff silty CLAY with black ferruginous fragments, orange staining and some rootlets.<br>WEALD CLAY | | |
| | | 0.80 | ES | 4.4kg/cm2 | 1.20 | 58.70 | | Very stiff brown and pale grey sandy gravelly CLAY with black ferruginous fragments and orange. Gravel is fine to medium sub angular sandstone and ironstone.<br>WEALD CLAY | 1 | |
| | | 1.50<br>1.50 | D<br>PP | 5.0kg/cm2 | 1.60 | 58.30 | | Very stiff brown silty CLAY with black ferruginous fragments and some decomposed rootlets and pale blue staining.<br>WEALD CLAY | 2 | |
| | | 2.00<br>2.00 | D<br>PP | 5.0kg/cm2 | 2.10 | 57.80 | | Brown and pale bluish grey silty CLAY with abundant weak siltstone.<br>WEALD CLAY | | |

Image 1. 1653490455304.jpg:  
WindowSamplerPhoto

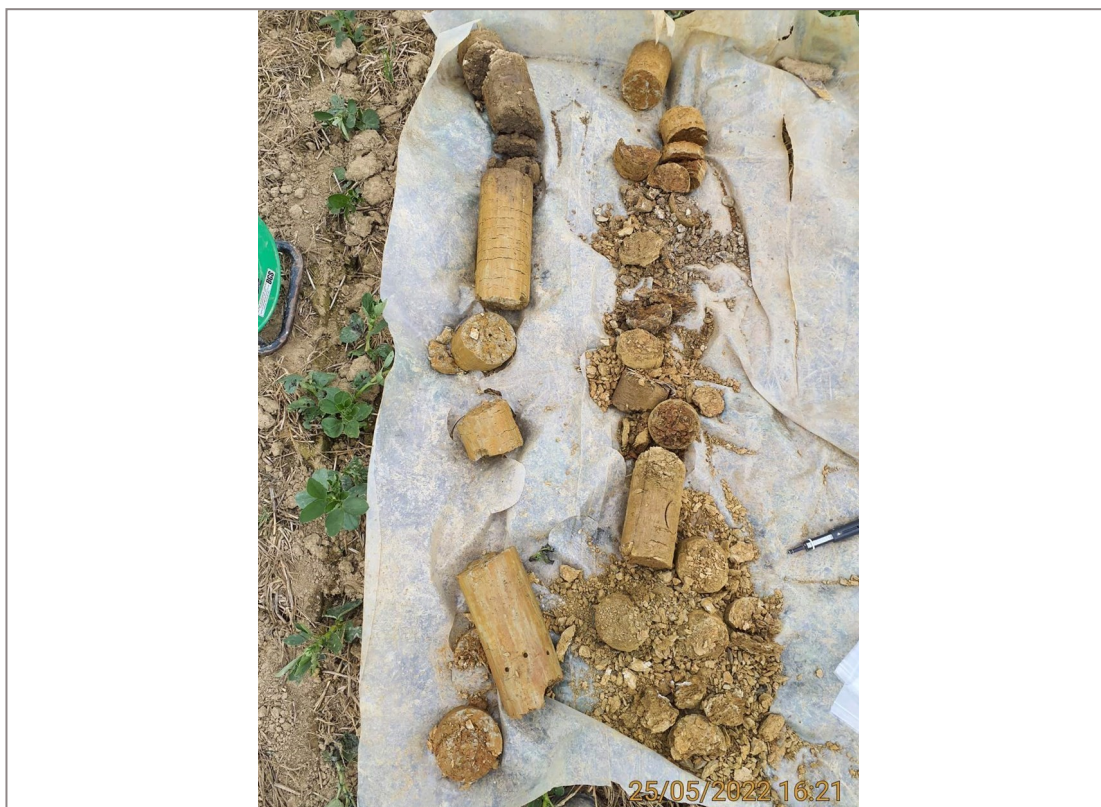
WS59  
GE20724

| Unit 7, Danworth Farm<br>Hurstpierpoint<br>BN6 9GL<br>www.gesl.net | | | <h1>Borehole Log</h1> | | | | Borehole No.<br><b>WS59</b><br>Sheet 1 of 1 | | |
|---|---|---|---|---|---|---|---|---|---|
| | | 0.10 | ES | 4.3kg/cm2 | 0.30 | 59.32 | | Crop overlying brown silty clay with frequent rootlets. TOPSOIL | |
| | 0.50<br>0.50<br>0.60 | D<br>PP<br>ES | 4.4kg/cm2 | | 1.10 | 58.52 | | Very stiff orangish brown and pale grey silty CLAY with orange staining WEALD CLAY | |
| | 1.00<br>1.00<br>1.10 | D<br>PP<br>ES | | | | | Orangish brown and brown silty clayey weakly cemented siltstone gravel. WEALD CLAY | | |

**Image 1.** 1653492070954.jpg:  
WindowSamplerPhoto

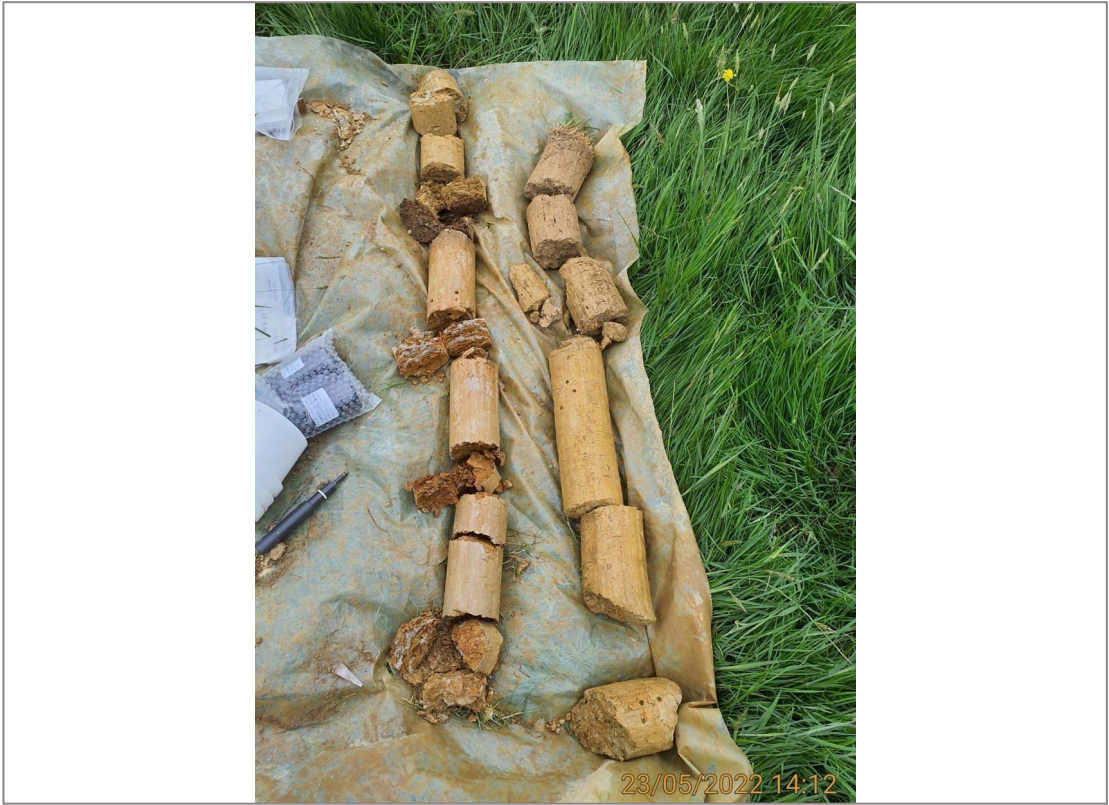
Image 1. 1653311536006.jpg:  
WindowSamplerPhoto

| <div> Unit 7, Danworth Farm<br/> Hurstpierpoint<br/> BN6 9GL<br/> <a href="http://www.gesl.net">www.gesl.net</a> </div> | | | | <div>Borehole Log</div> | | | | Borehole No.<br><b>WS60</b><br>Sheet 1 of 1 | |
|---|---|---|---|---|---|---|---|---|---|
| | | 0.20 | ES | | 0.40 | 61.86 | | Grass overlying brown silty clay with abundant rootlets, black flecking and orange staining. TOPSOIL | |
| | 0.50<br>0.50<br>0.60 | D<br>PP<br>ES | 3.3kg/cm2 | | | | Stiff orangish brown and pale grey mottled silty CLAY with black ferruginous fragments and orange staining. WEALD CLAY | | |
| | 1.00<br>1.00 | D<br>PP | 2.6kg/cm2 | | Orangish brown and pale grey silty sandy CLAY with weakly cemented silts and reddish brown staining. WEALD CLAY | | | | |
