## EXTENDED PHASE 1 ECOLOGICAL ASSESSMENT AND PHASE 2 BAT SURVEYS

PARK FARM, WHEATSHEAF ROAD, WOODMANCOTE, HENFIELD,  
WEST SUSSEX BN5 9BA

DRAFT REPORT

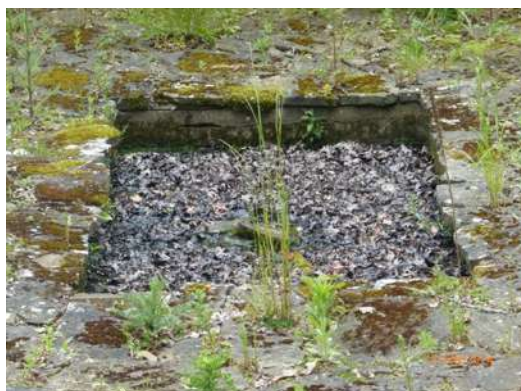
There are only two areas of standing water located on the site, a small ornamental pond and a swimming pool. At the time of the survey the ornamental pond was half full and the surface covered with dead leaves and the swimming pool was highly eutrophic, and lacked any emergent vegetation.

**Figure 11:** Ornamental pond near dwelling.

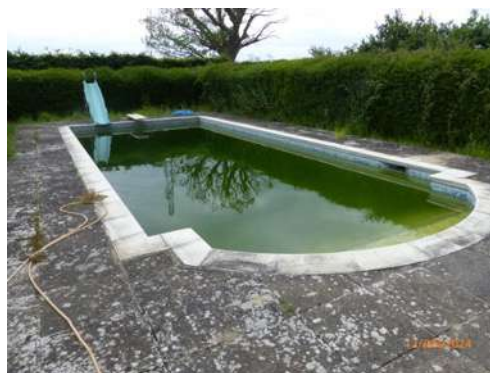
**Figure 12:** Unmanaged swimming pool, with highly eutrophic water.

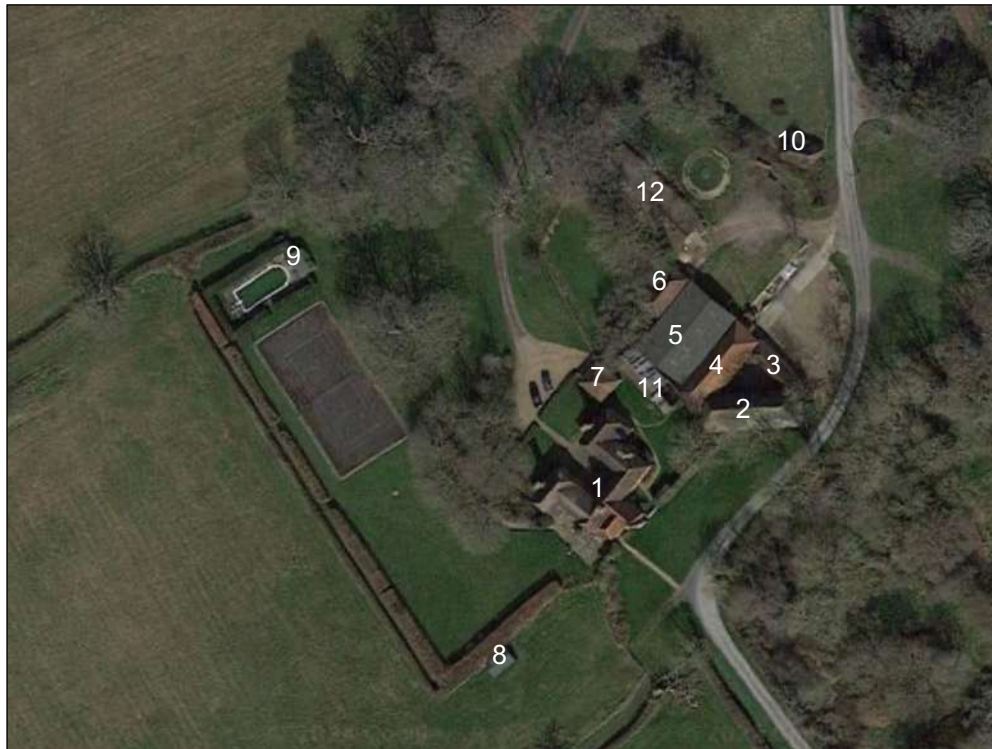
**Figure 13:** Building numbers, as used throughout this report and locations.

There are 12 buildings on the site that were assessed as part of the preliminary roost assessment, which for ease of reference have been numbered 1 – 12. The building number and location is depicted in Figure 13, with building descriptions, suitable bat roosting features and recorded evidence detailed in Table 5.

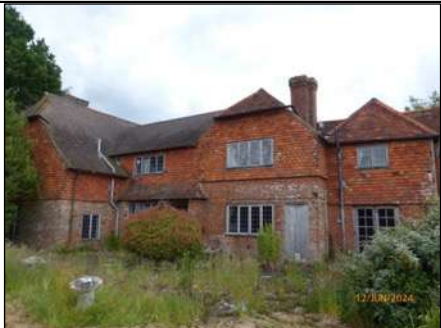
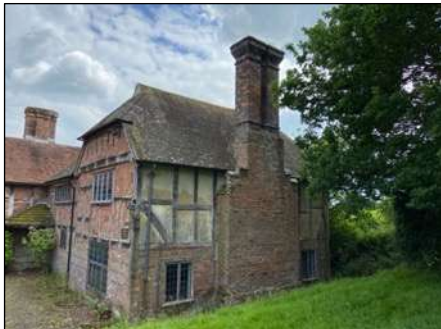
| Building no. | Figures | Description | Potential bat roosting features | Recorded evidence | Assessment of suitability |
|---|---|---|---|---|---|
| 1 | <p><b>Figure 14:</b> Building 1, showing hanging tiles.</p> <p><b>Figure 15:</b> Building 1, older part of building.</p> | <p>This building comprises a Grade II listed building which has been extended over time and now consists of a significant structure, which broadly forms a 'U' shape. The central part of the building is orientated with the ridge running southwest – north-east, with the wings extending in a northwesterly direction from each end.</p> <p>The original dwelling was constructed in Tudor times and consists of a brick and timber framed structure with daub infill. Ornate chimney stacks are present in places and extend up the exterior.</p> <p>The later additions to the building are constructed with brick to the lower half, or sometimes the whole elevation, but for the majority the upper half is clad with clay hanging tiles.</p> <p>The roof is also clad with clay tiles, and is complex in its design, comprising hipped, half-hipped and gable sections, rising to a central ridge.</p> | <p>There are numerous potential bat roosting features on this building.</p> <p><u>Exterior</u></p> <ul style="list-style-type: none"> <li>• Beneath ridge tiles.</li> <li>• Beneath roof tiles.</li> <li>• Beneath hip tiles.</li> <li>• Behind hanging tiles.</li> <li>• Within timber frames, where split (Figure 16).</li> </ul> <p><b>Figure 16:</b> Gaps in timber frame and brick work.</p> | <p>Bat evidence, in the form of droppings considered to be from a long-eared bat species <i>Plecotus</i> sp., were recorded throughout the roof void. Occasionally a concentration was found, suggesting roosting bats, but no live bats were recorded (Figure 17).</p> <p><b>Figure 17:</b> Cluster of long-eared bat droppings.</p> <p>A long dead brown long-eared bat was recorded within the roof void (Figure 20).</p> | High |

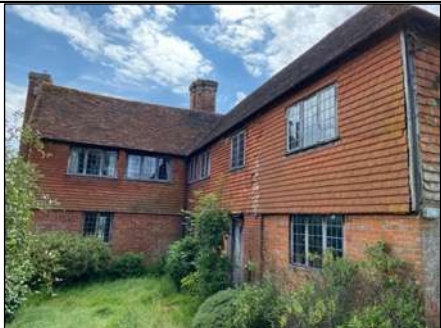
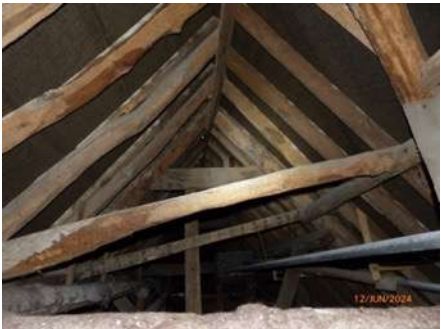
| Building no. | Figures | Description | Potential bat roosting features | Recorded evidence | Assessment of suitability |
|---|---|---|---|---|---|
| | <p><b>Figure 18:</b> Hanging tiles on Building 1.</p> <p><b>Figure 19:</b> Part of roof void.</p> | <p>Internally, a large roof void is present, and extends around the dwelling. The original timbers are still present in the Tudor section, but in other areas the rafters are constructed with a collar beam design, or traditional rafters.</p> <p>The clay roof tiles are underlaid with a variety of approaches, including bitumen felt, a modern breathable membrane, sarking or not underlaid.</p> <p>Gaps are present in several locations along the ridges and wall plate height, presumably to aid ventilation.</p> <p>Two basements are present, one is accessed from the kitchen via a trap door, the other from a door on an external wall.</p> | <p><u>Exterior</u></p> <ul style="list-style-type: none"> <li>Gaps where daub has fallen out, including at gable.</li> <li>Around entrance porch.</li> <li>Where lead flashing is present in valleys.</li> <li>Gaps where mortar is missing in brickwork.</li> <li>Ventilation hole in chimney.</li> </ul> <p><u>Interior</u></p> <ul style="list-style-type: none"> <li>Within the roof void</li> </ul> | <p><b>Figure 20:</b> Long dead long-eared bat.</p> <p>Externally, droppings consistent with a pipistrelle bat species <i>Pipistrellus</i> sp., were recorded at various locations on hanging tiles, suggesting bats roosting beneath the tiles.</p> <p>Barn swallow <i>Hirundo rustica</i>, robin <i>Erithacus rubecula</i> and wren <i>Troglodytes troglodytes</i> nests were recorded on the exterior of the building.</p> | |

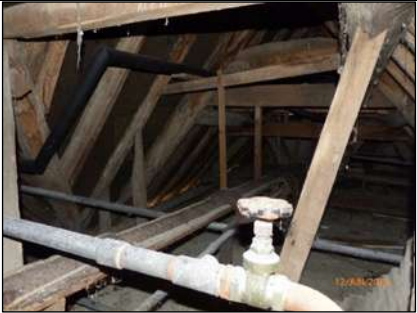
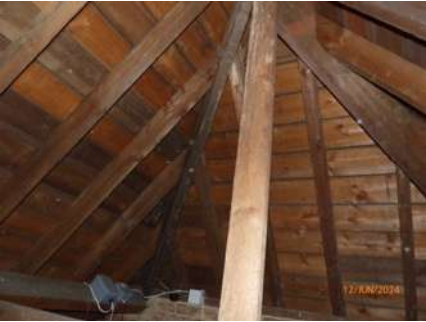
| Building no. | Figures | Description | Potential bat roosting features | Recorded evidence | Assessment of suitability |
|---|---|---|---|---|---|
| | <p>Figure 21: Part of roof void.</p> <p>Figure 22: Part of roof void.</p> | | | | |

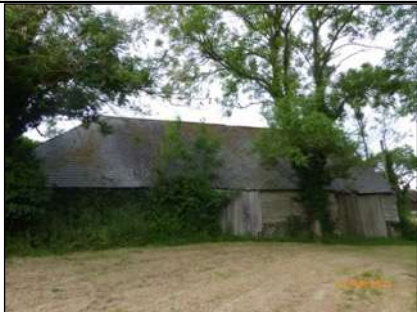
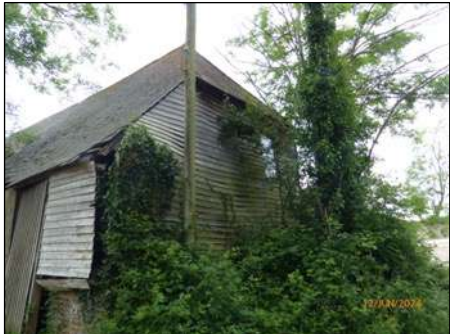
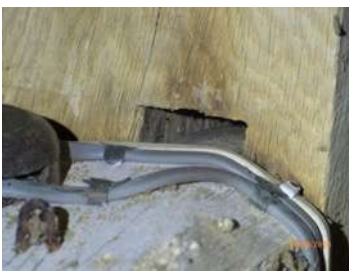
| Building no. | Figures | Description | Potential bat roosting features | Recorded evidence | Assessment of suitability |
|---|---|---|---|---|---|
| 2 | <p><b>Figure 23:</b> Southern elevation of Building 2</p> <p><b>Figure 24:</b> South-east corner of Building 2.</p> | <p>This building comprises an old oak framed threshing barn, that is constructed with a slate roof in a pitched and hipped design. The side elevations are wooden clad. The roof has suffered some damage and holes are present within it.</p> <p>Internally the building is mostly open plan, and the underside of the roof and beams are visible. However, the barn has undergone some modification previously, and part of the interior has been partitioned by creating block walls. These create several separate stables, which open onto a small triangular courtyard.</p> <p>The oak beams are typical of an old threshing barn and numerous mortice joints are present within them.</p> | <p>Potential bat roosting features on this building are mostly located internally, and within the old oak beams, or where they abut the side elevations.</p> <p>External features are associated with the hip and ridge tiles, and where slates have raised up to provide a secure crevice suitable for roosting.</p> <p><b>Figure 25:</b> Mortice joint.</p> | <p>Bat evidence in the form of droppings was recorded in several locations within the barn. These were mostly of cleaner surfaces, and indicative of bats flying within the barn, rather than the location of a roost.</p> <p>Several mortice joints in the oak beams were free of cobwebs, and staining to the wood from bats crawling up joints strongly suggested a roost location. In one instance a dropping was also located below the joint (Figure 28)</p> | High |

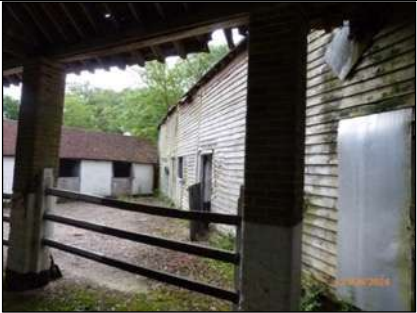
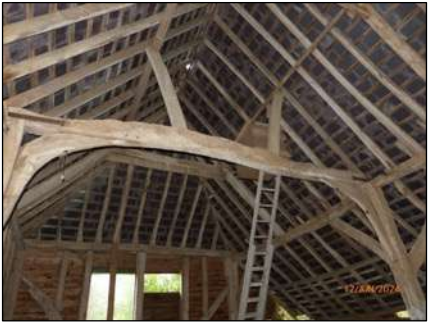
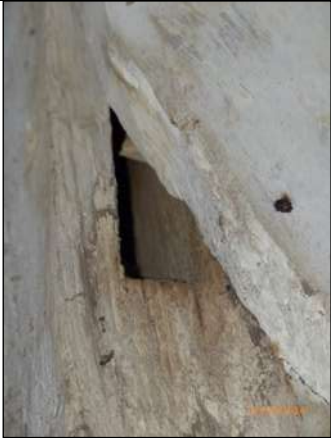
| Building no. | Figures | Description | Potential bat roosting features | Recorded evidence | Assessment of suitability |
|---|---|---|---|---|---|
| | <div><p>Figure 26: Northern elevation of Building 2.</p><p>Figure 27: Internal view of Building 2.</p></div> | | | <div><p>Figure 28: Mortice joint with dropping and fur staining.</p><p>A barn owl <i>Tyto alba</i> box was present within the barn and a long dead and mummified barn owl chick and stock dove <i>Columba oenas</i> chicks were present.</p></div> | |

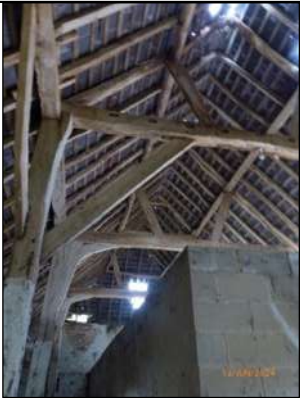
| Building no. | Figures | Description | Potential bat roosting features | Recorded evidence | Assessment of suitability |
|---|---|---|---|---|---|
| | <p><b>Figure 29:</b> Internal view of Building 2.</p> | | | | |

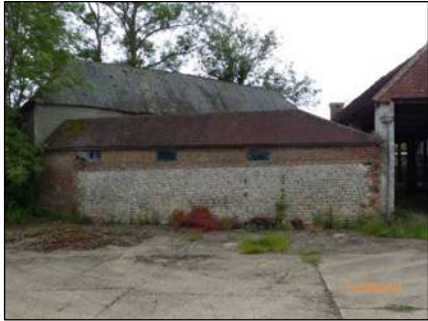
| Building no. | Figures | Description | Potential bat roosting features | Recorded evidence | Assessment of suitability |
|---|---|---|---|---|---|
| 3 | <p><b>Figure 30:</b> North-east elevation of Building 3.</p> | <p>This building comprises a single-storey brick and flint structure, with a clay tiled roof constructed in a pitched and hipped design.</p> <p>The building is partitioned internally below tie beam height to create separate compartments.</p> <p>The roof tiles are lined beneath with a bitumen felt underlay.</p> | <p>Potential roost locations are present externally and internally.</p> <p>On the exterior they are associated with the roof tiles, where they are damaged, thereby allowing access into the void between the tiles and the felt.</p> <p>Internally some suitability is present in the apex of the roof.</p> | <p>A scattering of long-eared bat type droppings was recorded on the floor and on top of tie beams, within this building.</p> | <b>Moderate</b> |

**Building 3 (Single-Storey Structure with Pitched Roof):** With moderate roost suitability, this building supports a likely satellite roost for brown long-eared bats and a day roost for common pipistrelle and brown long-eared bats. Frequent emergences and re-entries observed during the first emergence survey suggest that this building functions as a satellite roost for the brown long-eared bat maternity roost within the main house and is likely used seasonally or for specific reproductive or transitional purposes.

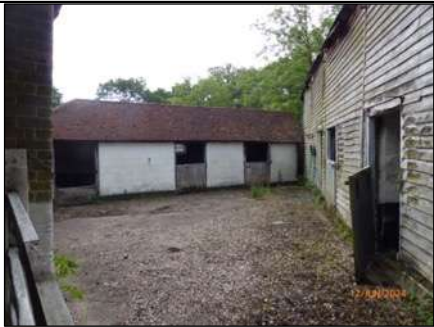
| Building no. | Figures | Description | Potential bat roosting features | Recorded evidence | Assessment of suitability |
|---|---|---|---|---|---|
| | <p><b>Figure 31:</b> Southwest elevation of Building 3, facing into courtyard.</p> | | | | |

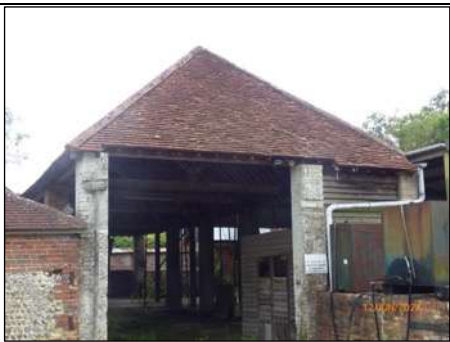
| Building no. | Figures | Description | Potential bat roosting features | Recorded evidence | Assessment of suitability |
|---|---|---|---|---|---|
| 4 | <p><b>Figure 32:</b> North-east elevation of Building 4.</p> | <p>This building consisted of a large, open sided barn, sat on brick pillars and constructed with a pitched and hipped clay tiled roof.</p> <p>The roof is constructed in a King post design, and the roof clad with clay peg tiles, which are not lined beneath.</p> <p>The underside of the roof is visible from within the building and no enclosed voids are present. A small wooden clad shed is situated in the northern corner.</p> | <p>Given the open plan nature of this building, potential roosting locations are limited, with those identified being beneath ridge and hip tiles and where roof tiles overlap.</p> | <p>No evidence of bat activity was recorded in this building.</p> <p>Barn owl splatter, a few pellets and feathers were recorded on the floor of this building.</p> | <b>Low</b> |

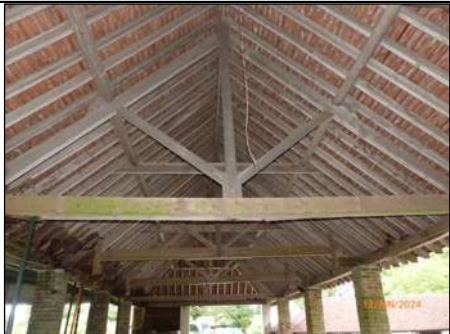
| Building no. | Figures | Description | Potential bat roosting features | Recorded evidence | Assessment of suitability |
|---|---|---|---|---|---|
| | <p><b>Figure 33:</b> Underside of roof of Building 4.</p> | | | | |

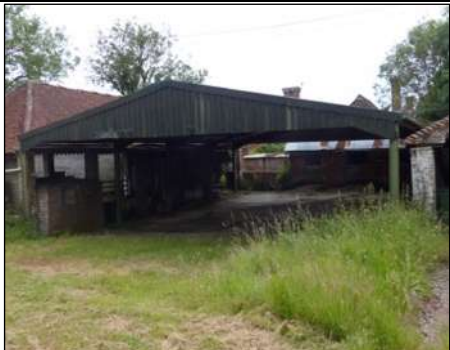
| Building no. | Figures | Description | Potential bat roosting features | Recorded evidence | Assessment of suitability |
|---|---|---|---|---|---|
| 5 | <p><b>Figure 34:</b> North-east elevation of Building 5.</p> | This building comprises a modern steel framed open-sided structure, with no internal areas. | No potential roosting features were present on this building. | <p>No evidence of bat activity was recorded.</p> <p>Barn owl splatter and feathers were recorded, suggesting a perched bird, preening.</p> | <b>Negligible</b> |

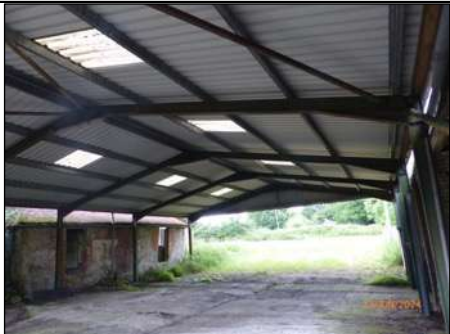
| Building no. | Figures | Description | Potential bat roosting features | Recorded evidence | Assessment of suitability |
|---|---|---|---|---|---|
| | <p><b>Figure 35:</b> Interior and underside roof of Building 5.</p> | | | | |

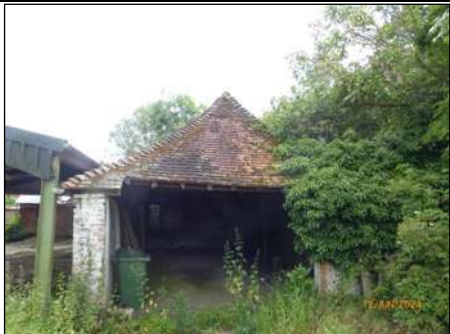
| Building no. | Figures | Description | Potential bat roosting features | Recorded evidence | Assessment of suitability |
|---|---|---|---|---|---|
| 6 | <p><b>Figure 36:</b> North-east elevation of Building 6.</p> | <p>This building consists of a brick and block-built structure with a pitched and hipped clay tiled roof. The clay tiles are traditional peg tiles, which are unlined, and the rafters appear traditional, in a Queen post design.</p> <p>Several large access points to the interior were present, these included at the entrance (north-east elevation), along the south-eastern elevation, where door and window openings were present and at the</p> | <p>The only potential roosting location was considered to be within the apex of the roof, but there were gaps present in places and the overall impression of the building was that it was unsuitable, and any roosting would be on a temporary basis, for example as a feeding hang up.</p> | <p>No evidence of bat activity was recorded either internally or externally on this building.</p> <p>Barn owl roosting in building.</p> | <b>Negligible</b> |

**Building 6 (Brick and Block Structure):** Also assessed as having negligible roost suitability due to the lack of suitable internal or external roosting features. Bat activity was not observed within the building.

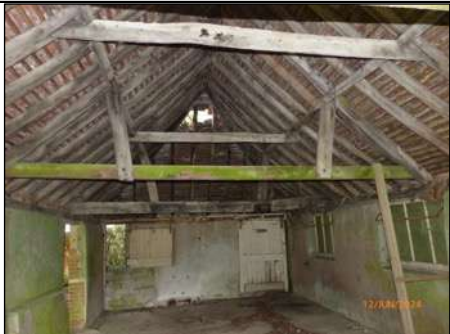
| Building no. | Figures | Description | Potential bat roosting features | Recorded evidence | Assessment of suitability |
|---|---|---|---|---|---|
| | <p><b>Figure 37:</b> Internal view of Building 6.</p> | <p>southwest corner. Windows on the northwestern elevation were intact.</p> <p>At the southwestern end a large hole was present at the apex of the hip, this added to the illumination of the interior and exposed it to the prevailing weather.</p> <p>The interior was damp and cool with water ingress in places.</p> | | | |

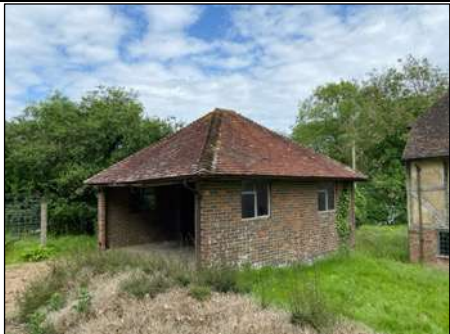
| Building no. | Figures | Description | Potential bat roosting features | Recorded evidence | Assessment of suitability |
|---|---|---|---|---|---|
| 7 | <p><b>Figure 38:</b> Building 7 viewed from the east.</p> | <p>This building consists of a brick-built structure with a clay tiled roof, constructed in a hipped design, rising to a central peak. A large opening is present on the northwest facing elevation.</p> <p>The roof is constructed with clay tiles which are lined beneath with a bitumen felt underlay, the roof rafters are a modern trussed design.</p> <p>A temporary void is present since sheets of chipboard have been placed on the rafters. It is considered that this may be to</p> | <p>Potential bat roosting features on this building are as follows:</p> <ul style="list-style-type: none"> <li>Beneath roof and hip tiles;</li> <li>Within the roof area</li> </ul> | <p>A scattering of pipistrelle bat type droppings were recorded on a shelf within the garage and on the chipboard sheets on the rafters.</p> <p>Old (not the current year) swallow nests were present.</p> | <b>Moderate</b> |

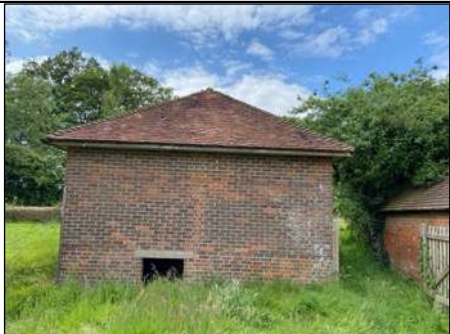
| Building no. | Figures | Description | Potential bat roosting features | Recorded evidence | Assessment of suitability |
|---|---|---|---|---|---|
| | <p><b>Figure 39:</b> Building 7 viewed from the south-east.</p> | <p>prevent barn swallow droppings falling onto any cars in the garage.</p> | | | |

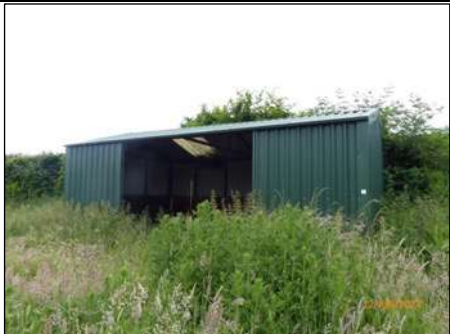
| Building no. | Figures | Description | Potential bat roosting features | Recorded evidence | Assessment of suitability |
|---|---|---|---|---|---|
| 8 | <p><b>Figure 40:</b> Building 8 viewed from the south.</p> | <p>This building comprises a single-skin, corrugated metal structure with a shallow pitched roof. A large opening is present on the south-east facing elevation, this and the opaque panels in the roof illuminated the interior.</p> <p>Internally there were no contained voids or crevices.</p> | <p>No potential bat roosting locations were identified on this building.</p> | <p>No bat evidence recorded, but a main badger sett was present within the building, and barn owl splatter and pellets were recorded within.</p> | <p><b>Negligible</b></p> |

**Buildings 8, 9, 10 and 12:** These buildings support negligible suitability. Structures like Building 8 (corrugated metal) and Building 9 (wooden shed) offer minimal or no roosting features, and no bat activity was observed, supporting the negligible assessments.

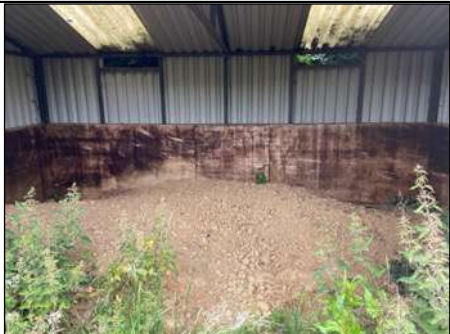
| Building no. | Figures | Description | Potential bat roosting features | Recorded evidence | Assessment of suitability |
|---|---|---|---|---|---|
| | <p><b>Figure 41:</b> Internal view of Building 8.</p> | | | | |

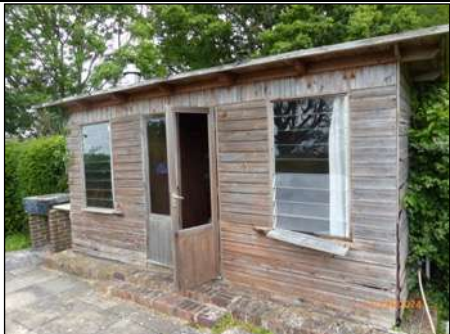
| Building no. | Figures | Description | Potential bat roosting features | Recorded evidence | Assessment of suitability |
|---|---|---|---|---|---|
| 9 | <p><b>Figure 42:</b> View of Building 9.</p> | <p>This building consists of a wooden shed, with a flat felt lined roof. The side cladding is single skin, although in places, secondary sheets were present. There is no internal roof void.</p> <p>The building is illuminated internally through the presence of windows, and at the time of the survey the doors and windows were closed, with no potential bat access locations.</p> | No potential bat roosting locations were identified on this building. | No bat evidence recorded. | <b>Negligible</b> |

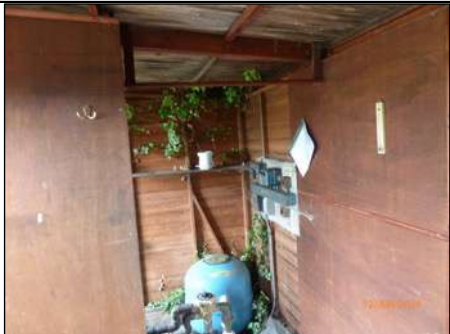
| Building no. | Figures | Description | Potential bat roosting features | Recorded evidence | Assessment of suitability |
|---|---|---|---|---|---|
| | <p><b>Figure 43:</b> Internal view of Building 9.</p> | | | | |

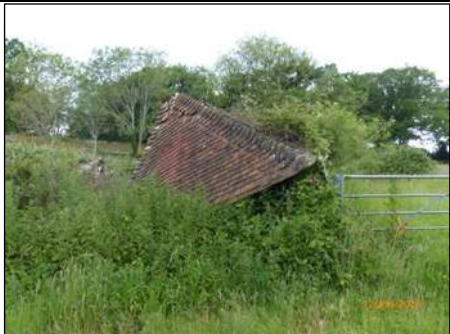
| Building no. | Figures | Description | Potential bat roosting features | Recorded evidence | Assessment of suitability |
|---|---|---|---|---|---|
| 10 | <p><b>Figure 44:</b> View of Building 10.</p> | <p>This building comprises a small wooden clad structure with a clay tiled roof in a pitched and hipped design. The structure had partially collapsed, with a small section of the roof remaining, although there were a small number of gaps in the remaining roof section.</p> <p>The side elevations were single skin, and only one side remained intact.</p> <p>It was not possible to gain access to the building due to dense vegetation within it, and the unsafe nature of the structure.</p> | No potential bat roosting features were identified on this building. | No bat evidence recorded. | <b>Negligible</b> |

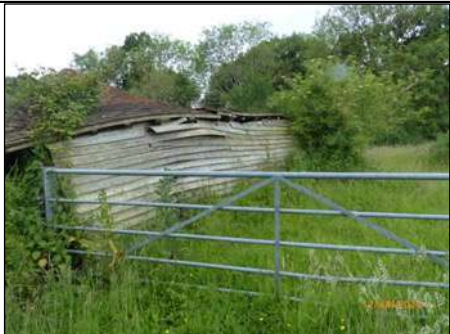
| Building no. | Figures | Description | Potential bat roosting features | Recorded evidence | Assessment of suitability |
|---|---|---|---|---|---|
| | <p><b>Figure 45:</b> View of Building 10.</p> | | | | |

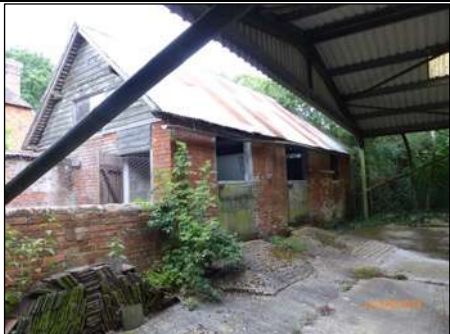
| Building no. | Figures | Description | Potential bat roosting features | Recorded evidence | Assessment of suitability |
|---|---|---|---|---|---|
| 11 | <p><b>Figure 46:</b> View of Building 11.</p> | <p>This building comprises a brick-built stable, with a pitched roof constructed in a gable end design. The southwest facing elevation is clad with traditional clay peg tiles, which are unlined, whereas the north-east facing elevation is clad with corrugated metal sheets.</p> <p>The gables are infilled with wooden cladding, this is single skin, with no lining behind.</p> | <p>The only potential roosting location identified in this building was within the apex of the roof, where bats could potentially cluster against the ridge beam.</p> <p>It was considered that this roosting feature was most likely temporary or occasional roost feature.</p> | <p>No evidence of bat activity was recorded on the floor or upper face of the internal rafters, of this building, which would be expected if being used as a roost.</p> <p>Extensive barn owl evidence and a roosting barn owl was recorded in this building.</p> | <b>Low</b> |

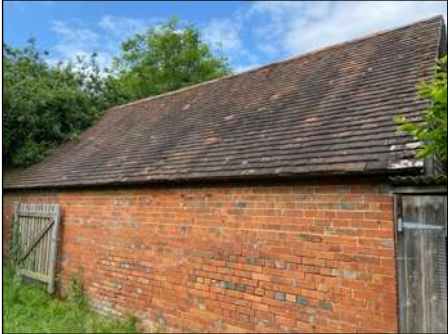
| Building no. | Figures | Description | Potential bat roosting features | Recorded evidence | Assessment of suitability |
|---|---|---|---|---|---|
| | <div><p><b>Figure 47:</b> View of southwest elevation of Building 11.</p><p><b>Figure 48:</b> Internal view of Building 11.</p></div> | <p>The roof is constructed in a Queen post design, with the apparent traditional rafters present.</p> <p>The building is partitioned internally to just below tie beam height, above that it is open plan.</p> <p>At the south-east facing elevation a single storey brick-built kennel, with a mono-pitch corrugated metal roof is located</p> | | | |

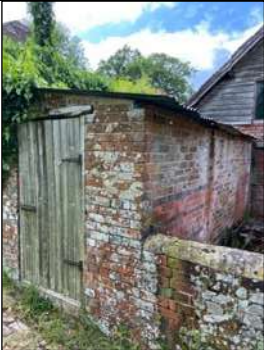
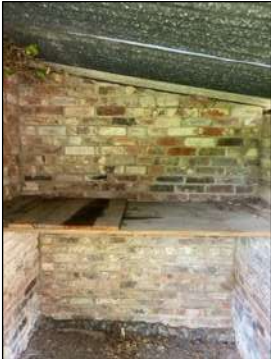
| Building no. | Figures | Description | Potential bat roosting features | Recorded evidence | Assessment of suitability |
|---|---|---|---|---|---|
| | <div><p><b>Figure 49:</b> Single storey extension section of Building 11.</p><p><b>Figure 50:</b> Internal view of single storey extension section of Building 11.</p></div> | | | | |

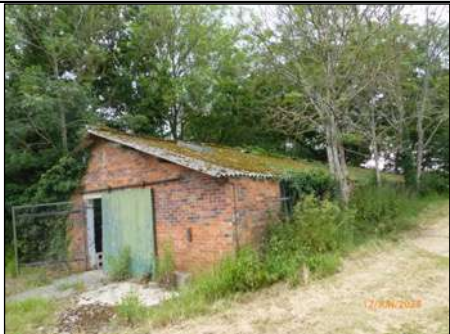
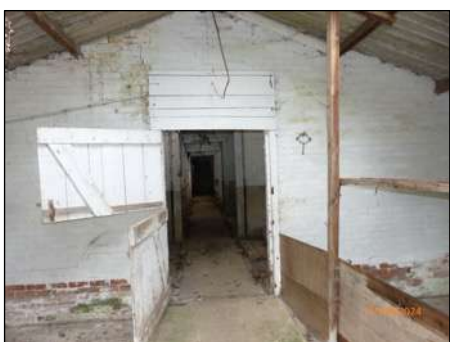
| Building no. | Figures | Description | Potential bat roosting features | Recorded evidence | Assessment of suitability |
|---|---|---|---|---|---|
| 12 | <p><b>Figure 51:</b> View of Building 12.</p> <p><b>Figure 52:</b> Internal view of Building 12.</p> | <p>This building comprises a single storey brick-built structure with a corrugated asbestos roof, constructed in a pitched and gable end design. A sliding wooden door is located at the south-east facing elevation, this was ajar at the time of the survey.</p> <p>Internally the building is open to the roof, and no contained voids or crevices were present. The building is partitioned internally, and several cracks were present in the partition walls.</p> <p>The interior was open and drafty, and illuminated through the presence of sky lights in the roof.</p> | <p>Given the design of the roof and lack of any internal rafters or beams and concealed void areas no suitable roosting locations were identified.</p> <p>There were numerous places where bats could gain entry to the building, but it is considered that its use as a foraging area during periods of inclement weather was the most likely scenario.</p> | <p>No bat evidence recorded despite the undisturbed condition of the interior and access to all suitable roost features.</p> <p>Bird splatter indicative of barn owl, and a disused wren nest of the year, was located within the building.</p> | <b>Negligible</b> |

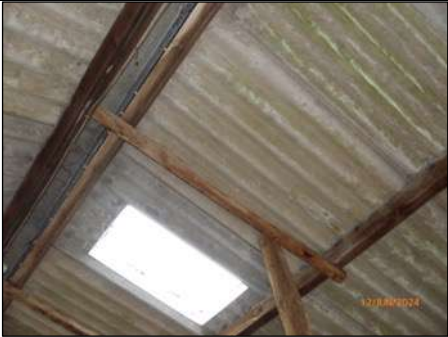
| Building no. | Figures | Description | Potential bat roosting features | Recorded evidence | Assessment of suitability |
|---|---|---|---|---|---|
| | <p><b>Figure 53:</b> Underside of roof of Building 12.</p> | | | | |

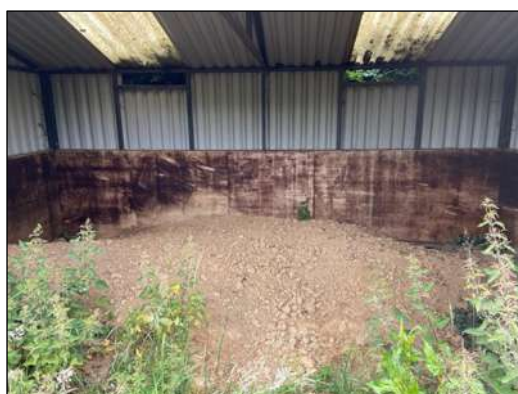
A main badger sett, with two entrances, was located within Building 8, in addition three further entrances were located beneath a hedgerow forming the boundary of the garden, approximately 8m west of Building 8. It is considered that these entrances all relate to the same sett complex given the amount of excavated spoil present within Building 8, which also suggests this sett has been active for many years. Numerous badger guard hairs were located in the sett entrances and within the spoil. During the camera trap surveys, the badger sett was found to be in frequent use with up to two badgers recorded at any one time.

**Figure 55:** Badger sett within Building 8. There are two entrances within the building, this image shows the large amount of excavated spoil.

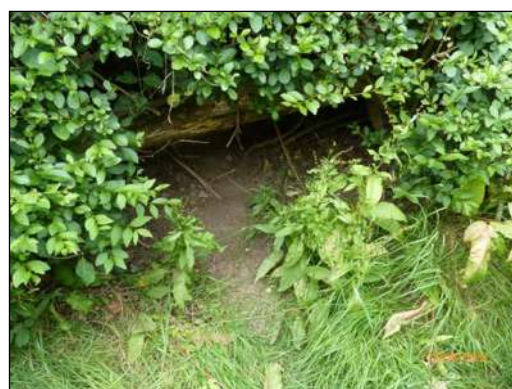
**Figure 56:** Badger sett entrance beneath hedge in garden.
