**GROUND APPRAISAL REPORT**

**PROPOSED SPORTS PITCHES &**

**A264 NEW ACCESS ROADWAY**

**NORTH HORSHAM, WEST SUSSEX**

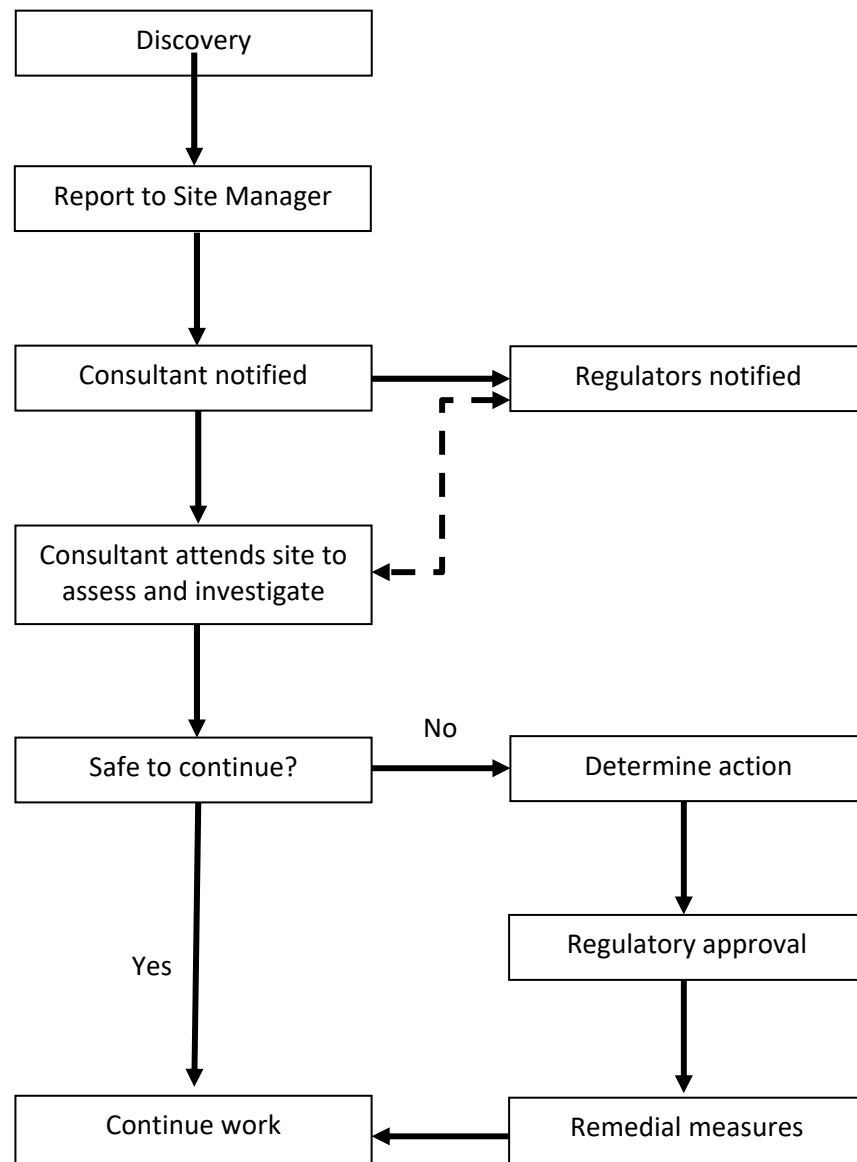
The process is shown below.

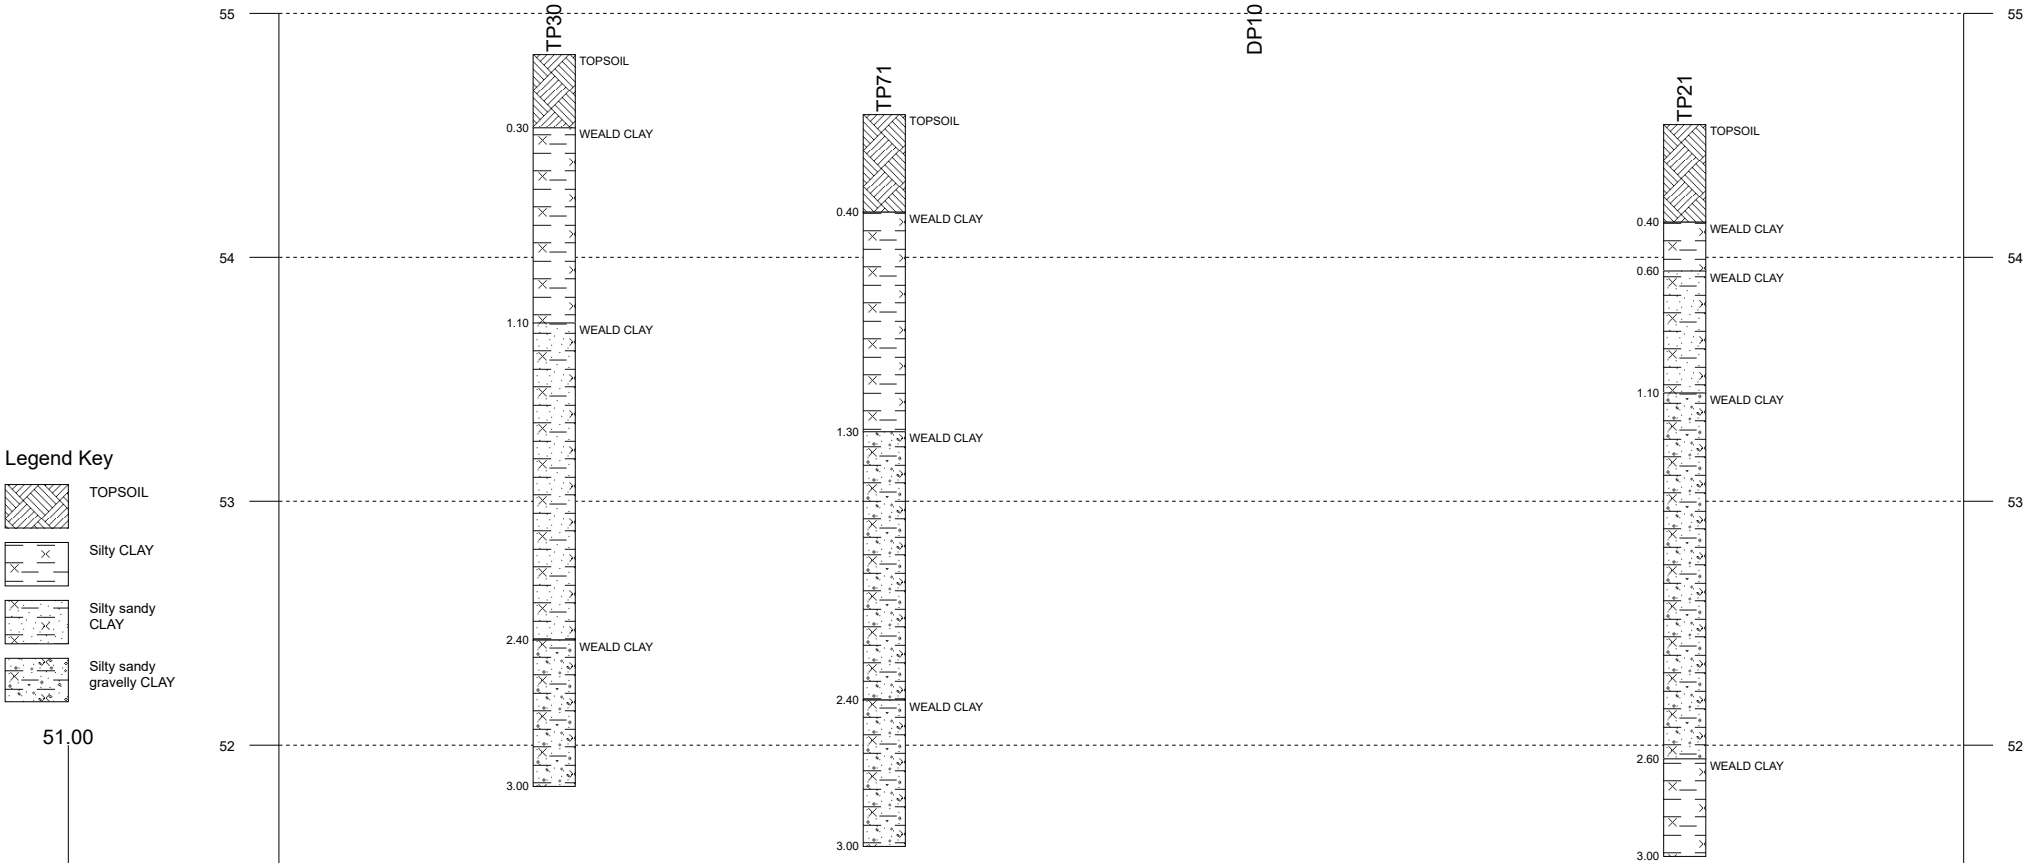
Title: Section line 2  
Vertical Scale: 1:31  
Horizontal Scale: 1:809  
Engineer: GE

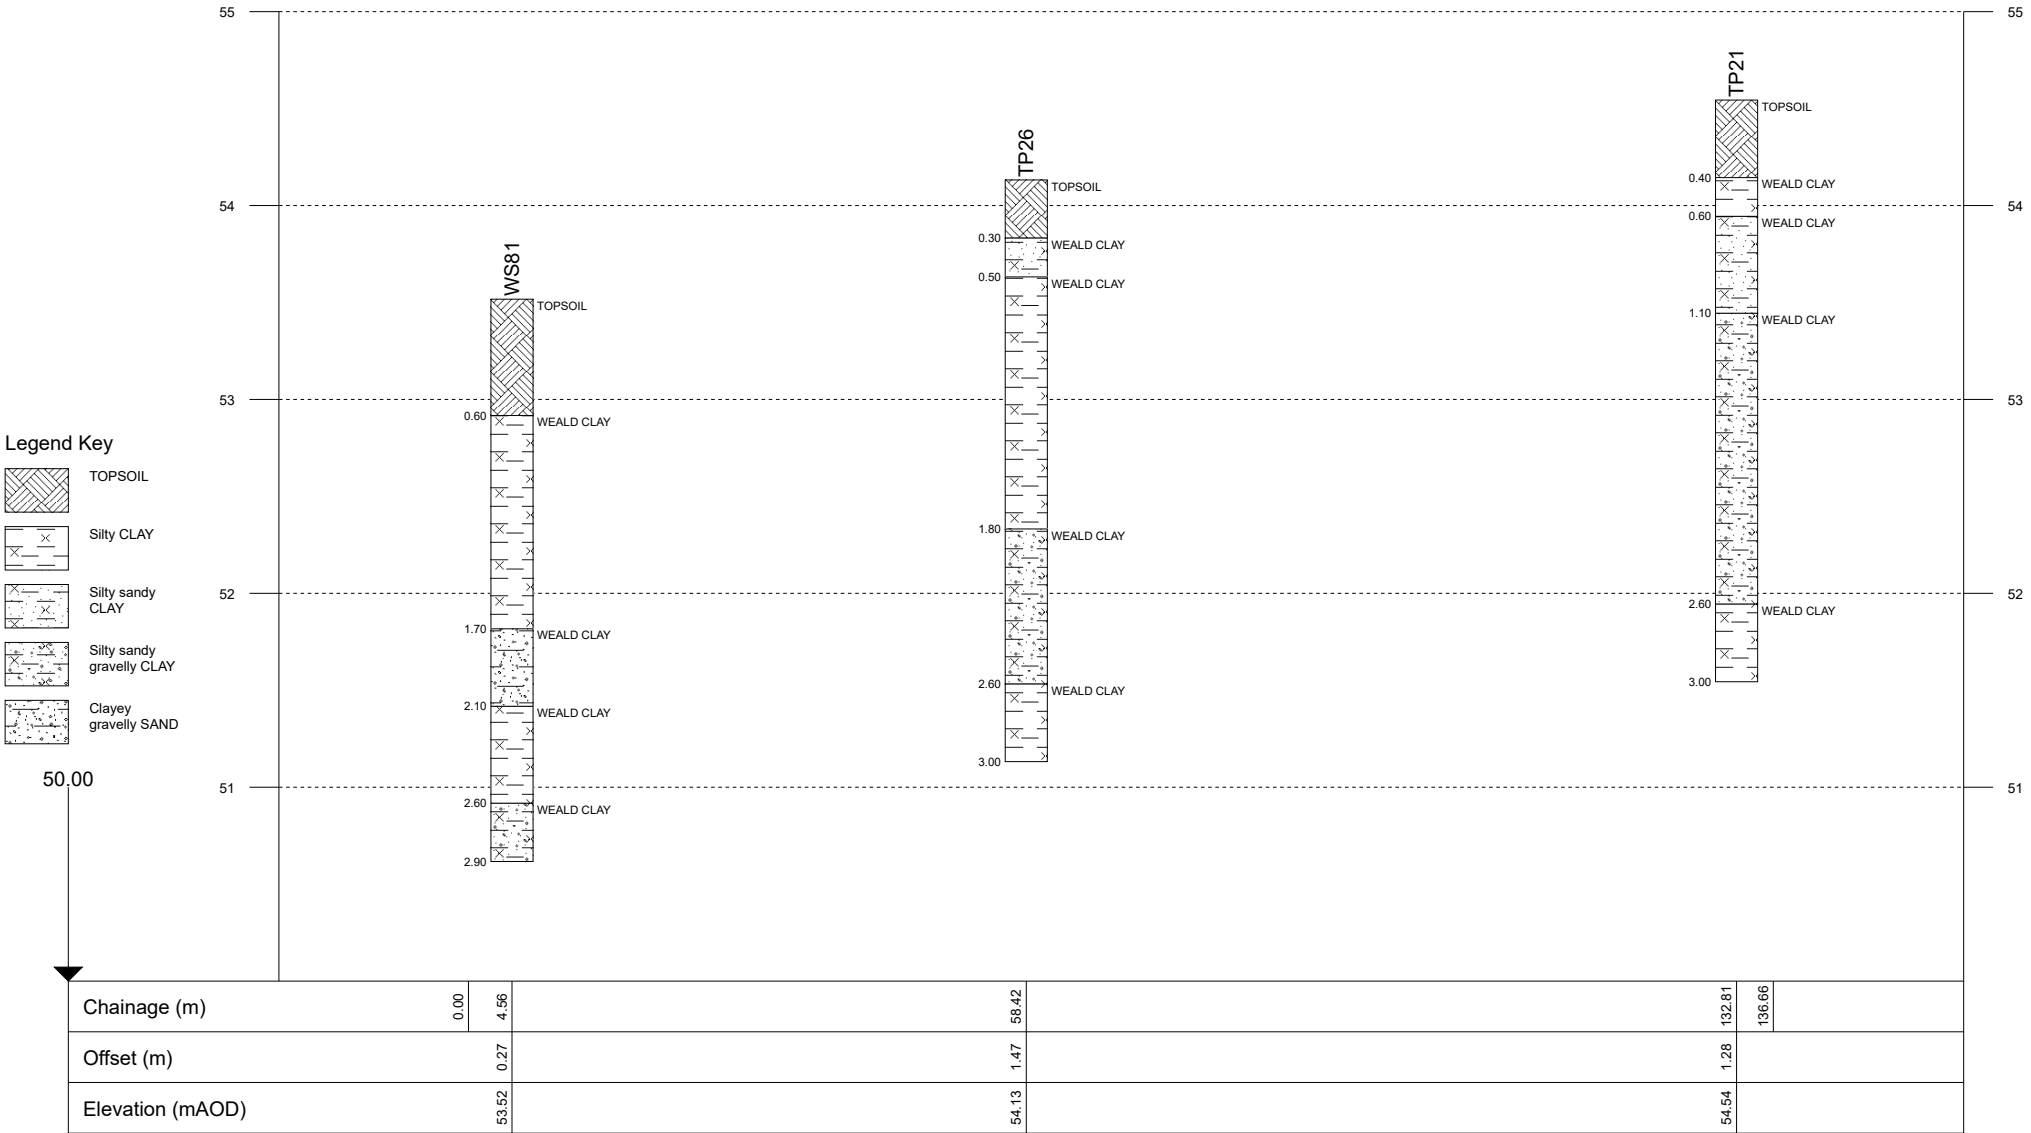
Title: Section line 5  
Vertical Scale: 1:39  
Horizontal Scale: 1:792  
Engineer: GE
