**Re: LP2910 Woodfords, Shipley Road- Additional Chemical Testing**  
***Issue 2: Amendment to proposed layout***

Leap Environmental Ltd (hereafter referred to as **LEAP**) has been appointed by Reside Holdings Ltd to undertake additional investigation of the potential contamination hotspots at a site known as Woodfords, Shipley Road, Southwater RH13 9BQ [Figure 1, Appendix B] to provide information on the geochemical composition of the soils. The proposed development comprises 73 No. residential properties along with associated access roads and garages. A central section of the site will be green space occupied by large trees. Several attenuation basins/ponds are proposed along the sites south-eastern boundary as illustrated in [Drawing Ref: 102108-BEL-SL-01, Appendix B].

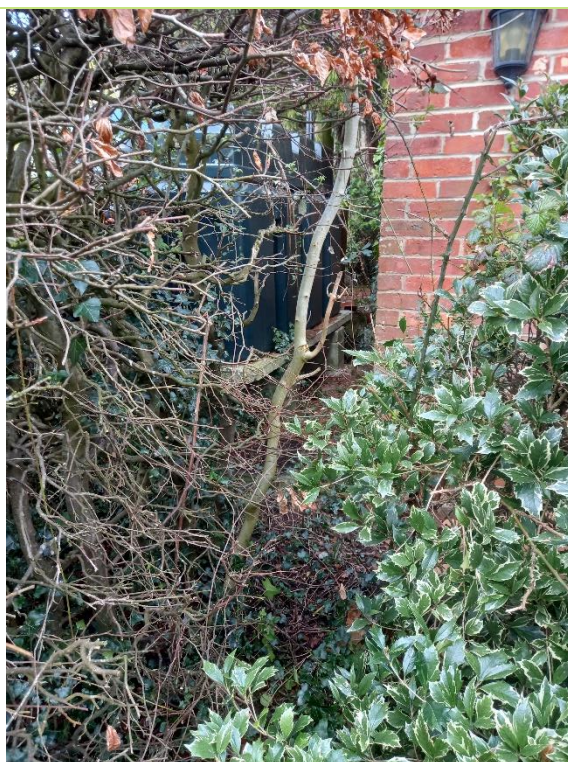
Photo 1 – Access path to HP1, oil tank to left and main residence to the right.

| Trial Hole Location | Rationale | Proposed Depth (m bgl) | Achieved Depth (m bgl) | Additional Comments |
|---|---|---|---|---|
| HP1 | To screen for potential heating oil contamination to soils underlying the residential oil tank | 1 | 0.2 | Access was very restricted, digging by hand trowel was the only available method. Shallow sample adequate for investigative aims. |

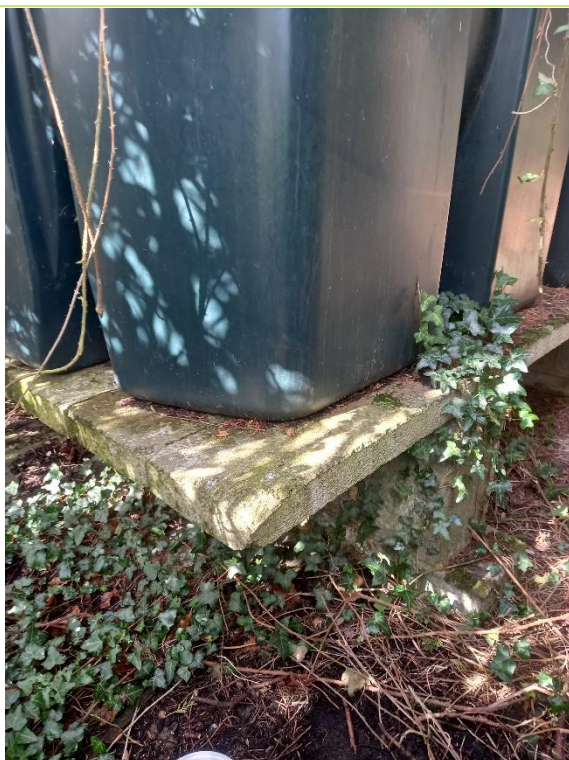
Photo 2:  
Oil tank on Plinth

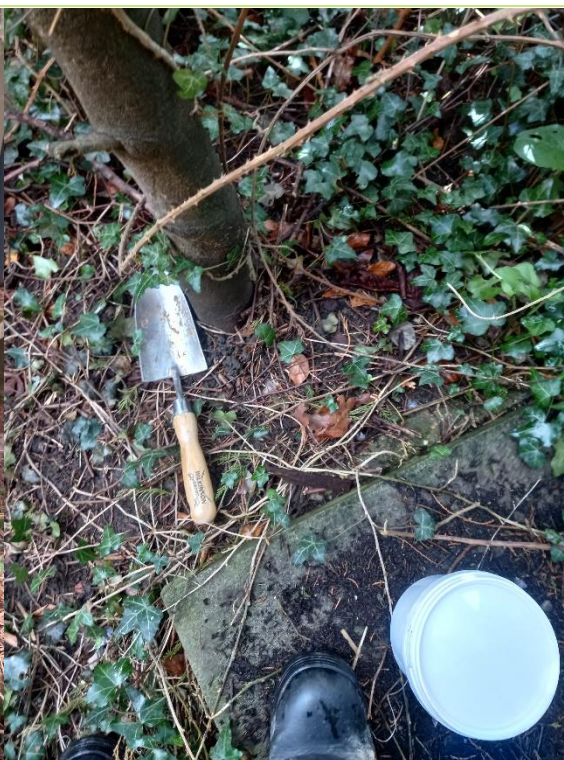
Photo 3:  
HP1 location

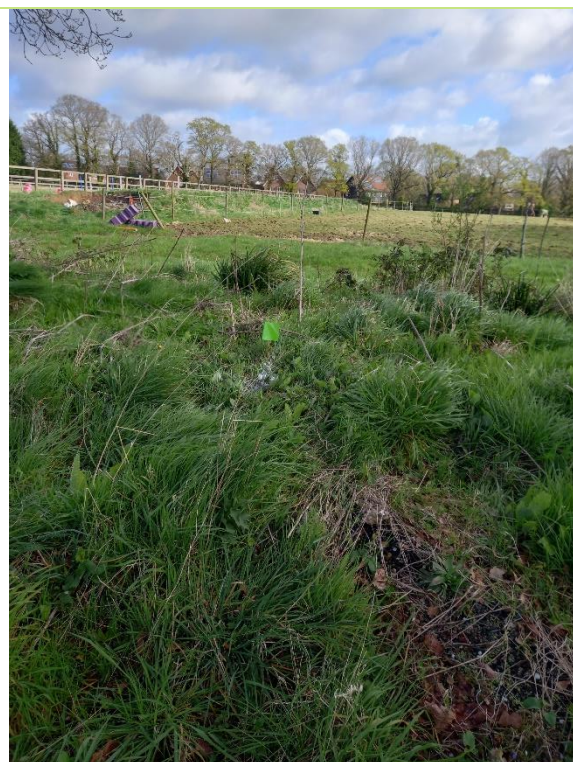
Photo 4:  
HP2 location marked by white spray and  
green flag (centre of photo)

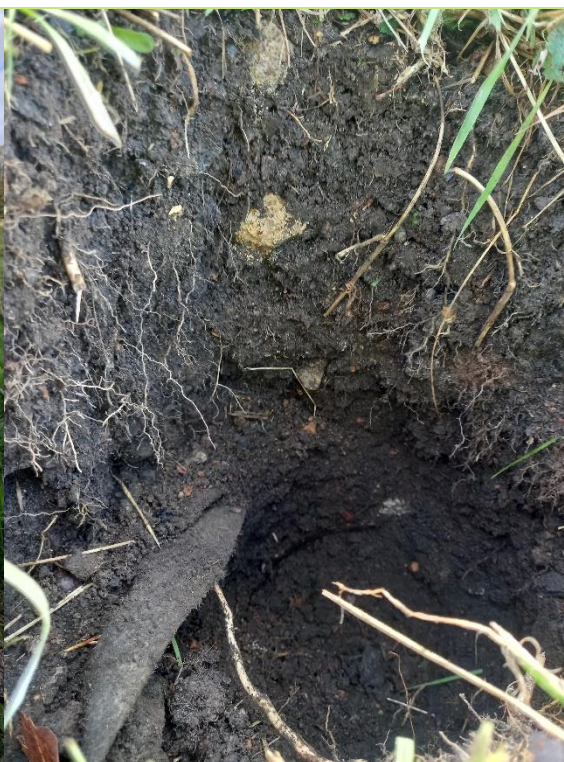
Photo 5:  
Mid-excavation of HP2

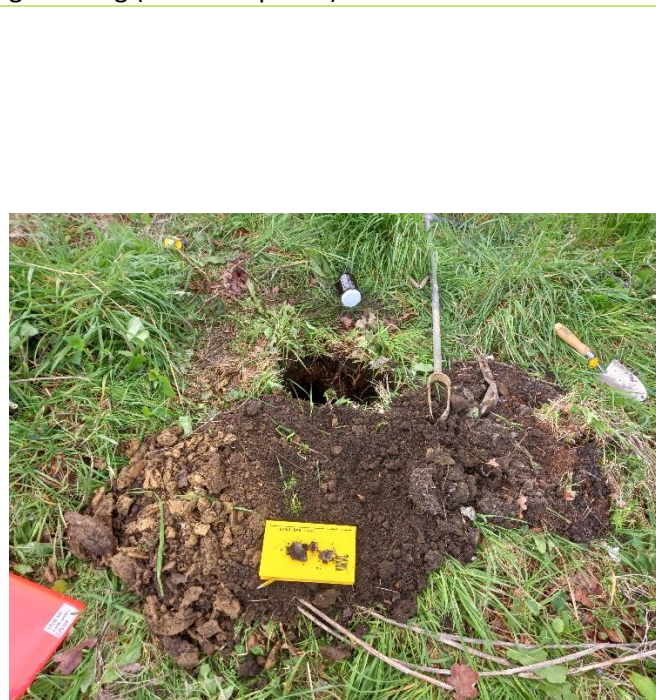
Photo 6:  
HP2 arisings

| Trial Hole/Test Location | Geology | Key observations/Anthropogenic inclusions |
|---|---|---|
| HP2 | Sandy silty gravelly MADE GROUND natural encountered 0.9mbgl | Blacktop, charcoal, clinker, scrap metal, geotextile, cemented sand |

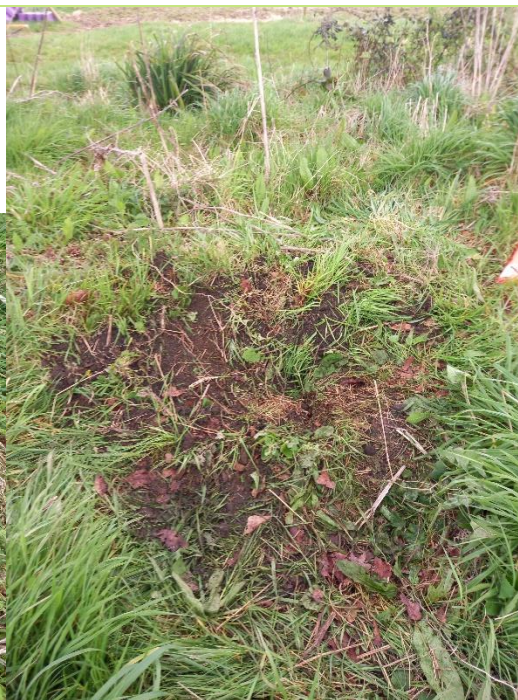
Photo 7:  
HP2 reinstated

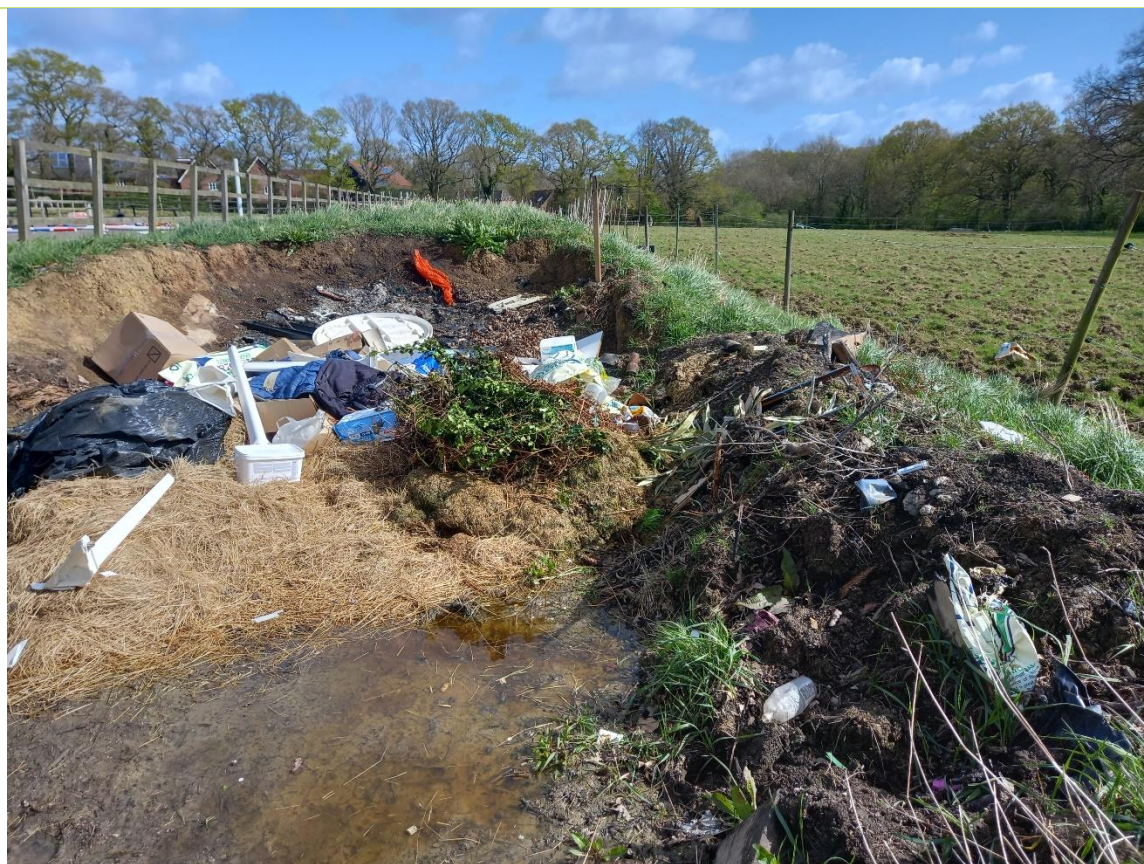
Photo 8- HP3 general location [wooden post within burning area approximately locates High Voltage cable]

| Trial Hole Location | Rationale | Proposed Depth (m bgl) | Achieved Depth (m bgl) | Additional Comments |
|---|---|---|---|---|
| HP3 | Southern end of the bund along sand school, used as a burning area for mixed wastes | 1 | 0.2 | Within 10m of underground HV cable, deep excavation prohibited. Terminated at 0.2 after possible ACM (AIB) found. Shallow sample adequate for investigative aims. |

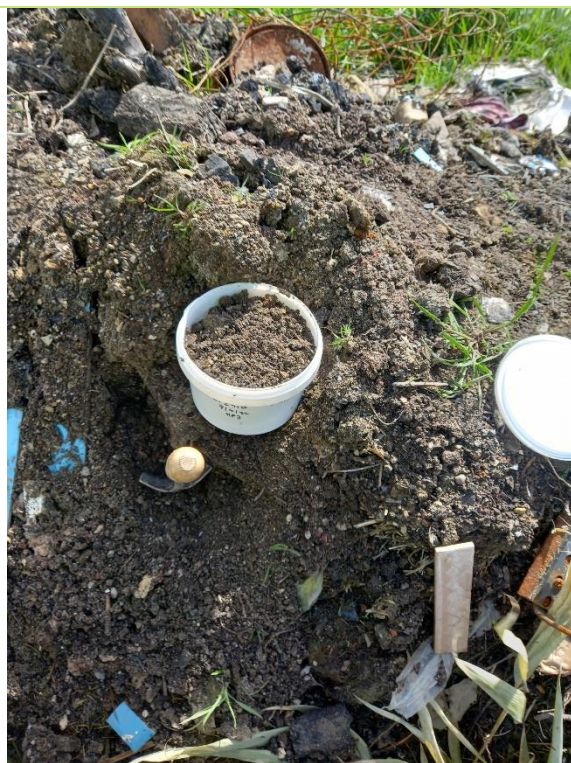
Photo 9:  
HP3 location

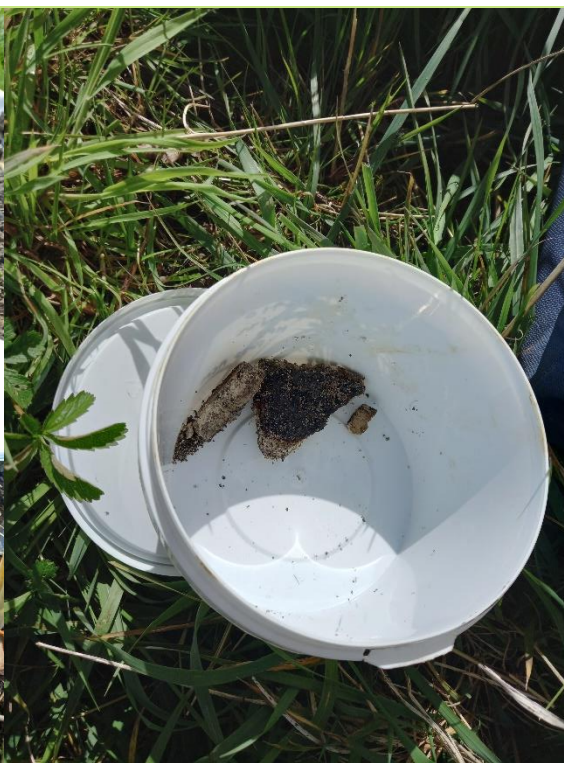
Photo 10:  
HP3 possible ACM (AIB?)

| Trial Hole/Test Location | Geology | Key observations/Anthropogenic inclusions |
|---|---|---|
| HP3 | Clayey MADE GROUND | Burnt wood, consolidated ash, ceramic tile, scrap metal, manufactured wooden board, cemented sand. Possible ACM (AIB?) recovered. |

No asbestos was detected within any of the samples tested.

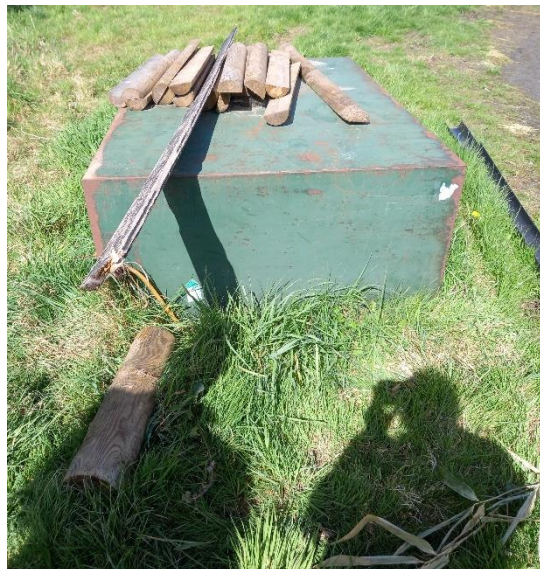
Photo 11:  
Old oil tank

| Trial Hole Location | Rationale | Proposed Depth (m bgl) | Achieved Depth (m bgl) | Additional Comments |
|---|---|---|---|---|
| HP4 | Old single skinned unbunded oil tank, lying on its side. | 1 | 1.1 | Site occupier advised tank was bought to heat swimming pool but never installed. |

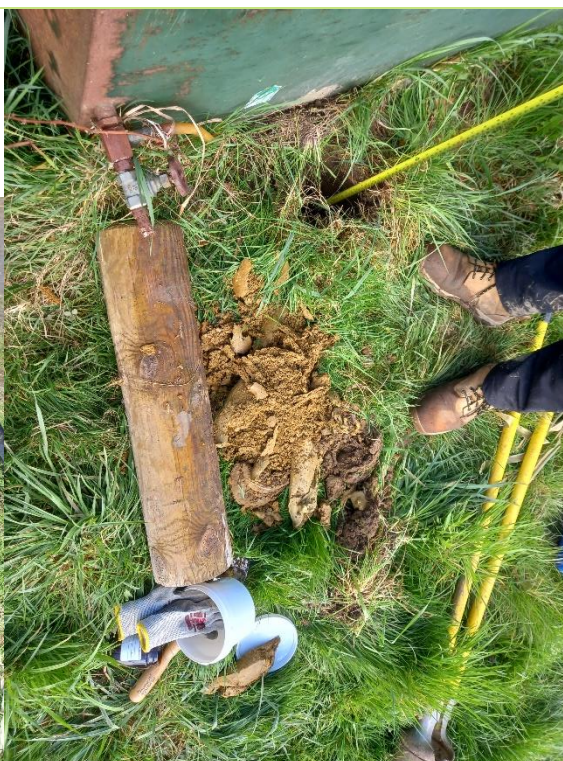
Photo 12:  
HP4 arisings

| Trial Hole/Test Location | Geology | Key observations/Anthropogenic inclusions |
|---|---|---|
| HP4 | Silty clayey TOPSOIL over sandy silty CLAY over clayey silty SAND. | Appeared natural, no anthropogenic inclusions or indicators of hydrocarbon contamination. |

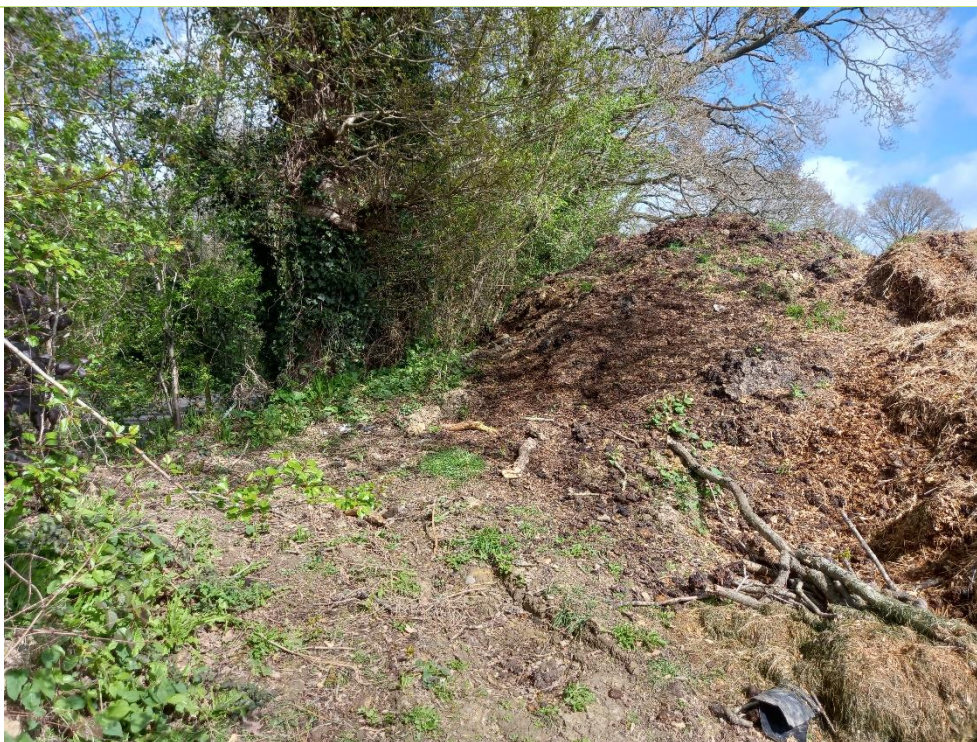
Photo 13:  
HP5 rear of year, southern extremity of western bund in northern field

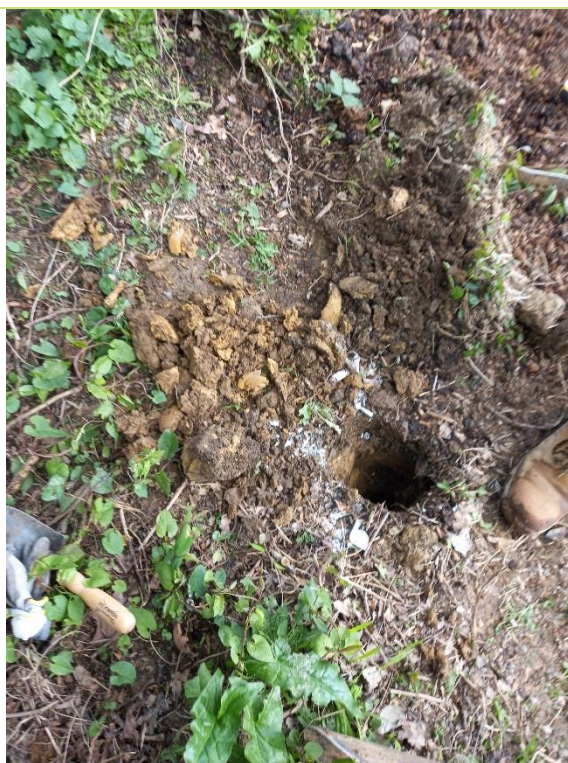
Photo 14 - HP5 arisings

| Trial Hole/Test Location | Geology | Key observations/Anthropogenic inclusions |
|---|---|---|
| HP5 | Clayey MADE GROUND | Occasional clinker and brick fragments |

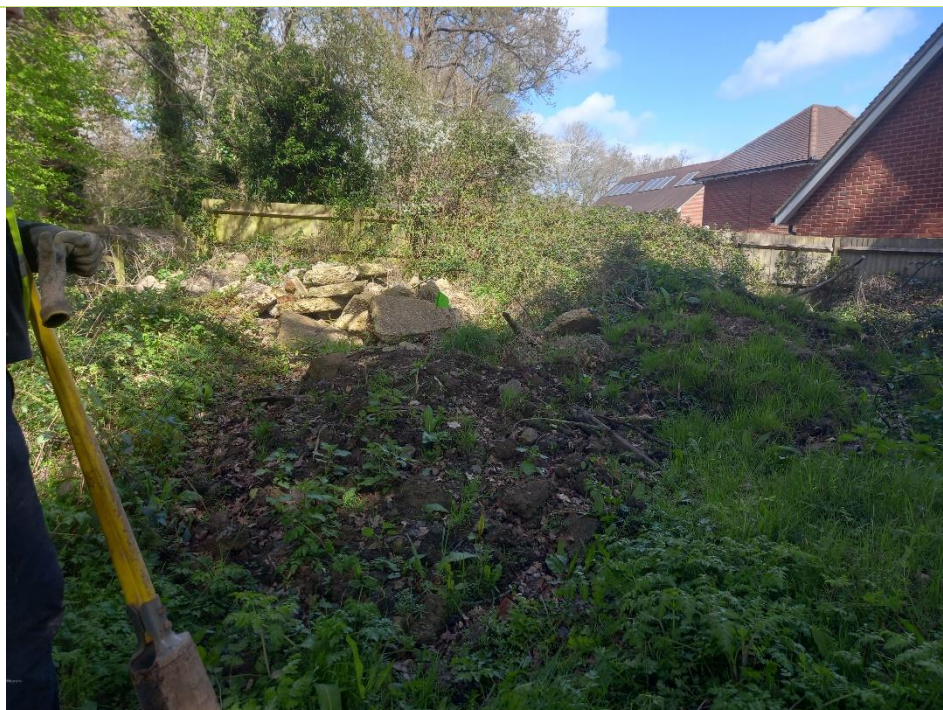
Photo 15- HP6 general location

| Trial Hole Location | Rationale | Proposed Depth (m bgl) | Achieved Depth (m bgl) | Additional Comments |
|---|---|---|---|---|
| HP6 | Old, abandoned access gate piled up with construction wastes noted LP2354. Far less waste was noted on this visit, but concrete blocks remain and small (c.1m mound) of made ground, which was targeted for investigation. | 1 | 0.6 | Terminated at 0.6m due to hitting a concrete obstruction. |

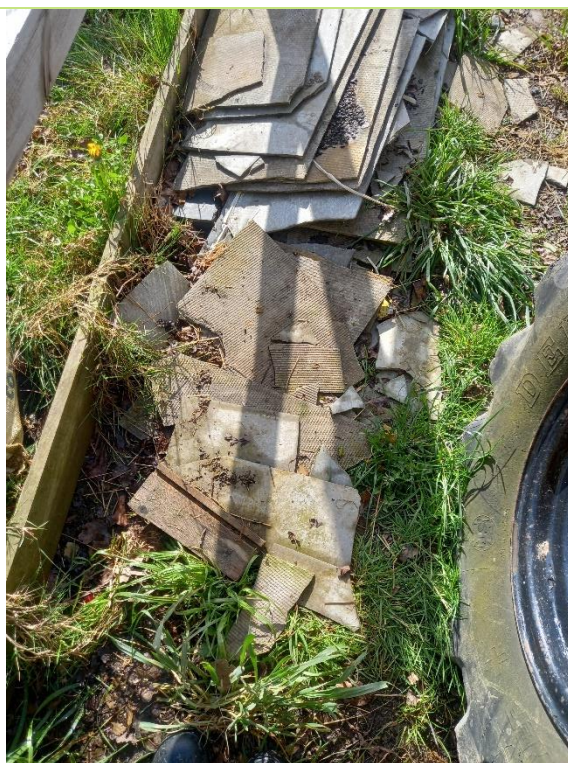
Photo 16- Possible ACM in yard area.

During the site investigation it was noted there were tiles in the yard area that potentially may contain asbestos. As these are not within the soils, they are outside the scope of this investigation. A photo has been included in Appendix C for reference.
