## Bat Emergence and Re-Entry Surveys (BERS)

Premier inn Horsham North (Horsham Station) hotel, 57 North Street, Horsham RH12 1RB

**Client:** Premier Inn Hotels / Whitbread Group PLC

This report has been prepared to support a planning application for the demolition of one structure (B2), the construction of an additional hotel building, and the refurbishment of one existing building (B1).

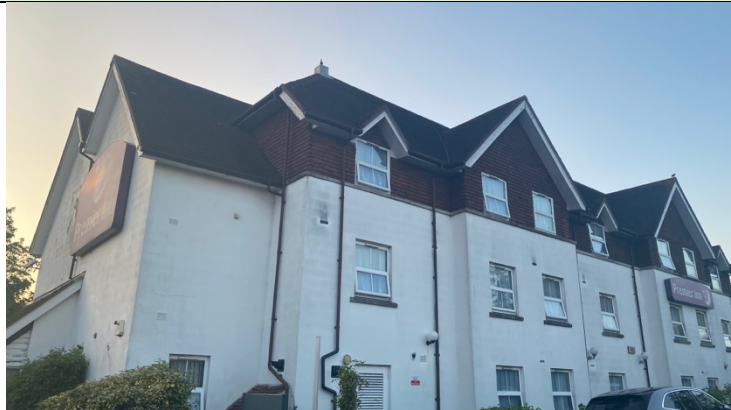
| | | Rain: None | | Rain: None | | |
|---|---|---|---|---|---|---|
| <i>Surveyor 1</i> | <b>Emergences observed</b> – No<br><br><b>Species</b> – Soprano pipistrelle, serotine.<br><b>Flight paths</b> – N/A<br><b>Foraging areas</b> – N/A<br><b>Summary of general activity:</b><br>The first bat detected was a heard but not seen (HNS) soprano pipistrelle at 21:13. At 21:36 a serotine was observed passing in a westerly direction between B1 and B2. The final bat detected was a soprano pipistrelle foraging in an easterly direction between B1 and B2 at 21:56. | | | | <p><i>Eastern and southern elevation of B1.</i></p> | |

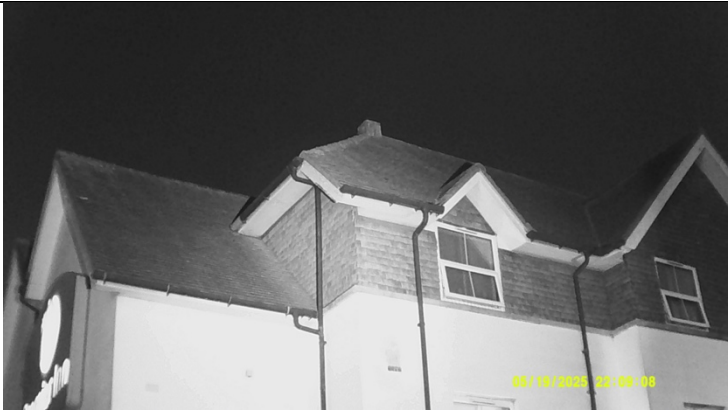
| <p><i>IR position 1</i><br/> <i>Nightfox Whisker</i><br/> <i>Nightfox XB5 PRO</i></p> | <p><b>Camera position:</b> observing eastern and southern elevation of B1.<br/> <b>Emergences observed:</b> No</p> <p>Activity captured on the IR footage reflects the observations recorded by surveyor 1. No further activity was recorded.</p> | <p><i>Darkest point eastern and southern elevation of B1.</i></p> |

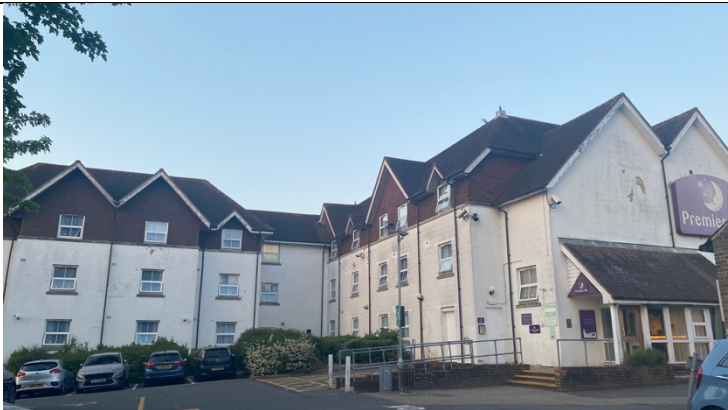
| <p><i>Surveyor 2</i></p> | <p><b>Emergences observed</b> – No</p> <p><b>Species</b> – Common pipistrelle, soprano pipistrelle, serotine.<br/> <b>Flight paths</b> – N/A<br/> <b>Foraging areas</b> – N/A<br/> <b>Summary of general activity:</b><br/> First activity was a soprano pipistrelle passing between B1 and B2 and flying from the east towards the west. A serotine was HNS at 21.36, and a common pipistrelle was HNS foraging close to the site at 21.55 and 22.01.</p> | <p><i>Western elevation of B1.</i></p> |

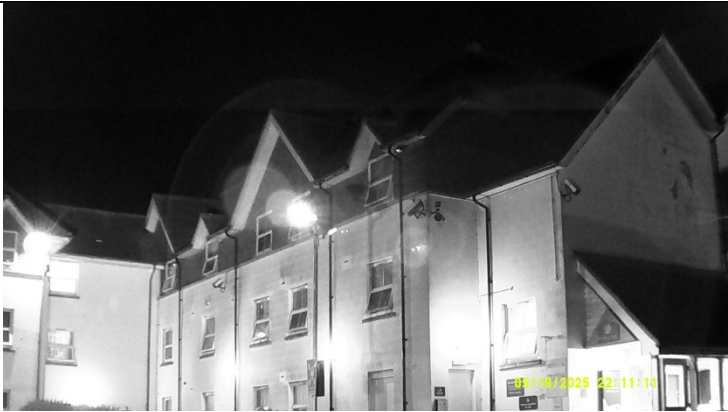
| <i>IR position 2</i> | <p><b>Camera position:</b> observing western elevation of B1.</p> <p><b>Emergences observed:</b> No</p> <p>Activity captured on the IR footage reflects the observations recorded by surveyor 2. No further activity was recorded.</p> | <p><i>Darkest point western elevation of B1.</i></p> |

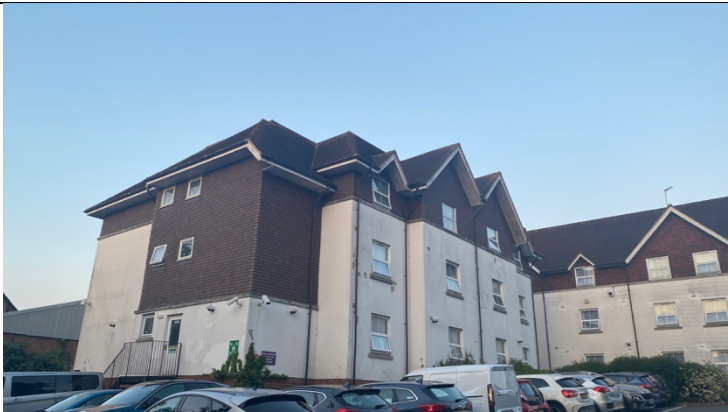
| <i>Surveyor 3</i> | <p><b>Emergences observed</b> – No</p> <p><b>Species</b> – N/A</p> <p><b>Flight paths</b> – N/A</p> <p><b>Foraging areas</b> – N/A</p> <p><b>Summary of general activity:</b><br/>No activity was recorded at this position.</p> | <p><i>Western elevation of B1.</i></p> |

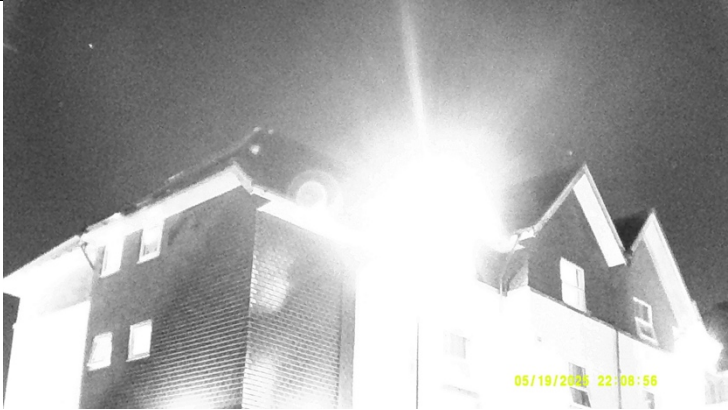
| <p><i>IR position 3</i><br/><i>Nightfox Whisker</i><br/><i>Nightfox XB5 PRO</i></p> | <p><b>Camera position:</b> observing western elevation of B1.</p> <p><b>Emergences observed:</b> No</p> <p>Activity captured on the IR footage reflects the observations recorded by surveyor 3. No further activity was recorded.</p> | <p>05/19/2016 22:08:56</p> <p><i>Darkest point western elevation of B1.</i></p> |

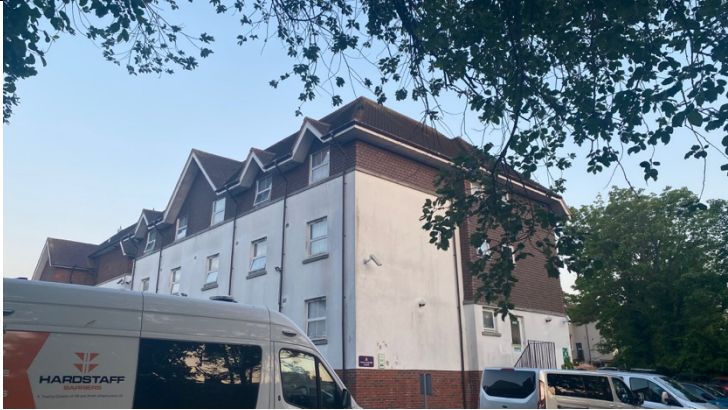
| <p><i>Surveyor 4</i></p> | <p><b>Emergences observed</b> – No</p> <p><b>Species</b> – N/A</p> <p><b>Flight paths</b> – N/A</p> <p><b>Foraging areas</b> – N/A</p> <p><b>Summary of general activity:</b><br/>No activity was recorded at this position.</p> | <p><i>Northwestern elevation of B1.</i></p> |

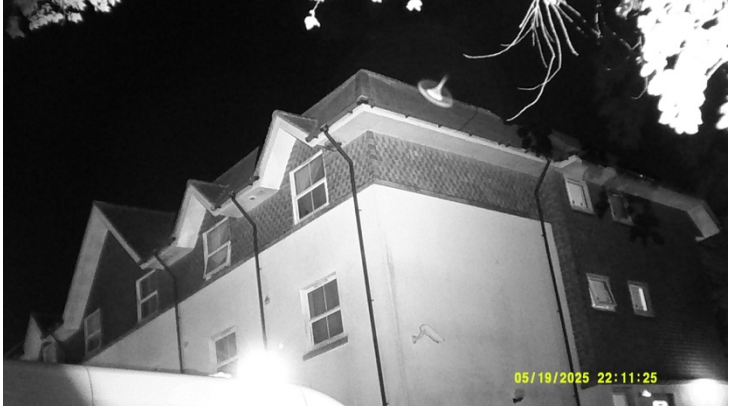
| <p><i>IR position 4</i><br/><i>Nightfox Whisker</i><br/><i>Nightfox XB5 PRO</i></p> | <p><b>Camera position:</b> observing northwestern elevation of B1.</p> <p><b>Emergences observed:</b> No</p> <p>Activity captured on the IR footage reflects the observations recorded by surveyor 4. No further activity was recorded.</p> | <p><i>Darkest point northwestern elevation of B1.</i></p> |

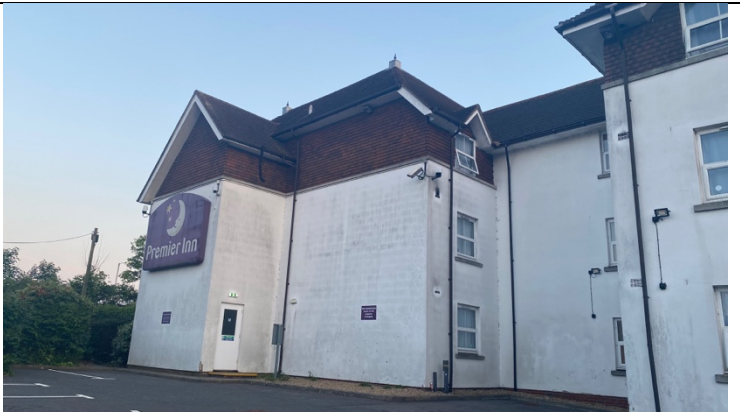
| <p><i>Surveyor 5</i></p> | <p><b>Emergences observed</b> – No</p> <p><b>Species</b> – N/A</p> <p><b>Flight paths</b> – N/A</p> <p><b>Foraging areas</b> – N/A</p> <p><b>Summary of general activity:</b><br/>No activity was recorded at this position.</p> | <p><i>Northeastern elevation of B1.</i></p> |

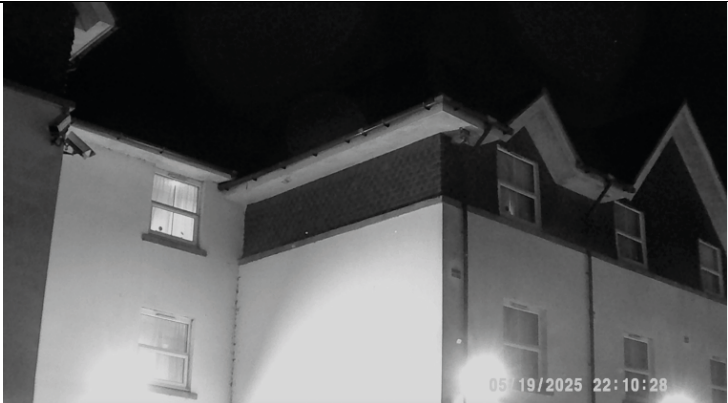
| <p><i>IR position 5</i><br/><i>Nightfox Whisker</i><br/><i>Nightfox XB5 PRO</i></p> | <p><b>Camera position:</b> observing northeastern elevation of B1.</p> <p><b>Emergences observed:</b> No</p> <p>Activity captured on the IR footage reflects the observations recorded by surveyor 5. No further activity was recorded.</p> | <p><i>Darkest point northeastern elevation of B1.</i></p> |

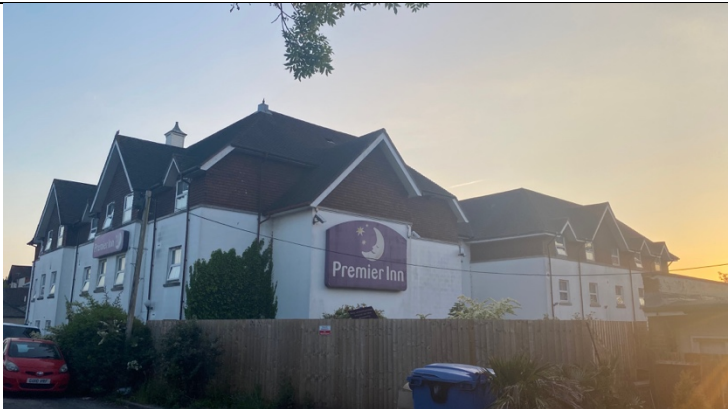
| <p><i>Surveyor 6</i></p> | <p><b>Emergences observed</b> – No</p> <p><b>Species</b> – Soprano pipistrelle.</p> <p><b>Flight paths</b> – N/A</p> <p><b>Foraging areas</b> – N/A</p> <p><b>Summary of general activity:</b><br/>A soprano pipistrelle was observed passing over the site at 21:56 it was flying from the northwest towards the southeast before foraging in the southeast.</p> | <p><i>Northeastern and eastern elevations of B1.</i></p> |

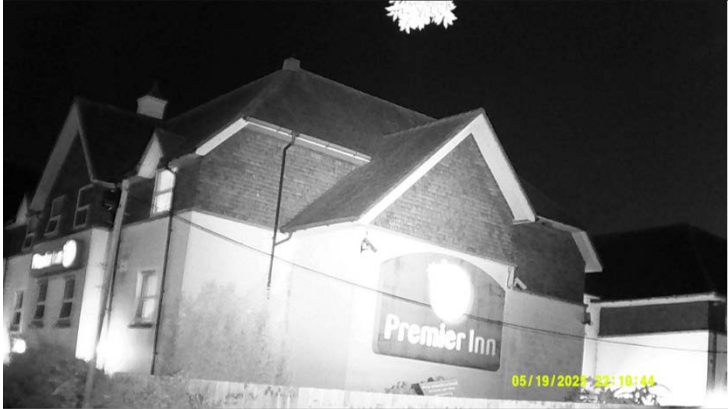
| <p><i>IR position 6</i><br/><i>Nightfox Whisker</i><br/><i>Nightfox XB5 PRO</i></p> | <p><b>Camera position:</b> observing northeastern and eastern elevation of B1.</p> <p><b>Emergences observed:</b> No</p> <p>Activity captured on the IR footage reflects the observations recorded by surveyor 6. No further activity was recorded.</p> | <p><i>Darkest point northeastern and eastern elevations of B1.</i></p> |

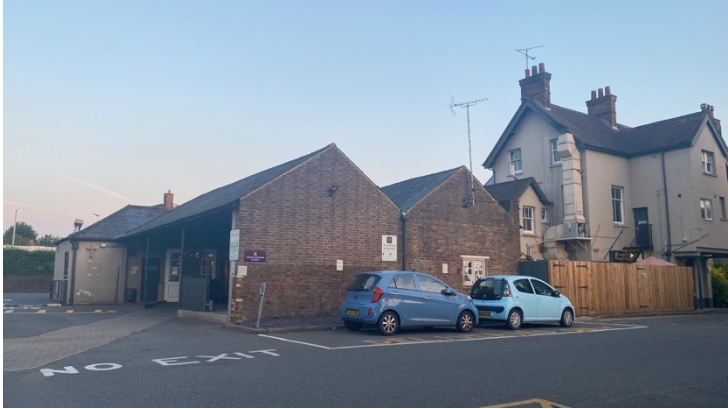
| Results | | | | | | |
|---|---|---|---|---|---|---|
| Surveyor 7 | | <b>Emergences observed</b> – No<br><br><b>Species</b> – Soprano pipistrelle and serotine.<br><b>Flight paths</b> – N/A<br><b>Foraging areas</b> – N/A<br><b>Summary of general activity:</b><br>A soprano pipistrelle was seen at 21:13 was from the east towards the west. A serotine seen foraging at 21:36 in a north easterly direction. | | | <p>Northeastern and northwestern elevations of B2</p> | |

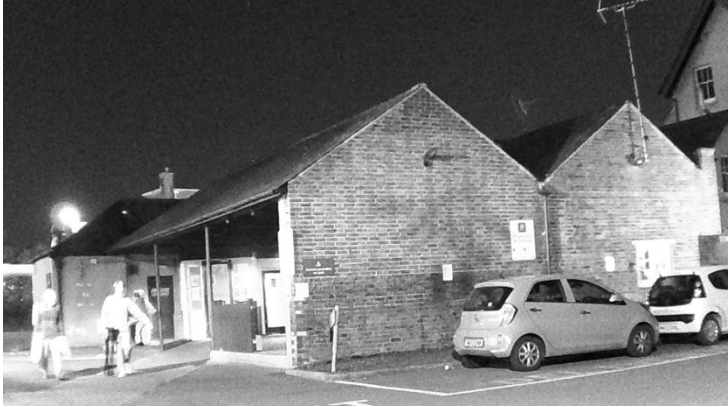
| <p><i>IR position 7</i><br/> <i>Nightfox Whisker</i><br/> <i>Nightfox XB5 PRO</i></p> | <p><b>Camera position:</b> observing northeastern and northwestern elevations of B2.</p> <p><b>Emergences observed:</b> No</p> <p>Activity captured on the IR footage reflects the observations recorded by surveyor 7. No further activity was recorded.</p> | <p><i>Darkest point northeastern and northwestern elevations of B2.</i></p> |

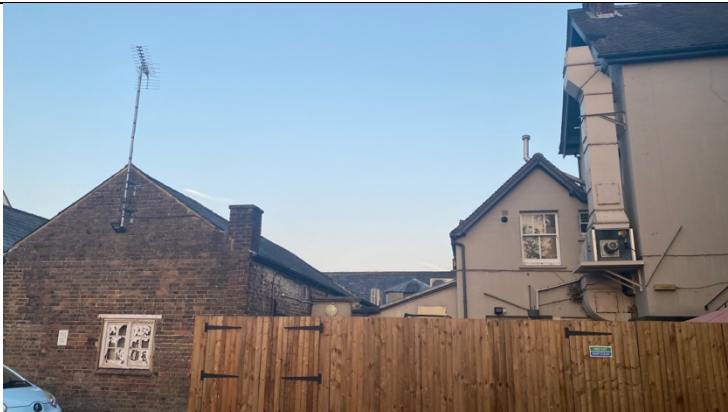
| <p><i>Surveyor 8</i></p> | <p><b>Emergences observed</b> – No</p> <p><b>Species</b> – Soprano pipistrelle and serotine.</p> <p><b>Flight paths</b> – N/A</p> <p><b>Foraging areas</b> – N/A</p> <p><b>Summary of general activity:</b><br/> A soprano pipistrelle was HNS foraging close to the site at 21:14. A Serotine was then HNS at 21:36.</p> | <p><i>Northwestern elevation of B2.</i></p> |

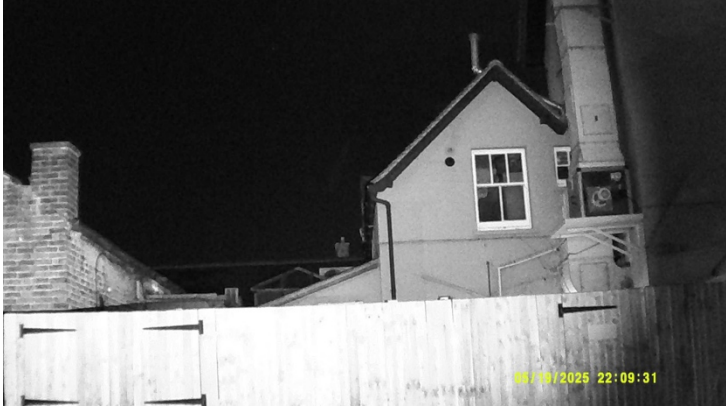
| <p><i>IR position 8</i><br/><i>Nightfox Whisker</i><br/><i>Nightfox XB5 PRO</i></p> | <p><b>Camera position:</b> observing northwestern elevation of B2.</p> <p><b>Emergences observed:</b> No</p> <p>Activity captured on the IR footage reflects the observations recorded by surveyor 8. No further activity was recorded.</p> | <p>06/10/2025 22:09:31</p> <p><i>Darkest point northwestern elevation of B2.</i></p> |

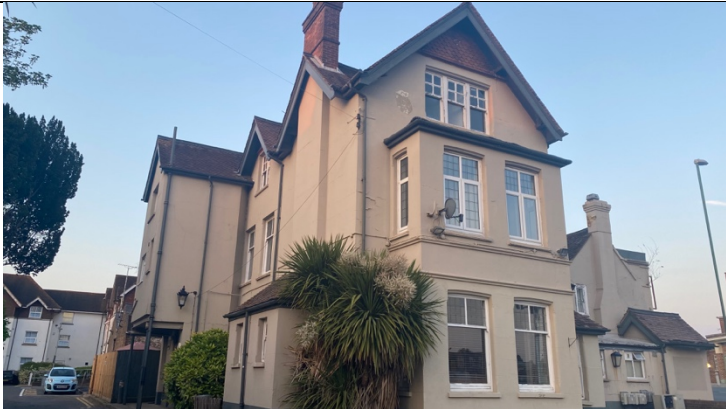
| <p><i>Surveyor 9</i></p> | <p><b>Emergences observed</b> – No</p> <p><b>Species</b> – N/A</p> <p><b>Flight paths</b> – N/A</p> <p><b>Foraging areas</b> – N/A</p> <p><b>Summary of general activity:</b><br/>No activity was recorded at this position.</p> | <p><i>Northwestern and southwestern elevations of B2.</i></p> |

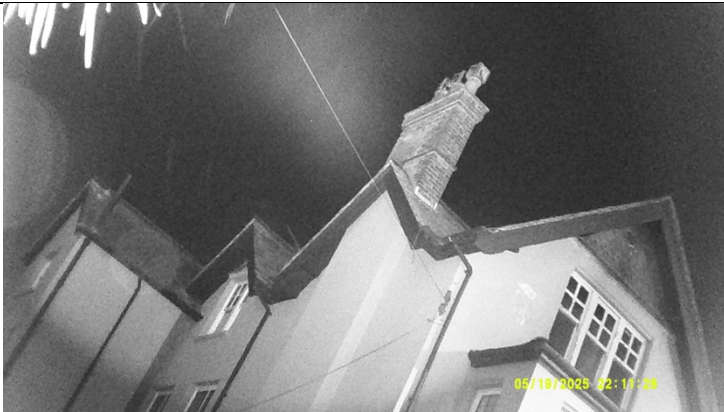
| <p><i>IR position 9</i><br/><i>Nightfox Whisker</i><br/><i>Nightfox XB5 PRO</i></p> | <p><b>Camera position:</b> observing northwestern and southwestern elevations of B2.</p> <p><b>Emergences observed:</b> No</p> <p>Activity captured on the IR footage reflects the observations recorded by surveyor 9. No further activity was recorded.</p> | <p><i>Darkest point northwestern and southwestern elevations of B2.</i></p> |

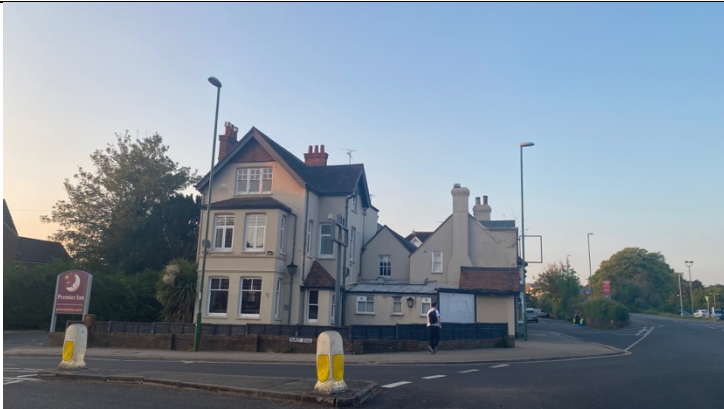
| <p><i>Surveyor 10</i></p> | <p><b>Emergences observed</b> – No</p> <p><b>Species</b> – N/A</p> <p><b>Flight paths</b> – N/A</p> <p><b>Foraging areas</b> – N/A</p> <p><b>Summary of general activity:</b><br/>No activity was recorded at this position.</p> | <p><i>Southwestern elevation of B2.</i></p> |

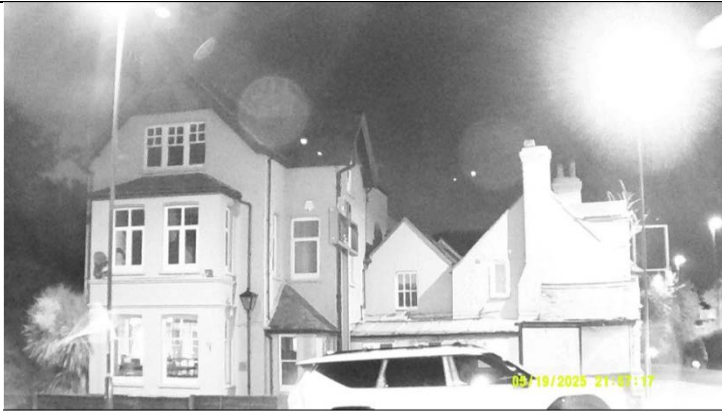
| <p><i>IR position 10</i><br/> <i>Nightfox Whisker</i><br/> <i>Nightfox XB5 PRO</i></p> | <p><b>Camera position:</b> observing southwestern elevation of B2.</p> <p><b>Emergences observed:</b> No</p> <p>Activity captured on the IR footage reflects the observations recorded by surveyor 10. No further activity was recorded.</p> | <p><i>Darkest point southwestern elevation of B2.</i></p> |

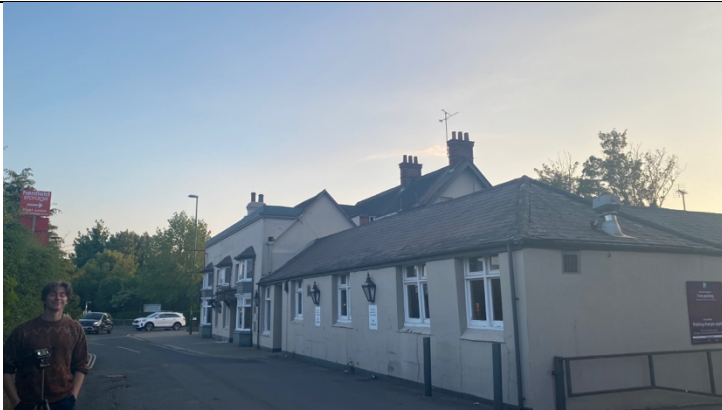
| <p><i>Surveyor 11</i></p> | <p><b>Emergences observed</b> – No</p> <p><b>Species</b> – Soprano pipistrelle, serotine.</p> <p><b>Flight paths</b> – N/A</p> <p><b>Foraging areas</b> – N/A</p> <p><b>Summary of general activity:</b><br/> The first bat detected was a HNS soprano pipistrelle at 21:14. At 21:36 a serotine was observed passing in a westerly direction between B1 and B2.</p> | <p><i>Southeastern and northeastern elevations of B2.</i></p> |

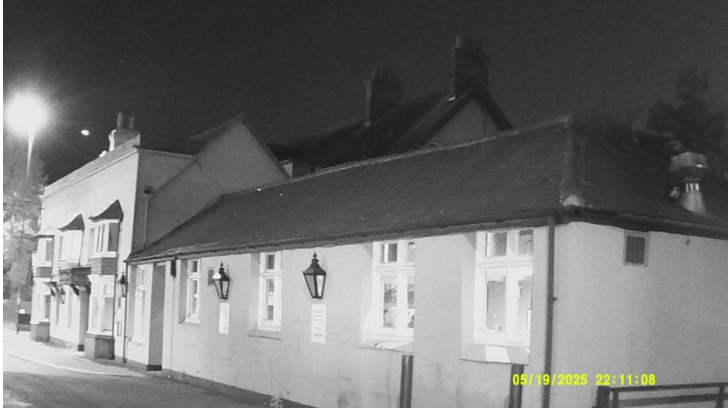
| <p><i>IR position 11</i><br/><i>Nightfox Whisker</i><br/><i>Nightfox XB5 PRO</i></p> | <p><b>Camera position:</b> observing southeastern and northeastern elevations of B2.</p> <p><b>Emergences observed:</b> No</p> <p>Activity captured on the IR footage reflects the observations recorded by surveyor 11. No further activity was recorded.</p> | <p><i>Darkest point southeastern and northeastern elevations of B2.</i></p> |

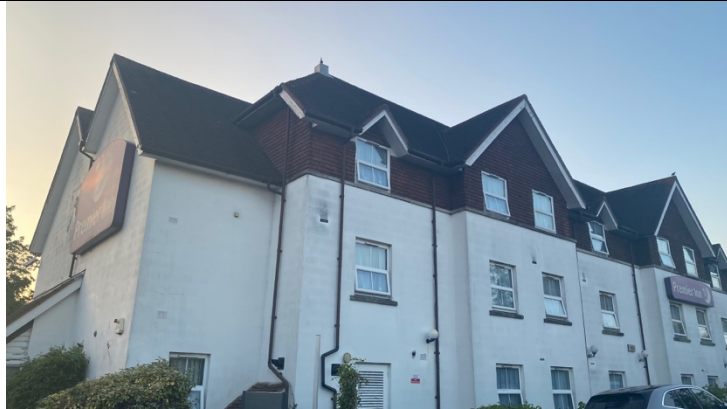
| Surveyor 1 | <b>Emergences observed</b> – No<br><br><b>Species</b> – N/A<br><b>Flight paths</b> – N/A<br><b>Foraging areas</b> – N/A<br><b>Summary of general activity:</b><br>No activity was recorded at this position. | | | | <p><i>Eastern and southern elevations of B1.</i></p> | |

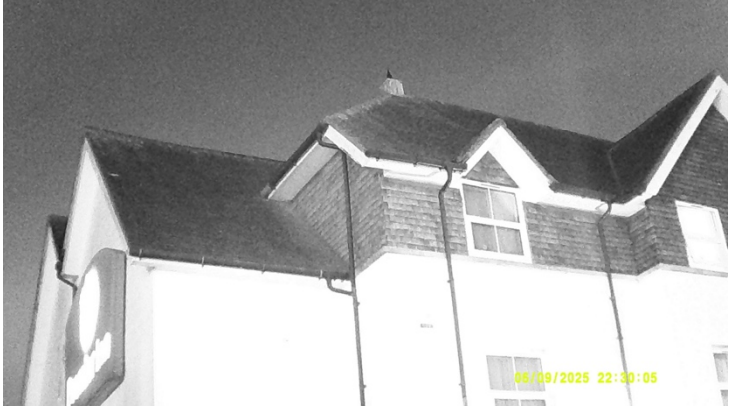
| <p><i>IR position 1</i><br/><i>Nightfox Whisker</i><br/><i>Nightfox XB5 PRO</i></p> | <p><b>Camera position:</b> observing eastern and southern elevations of B1.</p> <p><b>Emergences observed:</b> No</p> <p>Activity captured on the IR footage reflects the observations recorded by surveyor 1. No further activity was recorded.</p> | <p><i>Darkest point eastern and southern elevations of B1.</i></p> |

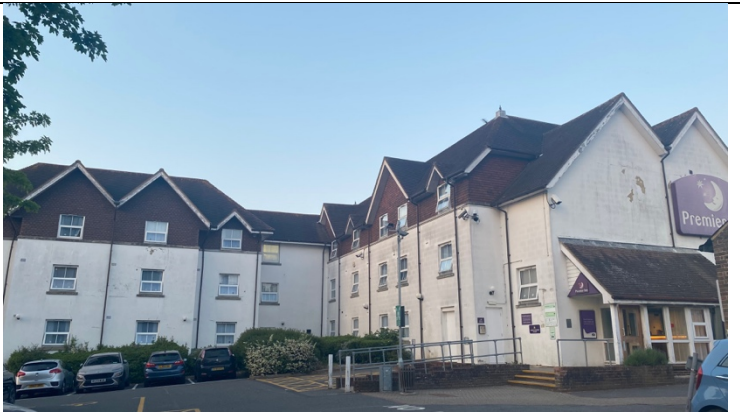
| <p><i>Surveyor 2</i></p> | <p><b>Emergences observed</b> – No</p> <p><b>Species</b> – N/A</p> <p><b>Flight paths</b> – N/A</p> <p><b>Foraging areas</b> – N/A</p> <p><b>Summary of general activity:</b><br/>No activity was recorded at this position.</p> | <p><i>Western elevation of B1.</i></p> |

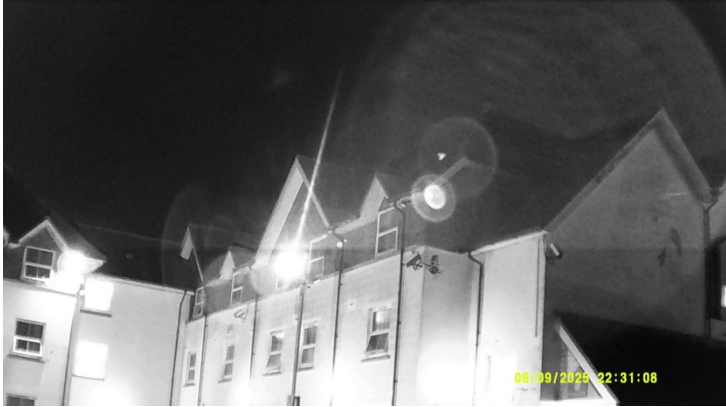
| <i>IR position 2</i> | <p><b>Camera position:</b> observing western elevation of B1.</p> <p><b>Emergences observed:</b> No</p> <p>Activity captured on the IR footage reflects the observations recorded by surveyor 2. No further activity was recorded.</p> | <p><i>Darkest point western elevation of B1.</i></p> |

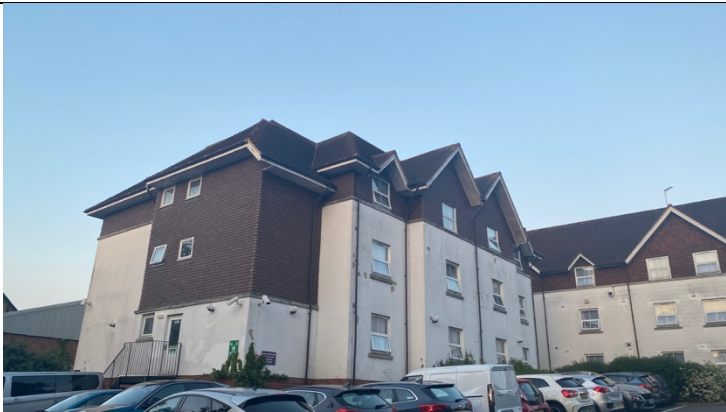
| <i>Surveyor 3</i> | <p><b>Emergences observed</b> – No</p> <p><b>Species</b> – N/A</p> <p><b>Flight paths</b> – N/A</p> <p><b>Foraging areas</b> – N/A</p> <p><b>Summary of general activity:</b><br/>No activity was recorded at this position.</p> | <p><i>Western elevation of B1.</i></p> |

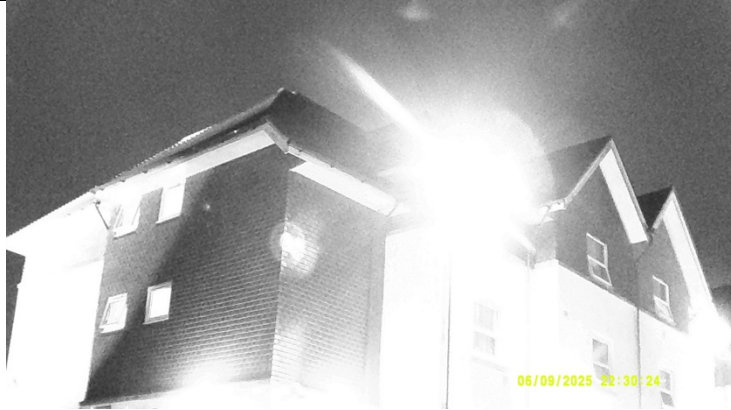
| <p><i>IR position 3</i><br/><i>Nightfox Whisker</i><br/><i>Nightfox XB5 PRO</i></p> | <p><b>Camera position:</b> observing western elevation of B1.</p> <p><b>Emergences observed:</b> No</p> <p>Activity captured on the IR footage reflects the observations recorded by surveyor 3. No further activity was recorded.</p> | <p><i>Darkest point western elevation of B1.</i></p> |

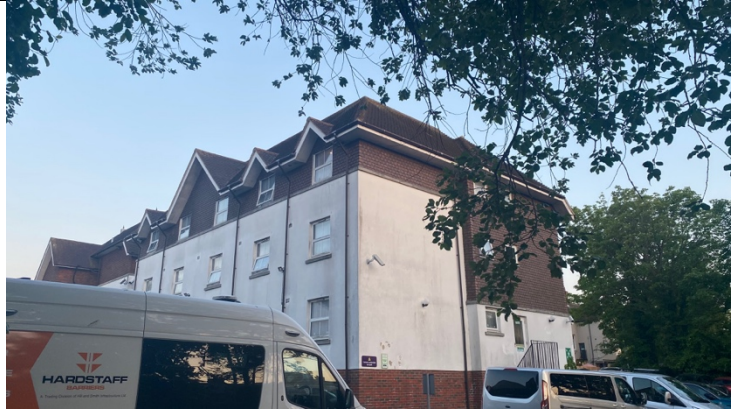
| <p><i>Surveyor 4</i></p> | <p><b>Emergences observed</b> – No</p> <p><b>Species</b> – N/A</p> <p><b>Flight paths</b> – N/A</p> <p><b>Foraging areas</b> – N/A</p> <p><b>Summary of general activity:</b><br/>No activity was recorded at this position.</p> | <p><i>Northwestern elevation of B1.</i></p> |

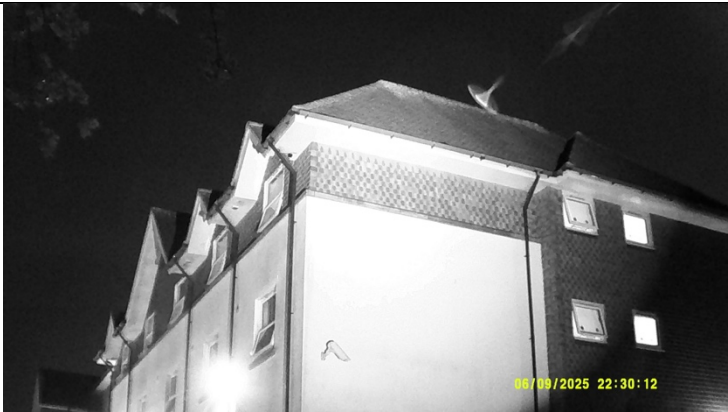
| <p><i>IR position 4</i><br/><i>Nightfox Whisker</i><br/><i>Nightfox XB5 PRO</i></p> | <p><b>Camera position:</b> observing northwestern elevation of B1.</p> <p><b>Emergences observed:</b> No</p> <p>Activity captured on the IR footage reflects the observations recorded by surveyor 4. No further activity was recorded.</p> | <p><i>Darkest point northwestern elevation of B1</i></p> |

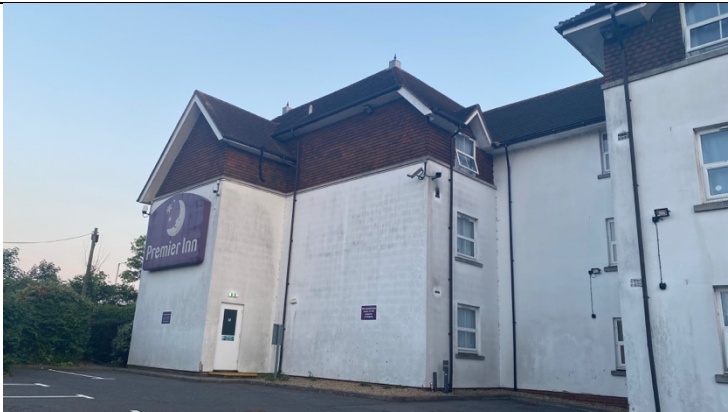
| <p><i>Surveyor 5</i></p> | <p><b>Emergences observed</b> – No</p> <p><b>Species</b> – N/A</p> <p><b>Flight paths</b> – N/A</p> <p><b>Foraging areas</b> – N/A</p> <p><b>Summary of general activity:</b><br/>No activity was recorded at this position.</p> | <p><i>Northeastern elevation of B1.</i></p> |

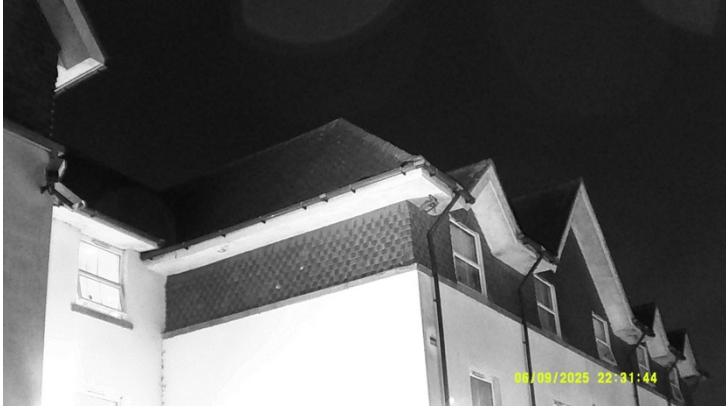
| <p><i>IR position 5</i><br/><i>Nightfox Whisker</i><br/><i>Nightfox XB5 PRO</i></p> | <p><b>Camera position:</b> observing northeastern elevation of B1.</p> <p><b>Emergences observed:</b> No</p> <p>Activity captured on the IR footage reflects the observations recorded by surveyor 5. No further activity was recorded.</p> | <p><i>Darkest point northeastern elevation of B1.</i></p> |

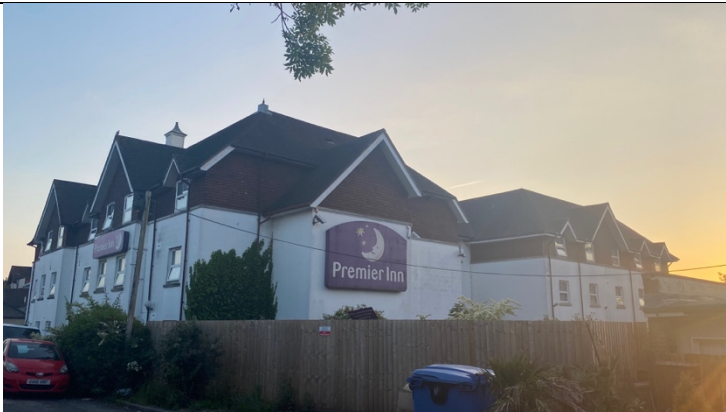
| <p><i>Surveyor 6</i></p> | <p><b>Emergences observed</b> – No</p> <p><b>Species</b> – N/A</p> <p><b>Flight paths</b> – N/A</p> <p><b>Foraging areas</b> – N/A</p> <p><b>Summary of general activity:</b><br/>No activity was recorded at this position.</p> | <p><i>Northeastern and eastern elevations of B1.</i></p> |

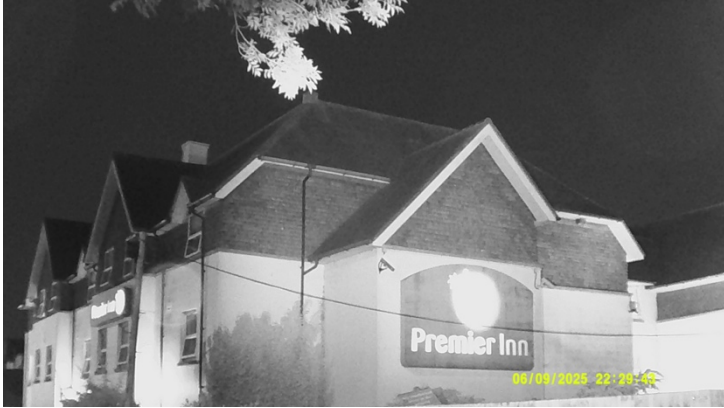
| <p><i>IR position 6</i><br/><i>Nightfox Whisker</i><br/><i>Nightfox XB5 PRO</i></p> | <p><b>Camera position:</b> observing northeastern and eastern elevations of B1.</p> <p><b>Emergences observed:</b> No</p> <p>Activity captured on the IR footage reflects the observations recorded by surveyor 6. No further activity was recorded.</p> | <p><i>Darkest point northeastern and eastern elevations of B1.</i></p> |

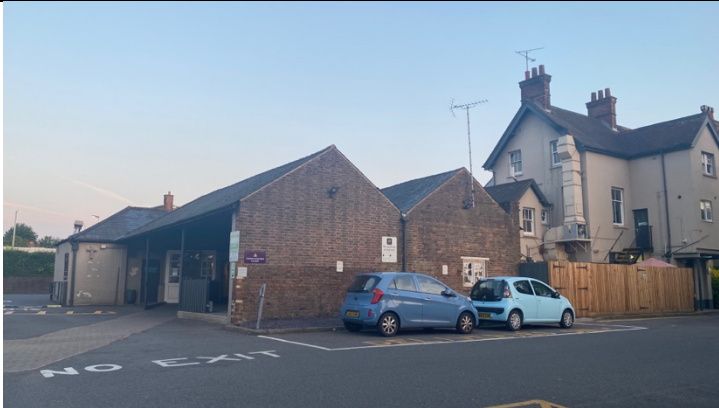
| Roost reference | Species and numbers | Roost type | Structure reference | Roost location | Access point | Dimensions (for lofts/ internal voids) |
|---|---|---|---|---|---|---|
| Surveyor 7 | | <b>Emergences observed</b> – No<br><br><b>Species</b> – N/A<br><b>Flight paths</b> – N/A<br><b>Foraging areas</b> – N/A<br><b>Summary of general activity:</b><br>No activity was recorded at this position. | | | <p>Northeastern and northwestern elevations of B2.</p> | |

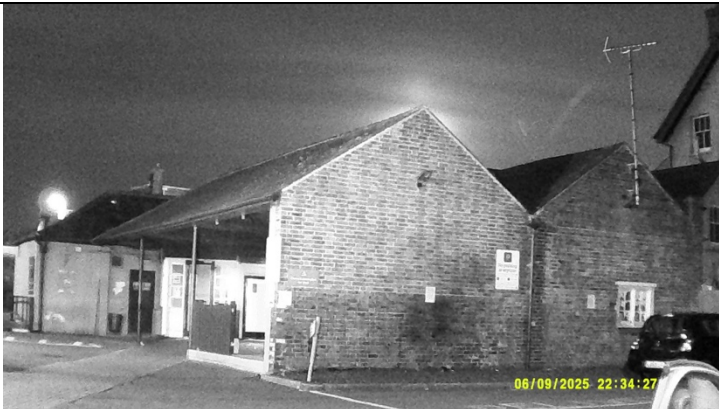
| Roost reference | Species and numbers | Roost type | Structure reference | Roost location | Access point | Dimensions (for lofts/ internal voids) |
|---|---|---|---|---|---|---|
| IR position 7<br>Nightfox Whisker<br>Nightfox XB5 PRO | | <b>Camera position:</b> observing northeastern and northwestern elevations of B2.<br><b>Emergences observed:</b> No<br><br>Activity captured on the IR footage reflects the observations recorded by surveyor 7. No further activity was recorded. | | | <p>Darkest point northeastern and northwestern elevations of B2.</p> | |

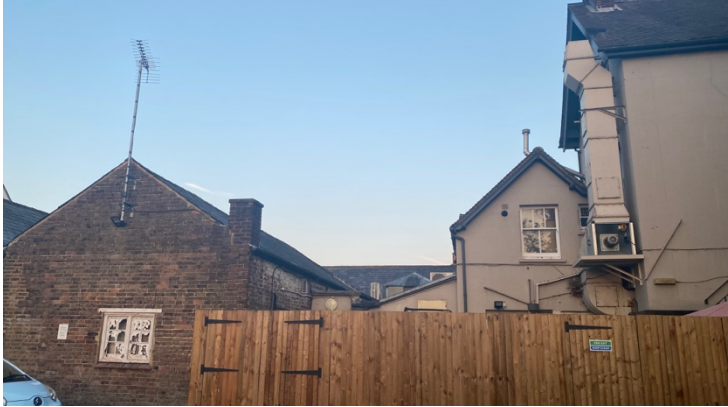
| <p><i>Surveyor 8</i></p> | <p><b>Emergences observed</b> – No</p> <p><b>Species</b> – N/A</p> <p><b>Flight paths</b> – N/A</p> <p><b>Foraging areas</b> – N/A</p> <p><b>Summary of general activity:</b><br/>No activity was recorded at this position.</p> | <p><i>Northwestern elevation of B2.</i></p> |

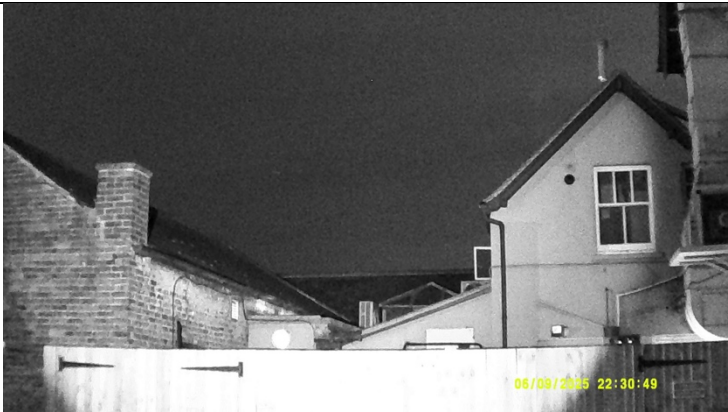
| <p><i>IR position 8</i><br/><i>Nightfox Whisker</i><br/><i>Nightfox XB5 PRO</i></p> | <p><b>Camera position:</b> observing northwestern elevation of B2.</p> <p><b>Emergences observed:</b> No</p> <p>Activity captured on the IR footage reflects the observations recorded by surveyor 8. No further activity was recorded.</p> | <p><i>Darkest point northwestern elevation of B2.</i></p> |

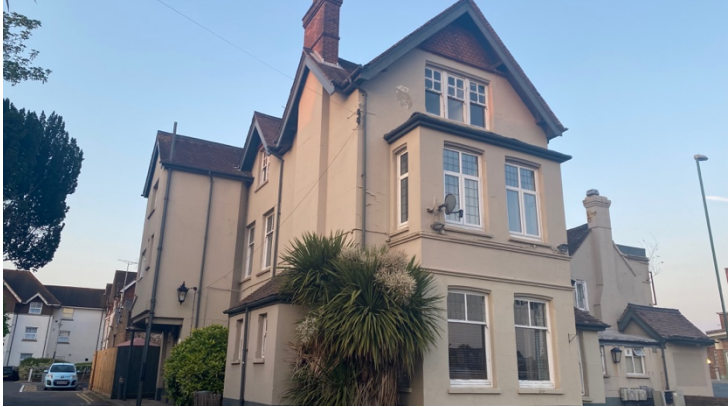
| <i>Surveyor 9</i> | <b>Emergences observed</b> – No<br><br><b>Species</b> – N/A<br><b>Flight paths</b> – N/A<br><b>Foraging areas</b> – N/A<br><b>Summary of general activity:</b><br>No activity was recorded at this position. | <p><i>Northwestern and southwestern elevations of B2.</i></p> |

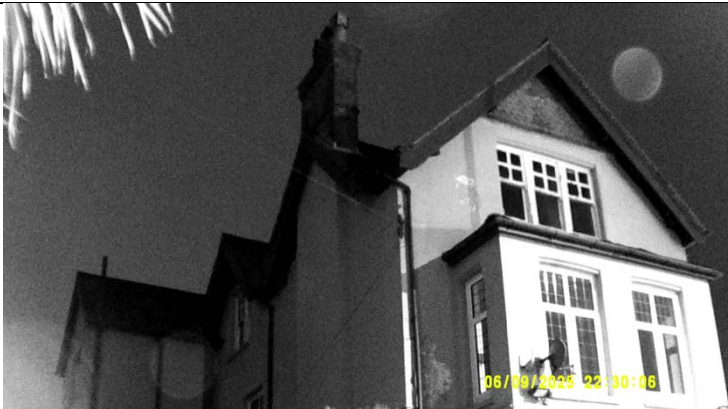
| <i>IR position 9</i><br><i>Nightfox Whisker</i><br><i>Nightfox XB5 PRO</i> | <b>Camera position:</b> observing northwestern and southwestern elevations of B2.<br><b>Emergences observed:</b> No<br><br>Activity captured on the IR footage reflects the observations recorded by surveyor 9. No further activity was recorded. | <p><i>Darkest point northwestern and southwestern elevations of B2.</i></p> |

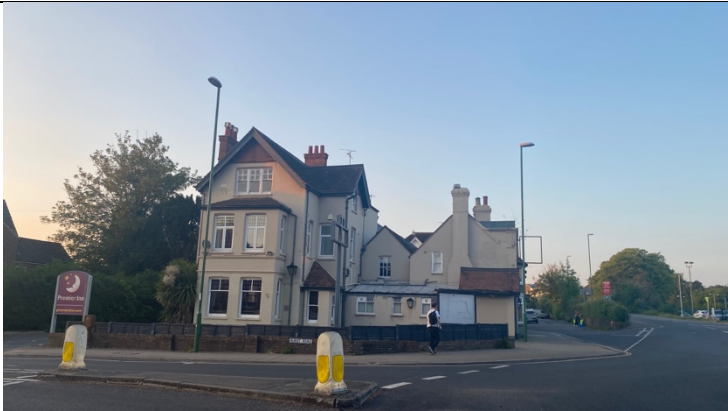
| <p><i>Surveyor 10</i></p> | <p><b>Emergences observed</b> – No</p> <p><b>Species</b> – N/A</p> <p><b>Flight paths</b> – N/A</p> <p><b>Foraging areas</b> – N/A</p> <p><b>Summary of general activity:</b><br/>No activity was recorded at this position.</p> | <p><i>Southwestern elevation of B2.</i></p> |

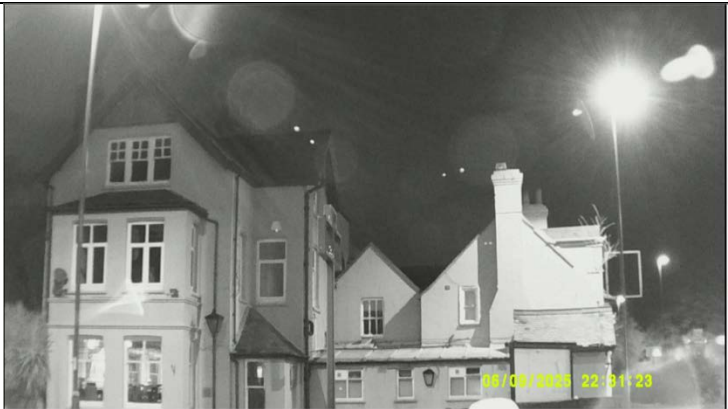
| <p><i>IR position 10</i><br/><i>Nightfox Whisker</i><br/><i>Nightfox XB5 PRO</i></p> | <p><b>Camera position:</b> observing southwestern elevation of B2.</p> <p><b>Emergences observed:</b> No</p> <p>Activity captured on the IR footage reflects the observations recorded by surveyor 10. No further activity was recorded.</p> | <p><i>Darkest point southwestern elevation of B2.</i></p> |

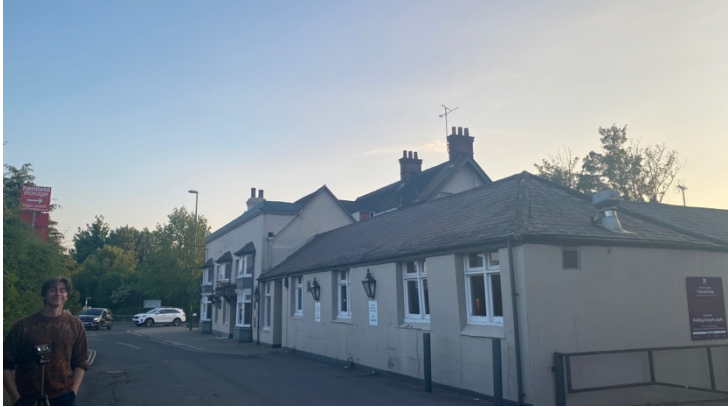
| <p><i>Surveyor 11</i></p> | <p><b>Emergences observed</b> – No</p> <p><b>Species</b> – N/A</p> <p><b>Flight paths</b> – N/A</p> <p><b>Foraging areas</b> – N/A</p> <p><b>Summary of general activity:</b><br/>No activity was recorded at this position.</p> | <p><i>Southeastern and northeastern elevations of B2.</i></p> |

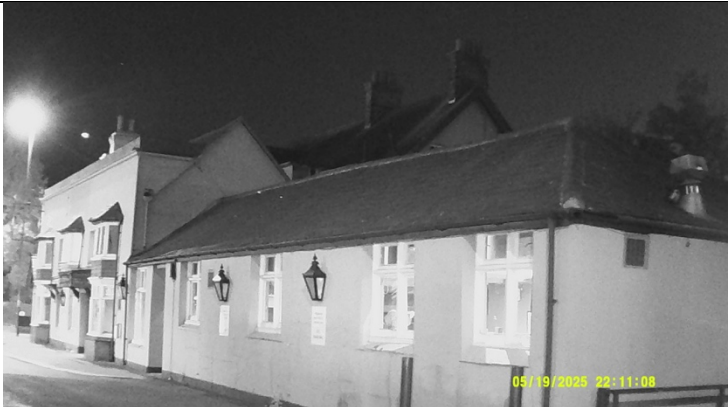
| <p><i>IR position 11</i><br/><i>Nightfox Whisker</i><br/><i>Nightfox XB5 PRO</i></p> | <p><b>Camera position:</b> observing southeastern and northeastern elevations of B2.</p> <p><b>Emergences observed:</b> No</p> <p>Activity captured on the IR footage reflects the observations recorded by surveyor 11. No further activity was recorded.</p> | <p><i>Darkest point southeastern and northeastern elevations of B2.</i></p> |

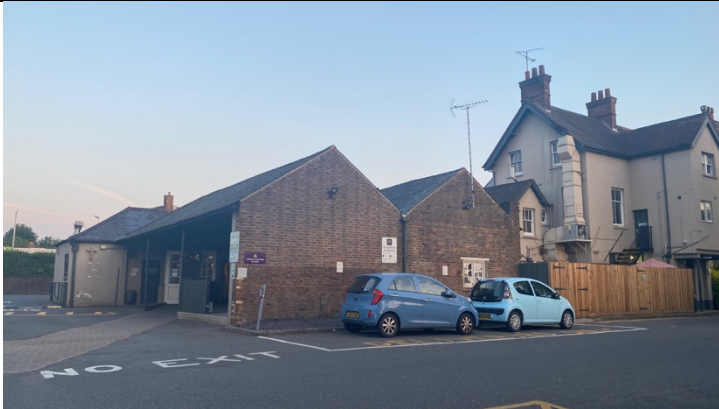
| Results | | | | | | |
|---|---|---|---|---|---|---|
| Surveyor 7 | | <b>Emergences observed</b> – No<br><br><b>Species</b> – Noctule<br><b>Flight paths</b> – N/A<br><b>Foraging areas</b> – N/A<br><b>Summary of general activity:</b><br>A single distant noctule pass was HNS at 21.57 and no other activity was recorded at this position. | | | <p>Northeastern and northwestern elevations of B2.</p> | |

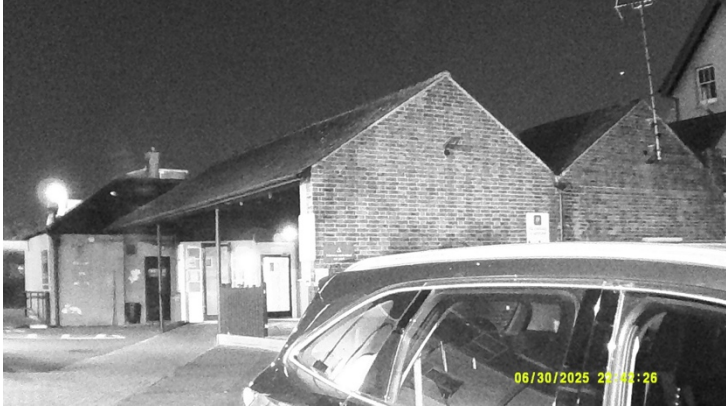
| <p><i>IR position 7</i><br/><i>Nightfox Whisker</i><br/><i>Nightfox XB5 PRO</i></p> | <p><b>Camera position:</b> observing northeastern and northwestern elevations of B2.</p> <p><b>Emergences observed:</b> No</p> <p>Activity captured on the IR footage reflects the observations recorded by surveyor 7. No further activity was recorded.</p> | <p><i>Darkest point northeastern and northwestern elevations of B2.</i></p> |

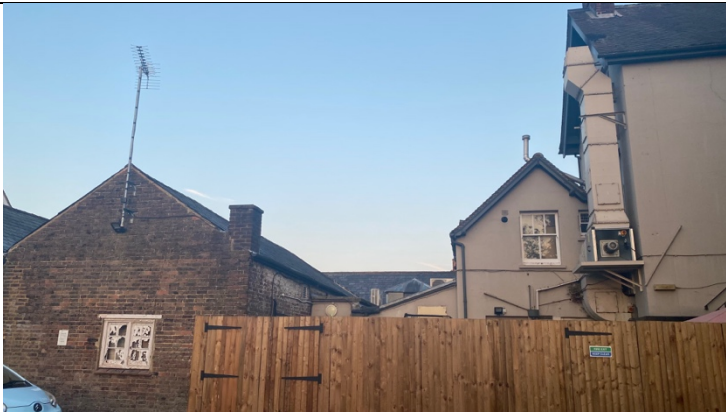
| <p><i>Surveyor 8</i></p> | <p><b>Emergences observed</b> – No</p> <p><b>Species</b> – Noctule</p> <p><b>Flight paths</b> – N/A</p> <p><b>Foraging areas</b> – N/A</p> <p><b>Summary of general activity:</b><br/>A single distant noctule pass was HNS at 21.56 and no other activity was recorded at this position.</p> | <p><i>Northwestern elevation of B2.</i></p> |

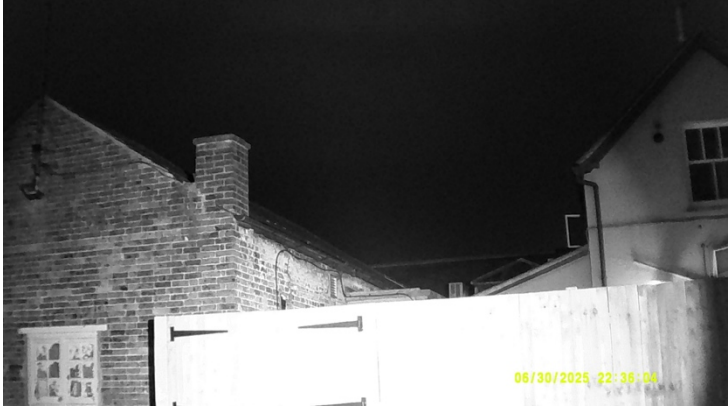
| <p><i>IR position 8</i><br/><i>Nightfox Whisker</i><br/><i>Nightfox XB5 PRO</i></p> | <p><b>Camera position:</b> observing northwestern elevation of B2.</p> <p><b>Emergences observed:</b> No</p> <p>Activity captured on the IR footage reflects the observations recorded by surveyor 8. No further activity was recorded.</p> | <p>06/30/2025 22:35:08</p> <p><i>Darkest point northwestern elevation of B2.</i></p> |

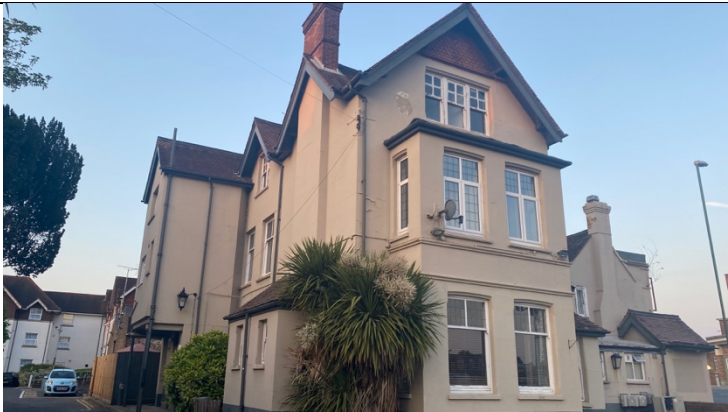
| <p><i>Surveyor 9</i></p> | <p><b>Emergences observed</b> – No</p> <p><b>Species</b> – Noctule</p> <p><b>Flight paths</b> – N/A</p> <p><b>Foraging areas</b> – N/A</p> <p><b>Summary of general activity:</b></p> <p>A single distant noctule pass was HNS at 21.59 and no other activity was recorded at this position.</p> | <p><i>Northwestern and southwestern elevations of B2.</i></p> |

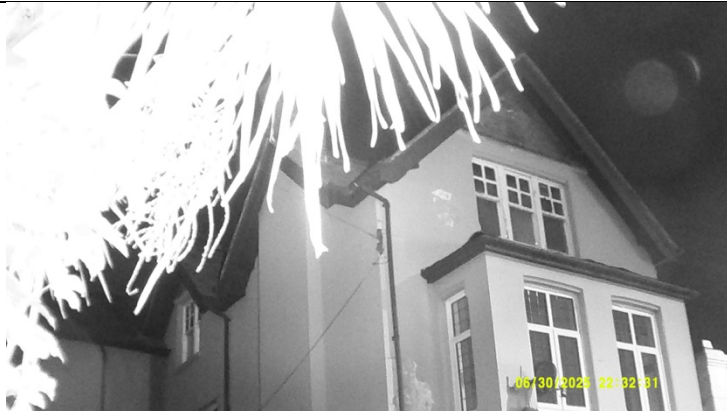
| <p><i>IR position 9</i><br/><i>Nightfox Whisker</i><br/><i>Nightfox XB5 PRO</i></p> | <p><b>Camera position:</b> observing northwestern and southwestern elevations of B2.</p> <p><b>Emergences observed:</b> No</p> <p>Activity captured on the IR footage reflects the observations recorded by surveyor 9. No further activity was recorded.</p> | <p><i>Darkest point northwestern and southwestern elevations of B2.</i></p> |

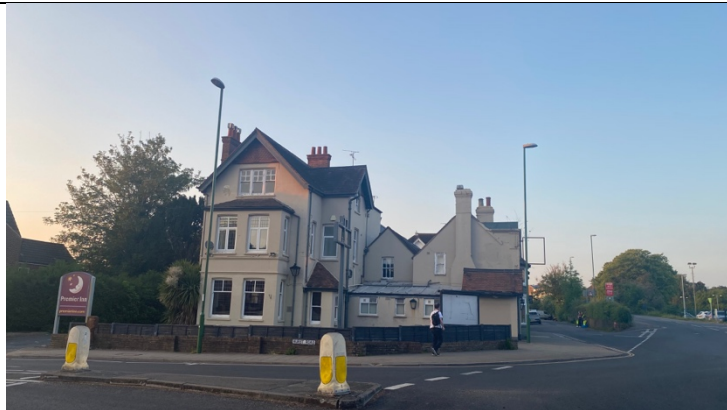
| <p><i>Surveyor 10</i></p> | <p><b>Emergences observed</b> – No</p> <p><b>Species</b> – Noctule</p> <p><b>Flight paths</b> – N/A</p> <p><b>Foraging areas</b> – N/A</p> <p><b>Summary of general activity:</b><br/>A single distant noctule pass was HNS at 21.59 and no other activity was recorded at this position.</p> | <p><i>Southwestern elevation of B2.</i></p> |

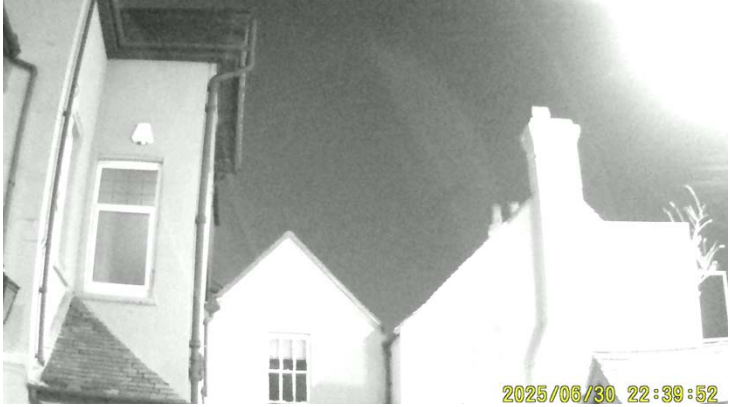
| <p><i>IR position 10</i><br/><i>Nightfox Whisker</i><br/><i>Nightfox XB5 PRO</i></p> | <p><b>Camera position:</b> observing southwestern elevation of B2.</p> <p><b>Emergences observed:</b> No</p> <p>Activity captured on the IR footage reflects the observations recorded by surveyor 10. No further activity was recorded.</p> | <p>2025/08/30 22:39:52</p> <p><i>Darkest point southwestern elevation of B2.</i></p> |

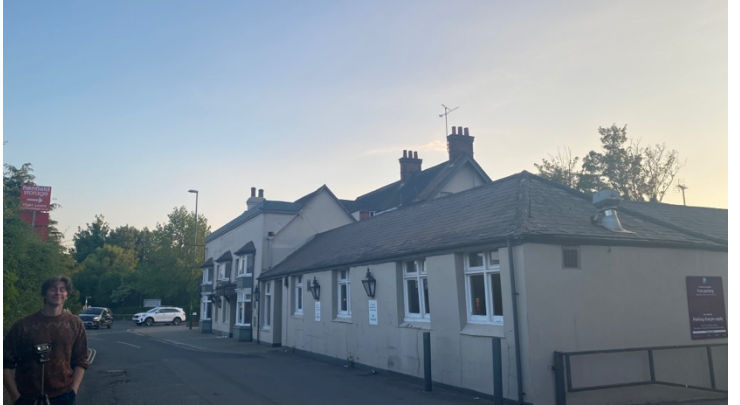
| <p><i>Surveyor 11</i></p> | <p><b>Emergences observed</b> – No</p> <p><b>Species</b> – Noctule</p> <p><b>Flight paths</b> – N/A</p> <p><b>Foraging areas</b> – N/A</p> <p><b>Summary of general activity:</b></p> <p>A single distant noctule pass was HNS at 21.58 and no other activity was recorded at this position.</p> | <p><i>Southeastern and northeastern elevations of B2.</i></p> |

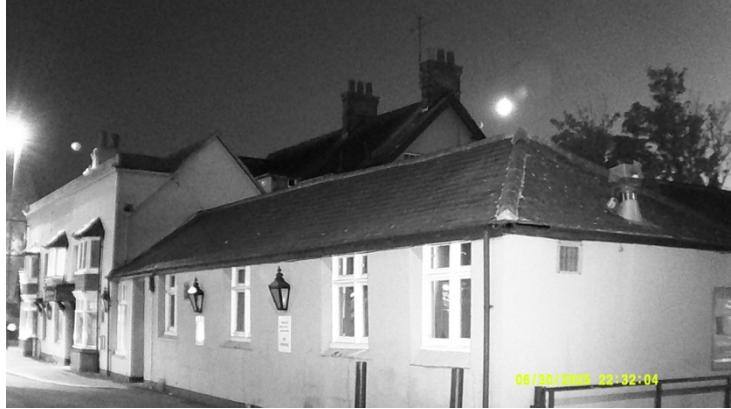
| <p><i>IR position 11</i><br/><i>Nightfox Whisker</i><br/><i>Nightfox XB5 PRO</i></p> | <p><b>Camera position:</b> observing southeastern and northeastern elevations of B2.</p> <p><b>Emergences observed:</b> No</p> <p>Activity captured on the IR footage reflects the observations recorded by surveyor 11. No further activity was recorded.</p> | <p><i>Darkest point southeastern and northeastern elevations of B2.</i></p> |
