## Bat Emergence and Re-Entry Surveys (BERS)

Premier inn Horsham North (Horsham Station) hotel, 57 North Street, Horsham RH12 1RB

**Client:** Premier Inn Hotels / Whitbread Group PLC

This report has been prepared to support a planning application for the demolition of one structure (B2), the construction of an additional hotel building, and the refurbishment of one existing building (B1).

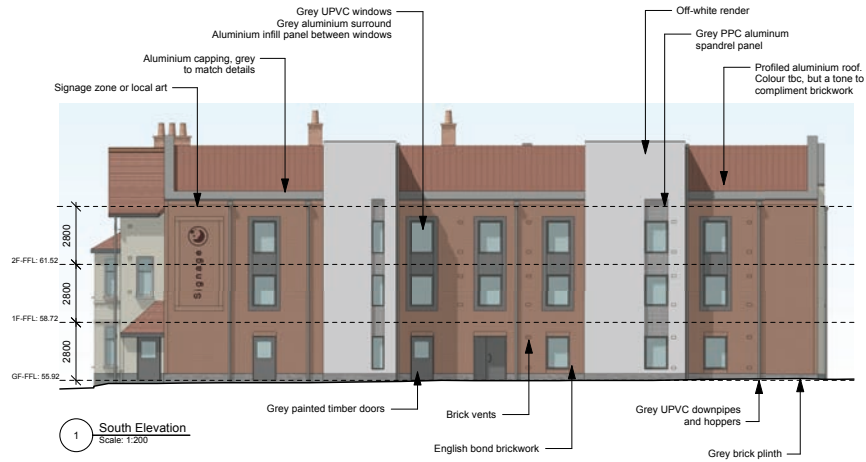
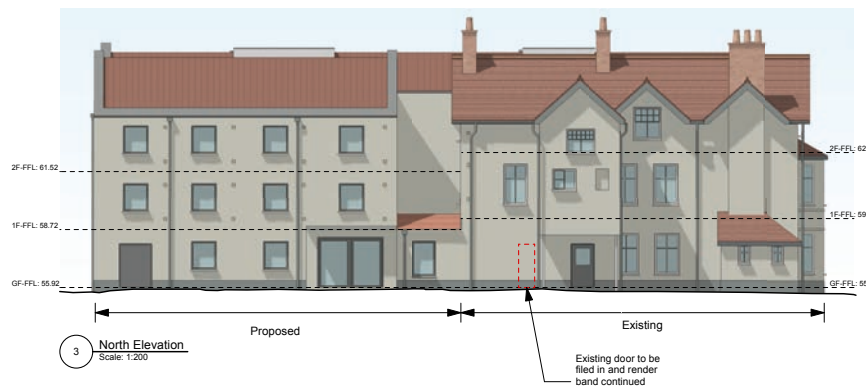
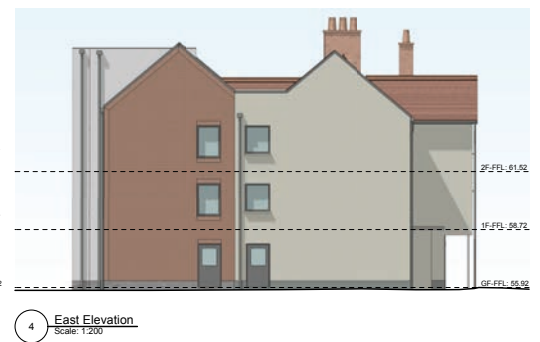
- Proposed Materials:**
- Walls:**
- Render: Heritage (north)
  - Off-white (south)
- Brick: Red in english bond pattern
- Decoration: PPC aluminium, grey
- Windows and doors:**
- Frame: White UPVC
  - Clit: White UPVC
- Doors: Grey painted Timber
- Roof:**
- Pitched: Aluminium with standing seam profiles, colour to closely match brickwork
- Parapet: PPC Aluminium coping
- Rainwater goods:**
- Gutter: Grey UPVC
  - Downpipes: Grey UPVC
- Timber compound:**
- Walls: Hit-and-miss timber battens
