## Ecology Addendum

### The Fox Inn, Bucks Green

| Document No.: | NPA 30205 0401 |

**Project:** The Fox Inn, Bucks Green

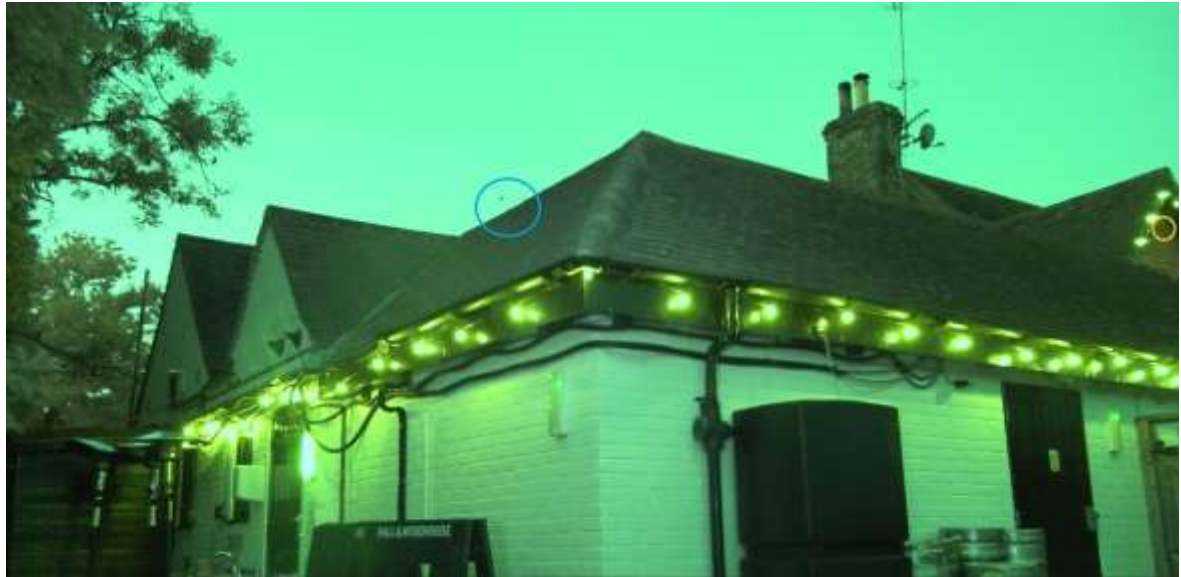
- 4.4 No bats were recorded emerging from or re-entering the extension during the first survey. A single Common Pipistrelle bat was recorded emerging from a ridge tile on the second survey (see blue highlight in Image 1 below). This triggered a third survey where a single Common Pipistrelle bat was incidentally recorded emerging from a gable end of the main pub building (see orange highlight in Image 2 below). No other bats were recorded roosting.
- 4.5 Low levels of bat activity were observed in the vicinity of the Site; mainly by pipistrelle bats *Pipistrellus sp.* with rare passes of Noctule *Nyctalus noctule* also recorded.

- 5.1 The bat surveys recorded a single Pipistrelle emerge from the extension where the works are proposed. In the absence of mitigation the proposals could disturb, injury or kill roosting bats. As such a Natural England bat mitigation licence will be obtained prior to works commencing. This will set out in detail the working measures to avoid the risk of killing or injuring (which will include roofing works being

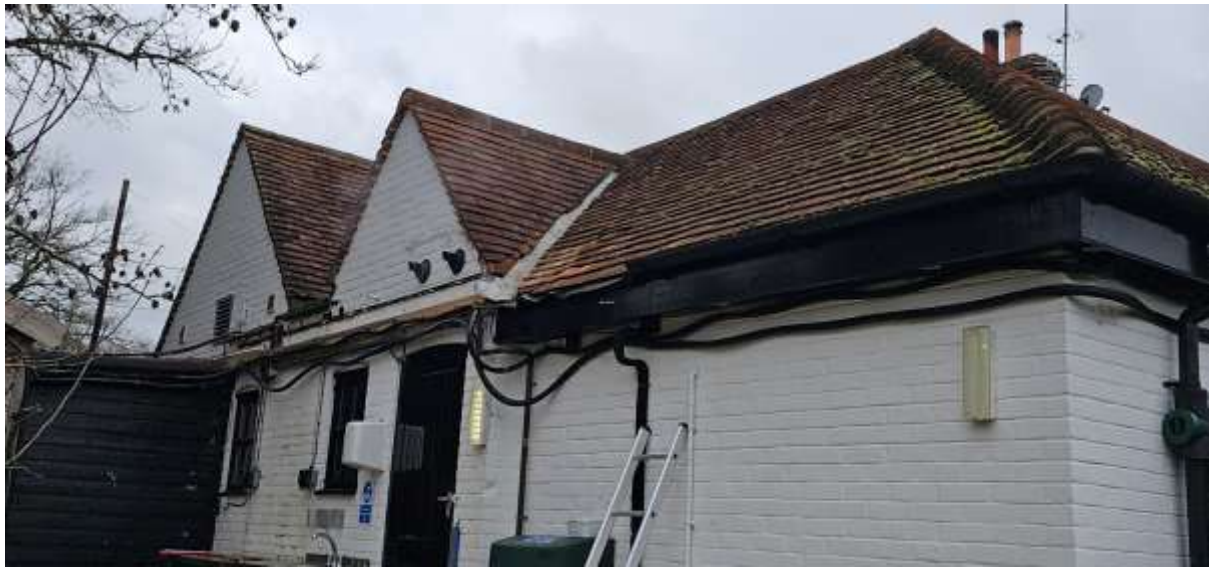
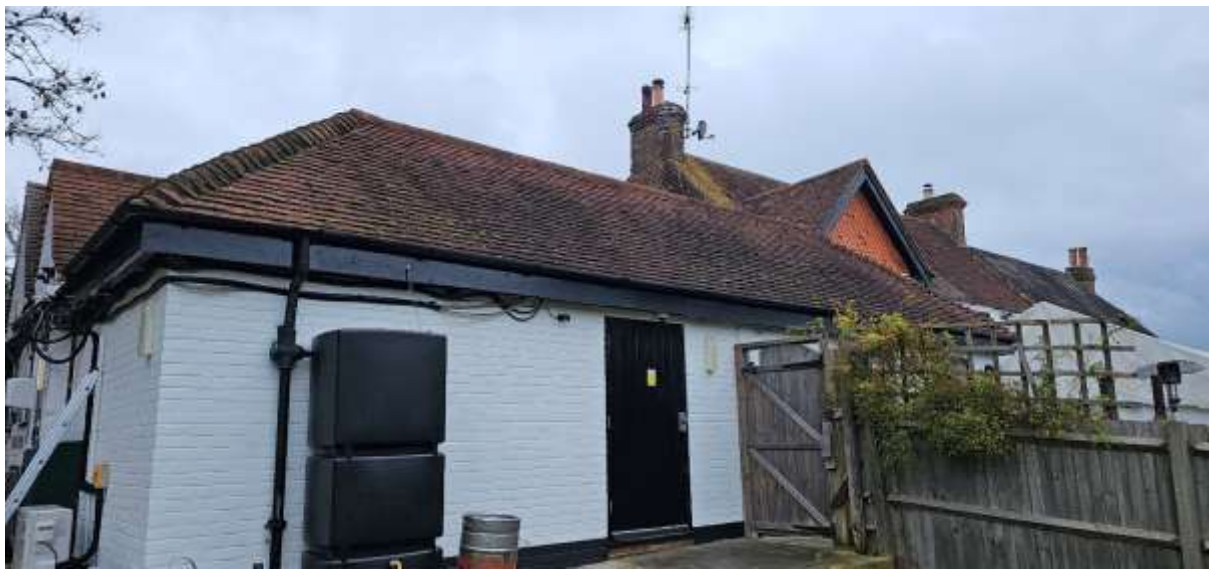
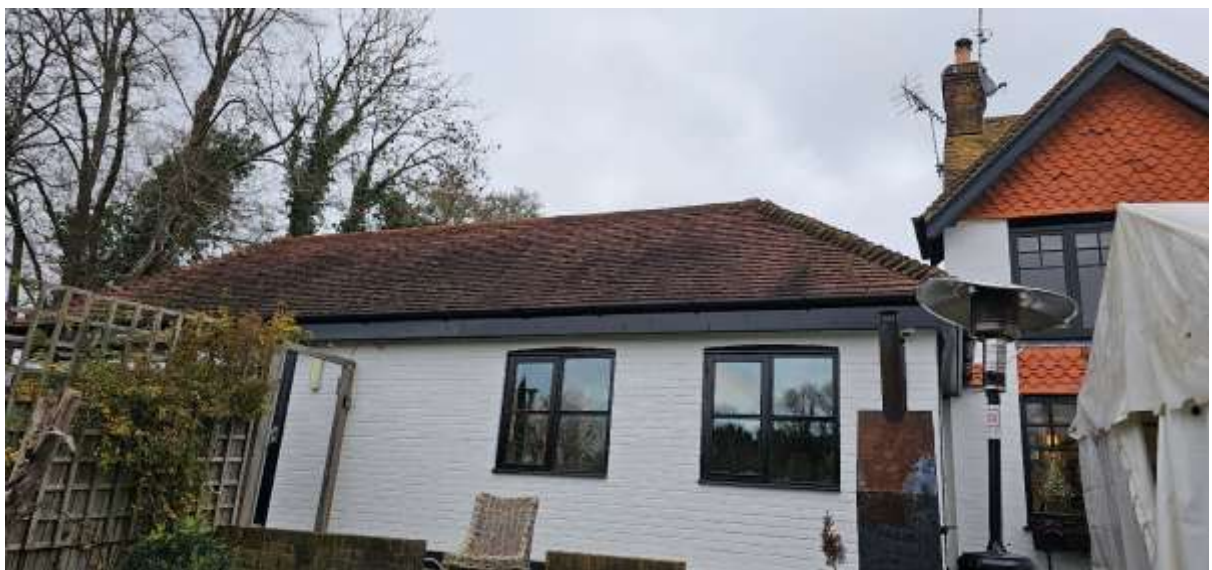
The roof of the extension is multi-pitched with two gable ends and a hipped roof section. The survey included just the hipped roof section which is the area of roof which will be affected by the planned works. It is a brick extension with cavity walls.

There are clay ridge tiles, and the roof has clay plain tiles with ladies' bonnets running along the hips.

There are wooden fascias and soffits.

There is a single plastic downpipe with water storage containers adjacent to it.

There are multiple service pipes / insulated electricity cables

The walls are painted brick (and probably block), cavity wall construction.

Windows and doors are wooden framed.

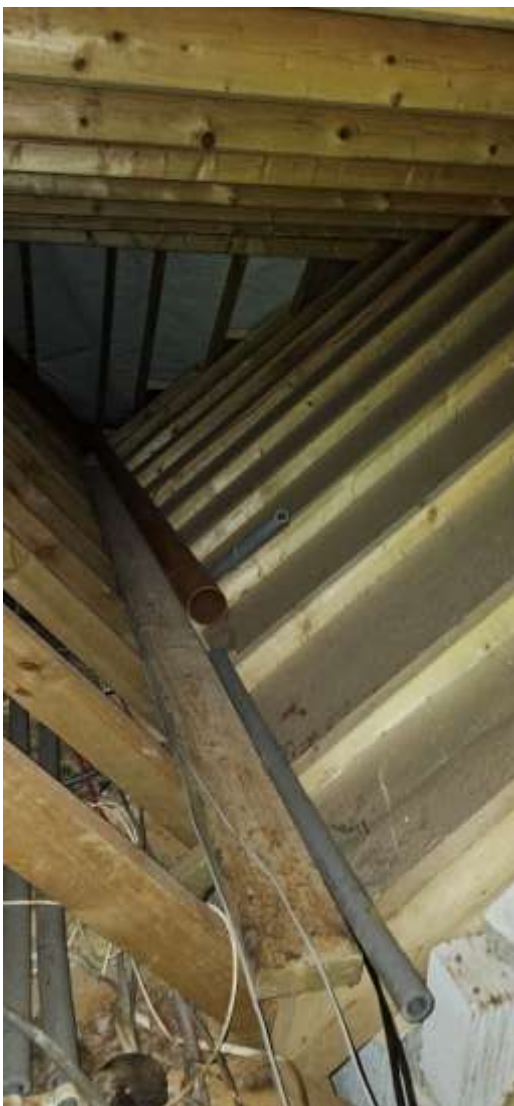
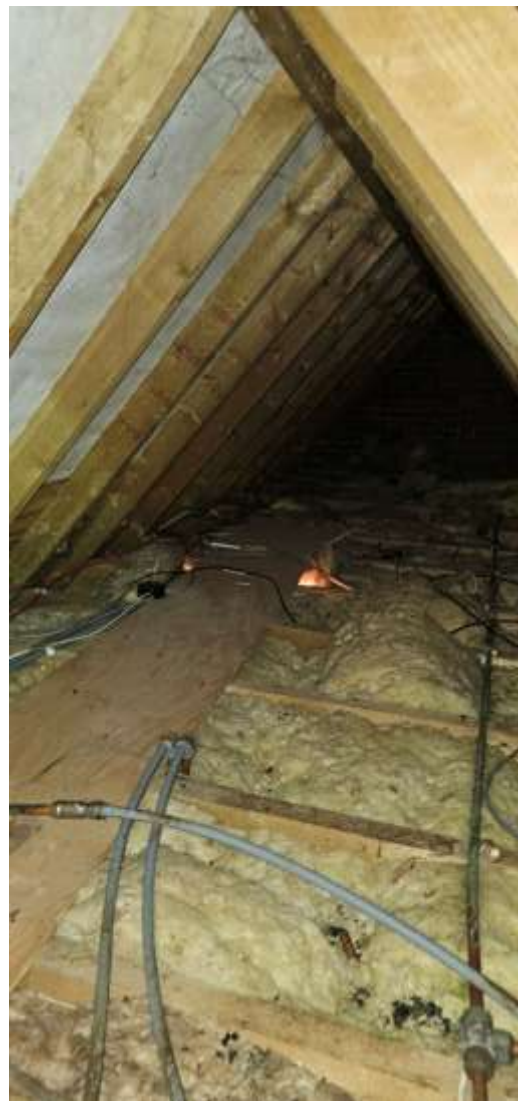
Adjacent A-framed rafters with horizontal roof struts (left), insulation, crawl boards, service pipes & cables. On the right side of the pic to the left is the 'celotex' type insulation above the vaulted bar areas vaulted roof. The picture on the right shows breathable membrane

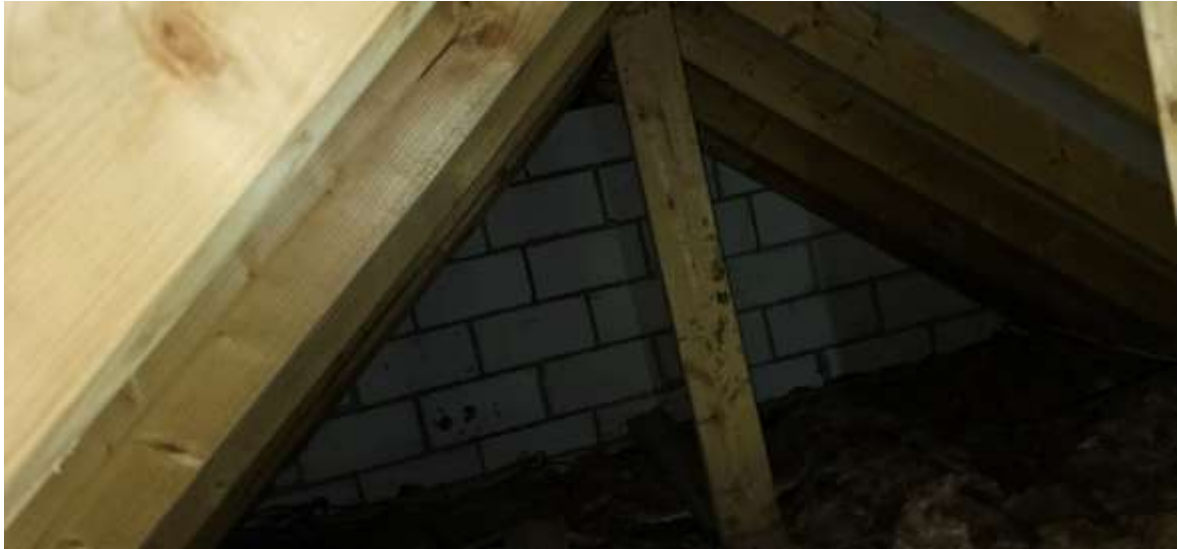
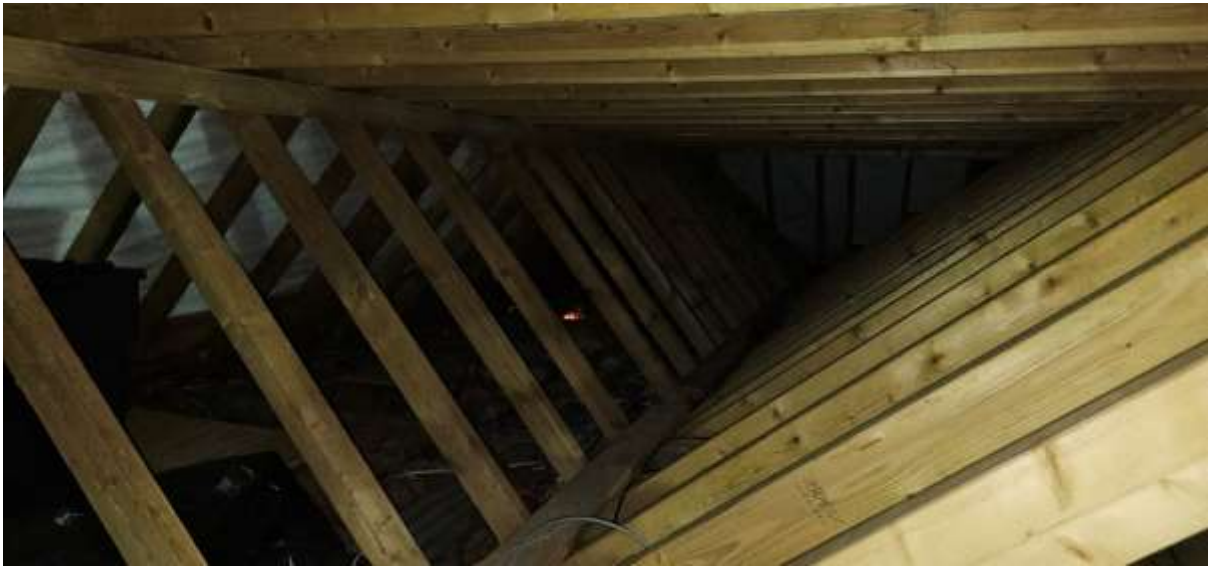
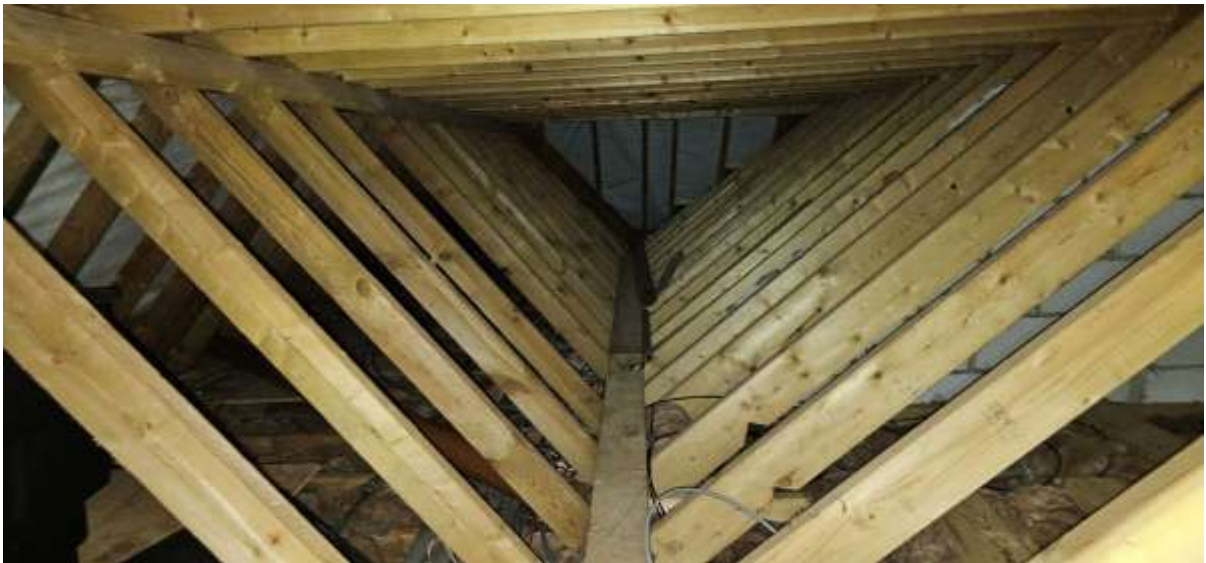
The block wall in two of the above pictures forms the back wall of the vaulted bar area beyond.

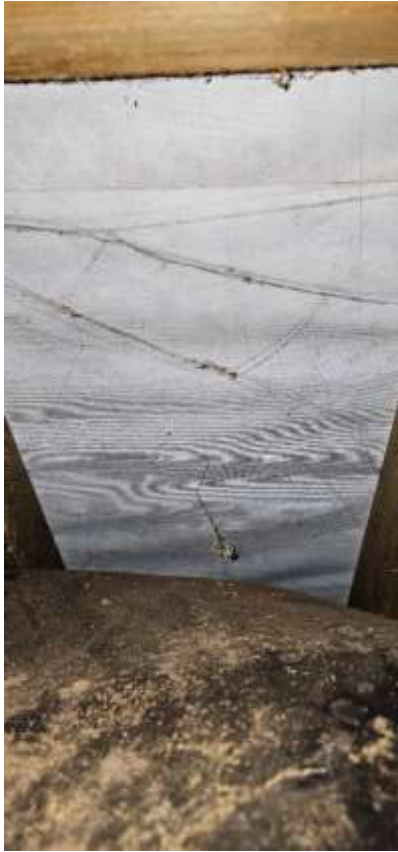
Breathable membrane

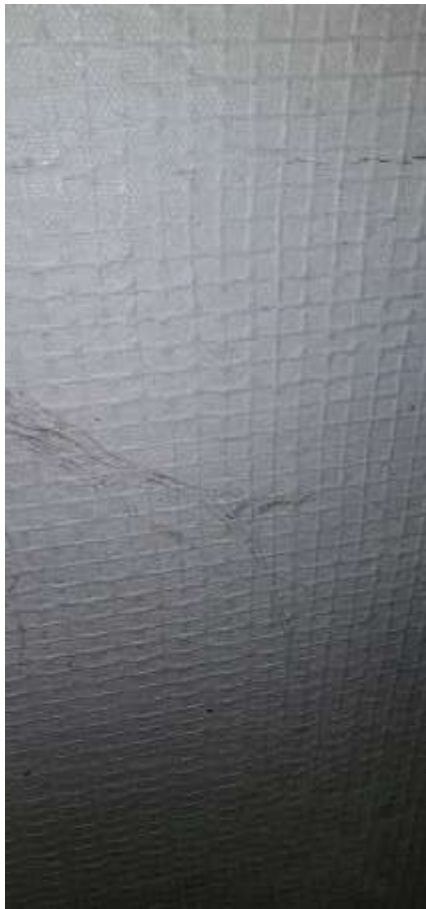
Reinforced plastic insulation

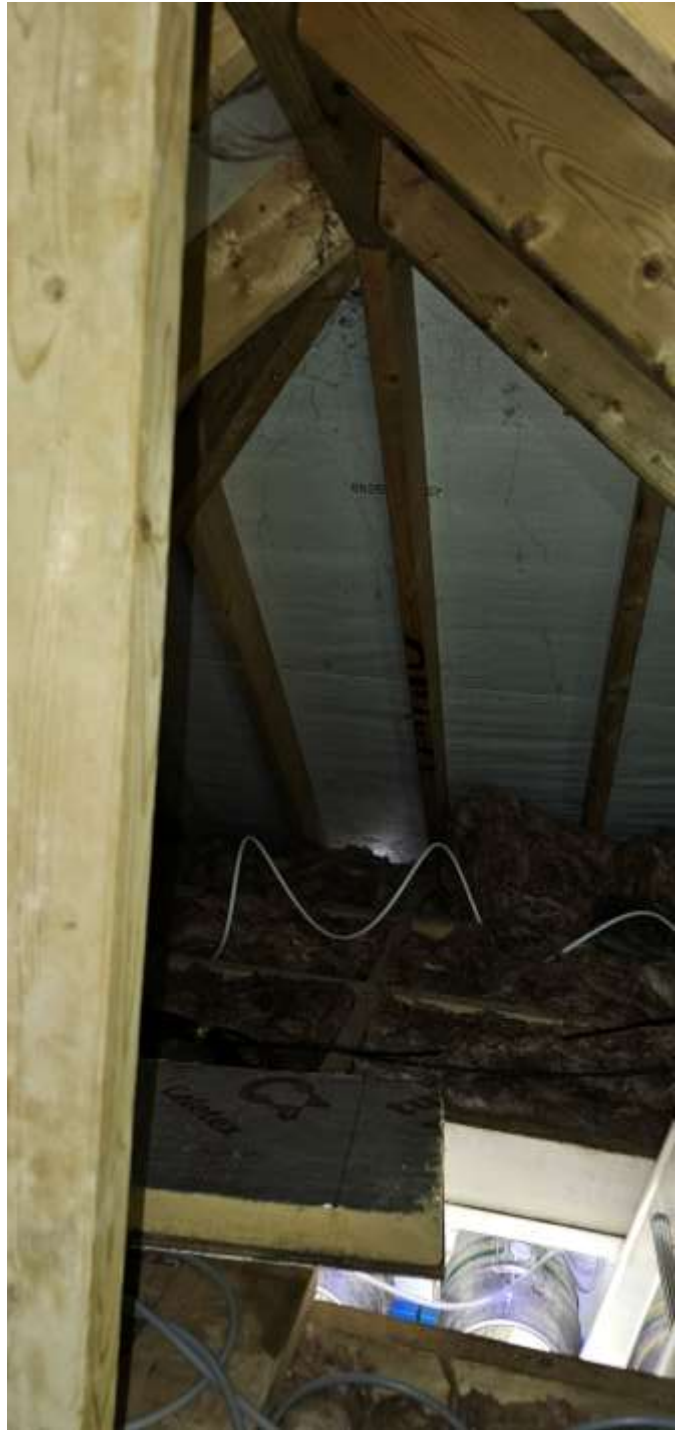
Loft hatch above ground floor beer 'cellar'

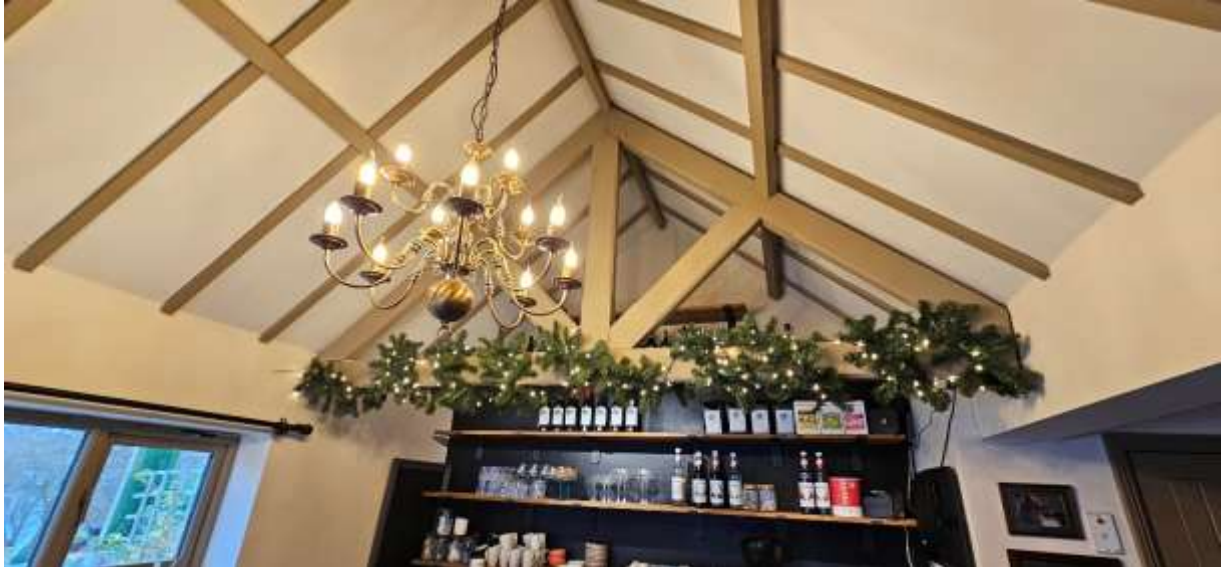
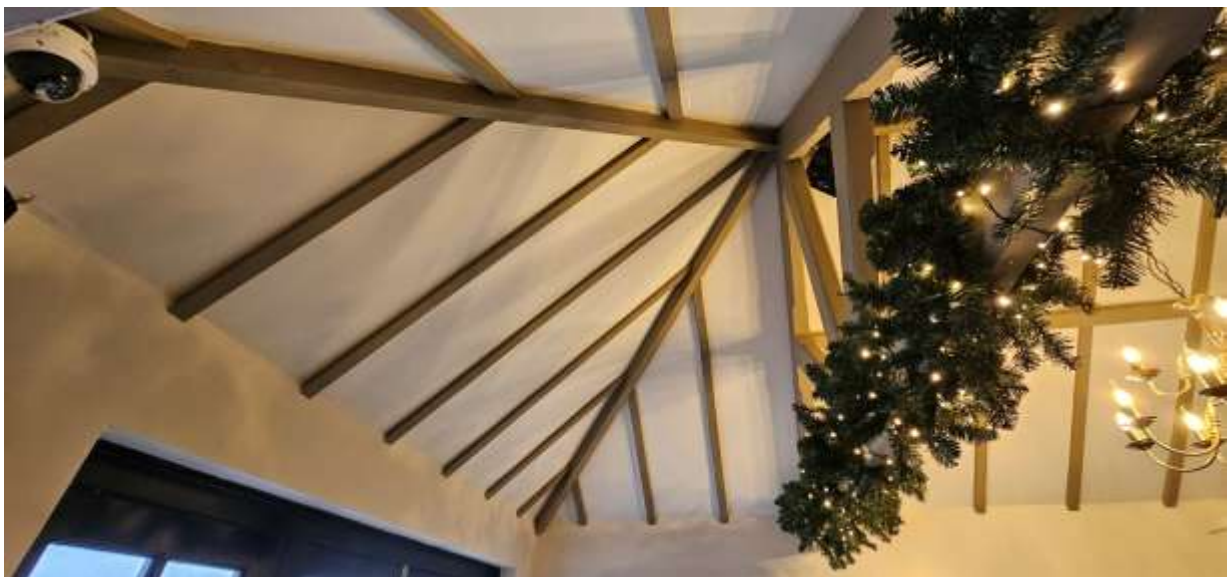
The eastern end of the extension has a vaulted ceiling and is a used bar area. There are exposed tied king-post trusses, rafters and purlins. It is hipped at its eastern end:

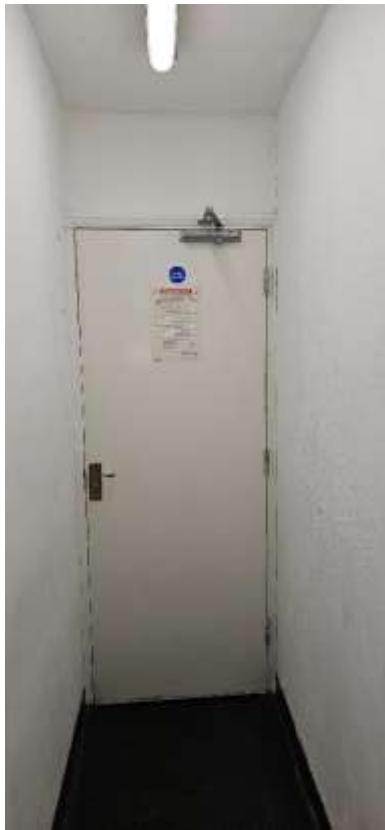
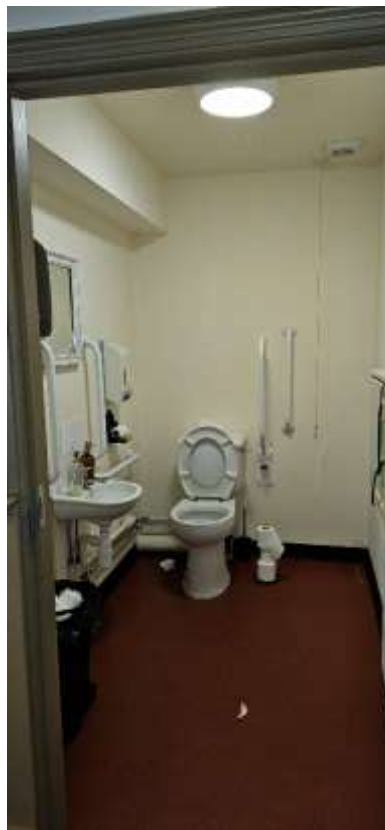
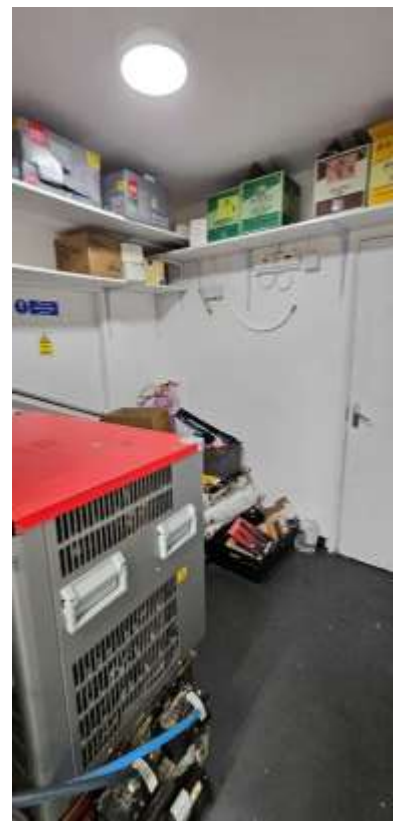
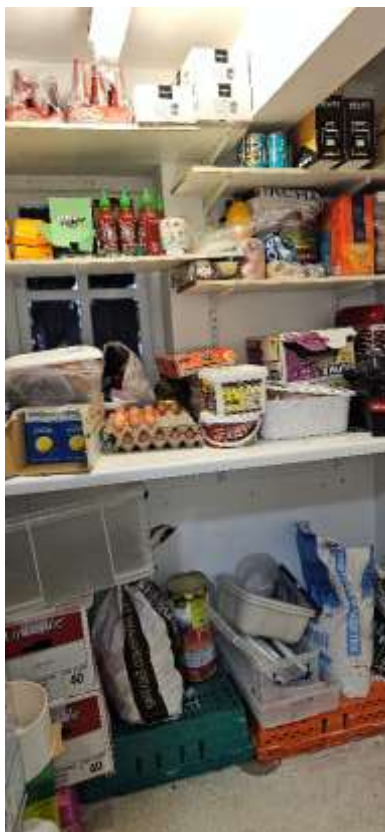
The western end of the extension has a toilet, passageway, beer 'cellar', storeroom and food cupboard:

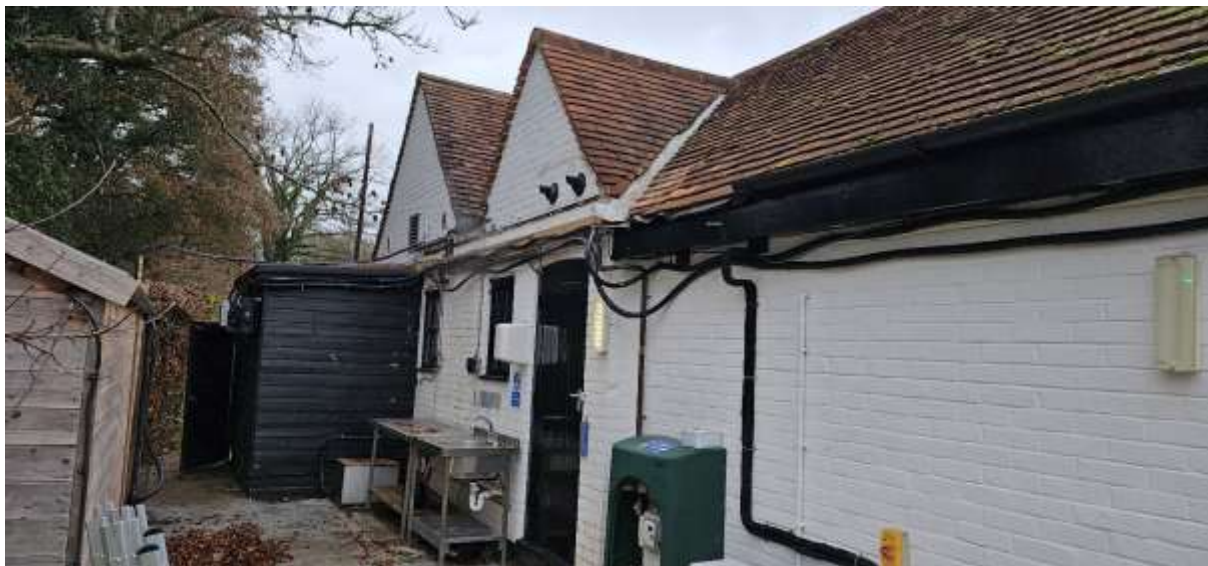
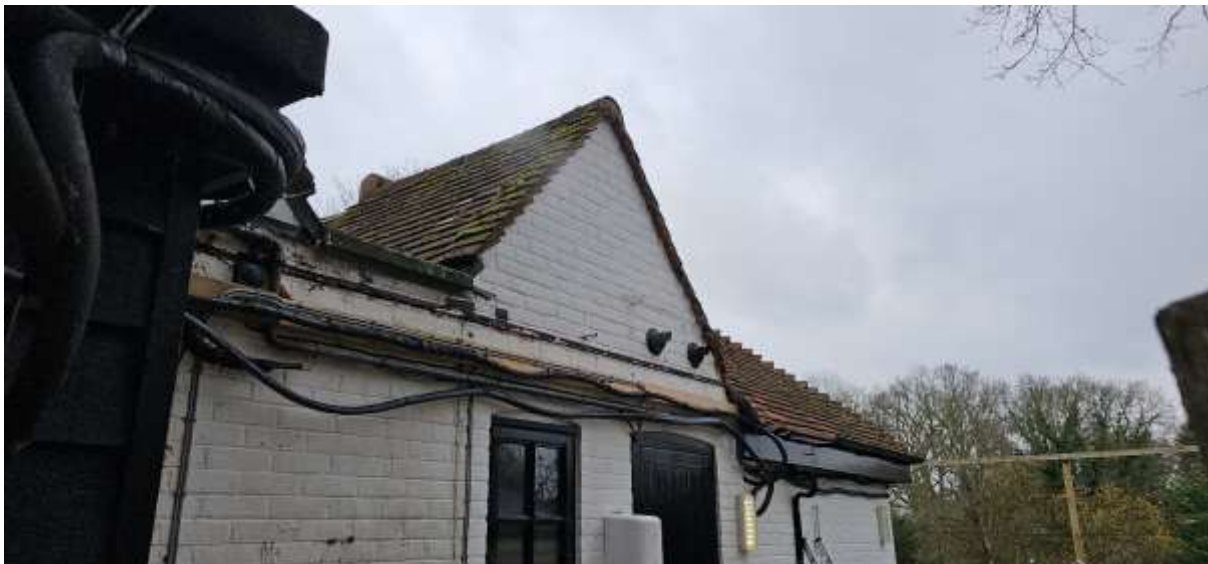
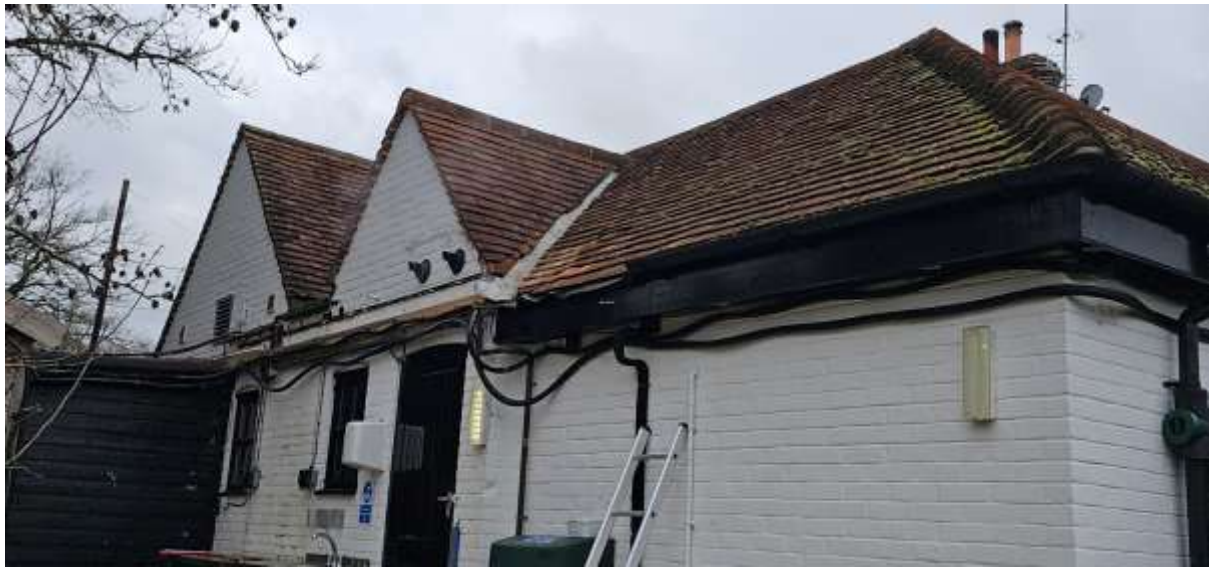
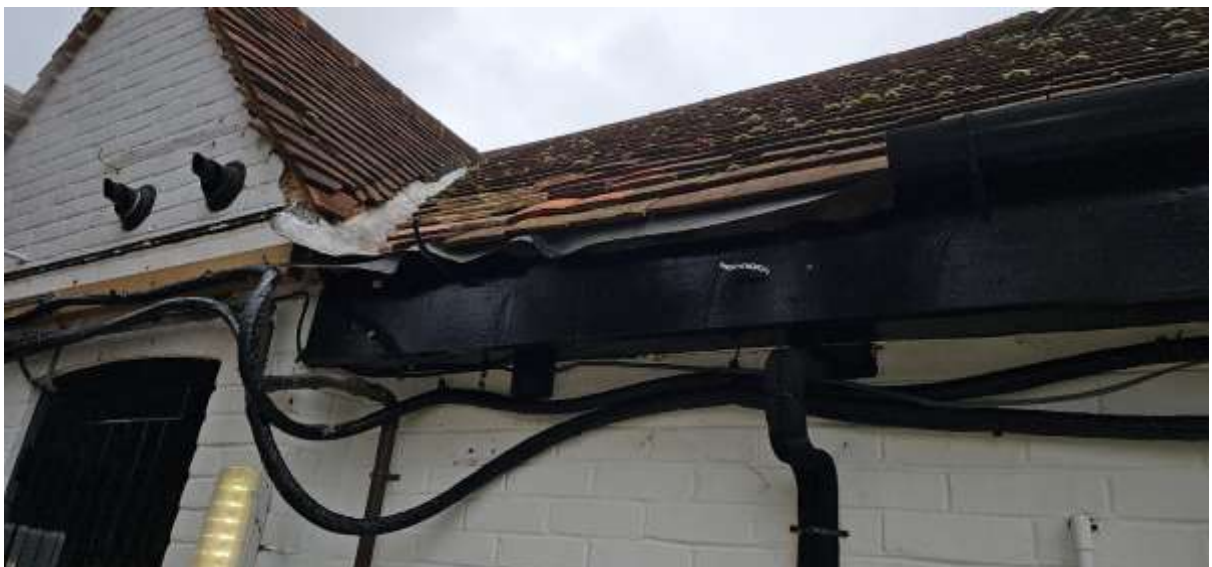
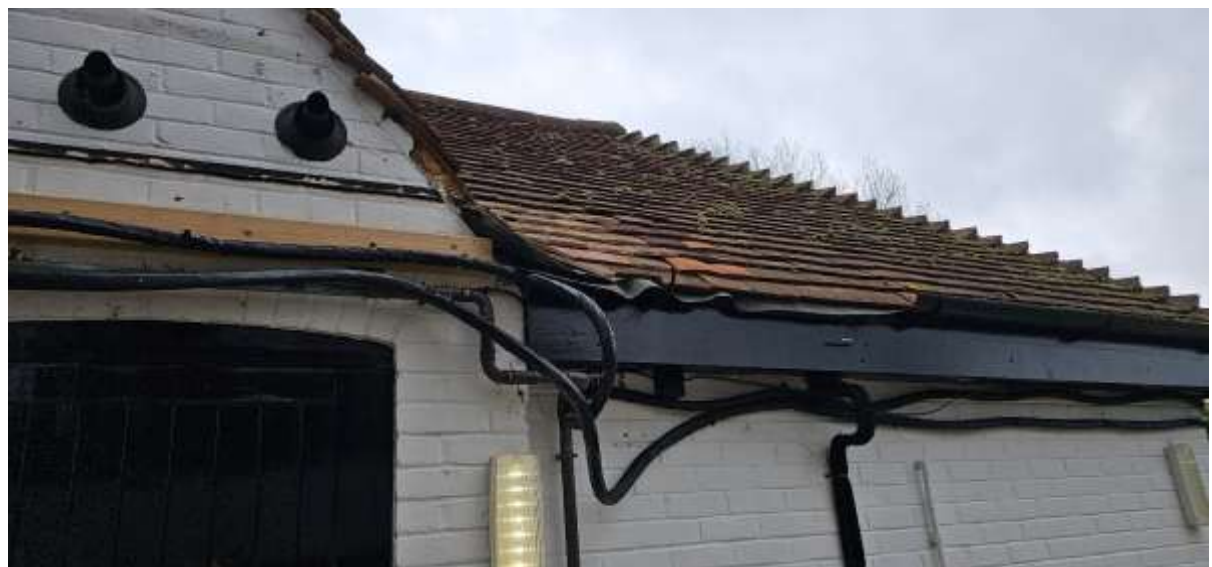
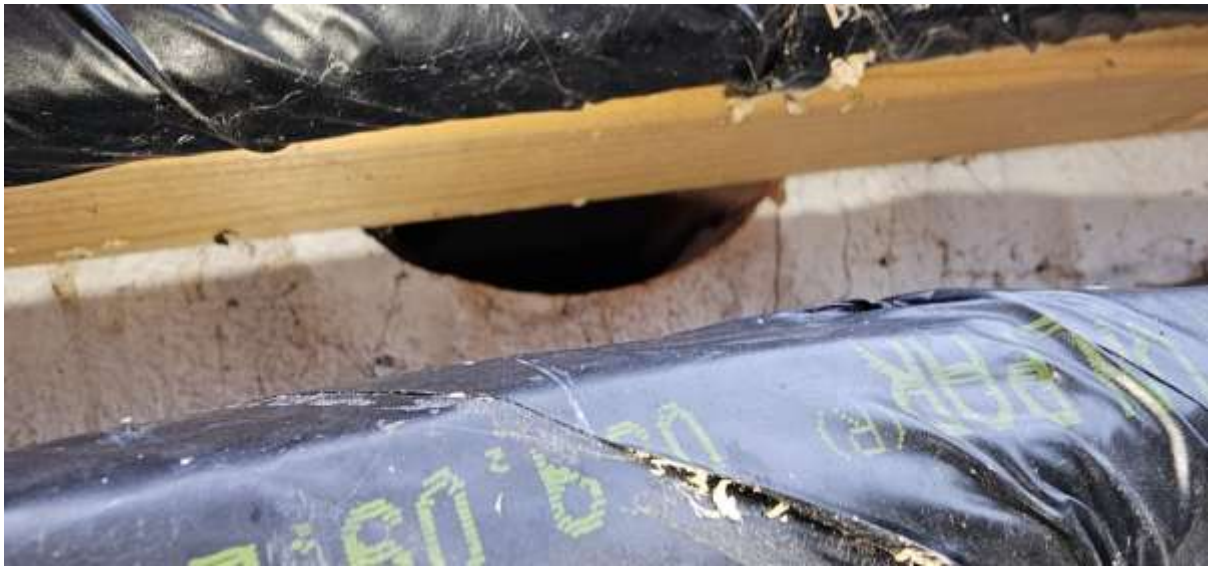
#### **Wooden Lean-to (west elevation of extension)**

The lean-to has been removed since the original survey was carried out by NPA.

The prf's identified in the original photos taken by NPA were endoscoped along with gaps beneath lead flashing and old pipe holes, one of which was partially obscured by wooden battoning. One area of roof has been re-tiled since the removal of the lean-to and the tiles are uneven.

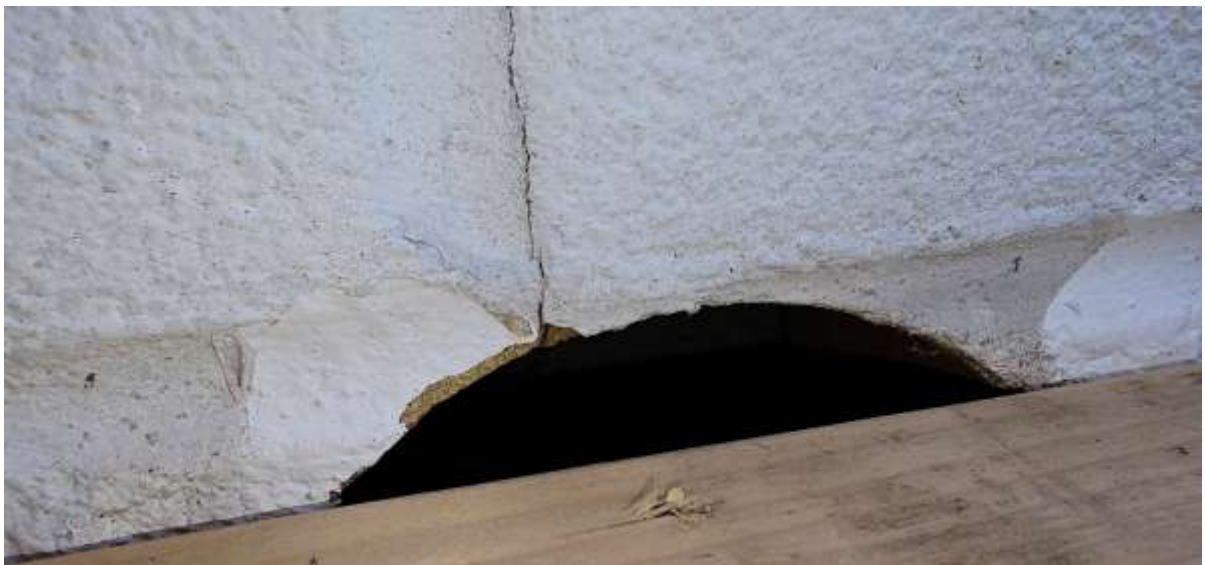
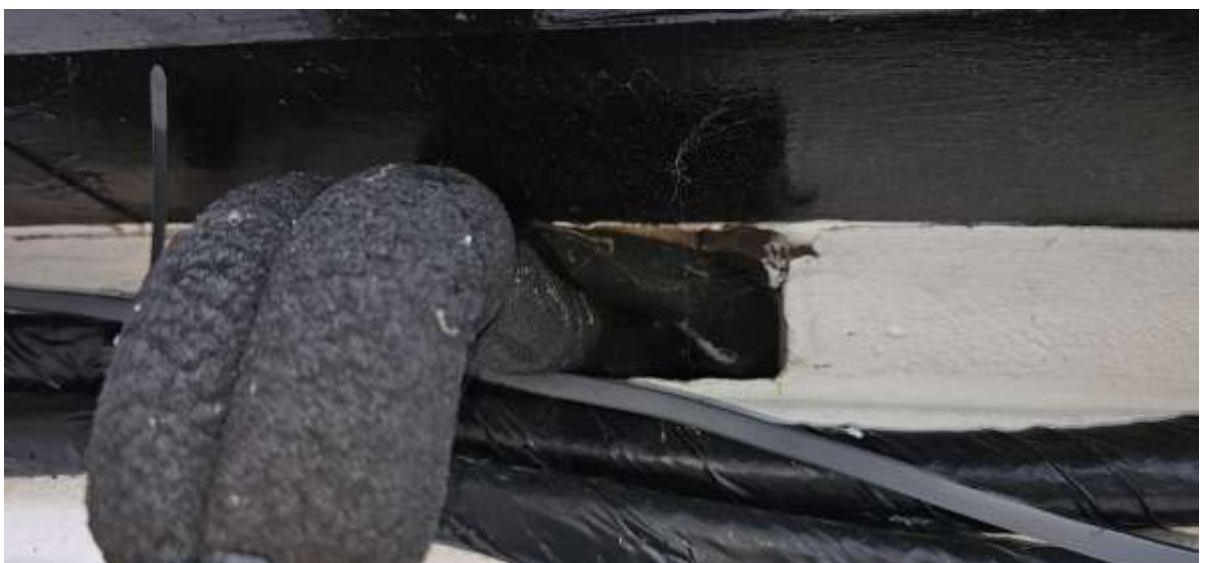
**West elevation roof:**

There were a few gaps beneath roof tiles and between bitumen underfelt and the lower edge of the roof tiles on this elevation, including gaps where the roof had been repaired after the lean-to had been removed.

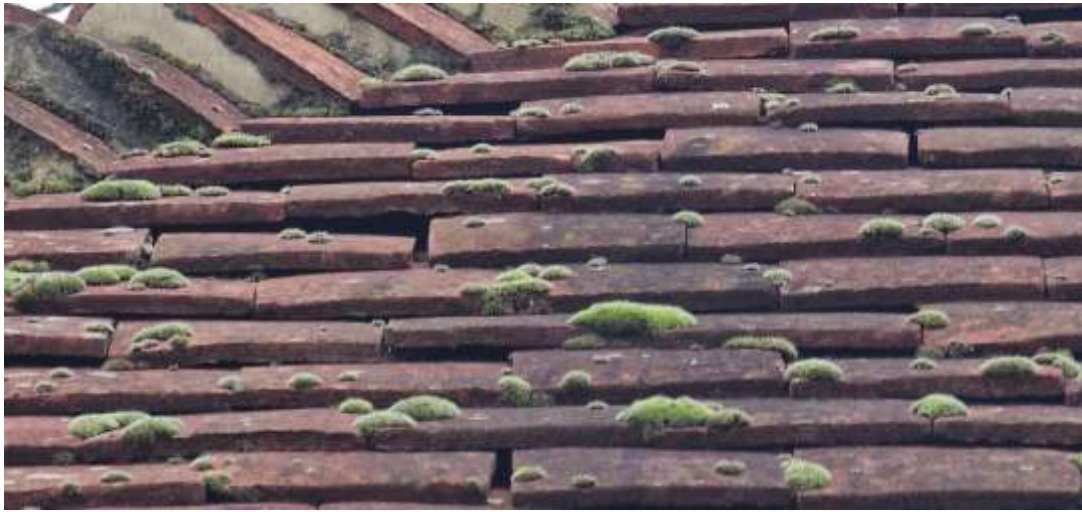
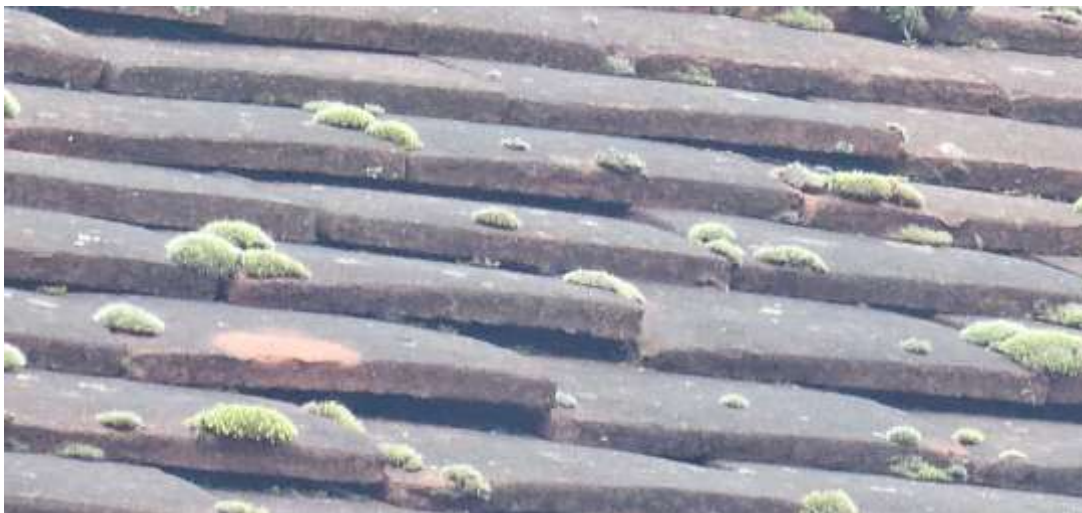
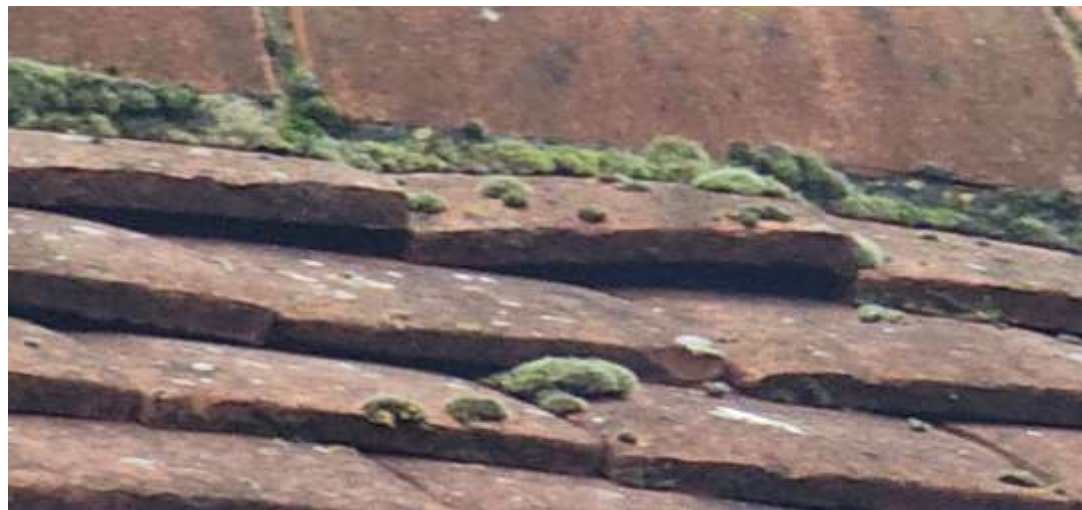
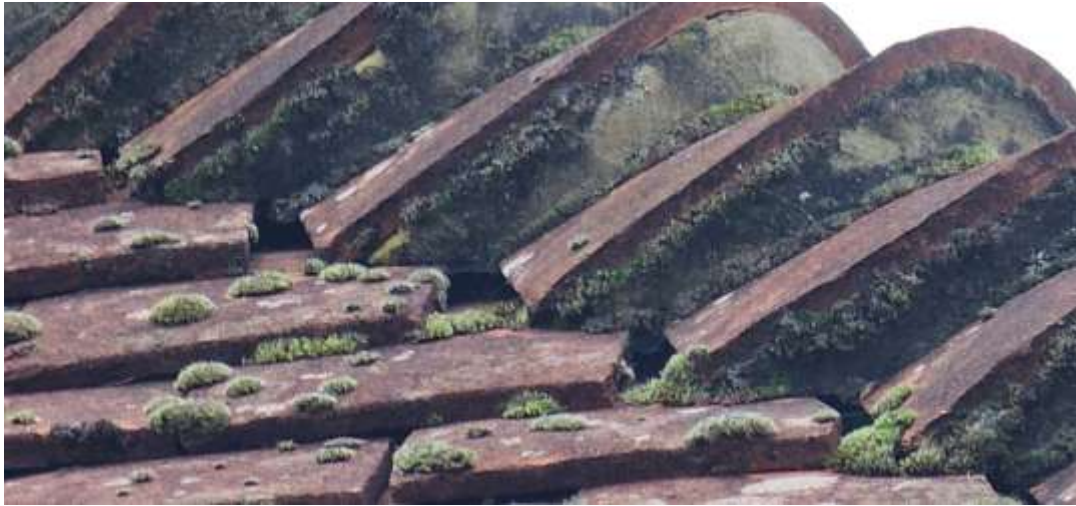
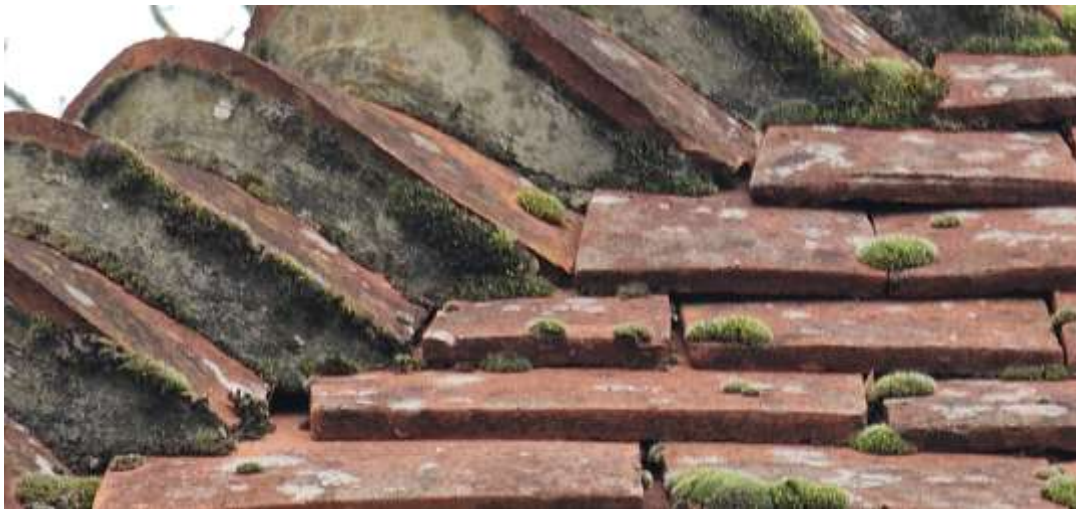
**South elevation:**

There are uneven clay tiles across this roof, with gaps between tiles and where the ladies' bonnets meet the roof tiles.

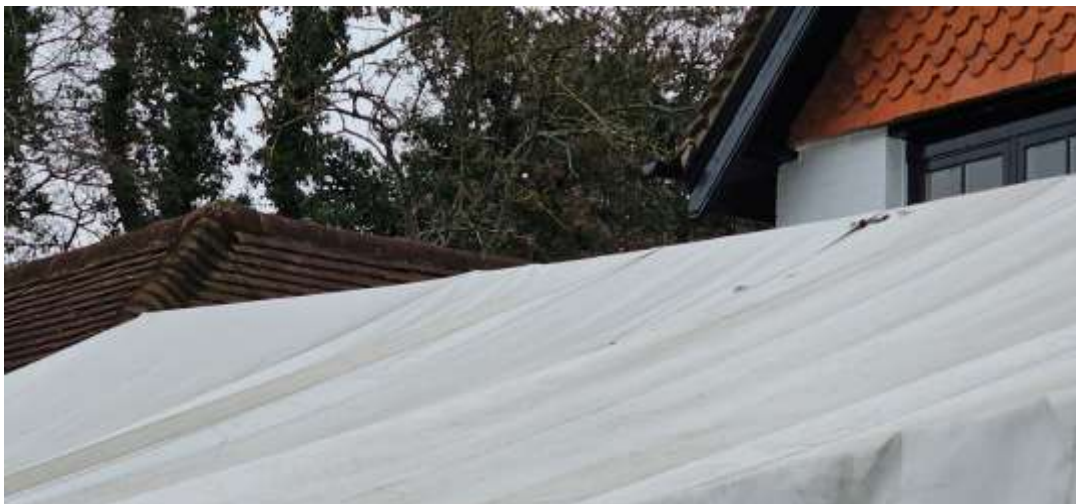
**East elevation:**

It wasn't possible to survey much of the roof on the east elevation as it was obscured by the presence of the marquee. However, it is likely that the entirety of the roof was in a similar condition. There was a visible gap between ridge tiles and several small gaps beneath roof tiles.
