# Flood Risk Assessment

Watermead, Henfield Road, Cowfold, RH13 8DT

Earlswood Homes Ltd

**Ref:** 13897

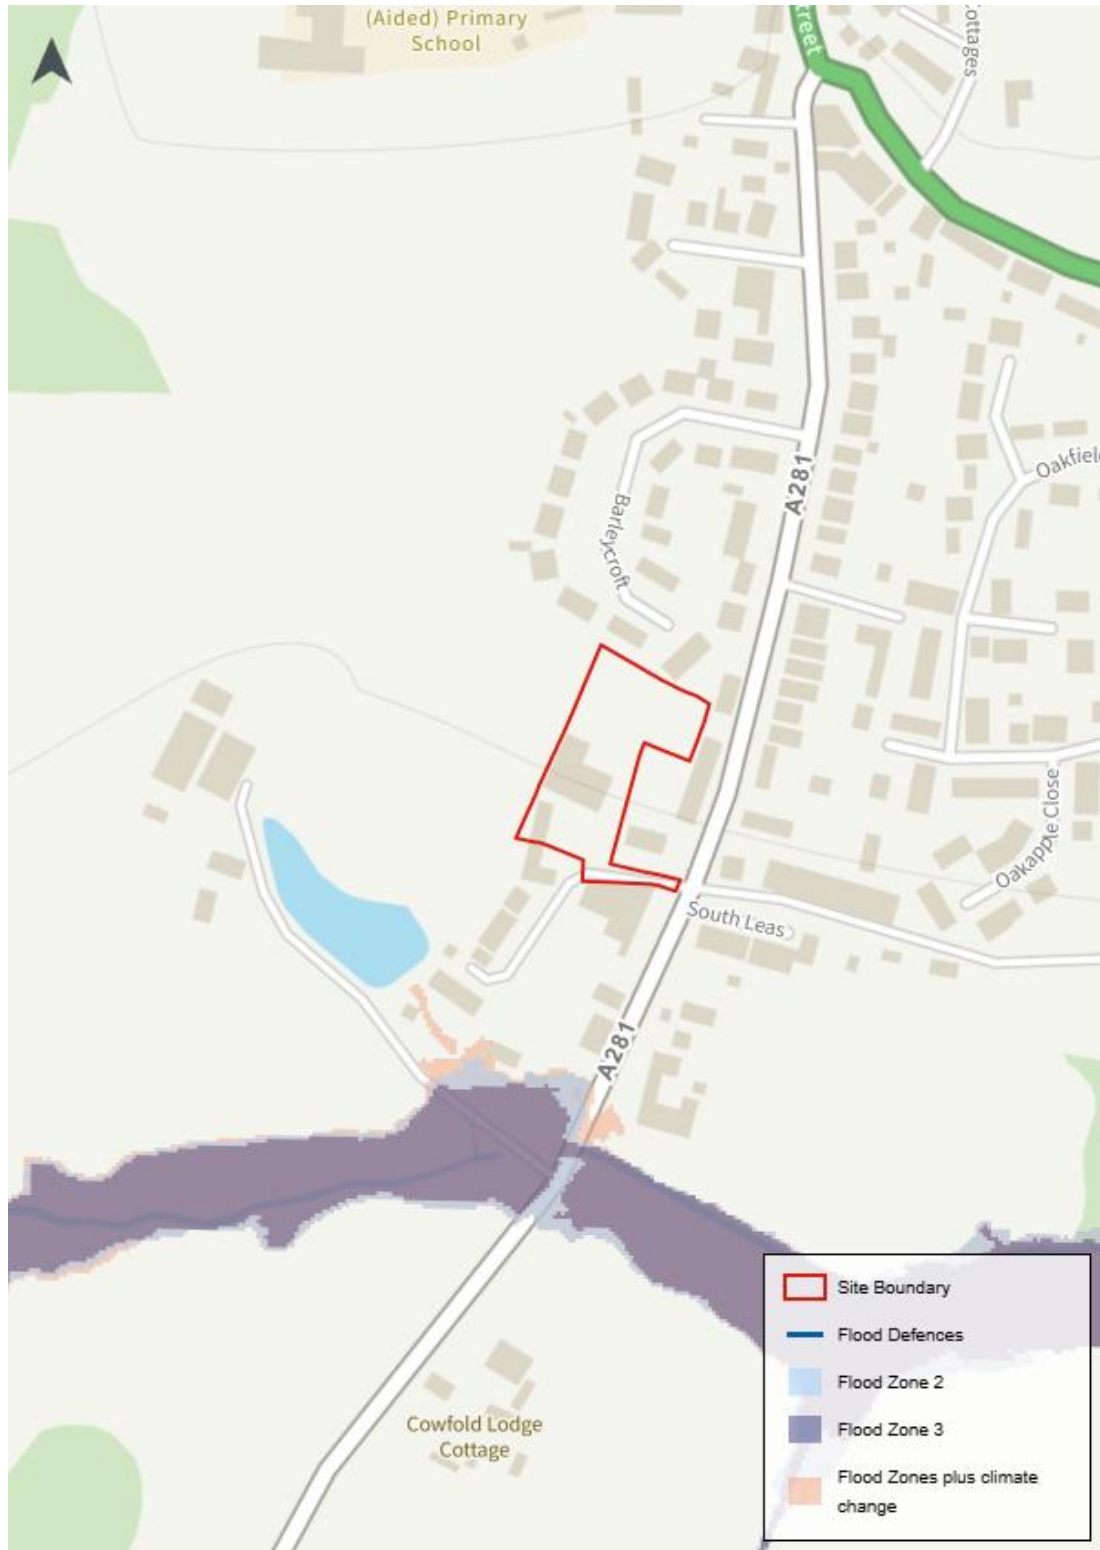
### **Environment Agency Flood Map for Planning**

The site is located in Flood Zone 1.

- 3.12 The EA's Flood Map for Planning shows the Site lies within Zone 1 – Low Probability, having less than a 1 in 1,000 (0.1%) annual exceedance probability (AEP) of river flooding.
- 3.13 A relevant extract from the EA's "Flood Map for Planning" is in Appendix D.
