**GEOTECHNICAL AND  
GROUND CONTAMINATION  
RISK ASSESSMENT REPORT**

**WATERMEAD  
HENFIELD ROAD  
COWFOLD  
WEST SUSSEX**

**PROJECT REFERENCE: P17246**

**REPORT REFERENCE: R16751**

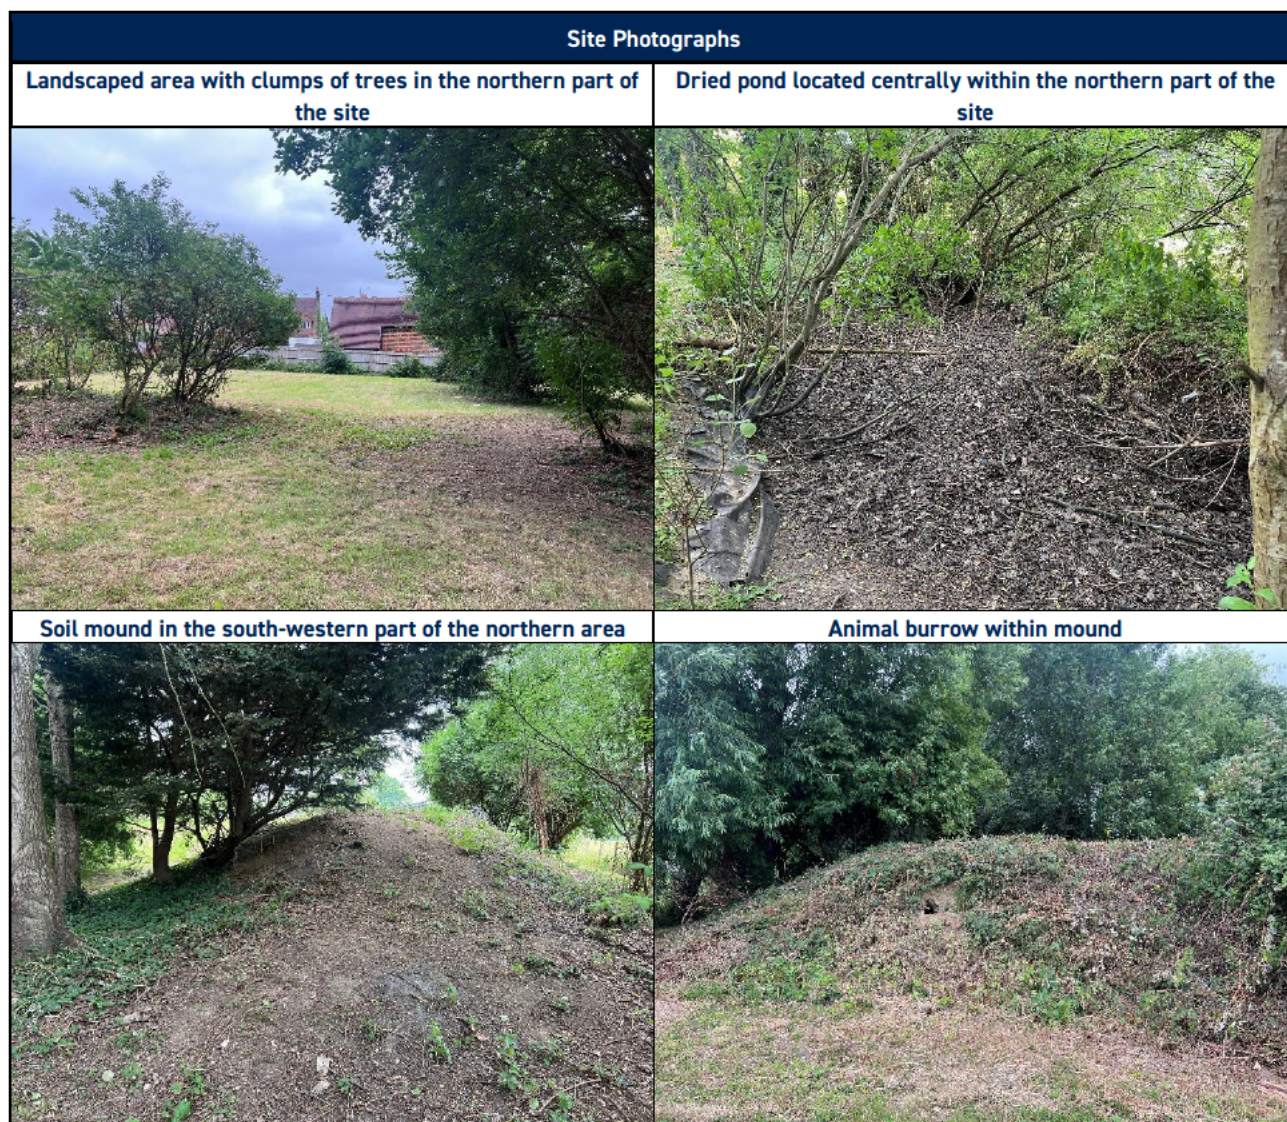
The northern part of the site comprises a mainly grass surfaced area dotted with groups of mature trees. A dried up, partially overgrown pond was located in the middle of this area and in the south-west was an L-shaped mound of soil, with mature trees growing from it. Animal burrows were noted within the mound.

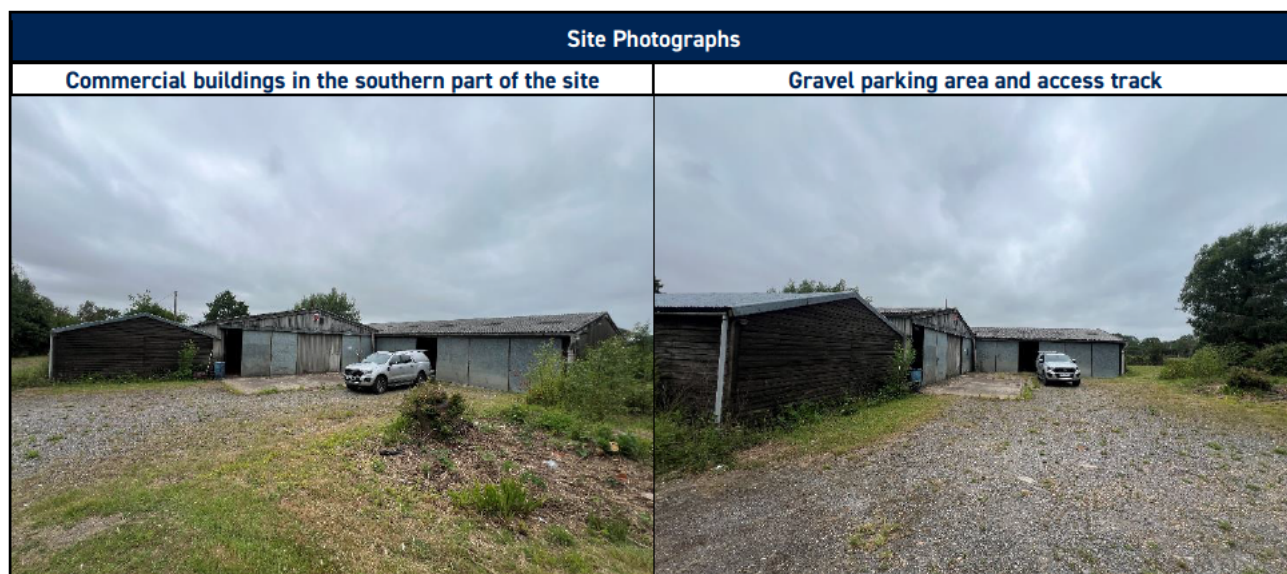
The southern part of the site contained three large commercial/industrial buildings in an L-shape configuration, with a number of smaller outbuilding type structures to the south. A small gravel parking area and access track surrounded the buildings.

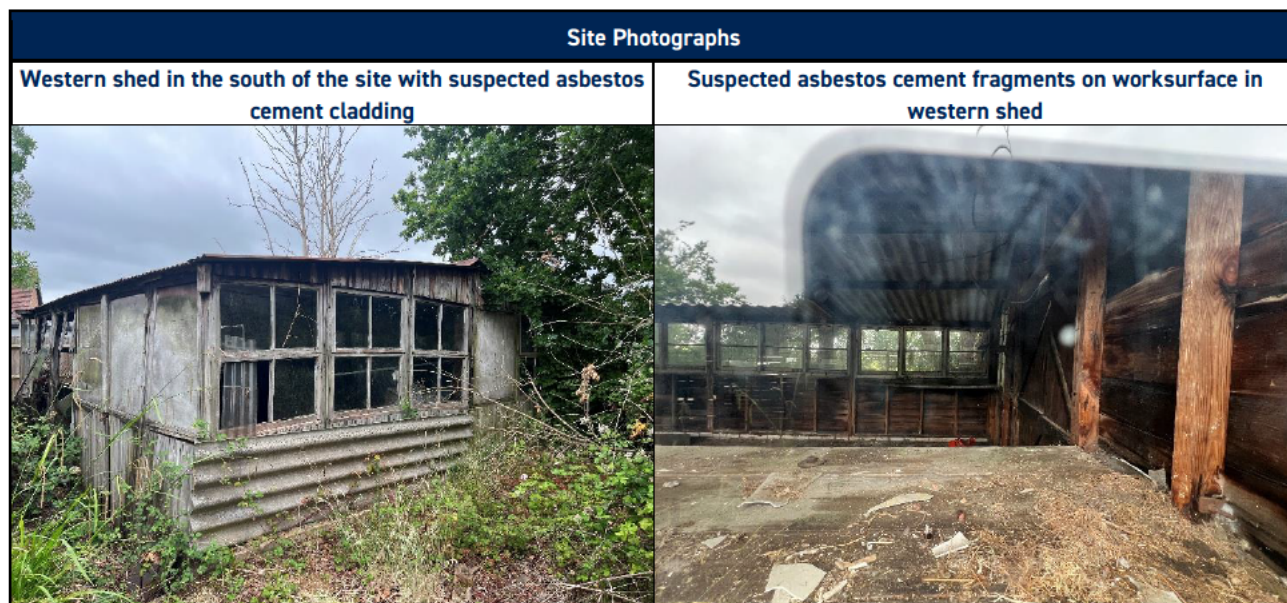
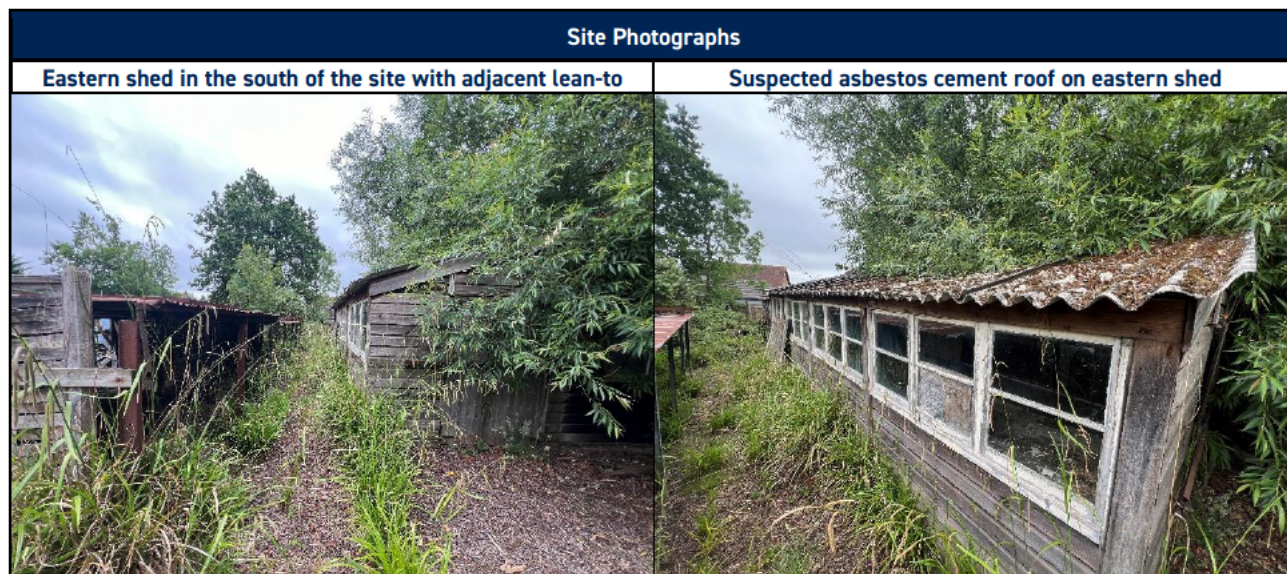
The outbuildings in the south of the site were mainly of wooden construction, though some suspected asbestos cement panels were noted on roofs and walls.

Fragments of broken suspected asbestos cement were noted on a bench within the westernmost shed.

It is also noted that an asbestos survey of existing structures and infrastructure<sup>2</sup> was beyond the brief of this report. The risk assessment assumes that, should asbestos be identified within buildings or infrastructure, with particular reference to the features identified in Section 2, any such materials will be managed in accordance with current legislation and guidance to ensure this does not represent an ongoing risk to end users and, specifically, to ensure that asbestos materials are not introduced into the underlying soils.

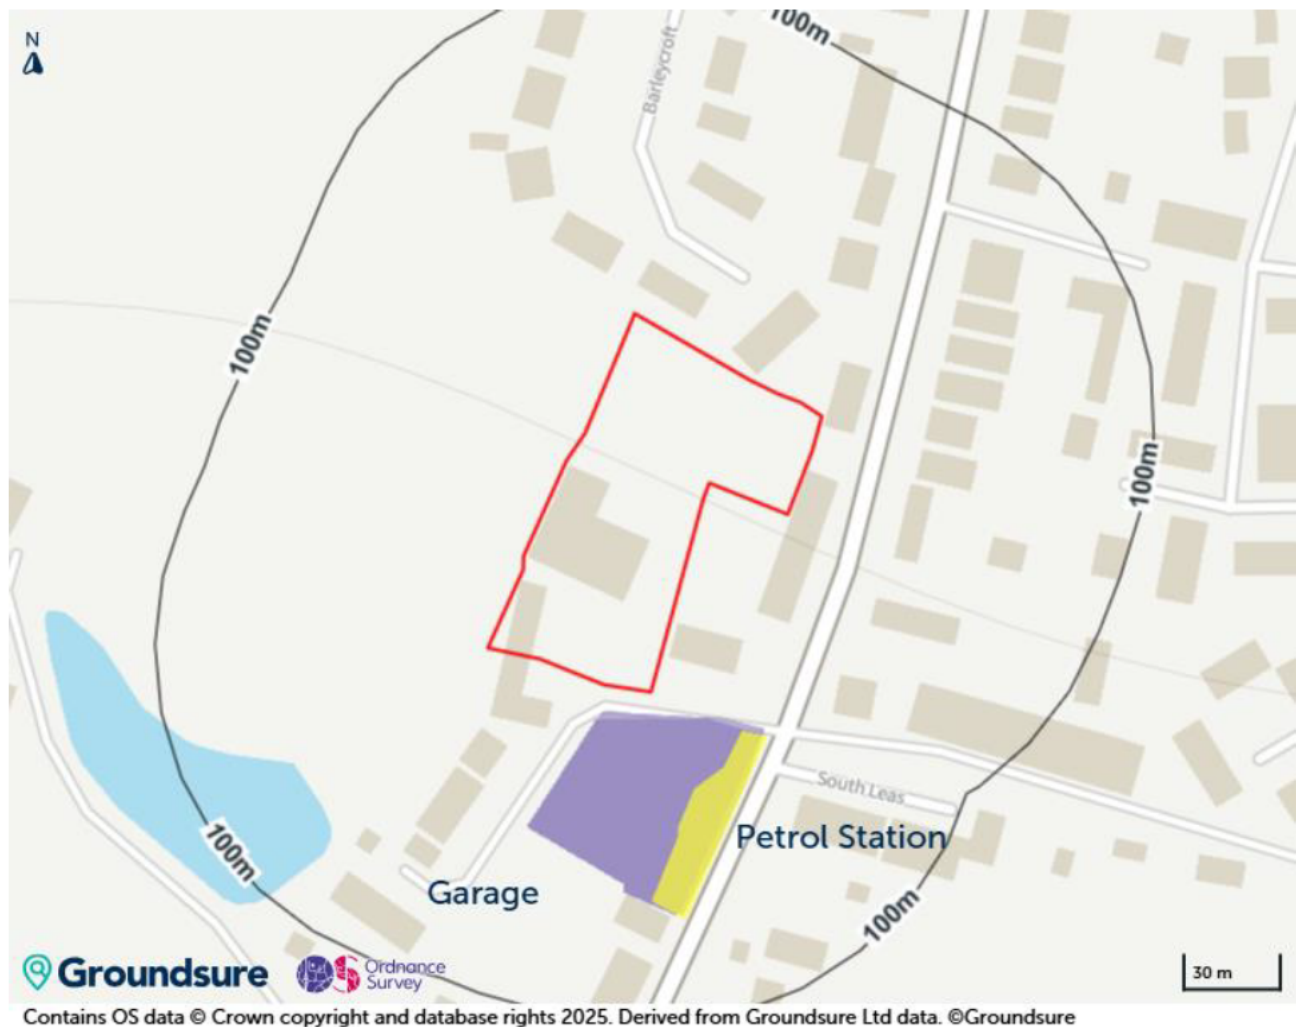
Diagram 3. Historical Petrol Station and Garage (Land Use Map)

A historical petrol station (1972 map) is identified 30m south-east of the site, this is shown within an area identified as a historical garage (1983 onwards and still present) located 8m south of the site, as shown in Diagram 3 to Diagram 5.
