# Flood Risk Assessment and Drainage Strategy

Land South of Sunningdale, Horsham Road, BN4 3AA

SJD Projects

**Ref:** 14007

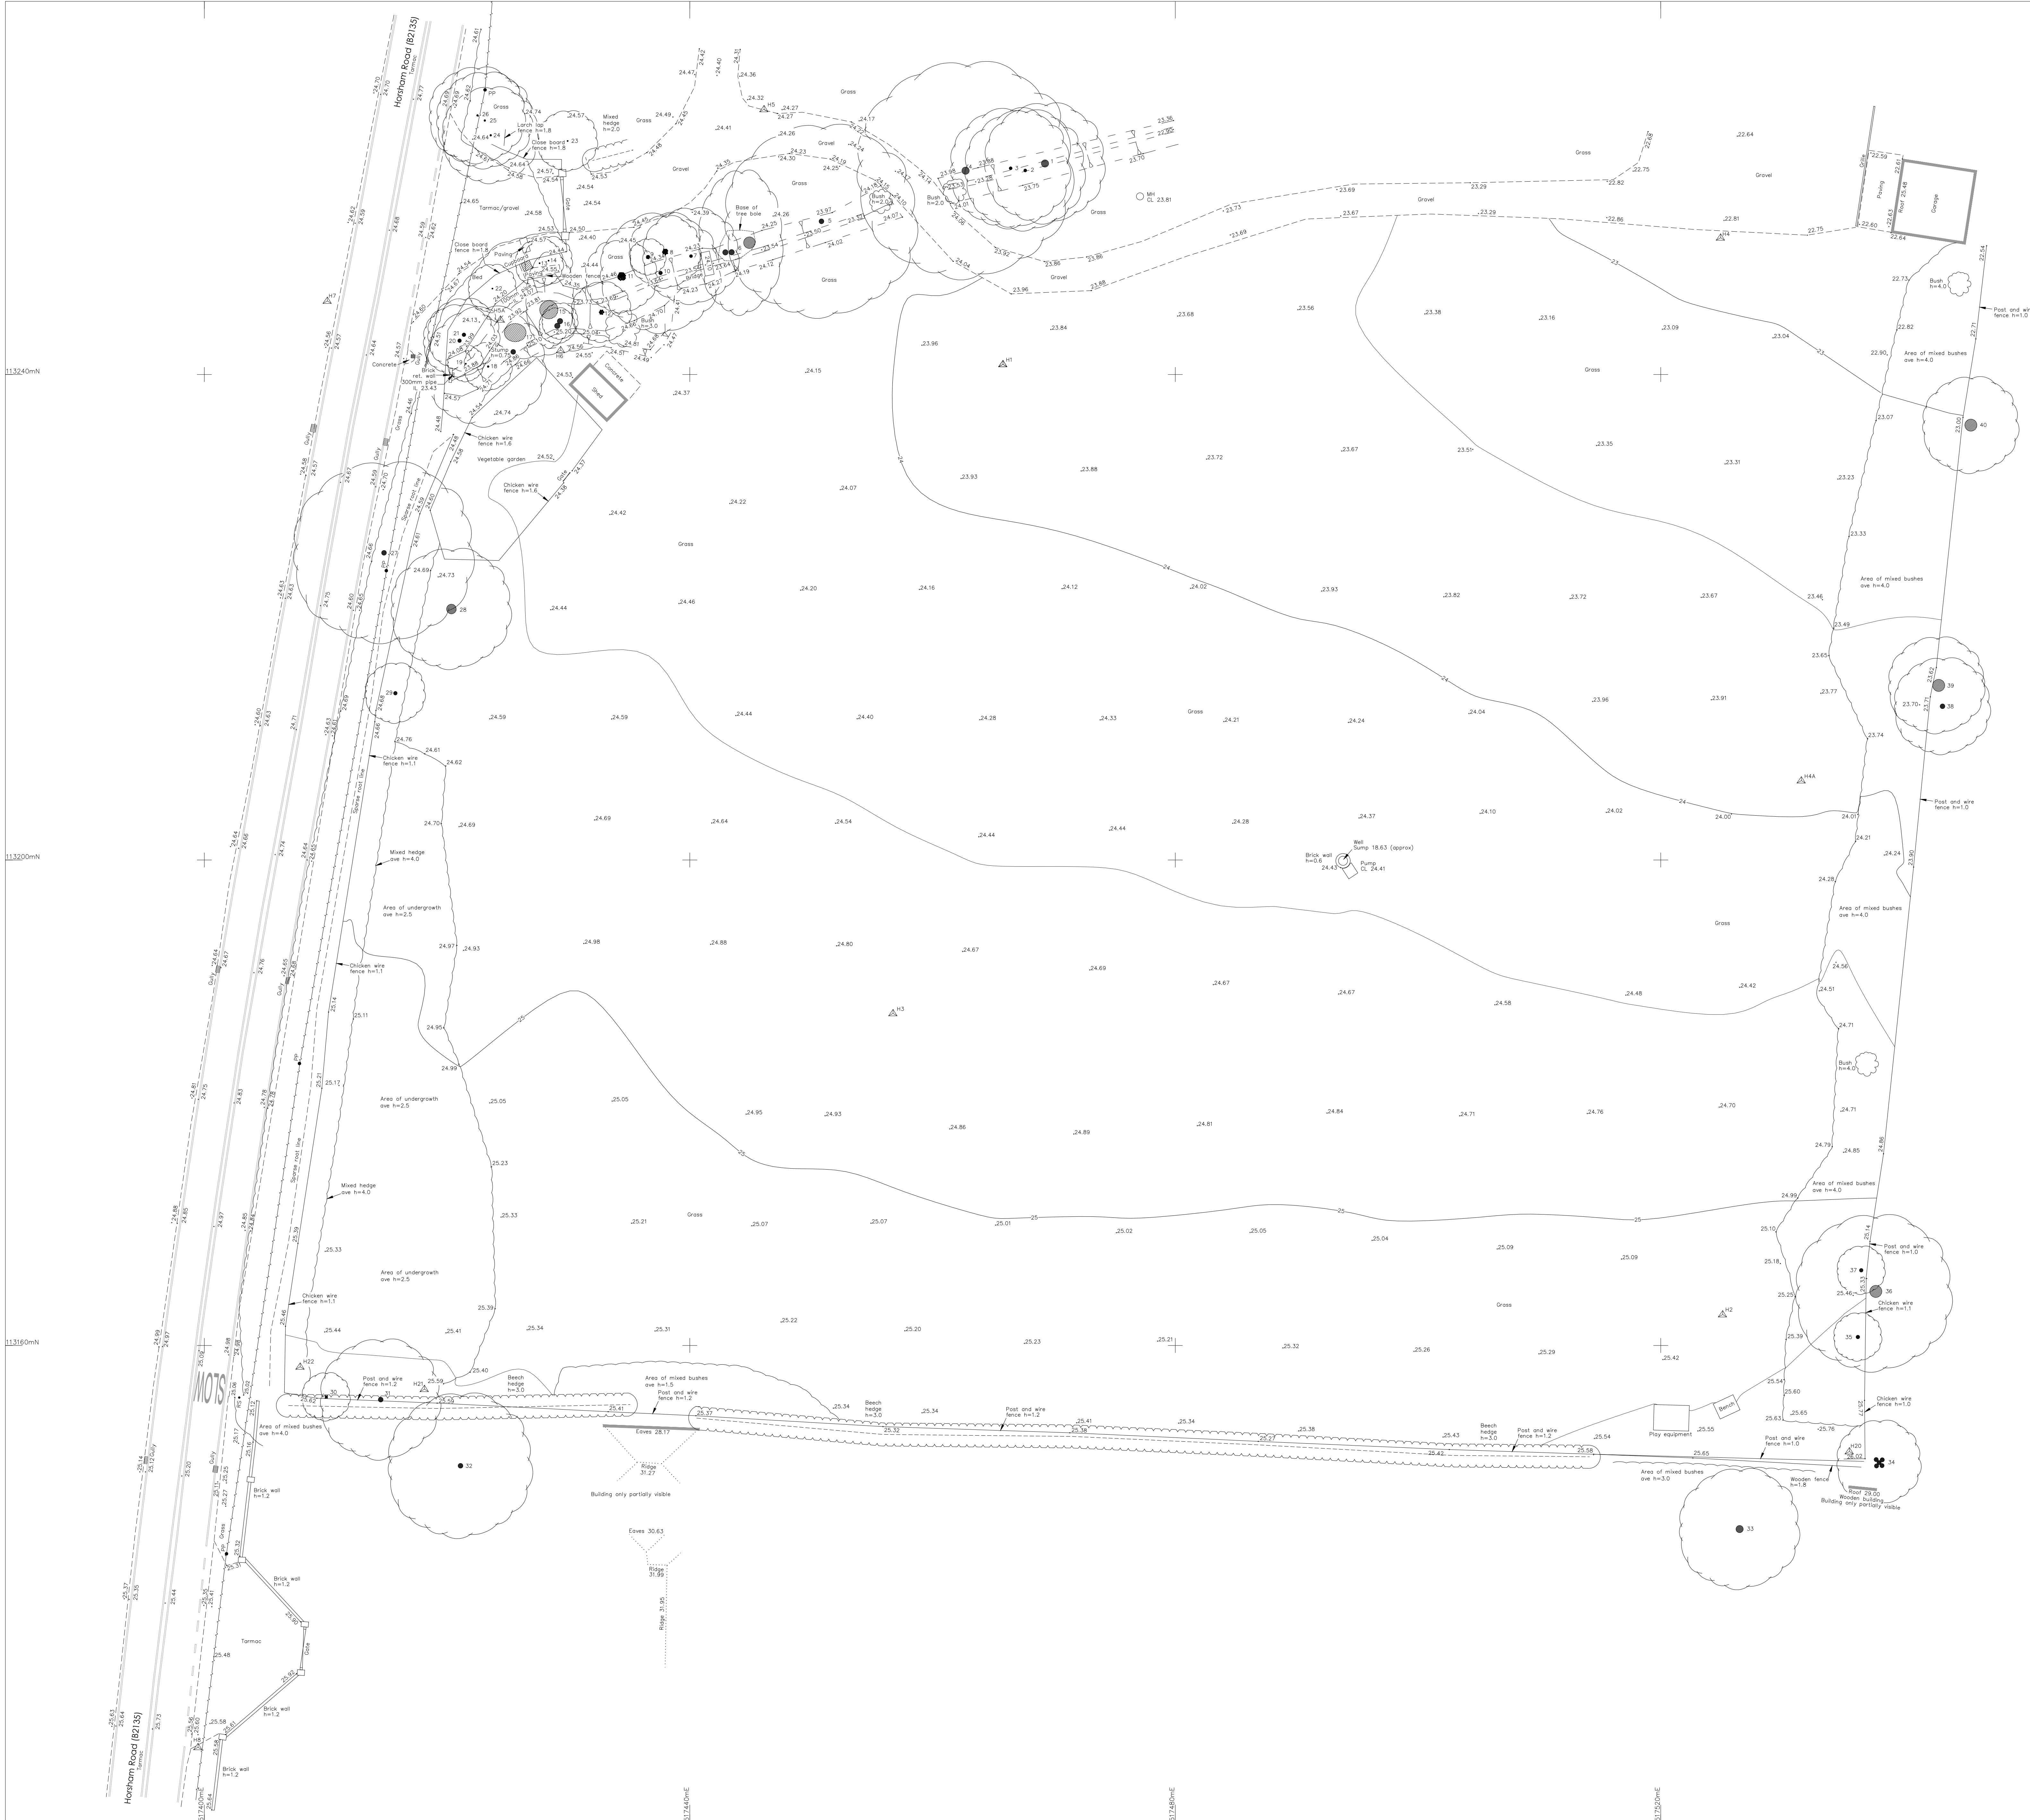
### Topographic Survey

Drainage has been surveyed where found, and traced where possible.

- 2.2 Topography: the site survey, included in Appendix B, indicates that the site slopes from south to north, with a secondary slight gradient falling from west to east, away from Horsham Road. Site levels range from approximately 25.6m Above Ordnance Datum (AOD) to 23.7m AOD.

- 2.3 Hydrology: An unnamed ditch (Ordinary Watercourse) is located parallel to the north-western boundary of the site. It flows in a west to east direction within the application site, before crossing into Sunningdale. A couple existing inlet pipes and culverts are identified on the topographic survey.

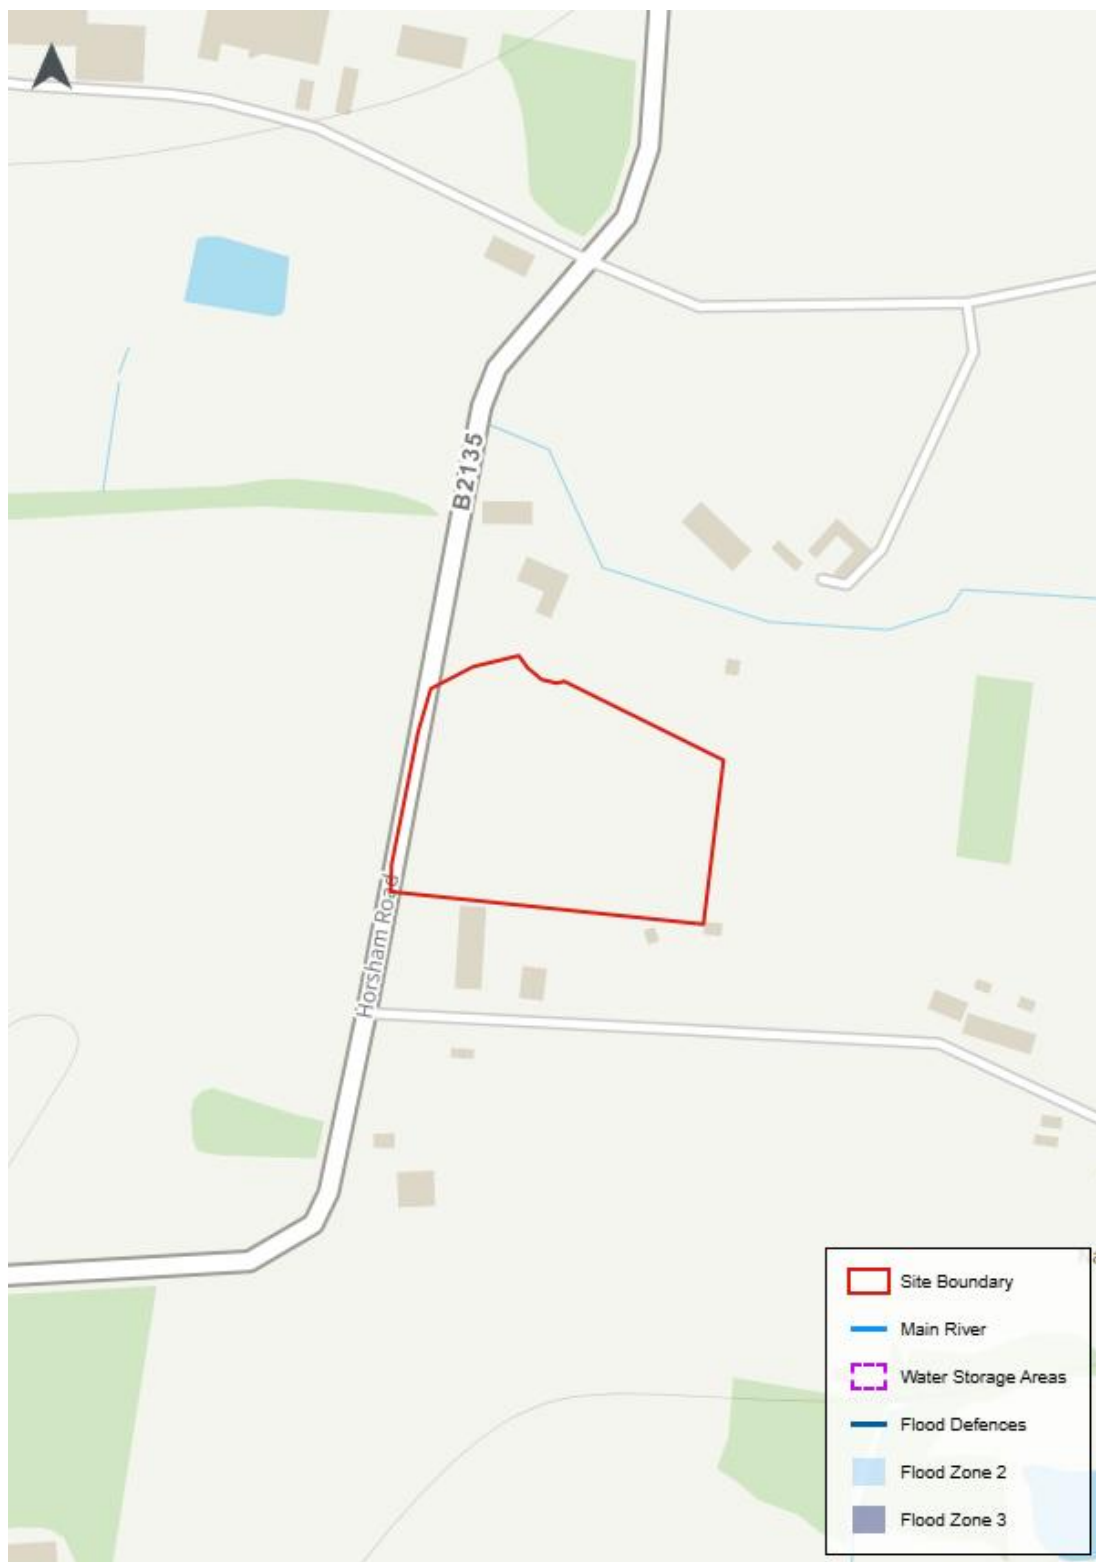
**Environment Agency Flood Map for Planning**

The site is located in Flood Zone 1

- 2.8 Fluvial/tidal flooding: The Environment Agency's (EA) Flood Map for Planning (Appendix C) confirms the site is situated in **Flood Zone 1 (Low Probability)**. This zone comprises land assessed as having a less than 1 in 1,000 (<0.1%) Annual Exceedance Probability (AEP) of river or sea flooding.

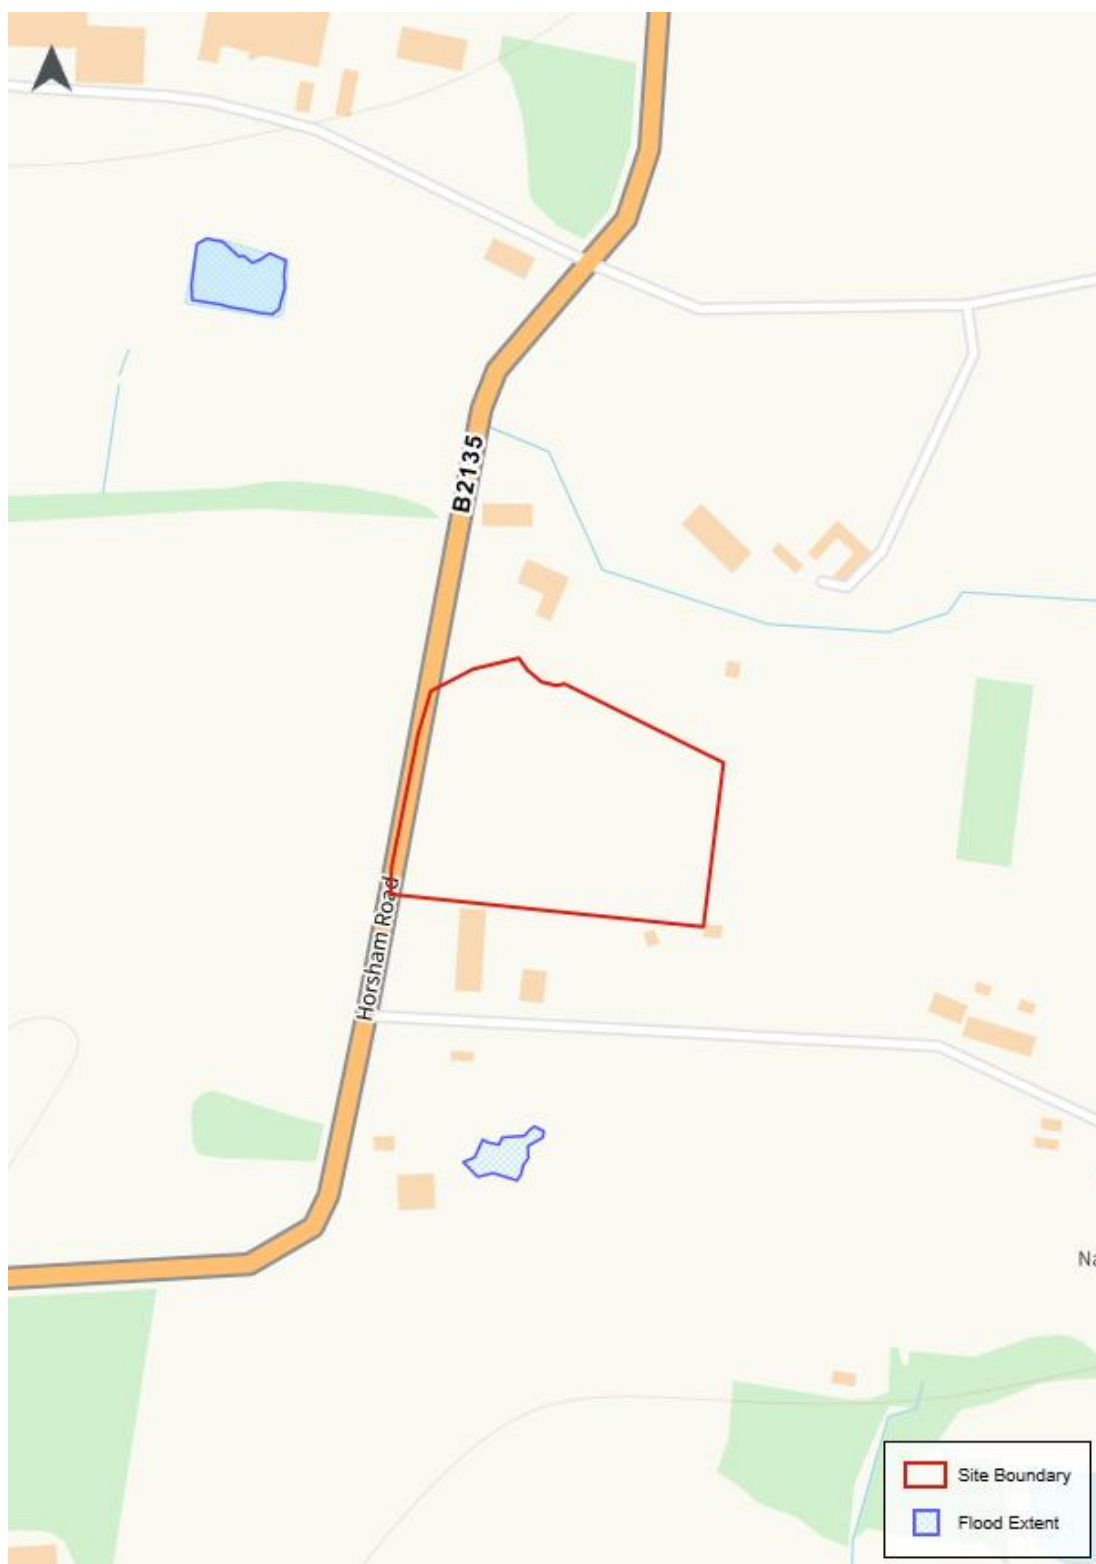
**DEFRA Historical Flooding Map**

Neither this site nor anywhere in the vicinity has been affected by flooding in the past

- 2.14 Historical Flooding: the EA's historical flood map in Appendix C shows this site has not been affected by flooding in the past. The nearest recorded events are contained to the existing natural ponds in the area.
