22-200.02

| Report Quality Management | | | |
|---|---|---|---|
| <b>Project Name</b> | Former Sandgate Nurseries, West End Lane, Henfield, West Sussex, BN5 9RD | | |
| <b>Project Title</b> | Groundwater Risk Assessment | | |

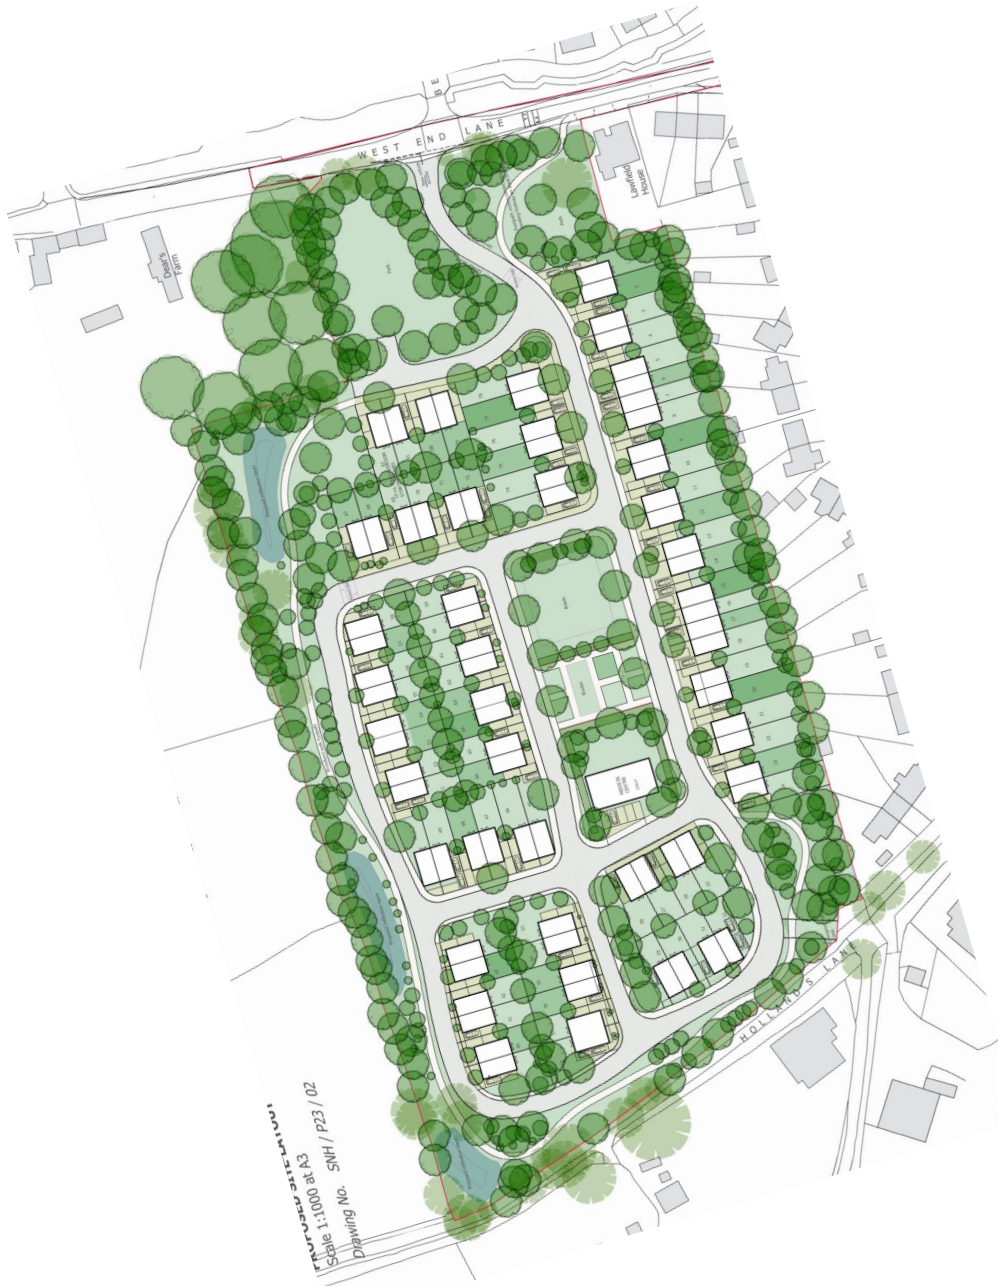
#### Figure 5

| <b>Proposed Land Use</b> | The proposed development is expected to comprise residential semi-detached homes with private gardens.<br><br><b>Figure 5</b> is enclosed as a Proposed Development Plan. |

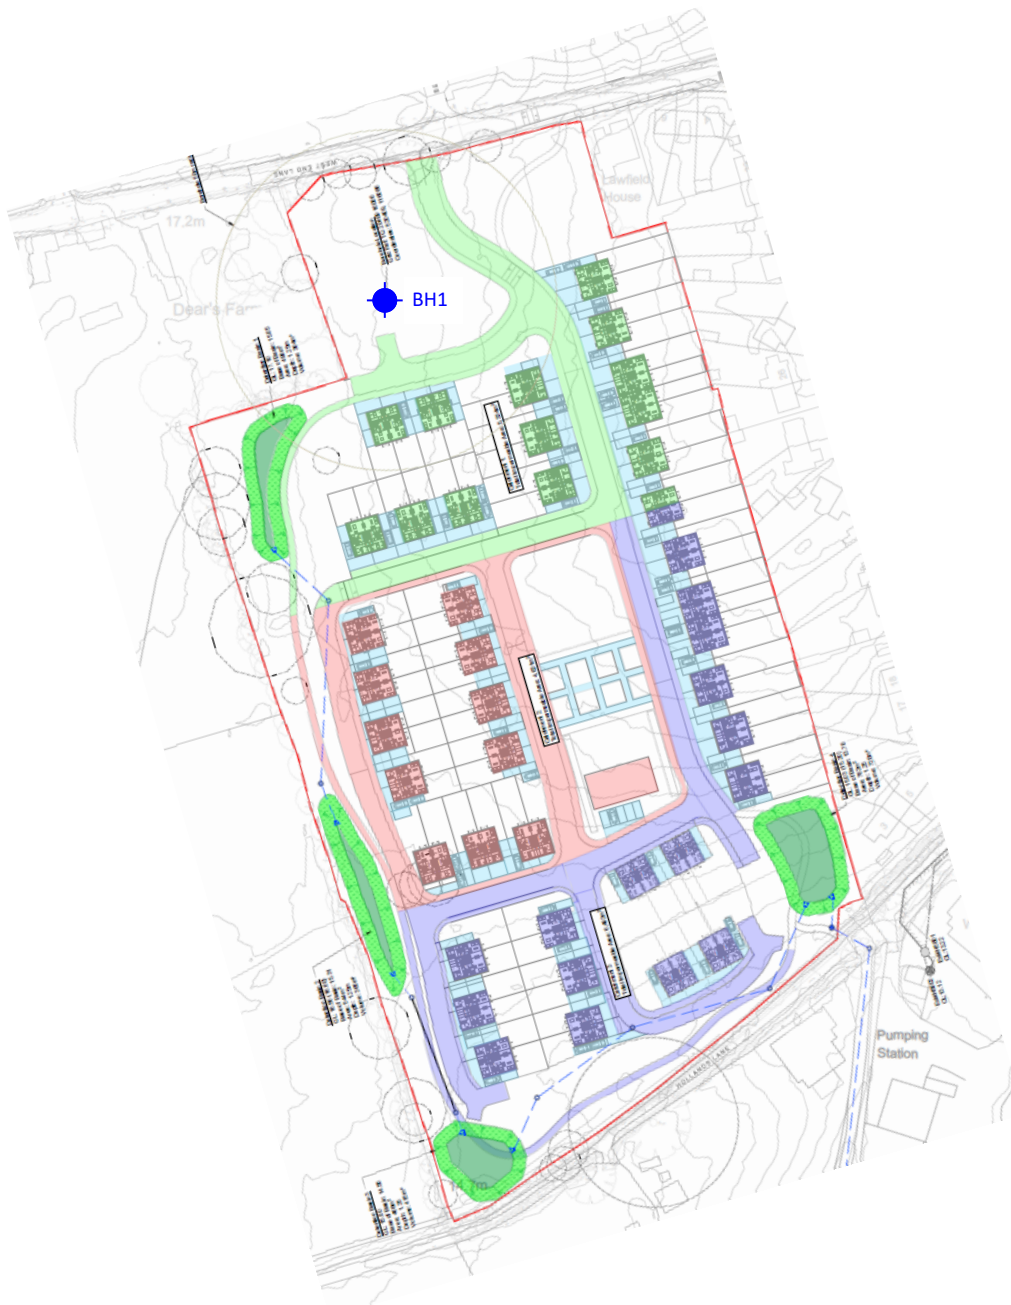
#### Figure 7

The Groundwater Borehole Well Location Plan is enclosed as **Figure 7**.
