# Bat Emergence and Re-Entry Survey

This report is supplementary to the Preliminary Roost Assessment report completed by Arbtech Consulting Ltd (2025).

**Little Orchard, Dagbrook Lane,  
Henfield, West Sussex  
BN5 9SH**

**This report is prepared to inform a planning application for the proposal described as the demolition of the existing dwelling and erection of a replacement dwelling.**

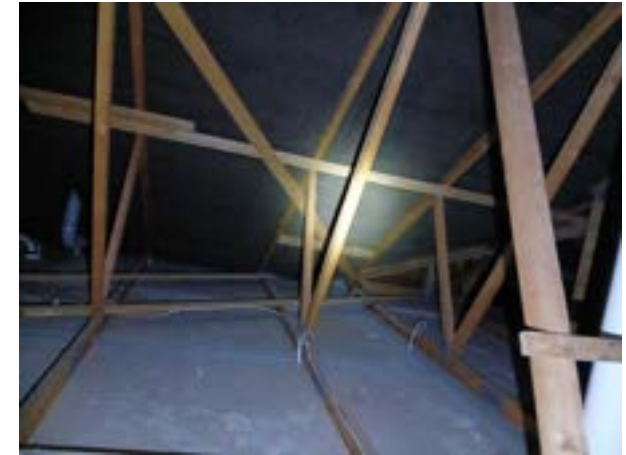
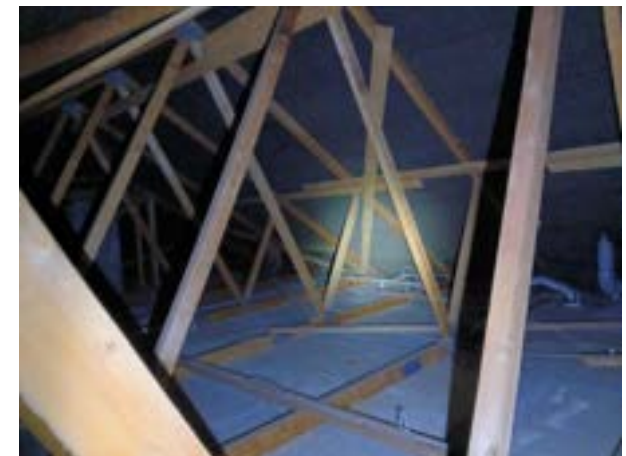
An updated internal and external inspection was undertaken by Thomas Doarks, immediately prior to the start of the second bat emergence survey (22nd June 2026). No evidence of bats, or bats themselves, were recorded. Additionally, no further suitable roosting features in addition to the PRA report were identified. All conditions remained the same as they were during the PRA survey.

**Figure 1a:** Internal roof void of building B1 during the updated internal inspection

**Figure 1b:** Internal roof void of building B1 during the updated internal inspection

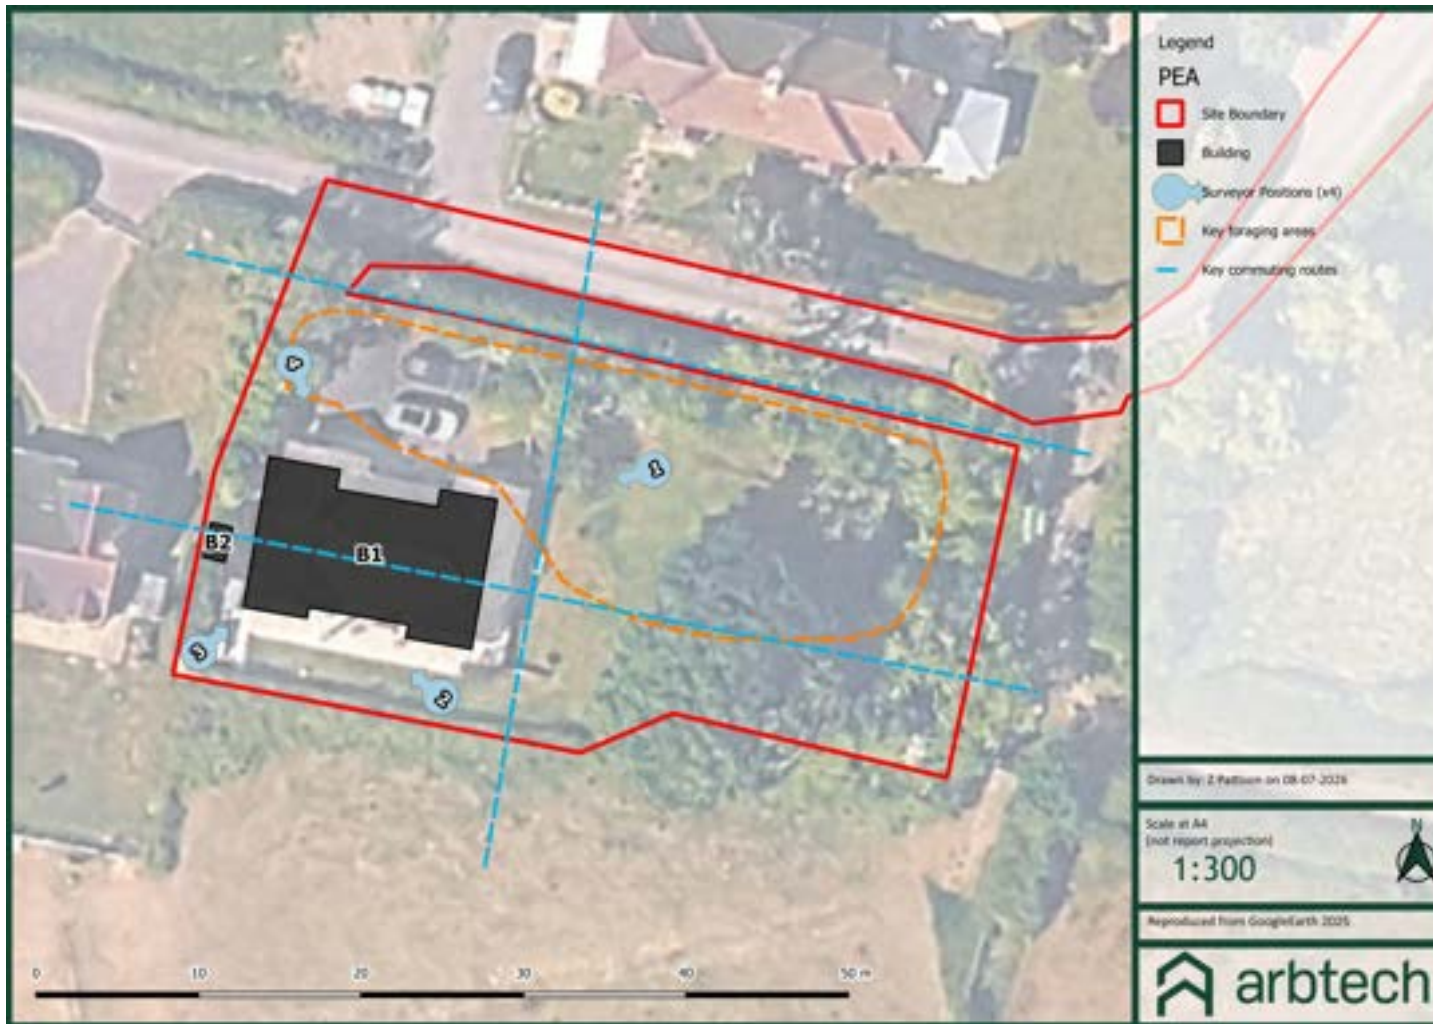
## Appendix 1: BERS plan

A diagram of the positions on site can be found in Appendix 1 along with the position images.
