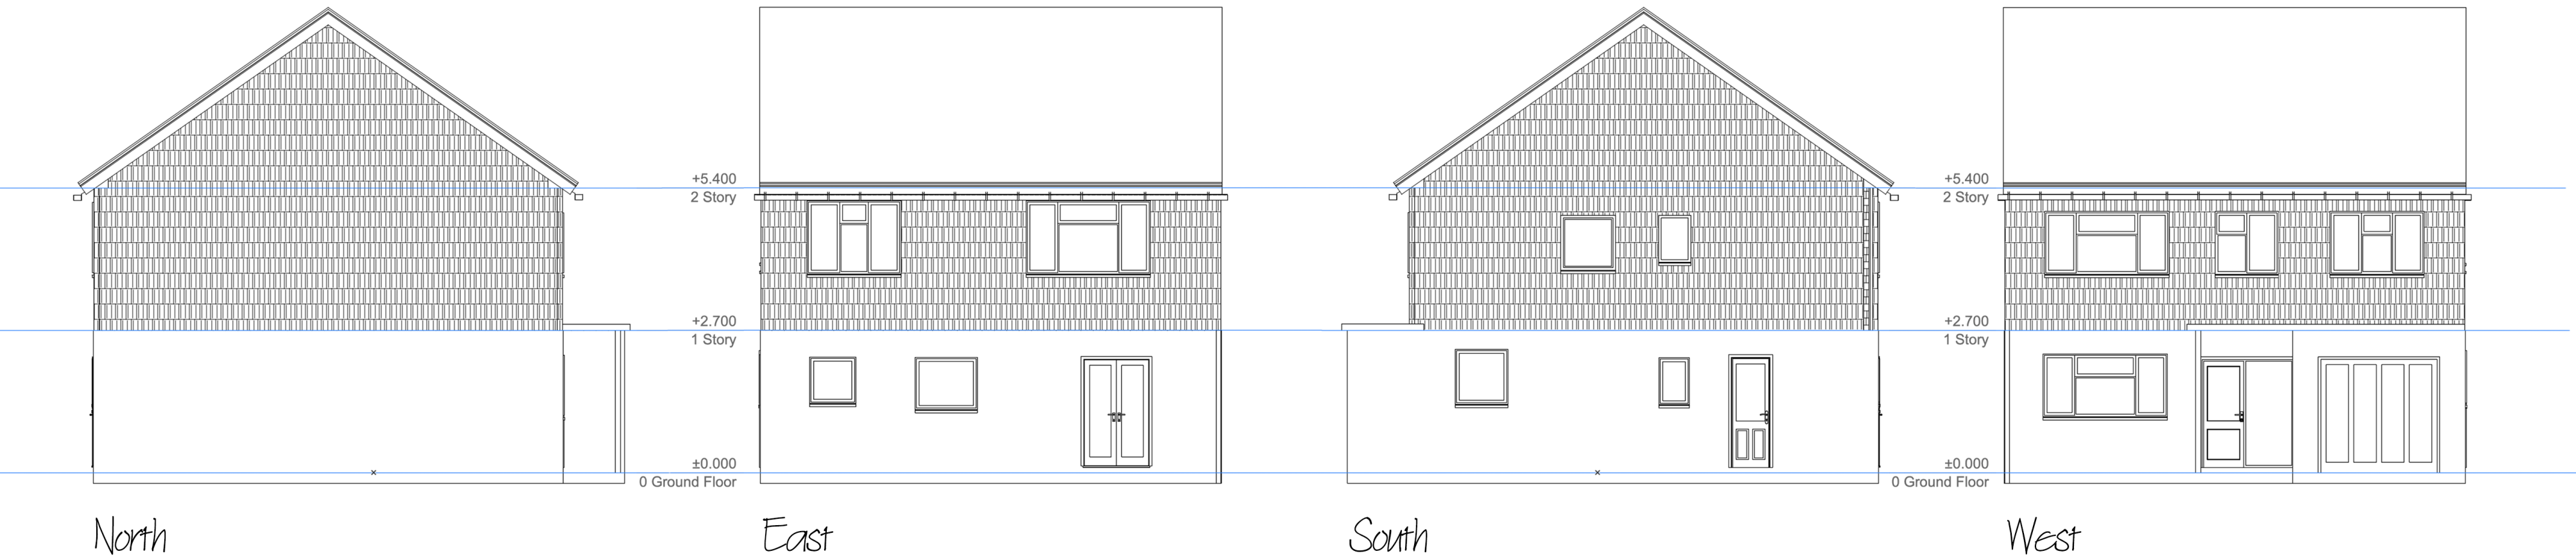
Existing Elevations      External face of first floor extending to gable consists of coloured red concrete tiles over timber batten and bitumen felt sheet covering. Overall poor condition with many slipped/damaged

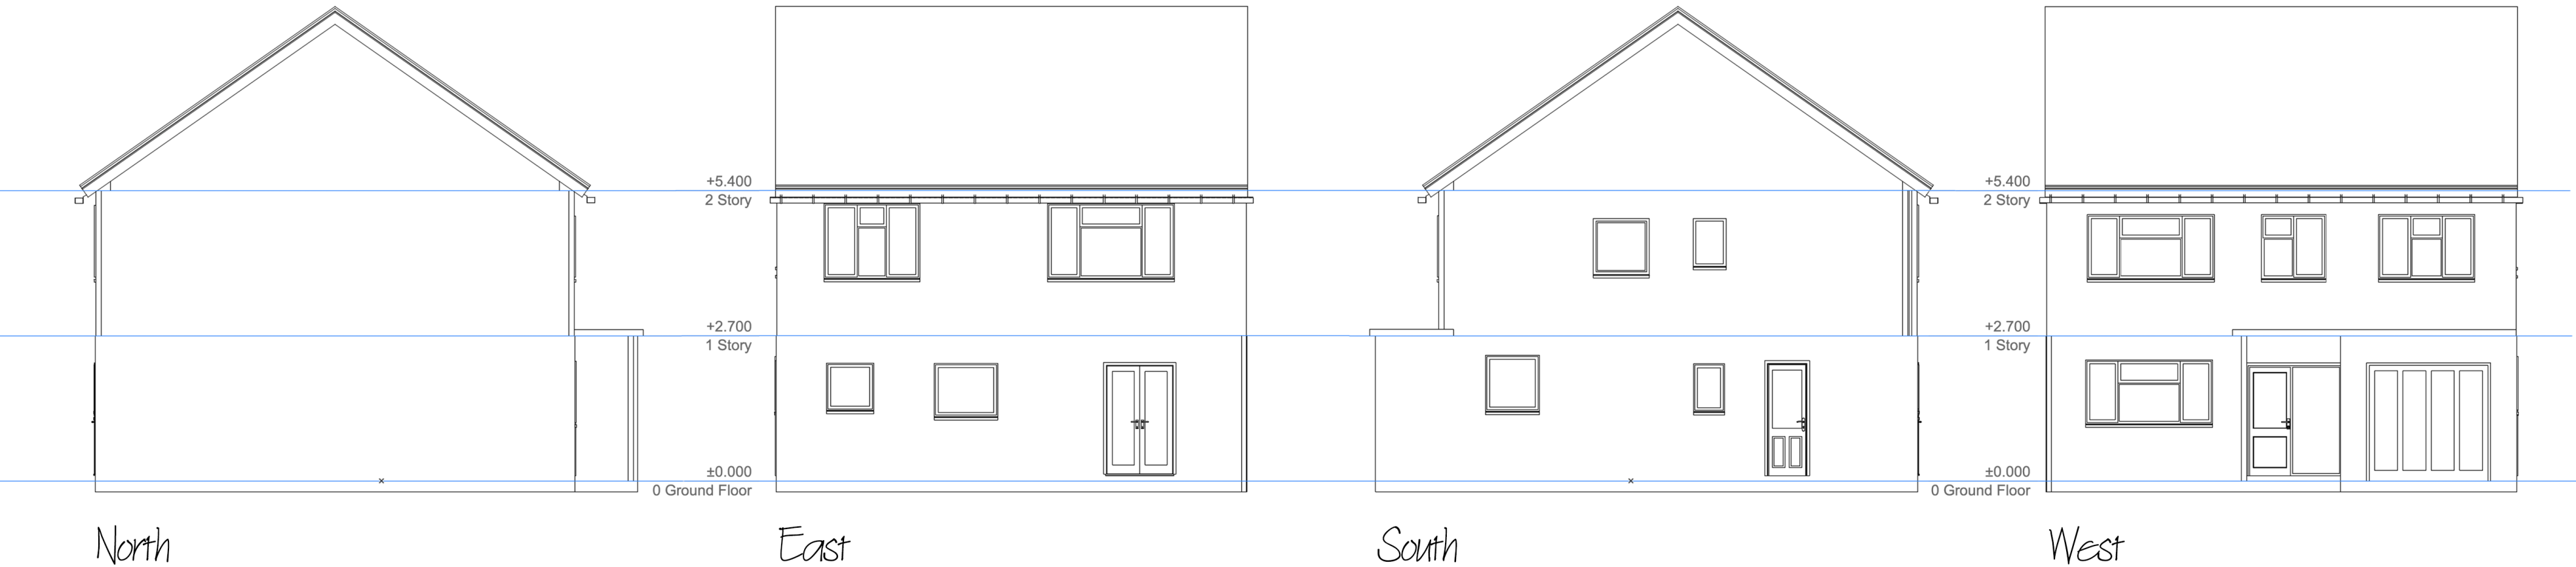
Proposed Elevations      External face of first floor extending to gable consisting of Mechanically fixed 90mm EPS external wall insulation covered with silicon render in custom colour NCS S 1505-Y20R
