LAND AT CRAWLEY ROAD, FAYGATE  
RESIDENTIAL DEVELOPMENT

STAGE 1 ROAD SAFETY AUDIT  
RESPONSE REPORT

APRIL 2026

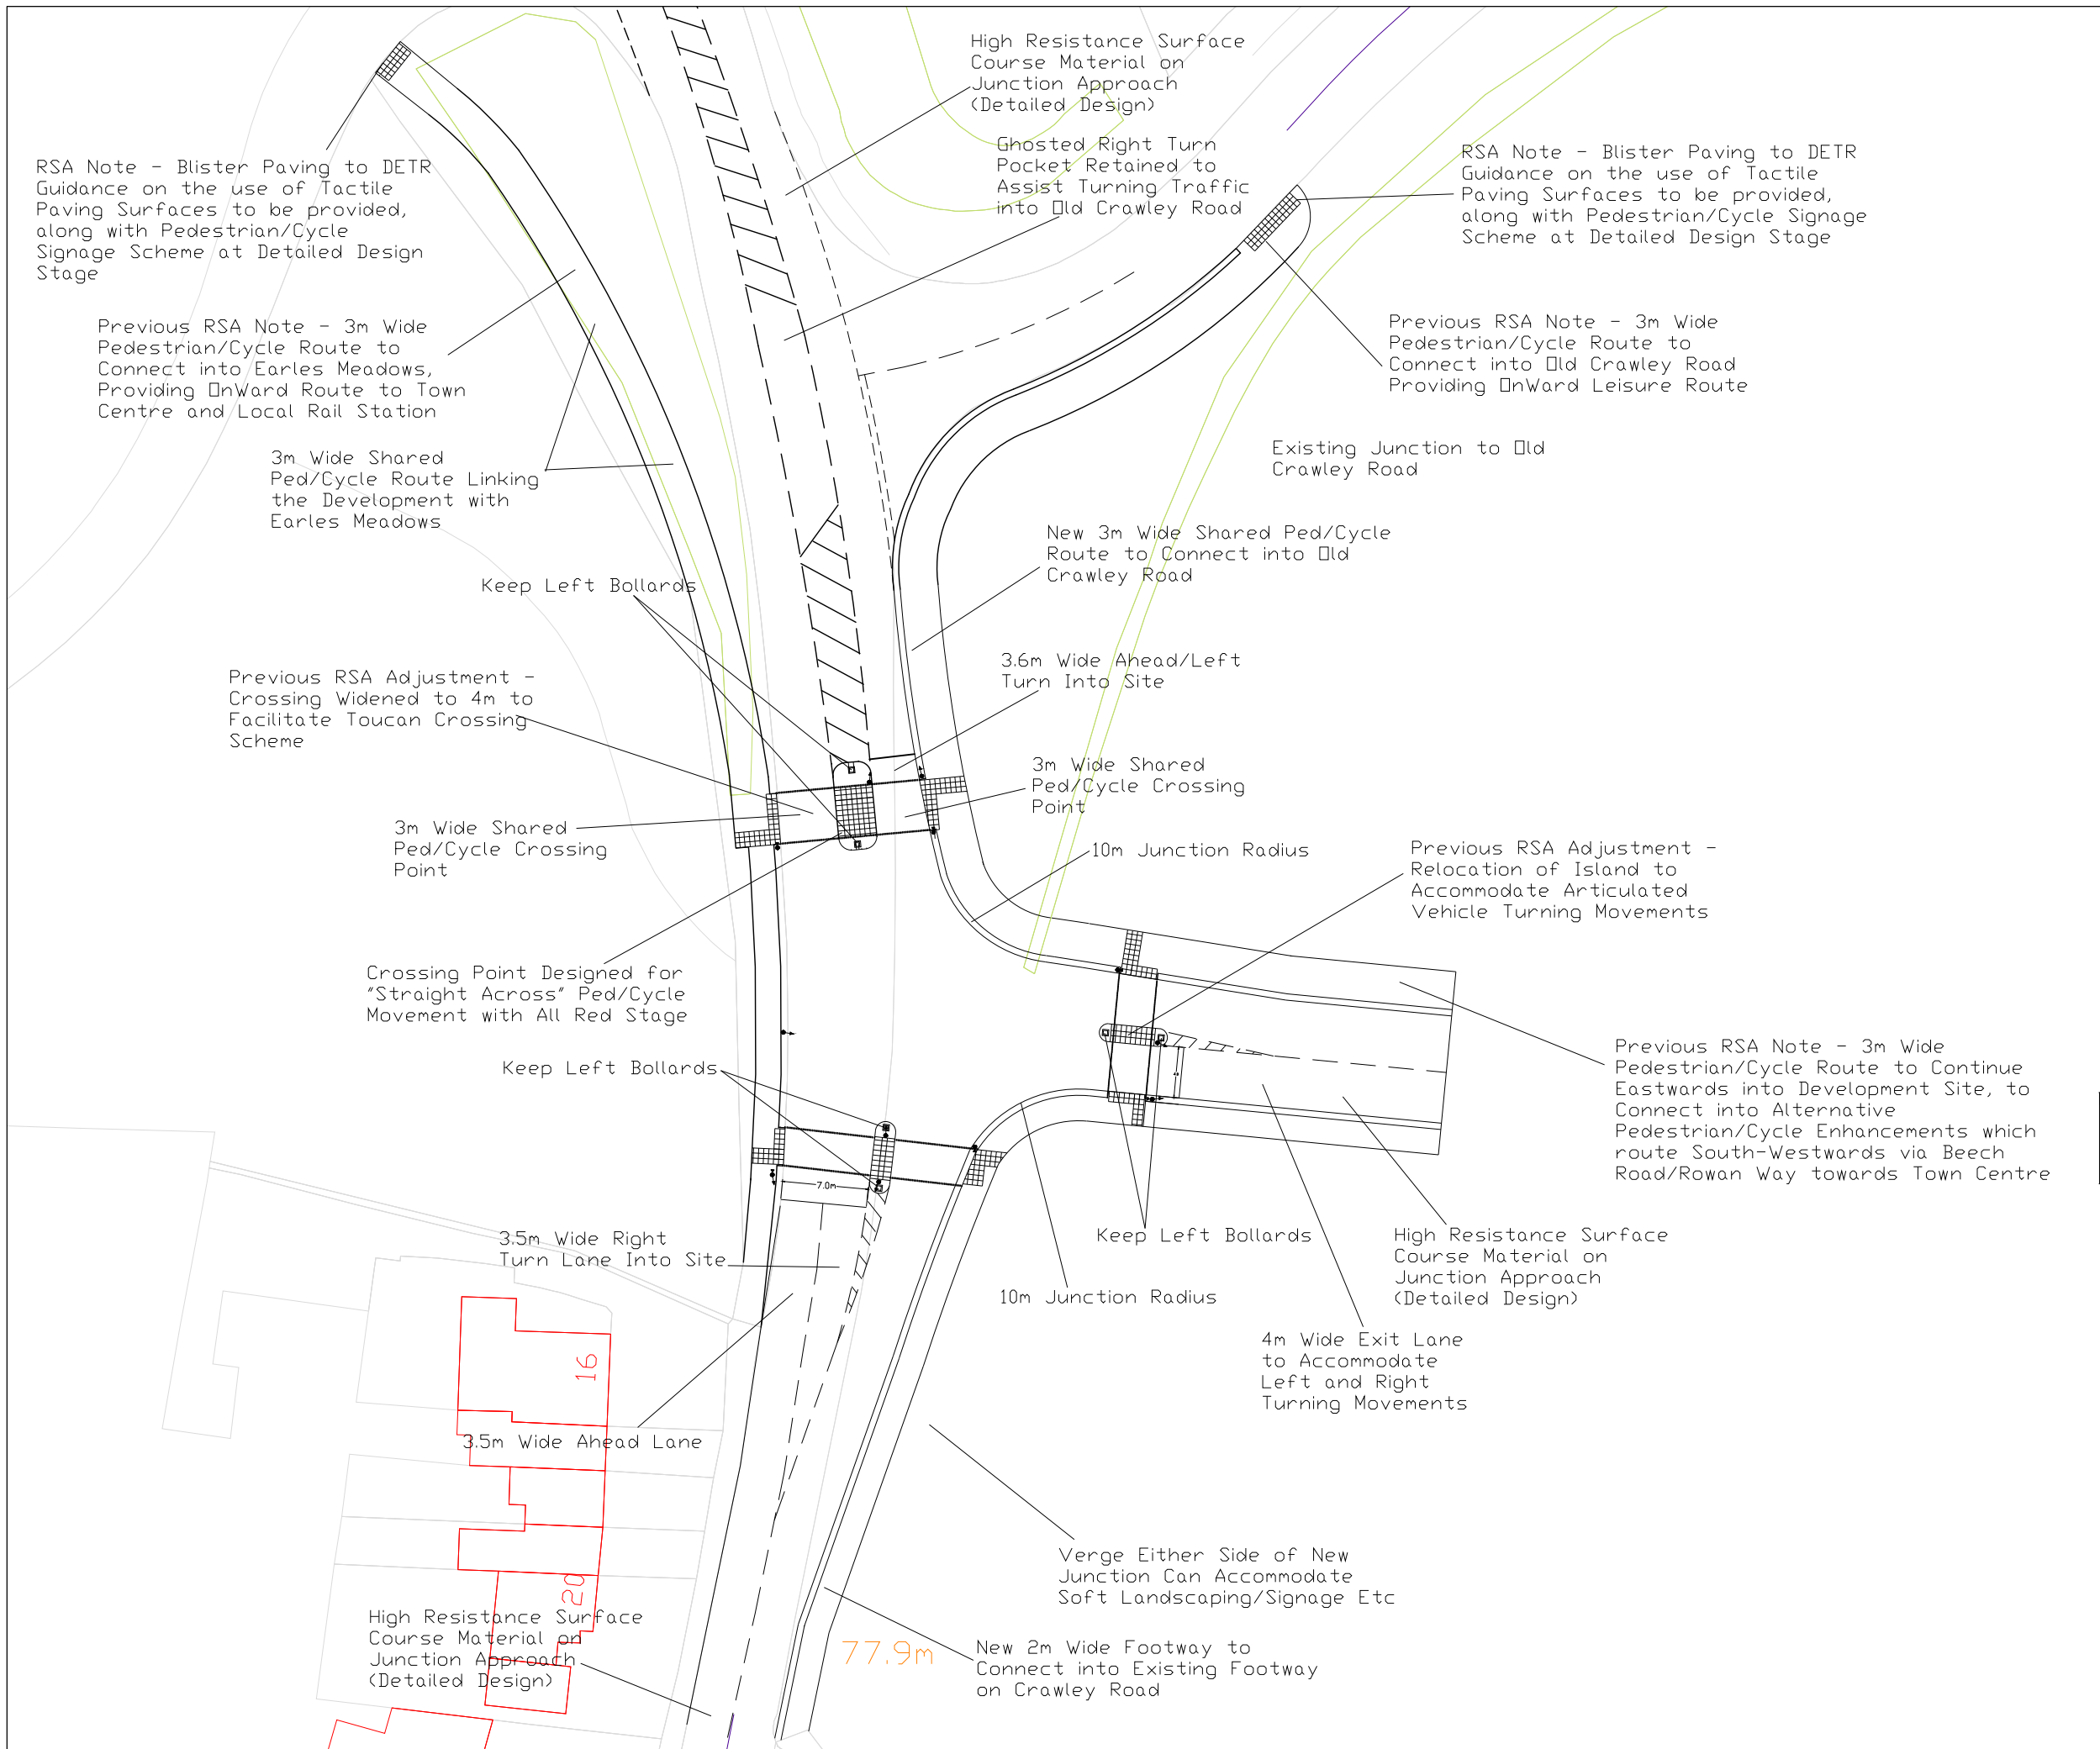
## **APPENDIX C**

- 2.33 In response to the RSA team's comments with the internal development layout being presented as an illustrative scheme, it will be possible to incorporate a parallel parking/service bay on the southern side of the development arm of the junction, close to the junction but outside of all visibility splays and junction equipment. The need for this bay has been noted on the updated drawing, provided in **appendix c**, and will be incorporated at detailed design stage.

- 2.37 The requirement for the detailed design to incorporate high resistance surfacing has been notated on the scheme drawing provided in **appendix c**.
