**Preliminary Roost Assessment, Bat Emergence Survey,  
BNG Review**

**Land at The Blue Ship, The Haven, Billingshurst,  
RH14 9BS**

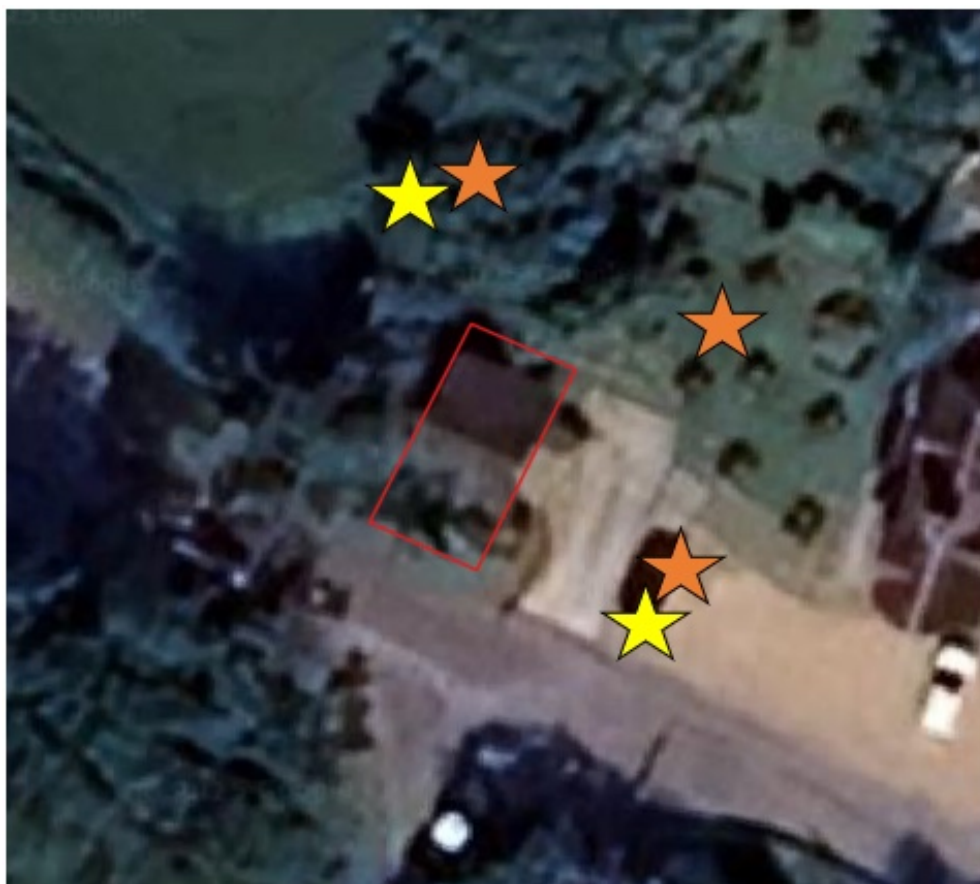
- 2.4 A dusk emergence survey was carried out on 6<sup>th</sup> August 2025. The survey started 15 minutes before sunset and was completed 1 and a half hours after sunset. The surveys followed Bat Conservation Trust guidelines (Collins 2016 & Interim Guidance Note 2022). Surveyors were positioned to cover all aspects of the building and areas of interest (Figure 3). Infra-Red (IR) cameras (Sony Handycam XAVC S and SiOnyx Aurora CDV-100C) were utilised during the survey to support surveyors. All surveyors were equipped with an Echo Meter Touch 2 Pro. Surveyors included Joe Hopkins MBiol (Hons) and Tom Rayfield BSc (Hons).

*Figure 2: Surveyor positions (yellow stars) and IR camera position (orange stars)*

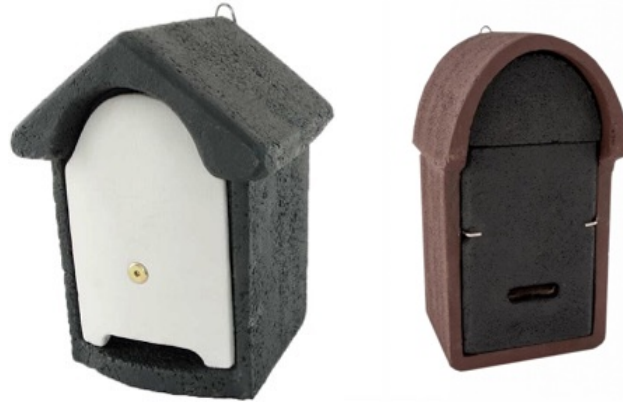
- Vivara Pro WoodStone Bat Box – A general-purpose bat box that supports a range of species (Figure 5). These can be hung on trees in a variety of heights and aspects in order to provide a variety of micro-climates.

- Large Multi Chamber WoodStone Bat Box – This is a multipurpose box designed for larger colonies and a range of bat species including pipistrelles, noctules and brown long-eared bats. These could be hung on the buildings on site post development (Figure 5).

*Figure 5: Vivara Pro WoodStone Bat Box (left) and Large Multi Chamber WoodStone Bat Box (right)*

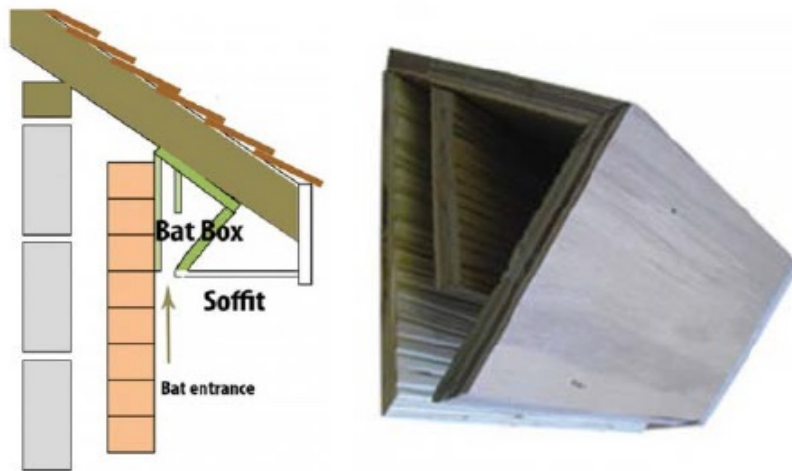
- 4.8 Another type of roost which can be incorporated into the redevelopment of the building is a soffit bat box. This caters for crevice-dwelling species such as pipistrelles and certain *Myotis* species such as Natterer's and Whiskered bat. This type of box makes use of an underutilised area of a building and would require no maintenance as droppings would drop through the entrance hole, shown in Figure 6.

*Figure 6: Soffit bat box (Wildcare)*

- 4.8 Bat boxes should ideally be exposed to the sun for most of the day, therefore southern and western aspects are preferable. Bat boxes should be hung as high as possible (around 5m above the ground).
- 4.9 It is always recommended that where possible enhancements for wildlife are included within the new development.

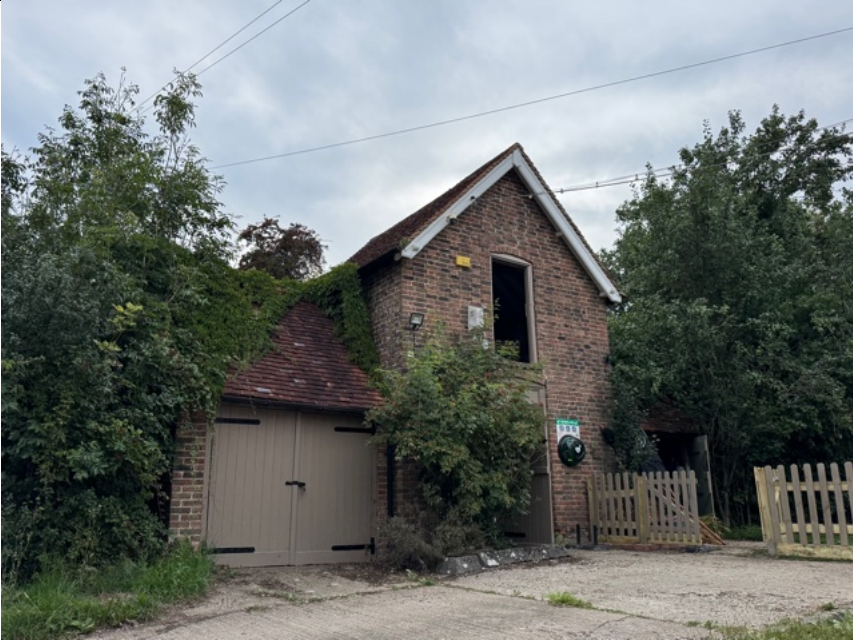
- 3.4 The outbuilding (building B1) present on site was assessed for its suitability for roosting bats.
- 3.5 The building is a two-story brick-constructed building in active use for storage. The clay-tiled roof is multi-level, pitched, and timber framed. The building contains four internal void spaces.
- 3.6 Externally, building B1 was in slightly worn condition. Some visible cracks were present in the brickwork with some small gaps present. The eaves were mostly open, except in the southern part of the building where chicken wire was present obstructing this. The roof supports some lifted and loose clay tiles were present. a gap was present between the ridge tiles in the northern part of the building. Moss, Virginia creeper, and English ivy

| <p><b>Photograph 1:</b></p> <p>Building B1</p> <p>external view</p> | A photograph of a two-story brick building with a gabled roof. The building is partially covered in ivy, particularly on the left side. A large, light-colored double door is visible on the ground floor. A small window is visible on the upper floor. The building is surrounded by trees and a wooden fence in the foreground. |

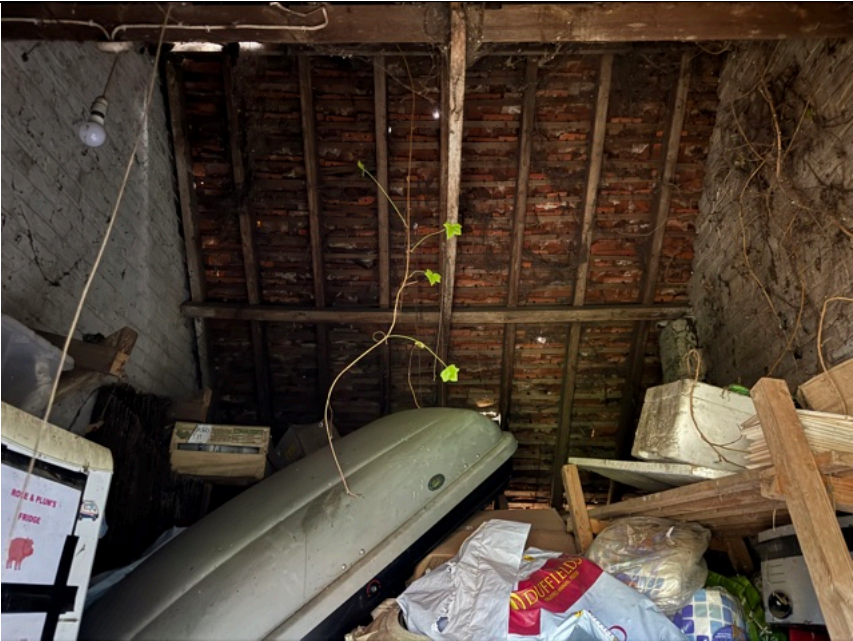
- 3.7 Building B1 was inspected internally, and all four internal voids were accessed. Internal void 1 was located on the ground floor in the north of building B1. It was constructed of timber beams with no lining. This void was actively in use for storage, and dense cobwebs and mouse droppings were present throughout. Multiple gaps were present in the roof tiles allowing the ingress of natural light, providing potential points of access for bats, although no direct evidence of roosting bats was recorded within this void.

| <p><b>Photograph 2:</b></p> <p>Internal void 1</p> <p>in active use for storage, with exposed roof tiles and gaps allowing ingress of natural light visible</p> | A photograph of the interior of a building, showing a cluttered storage area. The roof is made of exposed wooden beams and tiles, with gaps allowing natural light to enter. Various items are stored on the floor, including a large white bag, a red bag, and a white box. A small plant is visible hanging from the ceiling. |

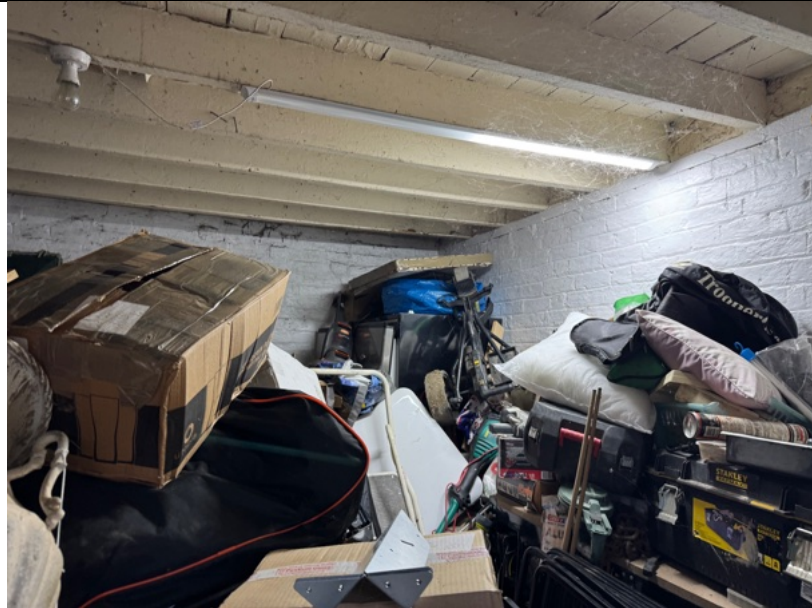
**Photograph 3:**

- 3.9 Internal void 3 was located on the ground floor in the south of building B1. It was brick-constructed with a wooden ceiling that isolated a small inaccessible void beneath the apex of the roof. This void was actively in use for storage and dense cobwebs and mouse droppings were present throughout. Small gaps were present in the ceiling allowing potential access into the apex void and roof by bats, although no direct evidence of roosting bats was recorded within this void.

Internal void 3  
in active use for  
storage

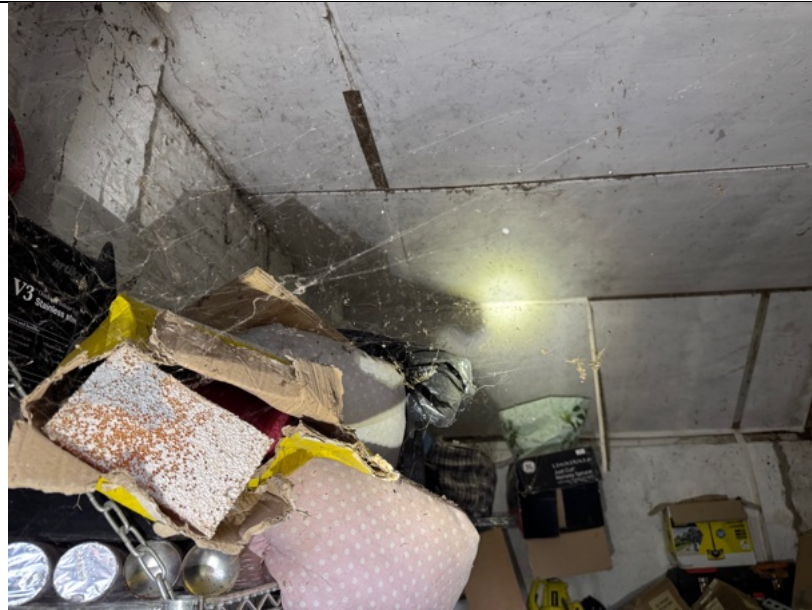
**Photograph 4:**

Internal void 3  
in active use for  
storage

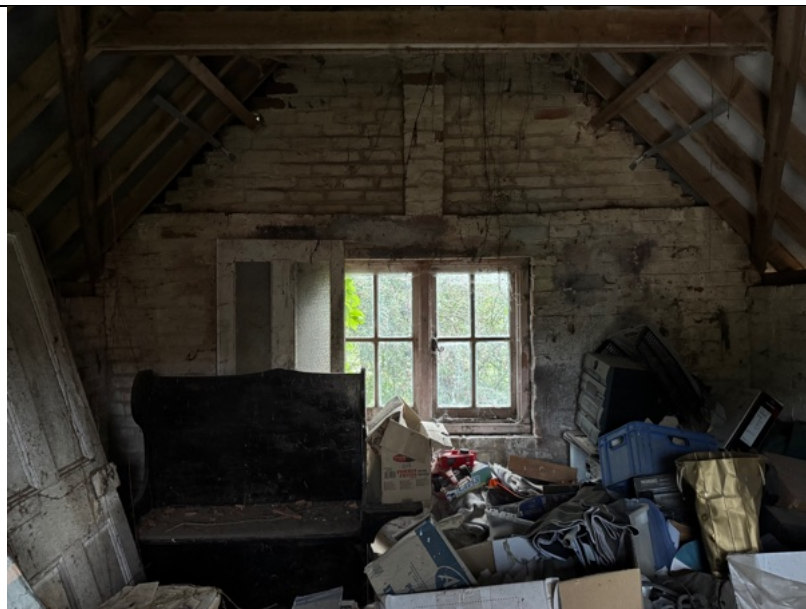
**Photograph 5:**

- 3.10 Internal void 4 was located on the first floor in the centre of the building. It was timber-constructed with a lining. A large window was present on the western aspect of the building allowing ingress of large amounts of natural light, reducing the suitability of the internal environment of the void for roosting bats. This void was actively in use for storage and dense cobwebs and mouse droppings were present throughout. A partial Peacock butterfly *Aglais io* wing was recorded within the void. No direct evidence of roosting bats was recorded within this void.

Internal void 4  
in active use for  
storage, with  
large windows  
allowing ingress  
of large  
amounts of  
natural light

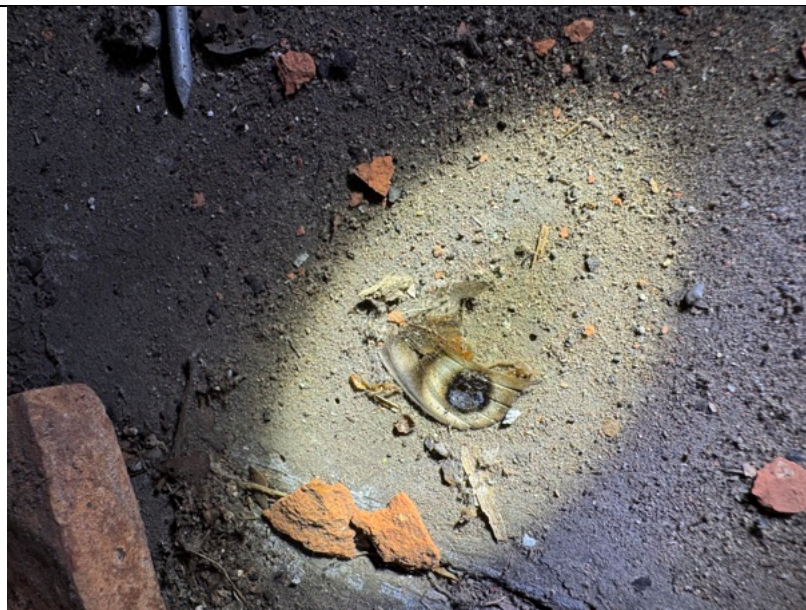
**Photograph 6:**

Partial Peacock  
butterfly wing  
present within  
internal void 4

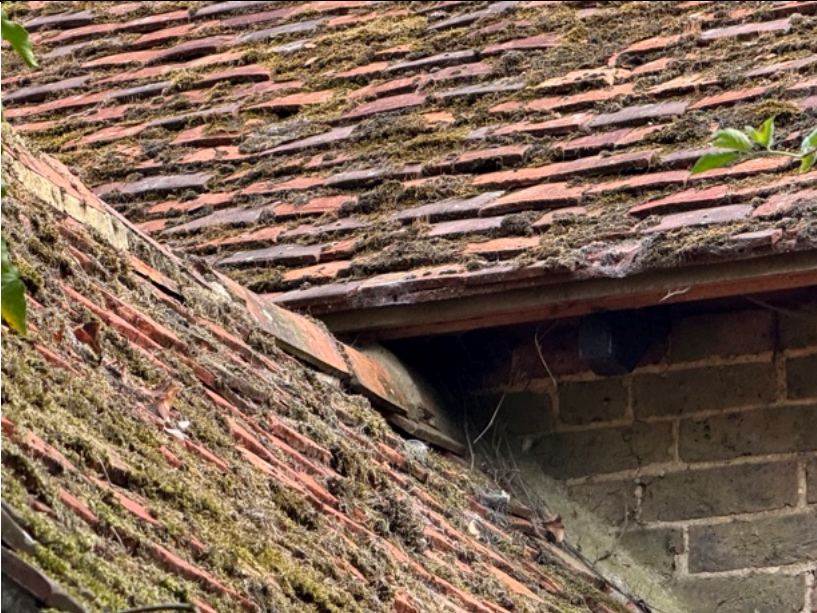
- 3.11 Overall, whilst no direct evidence of roosting bats was recorded, based on the number of PRFs recorded externally on the building, building B1 is considered to have 'Low' suitability for roosting bats.

- 6.1 The site consisted of a single public house outbuilding in active use for storage. This building (building B1) was subject to a Preliminary Roost Assessment and was considered to support 'Low' suitability for roosting bats due to the presence of gaps under loose, raised, and missing clay roof tiles.

| <p><b>Photograph 7:</b></p> <p>Gaps present underneath loose, lifted, and missing clay roof tiles</p> | |

- 4.3 It is understood that the building will be refurbished as part of the development, and as such, it is advised that an update inspection of the building is undertaken prior to any works, the results of which will determine the need of any subsequent work would be

required. If no bats or new evidence of bat activity is identified (e.g. new bat droppings), works can commence without a licence, but it is recommended that sensitive tile removal is undertaken.

- 4.4 A precautionary approach to the tile removal would be required. If a bat is found during works, then all works must cease and a licence applied for.

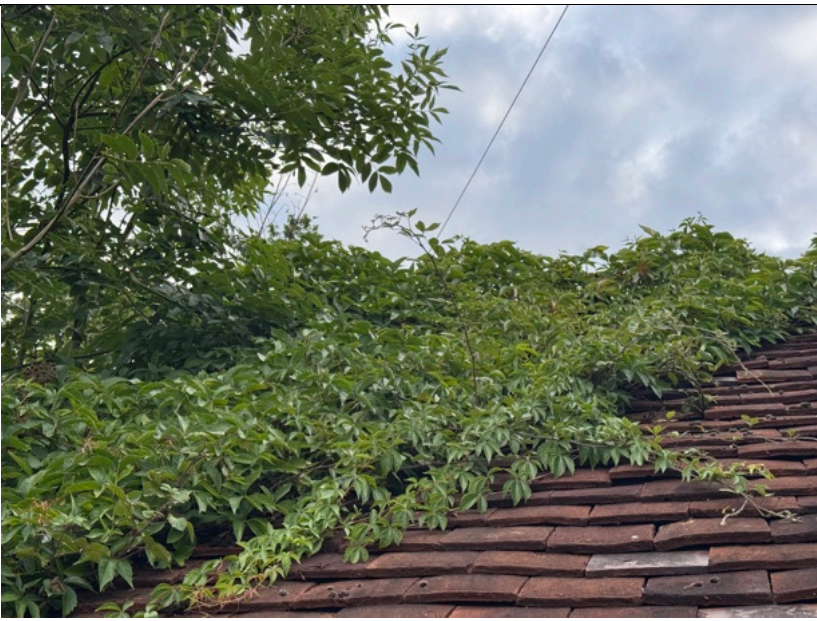
were present growing over the roof effectively sealing some areas and providing some potential value for bats.

| <p><b>Photograph 8:</b></p> <p>Virginia creeper present externally on building B1</p> | |

4.11 A Schedule 9 Invasive non-native species Virginia Creeper *Parthenocissus quinquefolia* was recorded growing externally on building B1. It is recommended that this species is sensitively removed by a specialist ecological contractor.
