**QUANTITATIVE GROUND  
CONTAMINATION RISK  
ASSESSMENT REPORT**

**LOT 8  
STONEHOUSE FARM  
PLUMMERS PLAIN  
LOWER BEEDING  
WEST SUSSEX**

**PROJECT REFERENCE: P17630**

**REPORT REFERENCE: R17095**

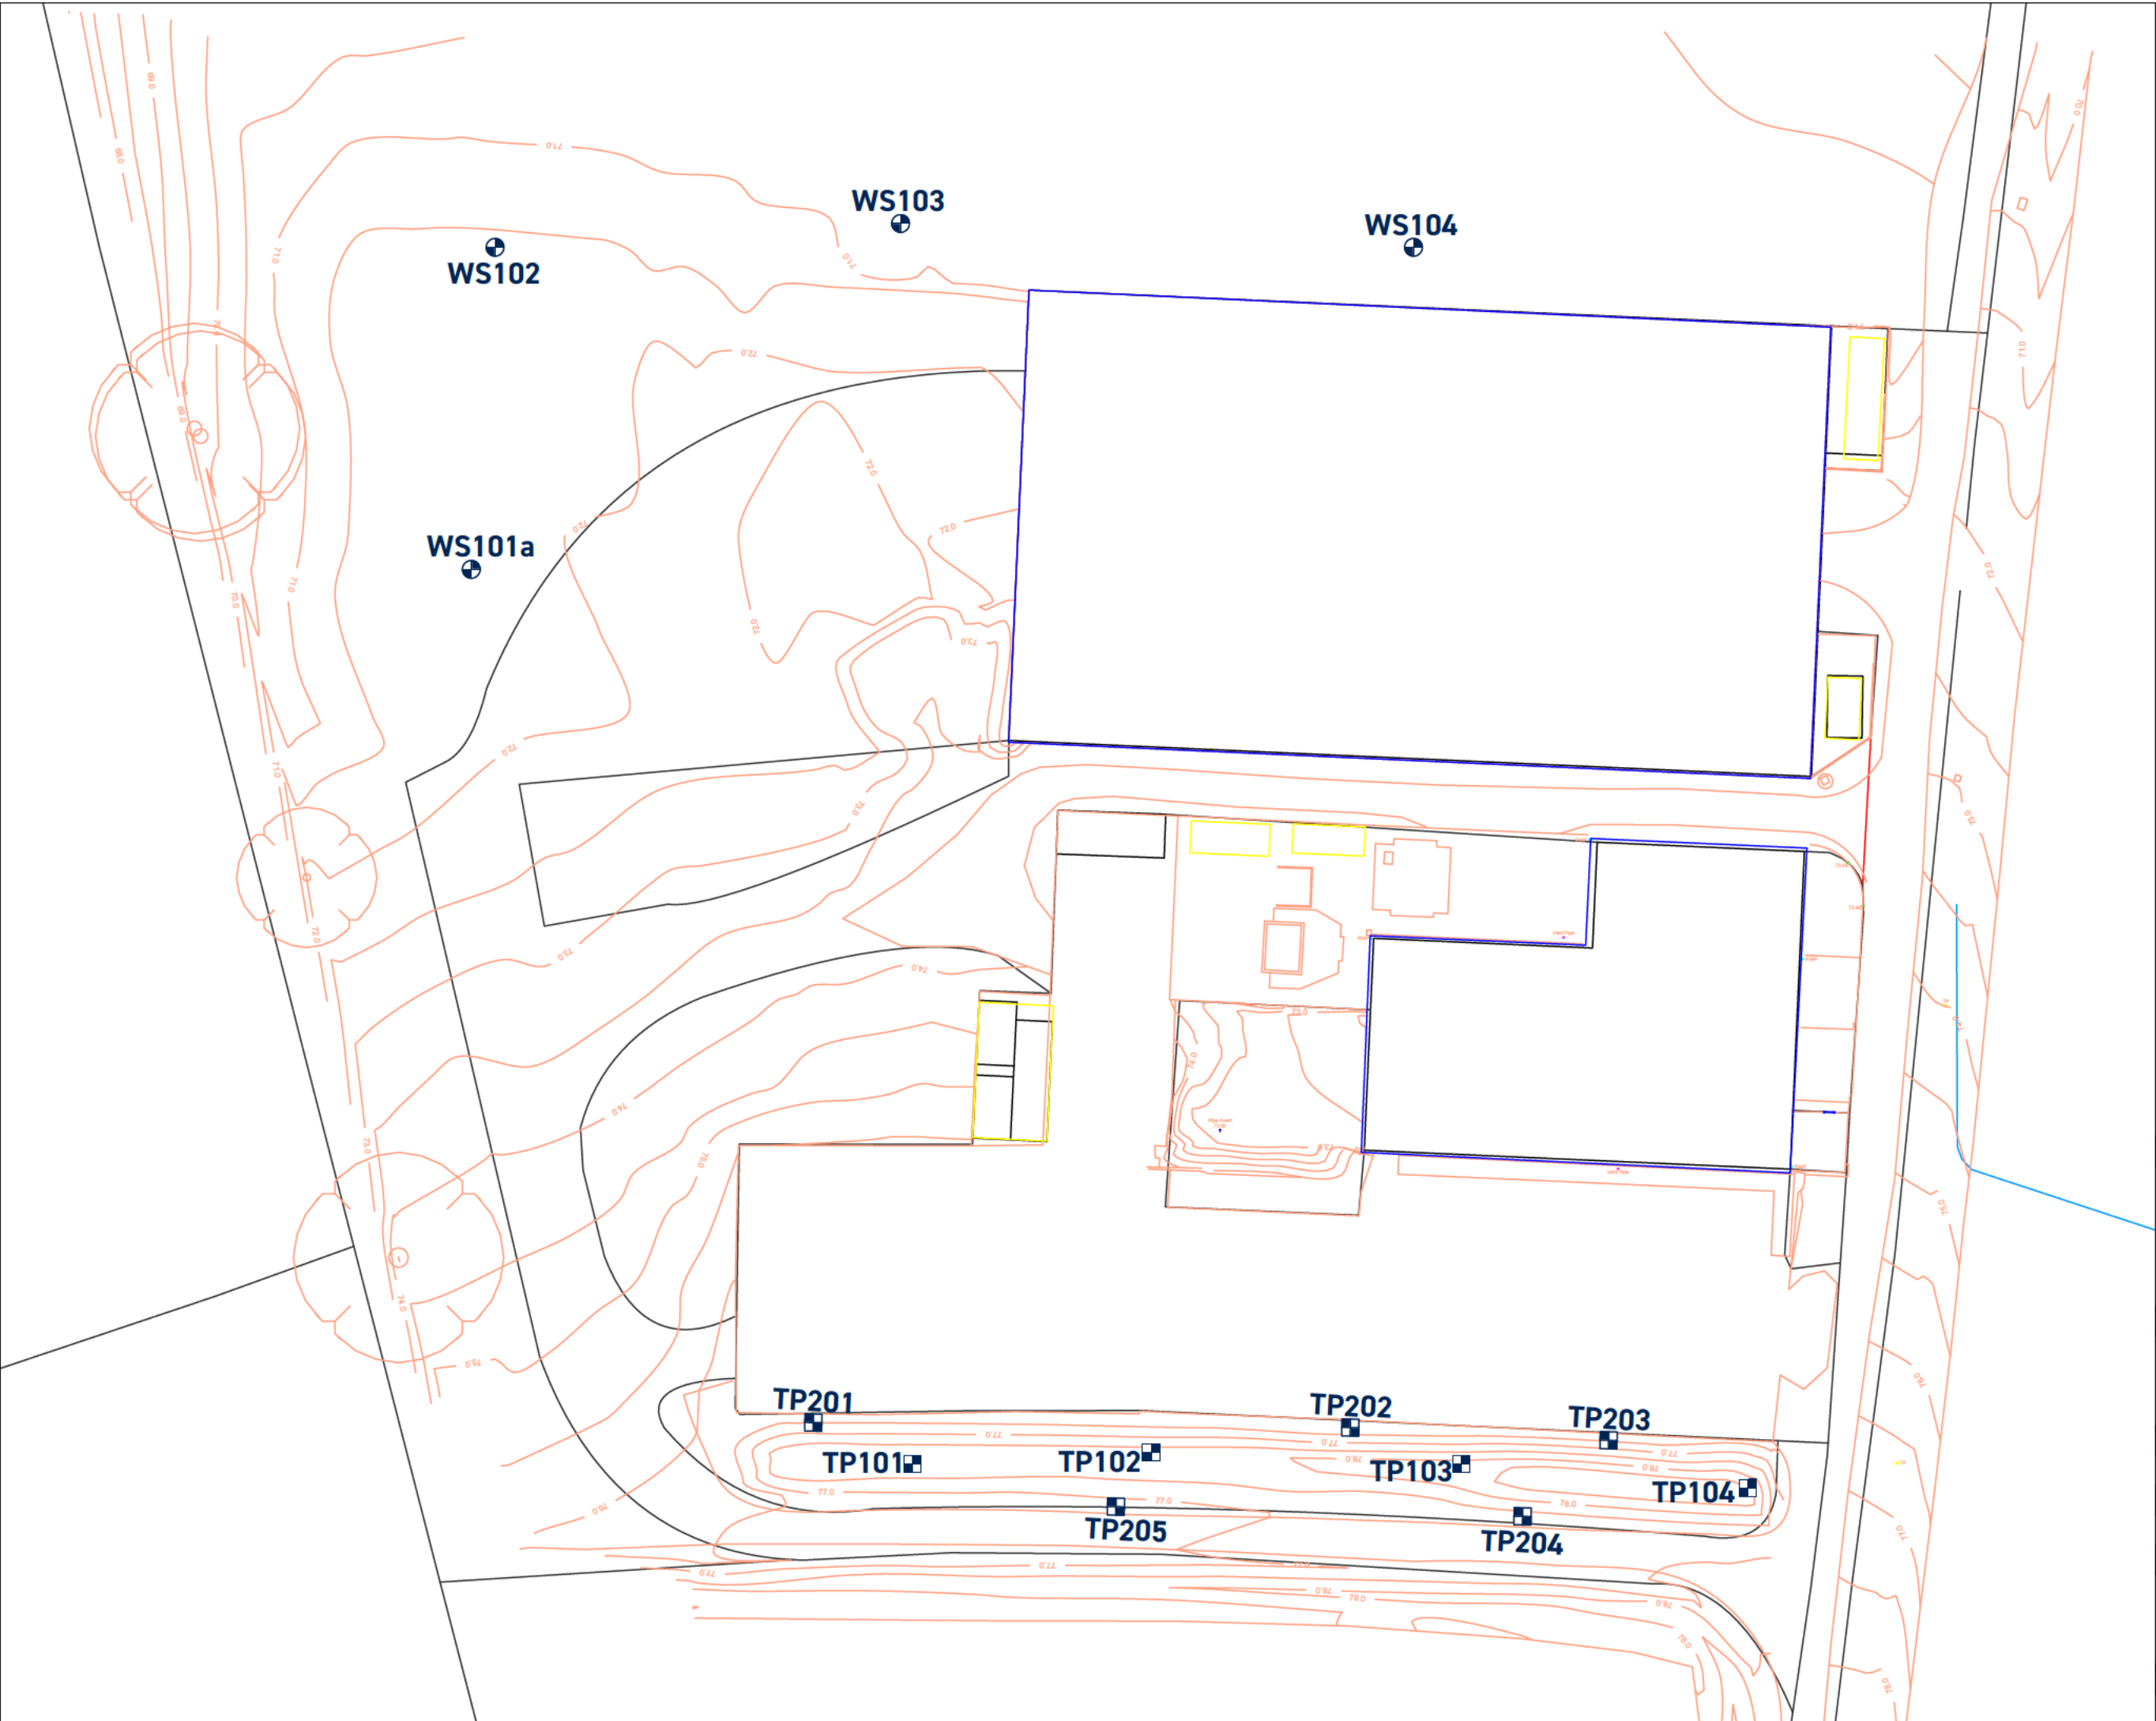
The current phase of intrusive site works comprised a series of dynamic sampler boreholes and hand dug pits. The intrusive work was carried out on 13<sup>th</sup> February 2025 and a further phase of investigation was completed on 26<sup>th</sup> March 2026. The exploratory hole locations from both these phases are shown on Figure 2.

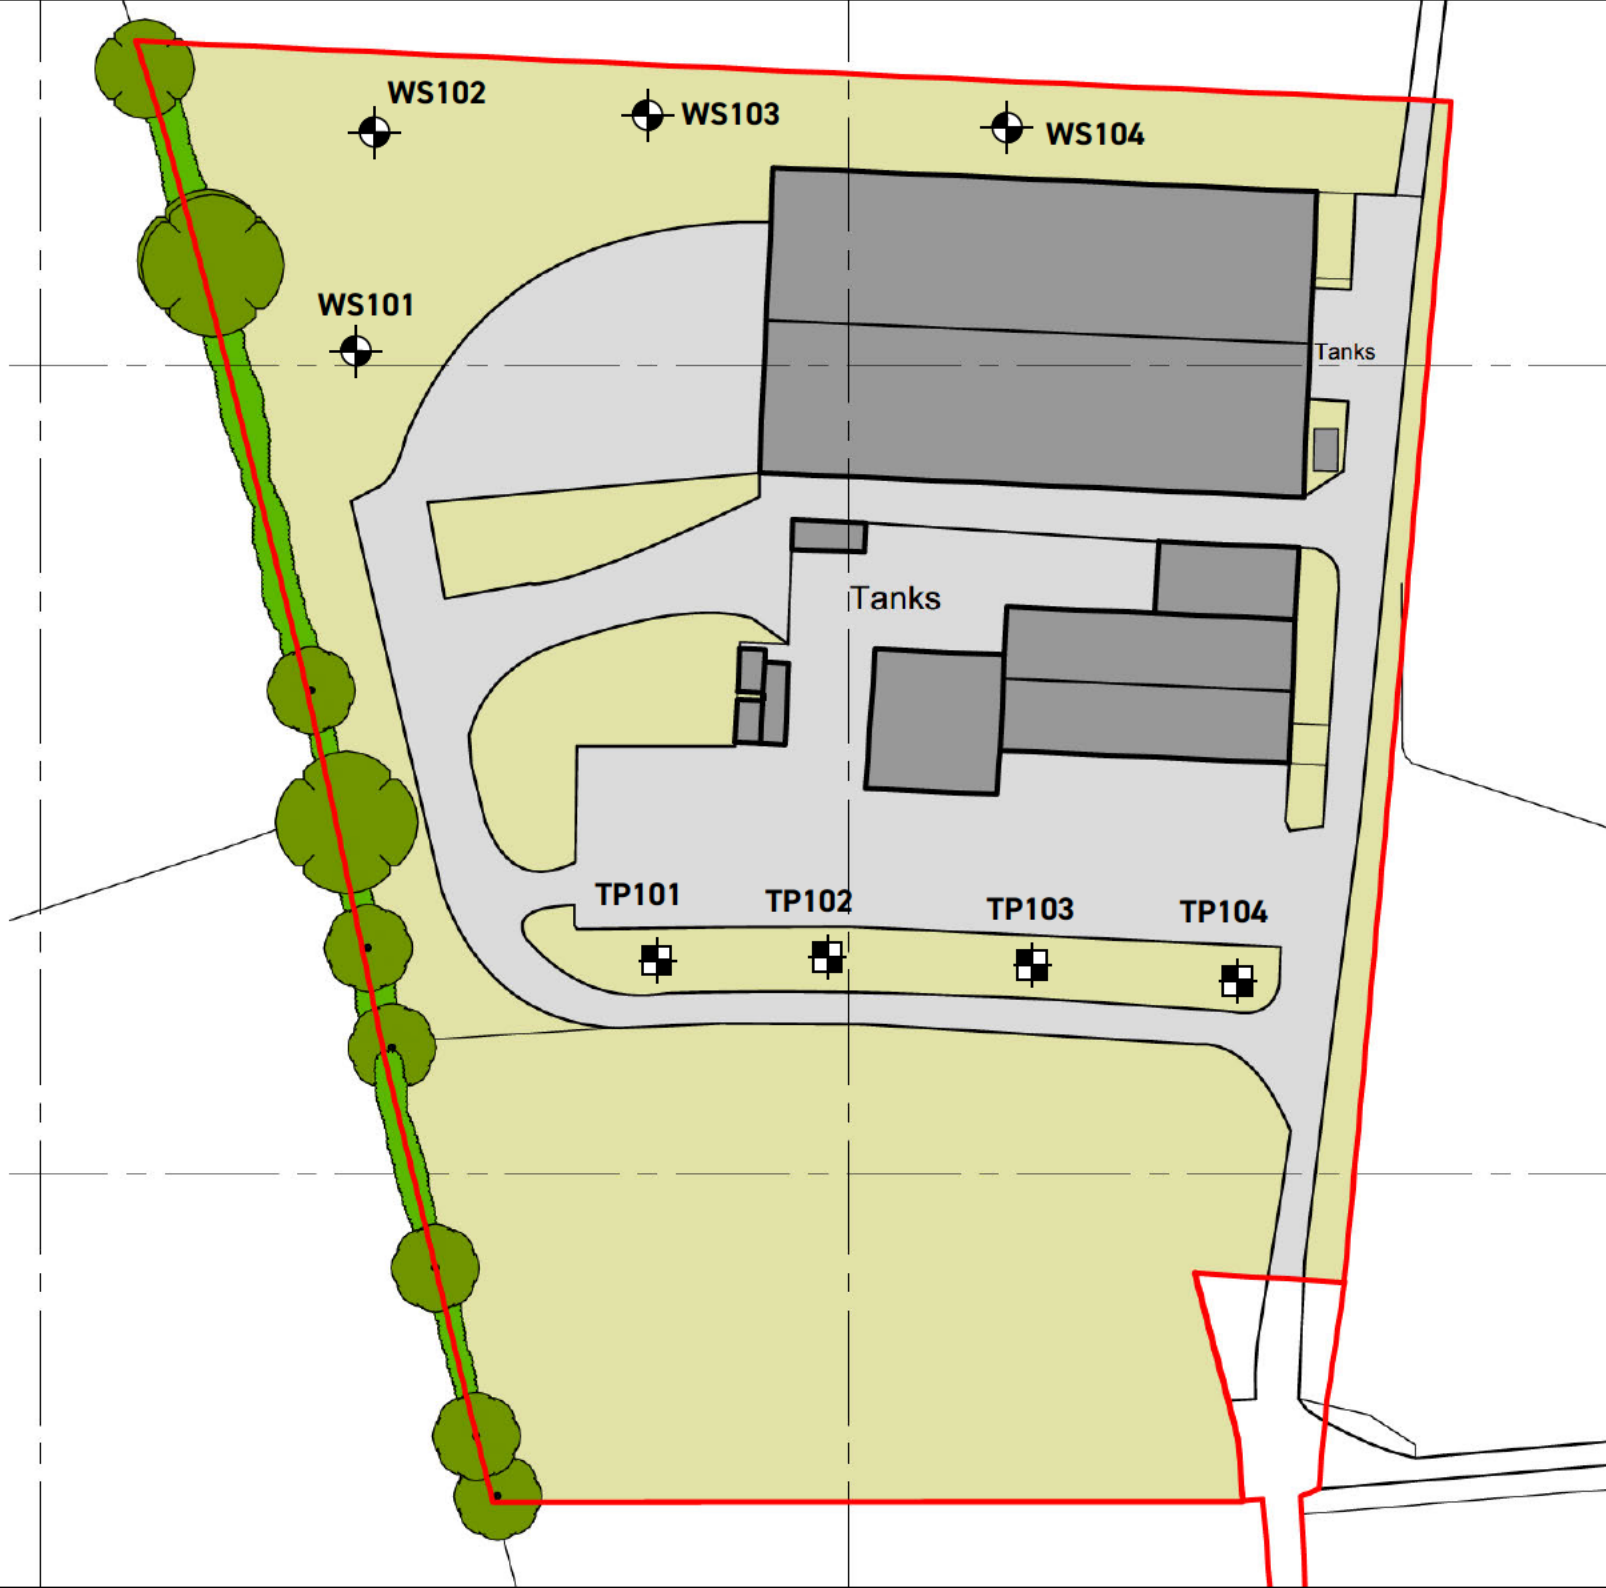
**Figure 3**

Proposed Investigation Layout

Although previous investigation and testing of the soils from the bund recorded no evidence of contamination that would pose an unacceptable risk to end users of the proposed development, to address the concerns of the local authority it is recommended that a further four hand dug pits are excavated into the earth bund.
