## Preliminary Roost Assessment

Cedar Cottage, Sandygate Lane, Lower Beeding, Horsham, West Sussex, RH13 6LR

This report is prepared to inform a planning application with the Horsham District Council. The proposal is described as:

The construction of ~25 dwellings.

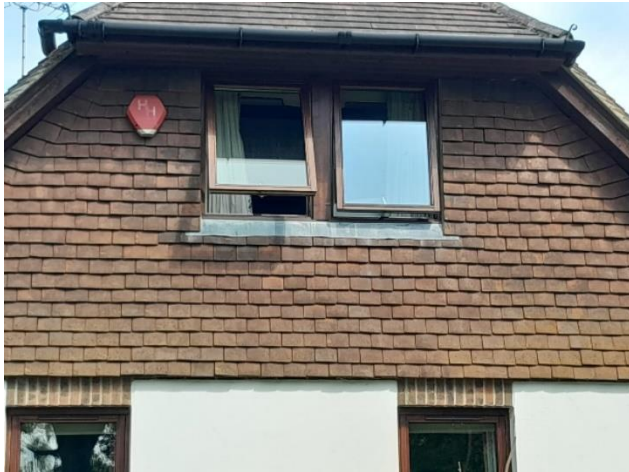
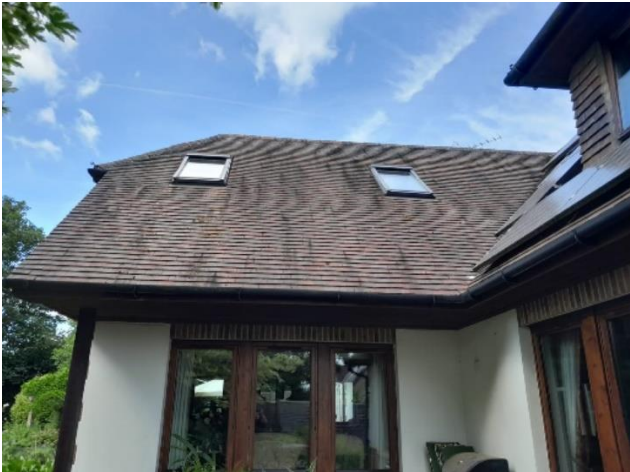
| Description | Photographs | |
|---|---|---|
| Overview of building | | |

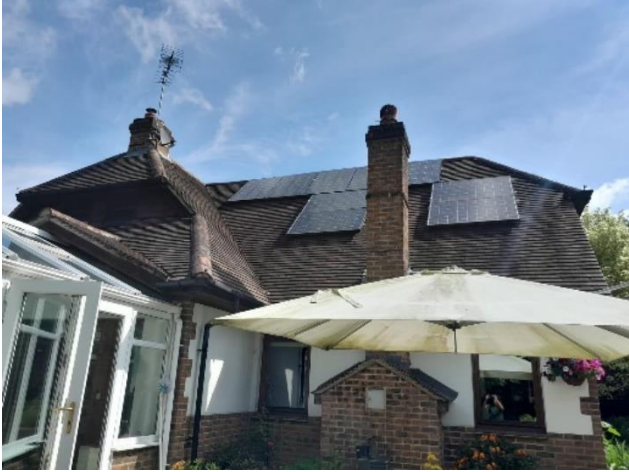
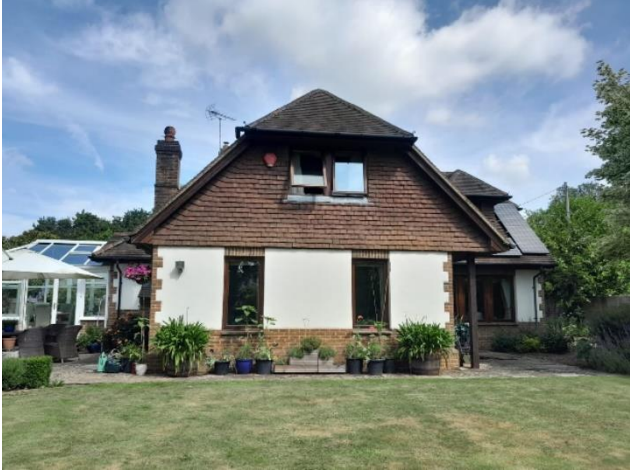
| <p>Suitable roosting features</p> <ul style="list-style-type: none"><li>• Gaps under hung clay tiles</li><li>• Gaps under lifted roof tiles</li><li>• Gaps under lifted lead flashing</li></ul> | | |

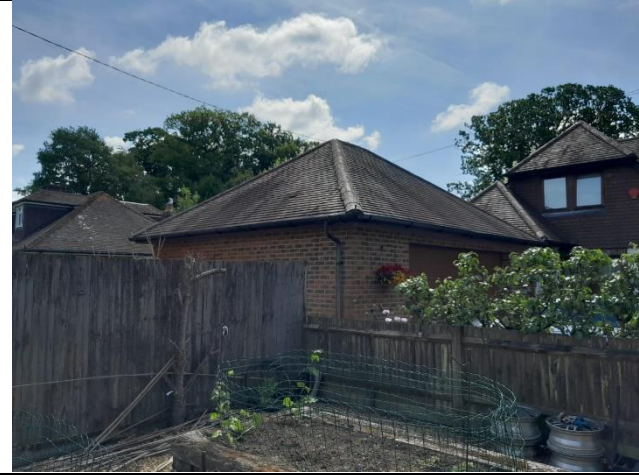
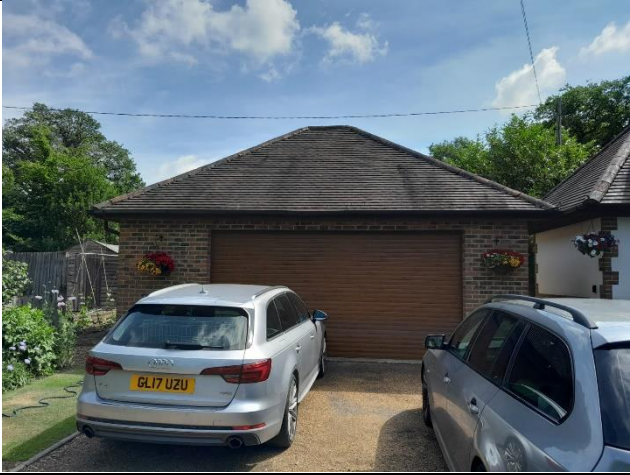
| | <p><u>Building 2</u></p> <p>Building two is a single storey, square shaped, brick-built garage with a hip roof. There are gaps underneath slipped roof tiles which are suitable for roosting bats. The interior comprises a vaulted ceiling, lined with breathable membrane. No direct evidence of bats was observed in the interior or exterior. This building is assessed as <b>low value</b> to roosting bats.</p> |

| Building 2 Overview | | |
