# HB Archaeology & Conservation Ltd

HARWOODS, WEST END LANE, HENFIELD,  
WEST SUSSEX, BN5 9RF

## HERITAGE STATEMENT AND IMPACT ASSESSMENT (NGR: TQ 19409 15365)

Prepared for  
Mr and Mrs Hazel

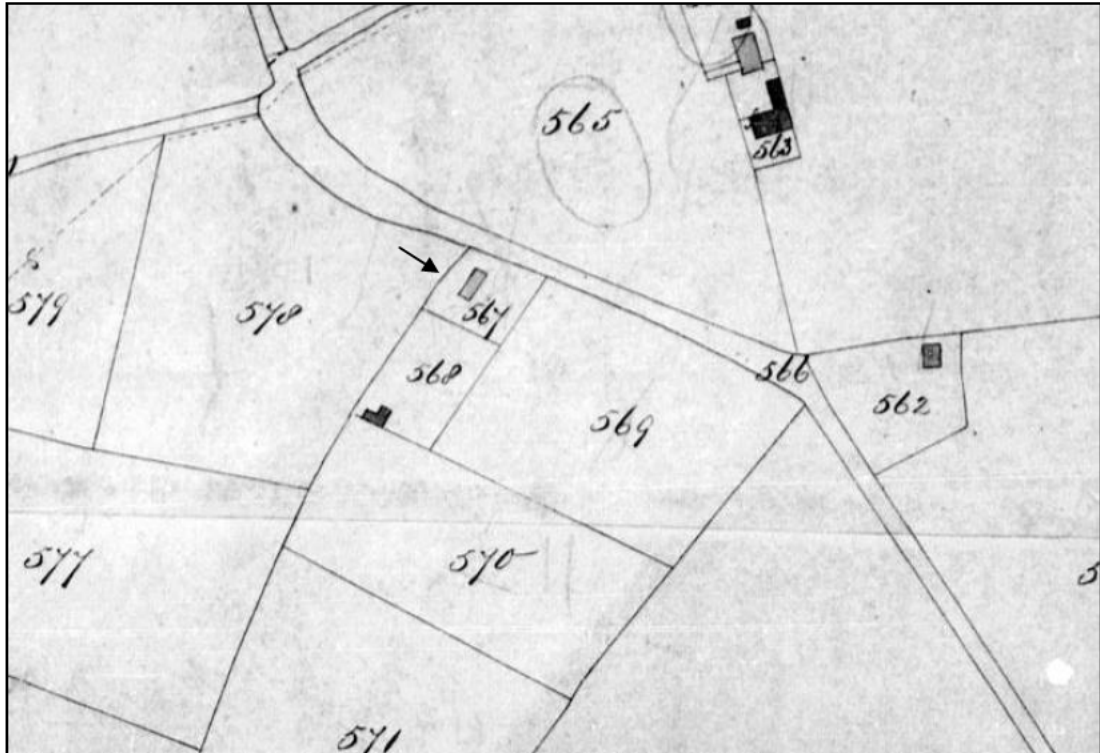
Plate 1: Henfield tithe map extract showing the property in 1845

- 5.1.2 The tithe map of 1845 shows house (plot 567) and a detached L-plan ancillary building in a field to the south of it (Plot 568). The tithe apportionment records the owner and occupier as William Trower, with plot 567 described as a cottage and garden and plot 568 as garden field. Plots 569-573 were under the same ownership and occupation, amounting to a holding of 8 acres, 1 rood and 14 perches.

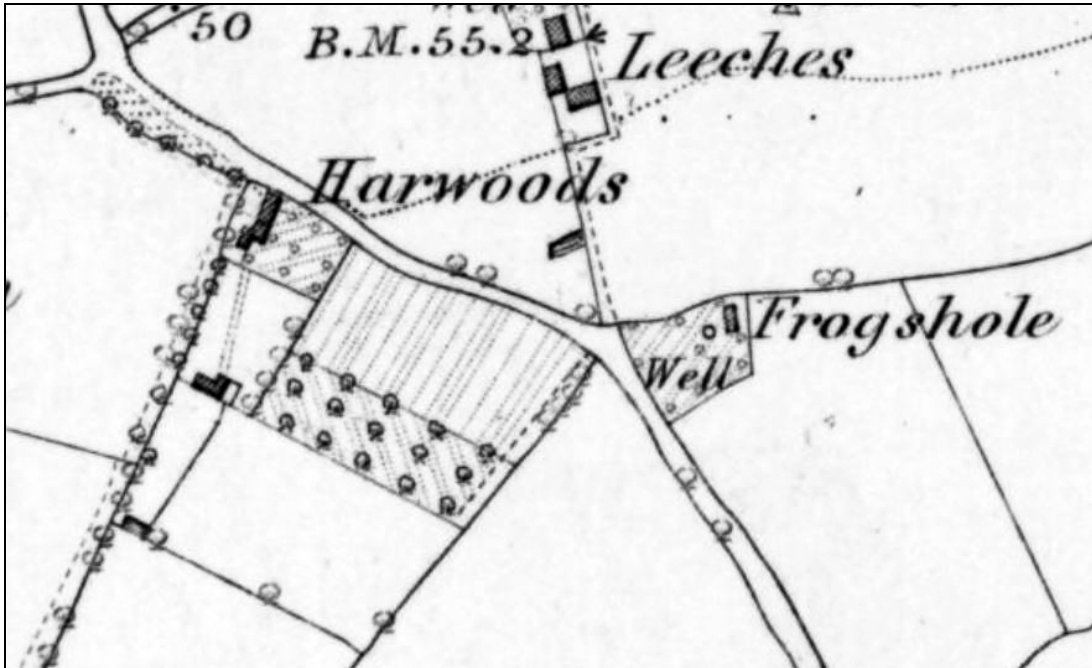
Plate 2: Extract of the 6 inch First Edition Ordnance Survey map, 1874

- 5.2.2 The 6 inch first edition Ordnance Survey map of 1874 shows the same arrangement as that of the tithe map, albeit with extensions to the southwest corner of the house and the addition of a new detached structure in the field to the south of its earlier counterpart (compare Plates 1 and 2). The large field to the east of the buildings is shown under cultivation to the north and as an orchard to the south (Plate 2).

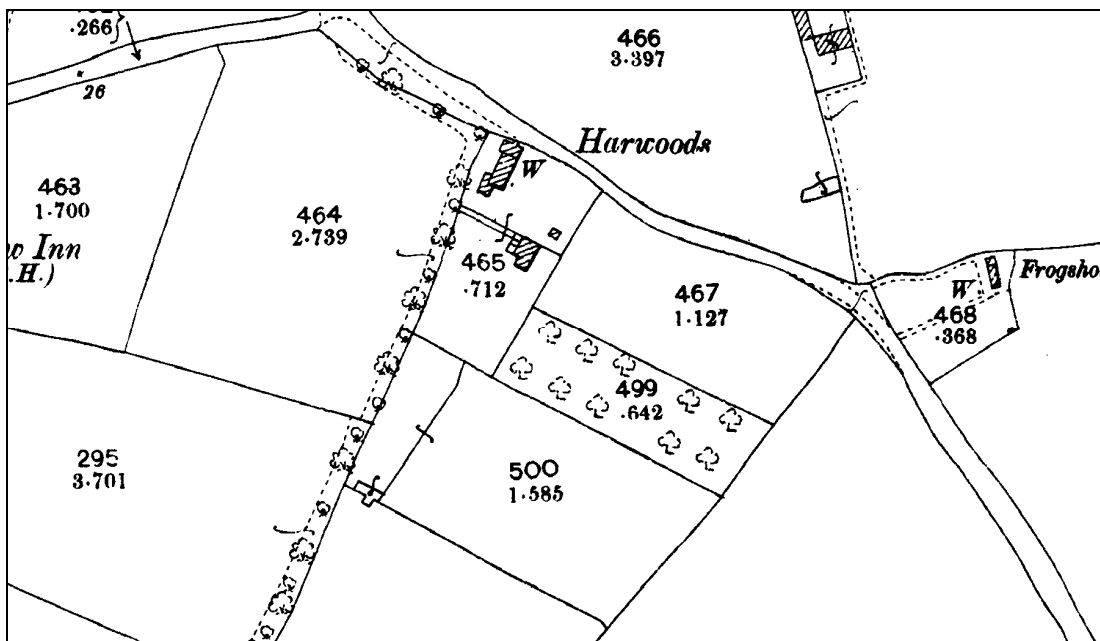
Plate 3: Extract of the 25 inch First Revision Ordnance Survey map, 1897

- 5.2.3 The second revision Ordnance Survey map of 1897 shows the removal of the L-plan building in the field to the south of the house and the creation of a new detached group in the same field, situated towards the northeast corner and in close proximity to the domestic building at just over 17 metres from the rear of the house (Plate 3). A small detached building is shown to the northeast of the ancillary building, within the enclosure or field associated with the domestic building.

- 5.2.4 The structure to the south of the group, already in situ by 1874, is shown to a T-plan and is by this stage, if not from the outset, a pond or reservoir.

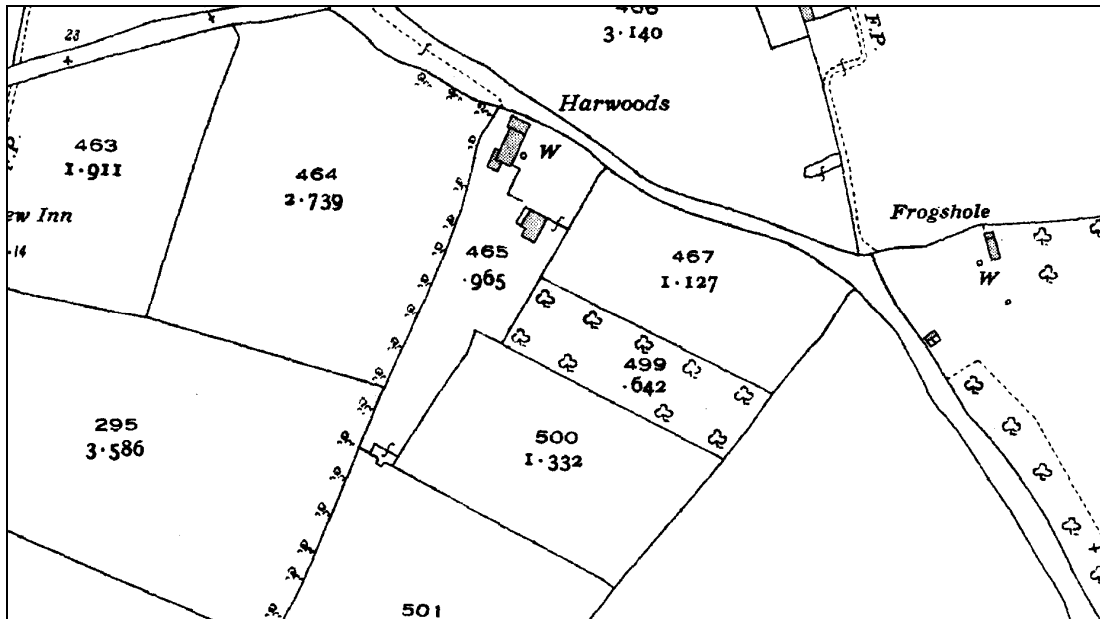
Plate 4: Extract of the 25 inch Second Revision Ordnance Survey map, 1908

- 5.2.5 The next available map dates to 1908; this shows much the same arrangement as its predecessor, with the loss of the small detached structure to the northeast of the ancillary building and the removal of the path leading up to the latter (Plate 4).

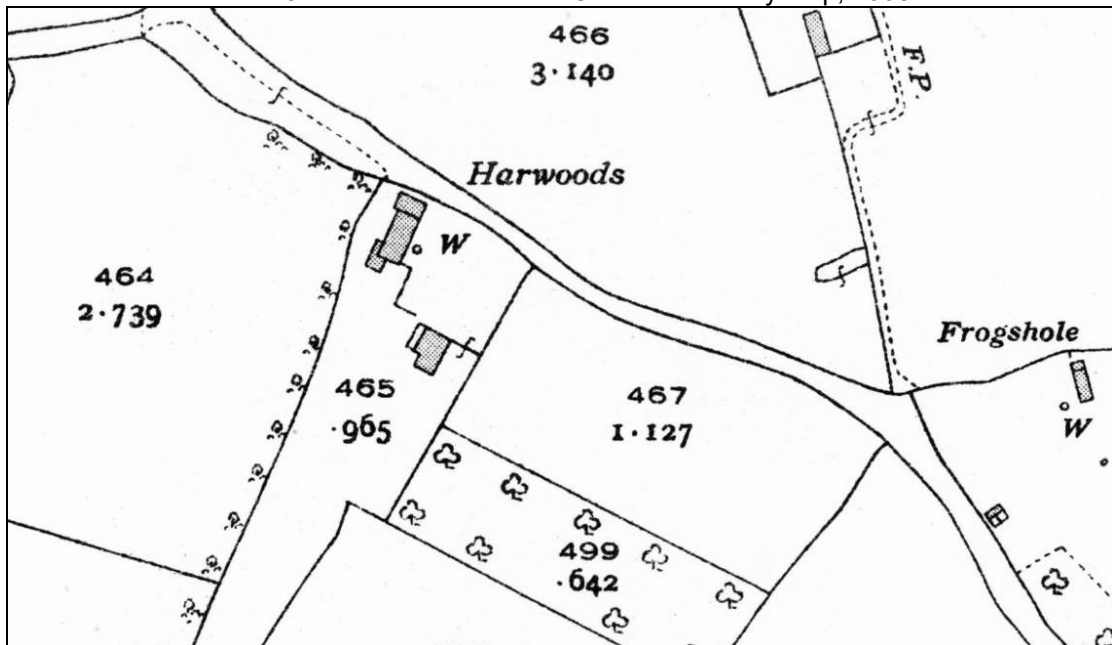
Plate 5: Extract of the 25 inch Third Revision Ordnance Survey map, 1938

- 5.2.6 No changes are indicated on the 1938 edition Ordnance Survey map (Plate 5).

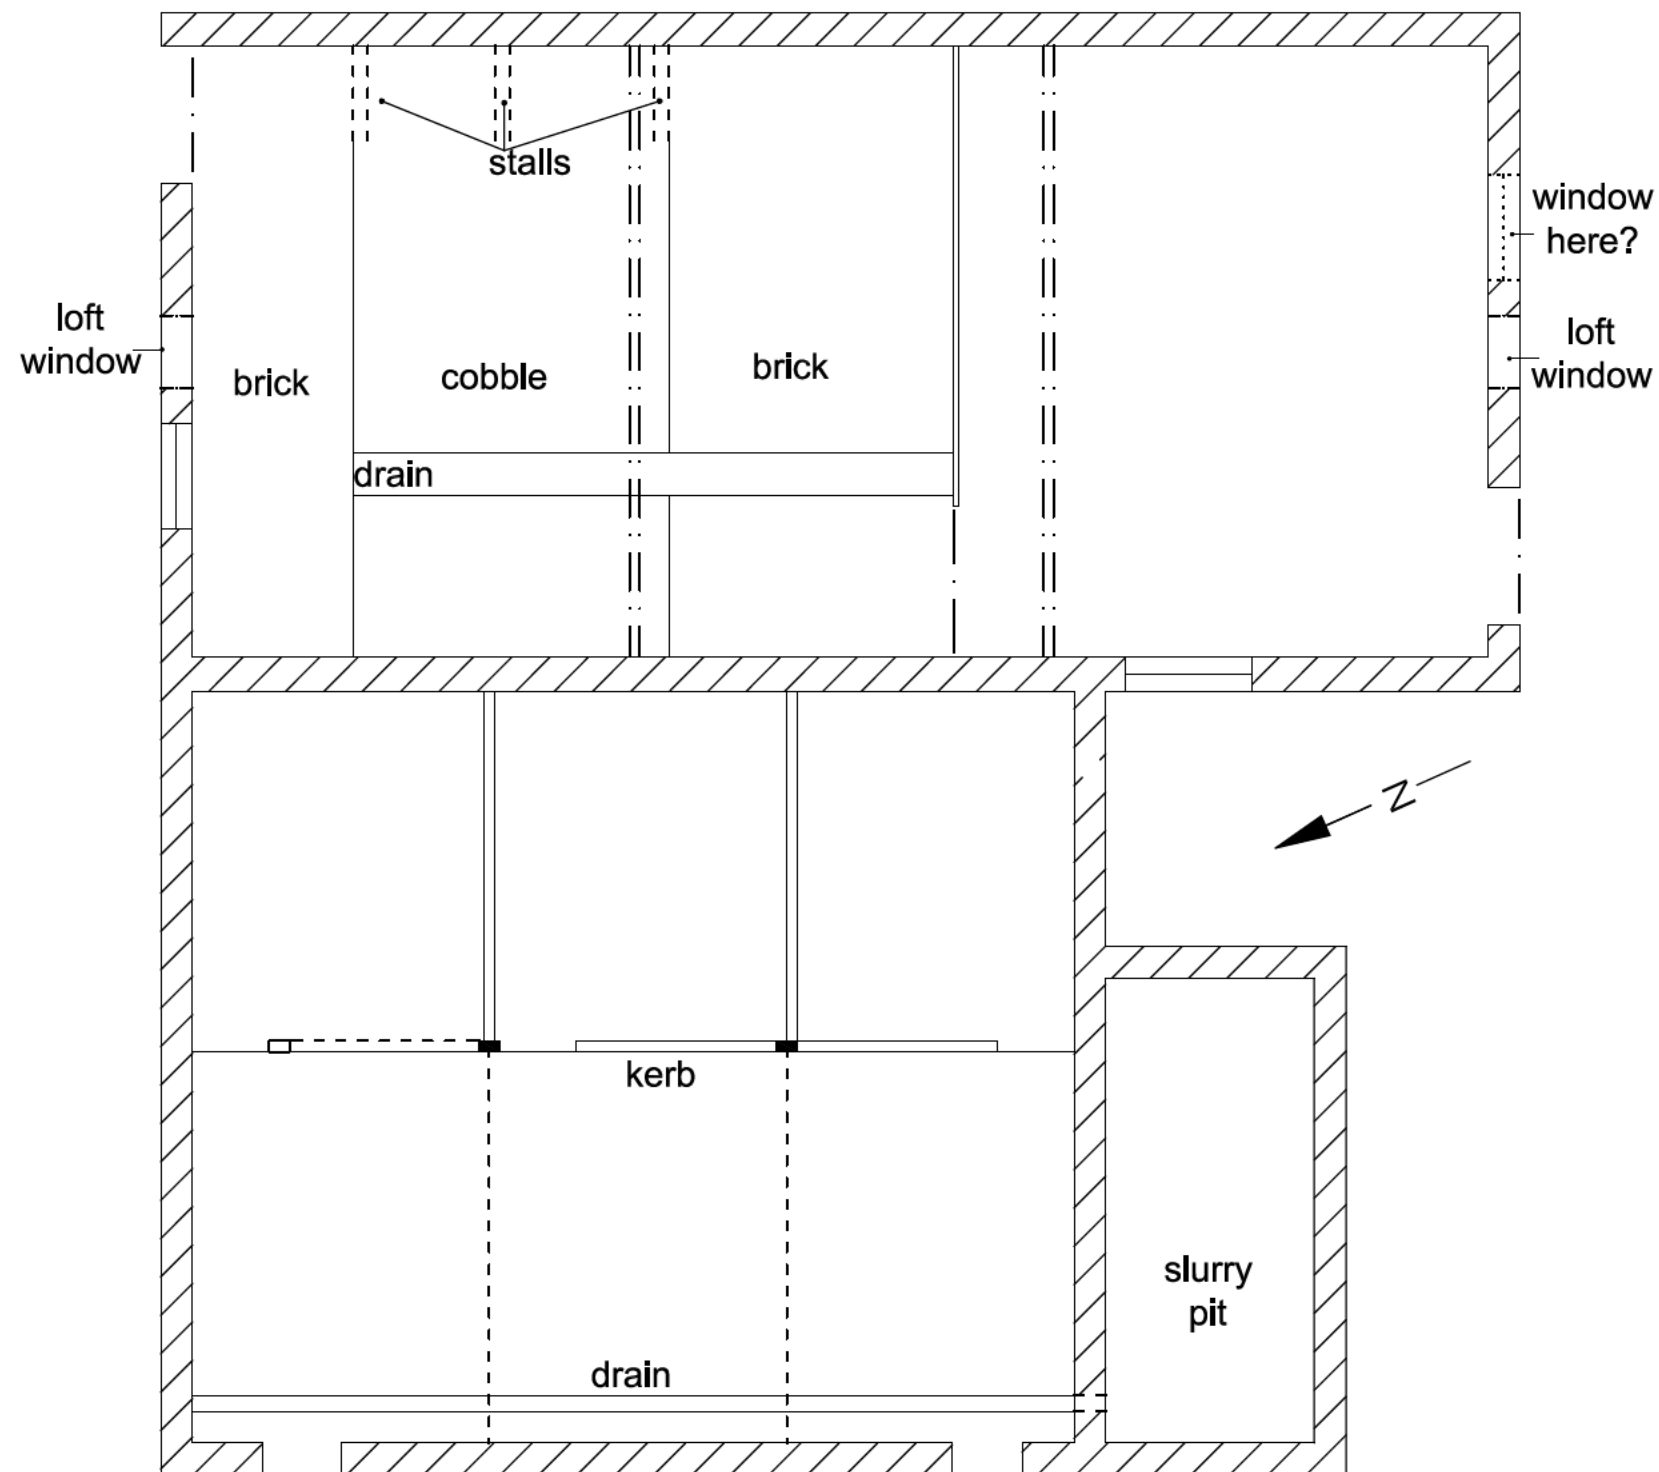
- KEY:
- Phase 1: Added between 1874 & 1898
  - Evidenced
  - Conjectural
  - Overhead

- 7.1.1 The building is northeast – southwest oriented, simplified for clarity within the text as having a north – south axis, comprising, as first built, a main range to the east and a contemporary lean-to outshot to the west, the latter is served by an integral enclosure or yard, and is abutted on its southern side by a slurry pit. All parts of the building are contemporary (Figure 2).

7.1.15 The lean-to outshot included three doorways in the timber-framed west elevation of the stalls, each leading to the individual stall (Plate 13). Two external doorways were integral to the west wall of the yard: these are very narrow at 0.48 metres wide (Figure 2; Plate 14).

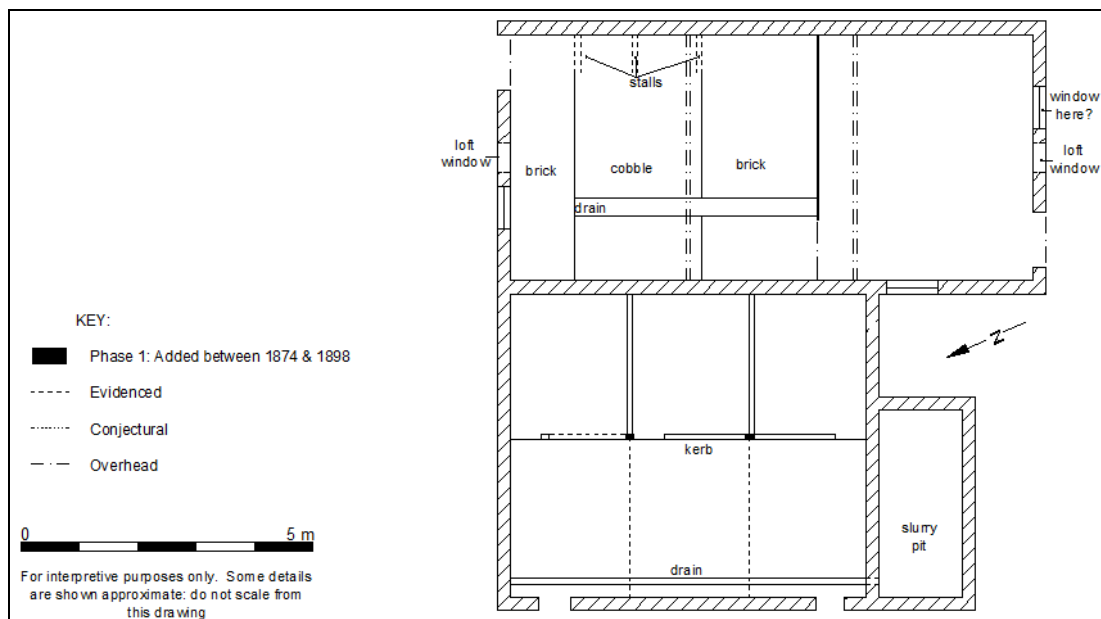
Plate 6: Ground floor plan of the ancillary building as first built between 1874 and 1898

- 7.1.7 A compact slurry pit was included on the south side of the walled enclosure, complete with an integral drainage outlet in the wall between the pit and the yard (Plate 6).

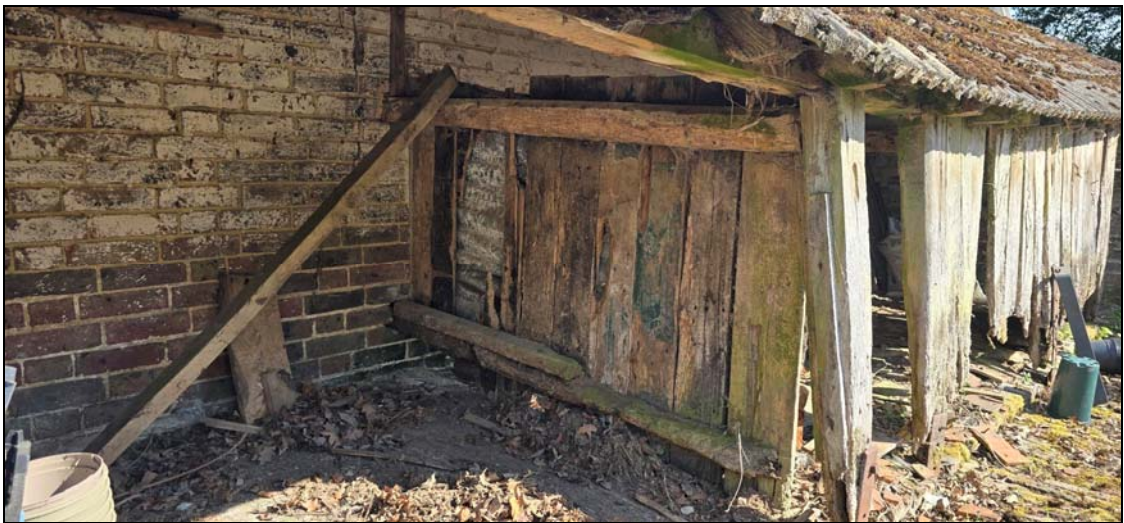
Plate 9: Light-weight partitioning between the stalls in the lean-to outshot (image provided by the owner)

- 7.1.9 The wall construction for the west elevation and internal partitions of the lean-to outshot were similarly constructed using horizontal rails and vertical boards (Plates 9 and 10).

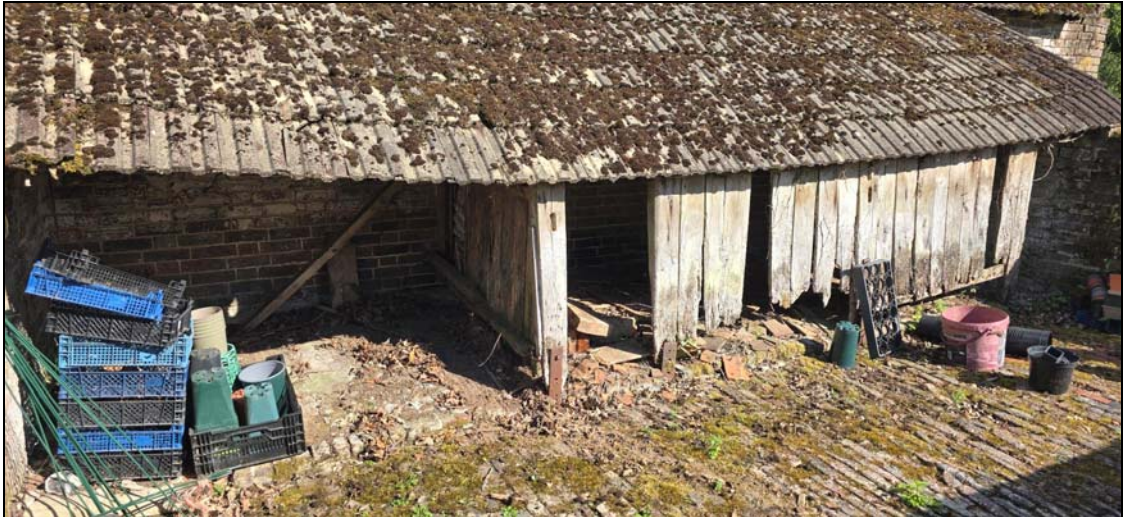
Plate 10: The lean-to outshot, its vertically-boarded front, brick kerb and yard surface (image provided by the owner)

- 7.1.13 The floor of the lean-to outshot is obscured by a patched concrete screed. The western side of the floor is defined by a brick kerb, and the yard is surfaced in brick, all of which suggests that the floor within the stalls were of a similar fabric and form (Plate 10).

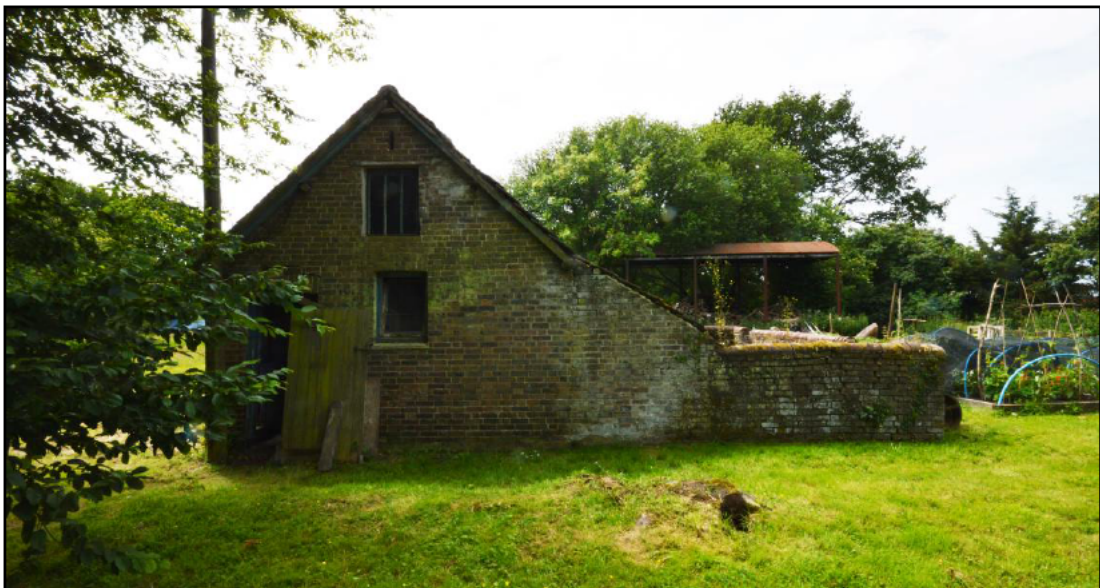
Plate 11: The north end of the group with its single-width doorway and windows

7.1.14 Both end elevations included a single-width boarded-and-ledged door: the north elevation includes a timber-framed window, whilst the southern cell may have been lit by a window in the west elevation (Figure). It is unclear, due to stored items, if there had been a further window in the south elevation. Both extant windows are under segmental arched soffits of brick (Plates 11 and 12). Both gables included small windows, now altered, evidenced at the south end of the range as an integral feature by virtue of the surviving voussoirs (Plate 12). Small ventilation slots are situated just below the apex of each gabled roof terminal and two window openings were included within the partition separating the two rooms of the main range.

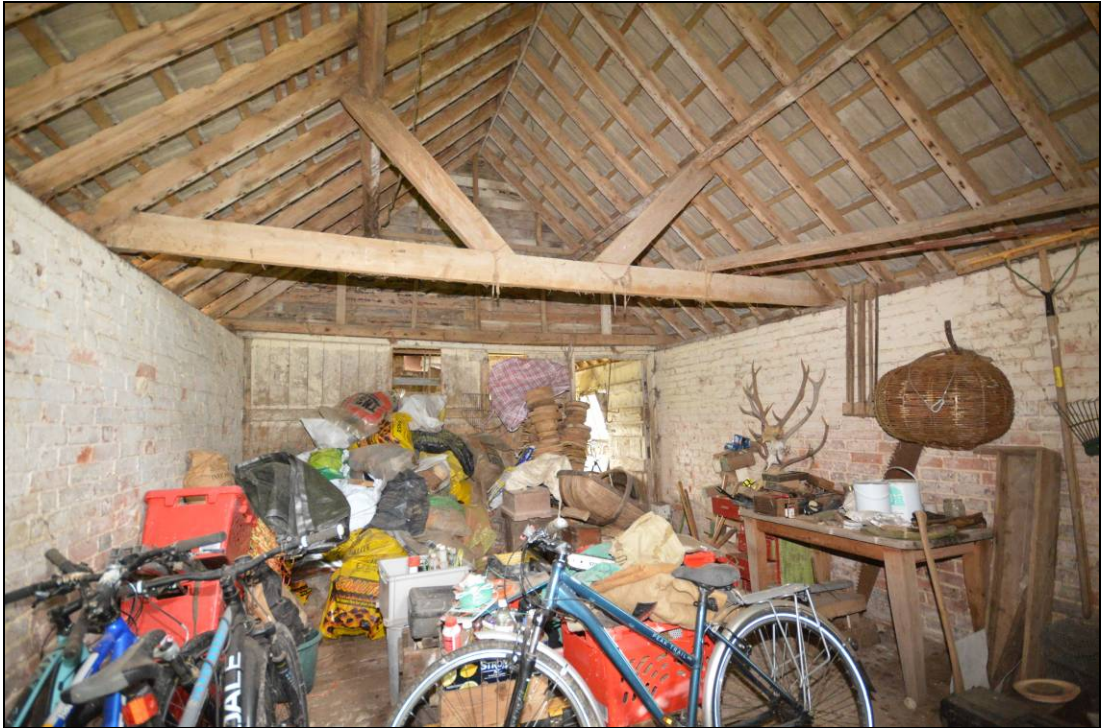
Plate 15: The interior of the north room showing the roof construction

7.1.16 The roof structure is of paired common rafter type, the rafters terminating to each side of a continuous ridge-board and supported at mid-slope by a single tier of purlins set at right angles to the roof (Plate 15).

7.1.17 A single truss is situated within each room: this comprises a tie-beam and a pair of raking struts that rise from the tie-beam to clasp the side purlins (Plates 15 and 16). All members are mechanically fixed. The south room roof includes a pair of long diagonal braces, also nailed in place (Plate 16).

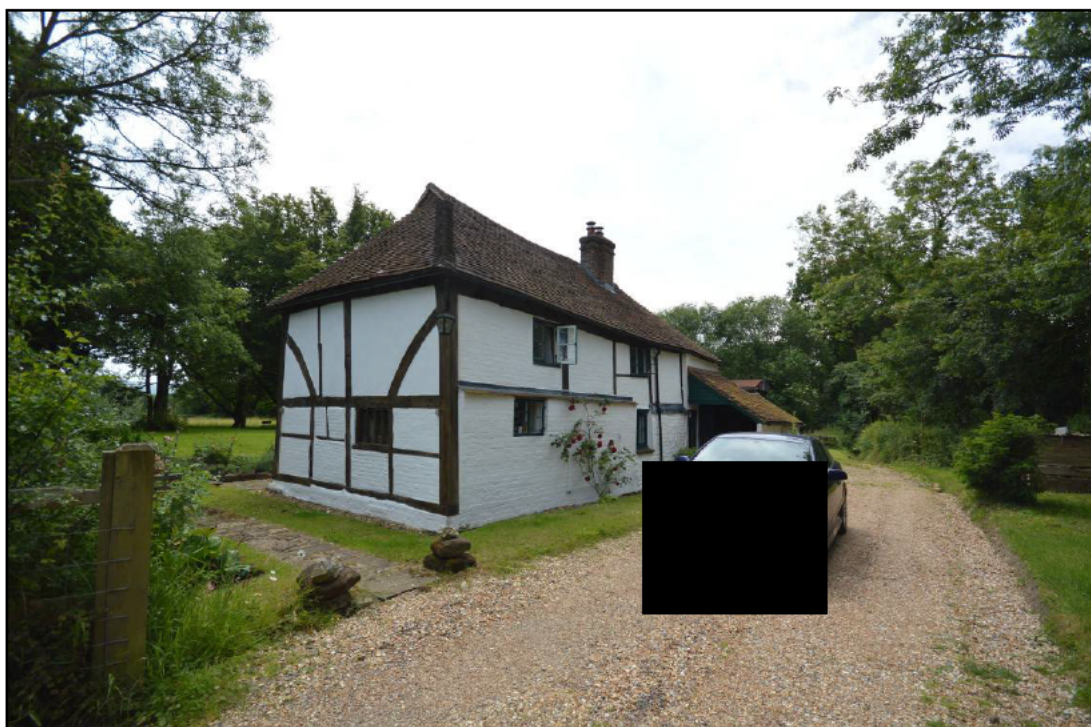
Plate 17: The north and west elevations of the domestic dwelling at Harwoods

- 7.3.1 The house (Plates 17 and 18) was built to a traditional three-cell layout comprising a single-bay hall with under-shot cross-passage flanked by two two-storey end bays (parlour and services respectively). A.F. Hughes in her 2009 report, suggests a date of construction c. 1450. The addition of a smoke-hood within the cross-passage is suggested at the end of the 16<sup>th</sup> century (c. 1580), followed by a chimney stack and flooring over of the hall in the early 17<sup>th</sup> century. Later additions were made to the house after 1844.

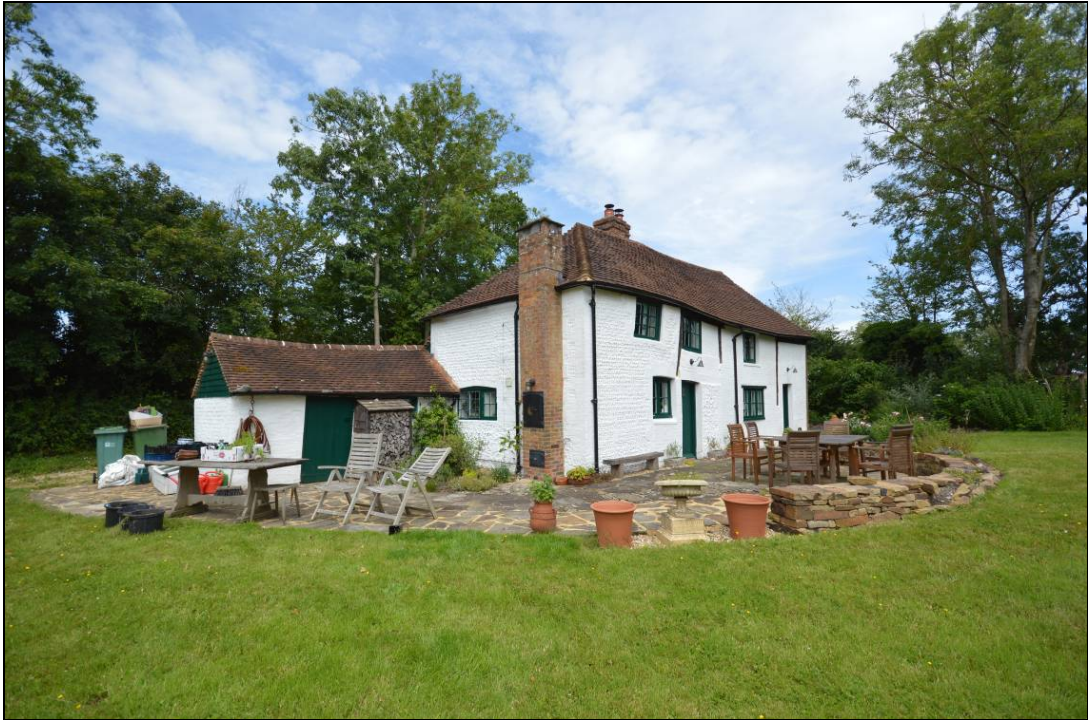
Plate 18: The east and south elevations of the domestic dwelling at Harwoods with its abundant brickwork, facing towards the brick-built ancillary building
