## **BENJAMIN ALLEN CONSTRUCTION LTD**

**WOODHOUSE FARM, WHEATSHEAF ROAD,  
WOODMANCOTE, WEST SUSSEX**

### **Preliminary Contamination Risk Assessment**

Addendum June 2026

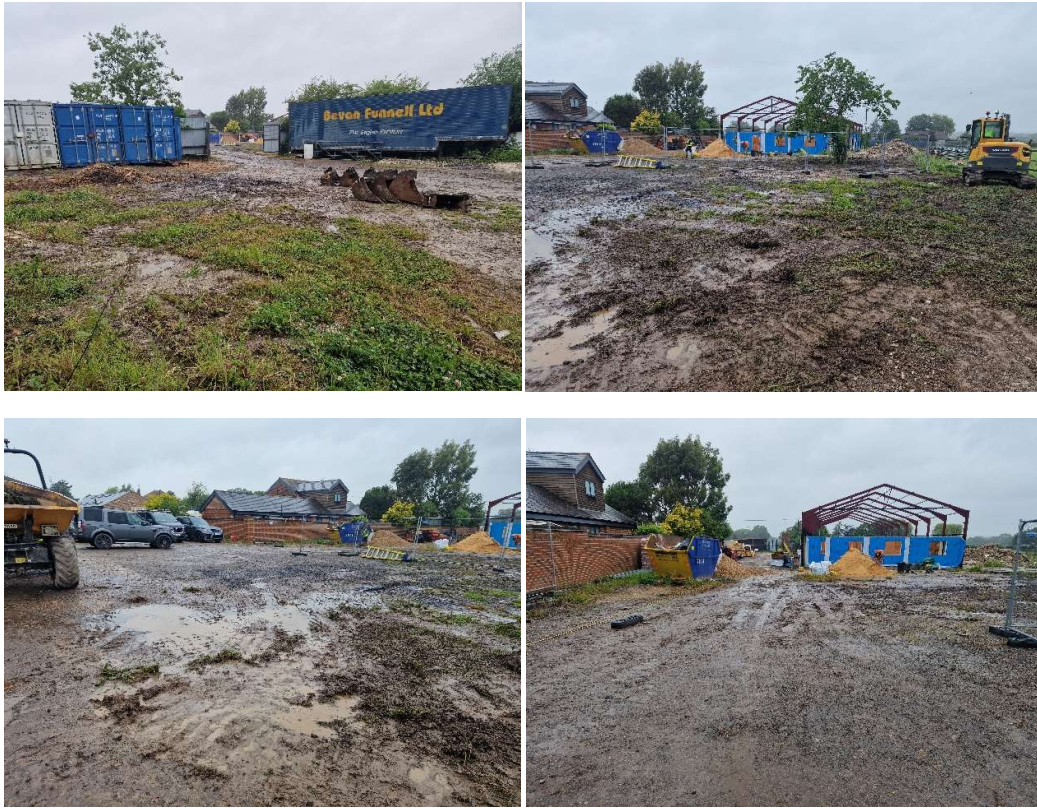
**Photographs 1 – 4:** Farm Yard and Buildings proposed for residential use.

- 6.2 However, there is a significant potential for contamination which may impact standard PE pipework within the yard area to the east of the site, and along the route to each of the proposed dwellings.
- 6.3 It is therefore recommended that barrier pipe be used along the route of the proposed mains through the former yard area to the east of the site from the gate line between the field and the yard, up to the entrance point into each of the dwellings.

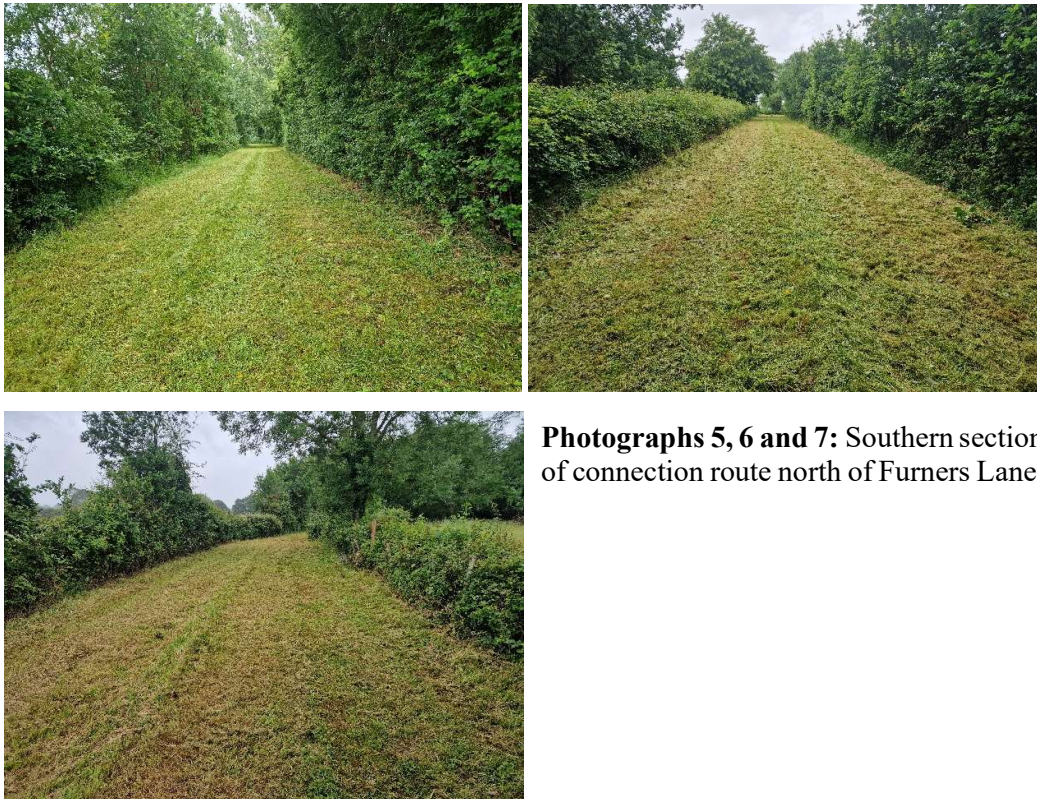
**Photographs 5, 6 and 7:** Southern section of connection route north of Furners Lane.

6.1 No potential contamination risk has been identified along the proposed route of the mains through the undeveloped fields between Furners Lane and the eastern yard gate, located to the east of the site. Standard PE pipework may be used along this section of the proposed connection route.

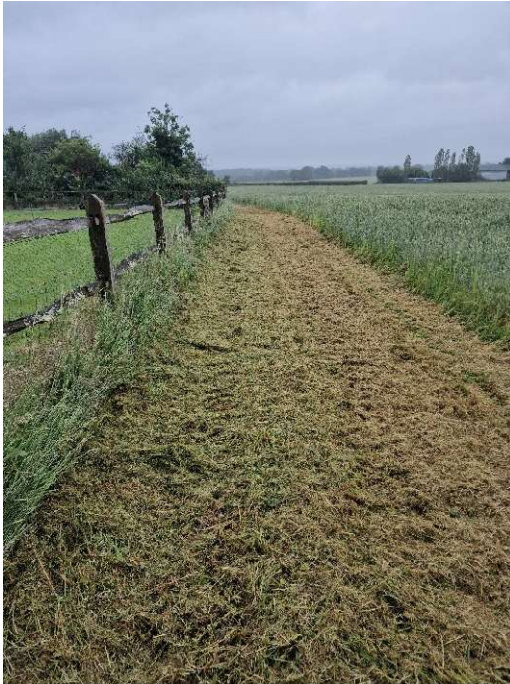
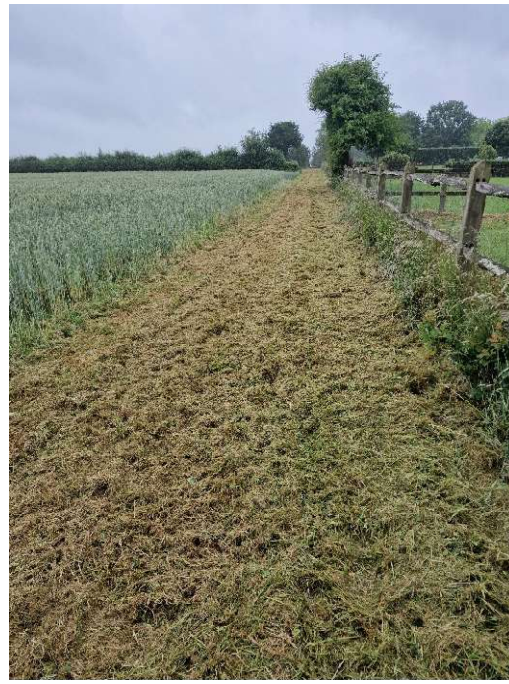
**Photographs 8 and 9:** Northern section of connection route through fields north of Furners Lane.

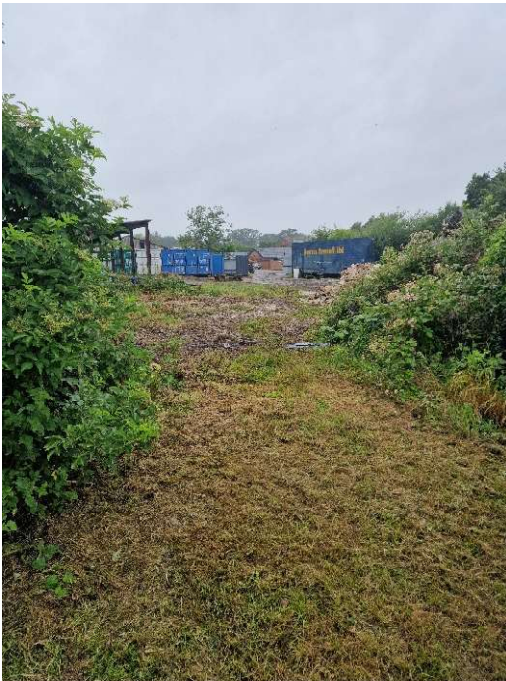
**Photograph 10:**

Access point between fields and yard area.

Standard PE pipework to be used through fields to stop at this point and barrier pipe work to be used through yard to proposed dwellings.
