## Bat Scoping and Emergence Survey Report

Town House Farm, Horsham

**Project No: P10623**

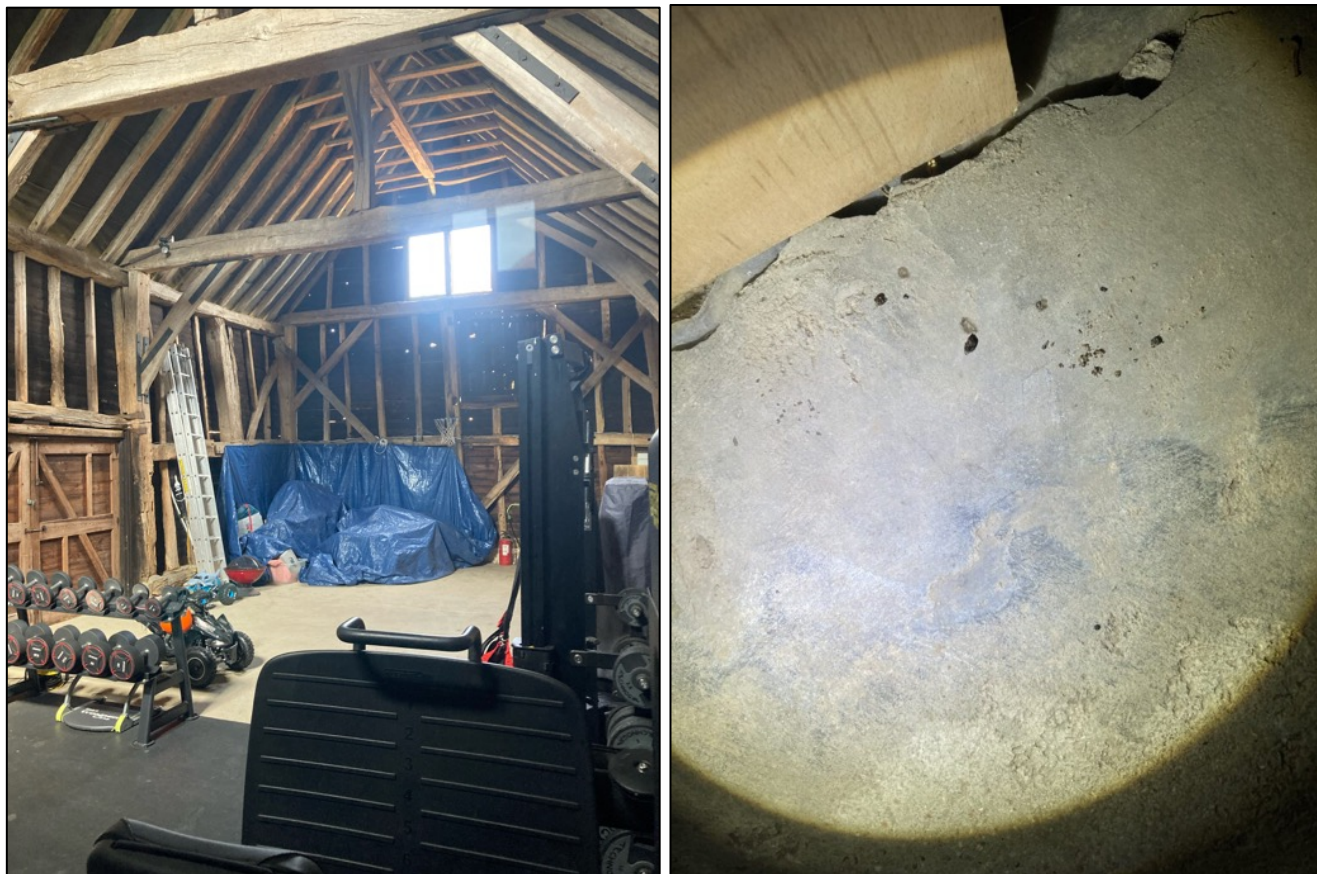
The barn supports a pitched roof, covered in machine-made clay tiles with open eaves. Approximately 15-20 gaps were identified between weather boards, although rose *Rosa* sp. covers the majority of the wall on the northern elevation and restricts access on this side. The barn has been partially converted into a gym, as well as being used for storage, and has an open ridge with bitumen felt lining the underside of the roof. A few potential crevice features were identified in mortice joints between and in splits within timber beams, although the majority of these were likely too shallow to be suitable. Torn bitumen felt lining was also identified in the south-east of the barn, providing access to the roof and ridge tiles above. Approximately 40 droppings were found in the barn, concentrated primarily under the ridge and at the north-eastern and south-western walls (with approximately 15 droppings found in the eastern corner). The droppings found were morphologically similar to brown long-eared *Plecotus auritus* bats.

**Photograph 1a & 1b.** Interior of the barn at Town House Farm (left) with some of the bat droppings identified within (right). These droppings were morphologically similar to brown long-eared bats.

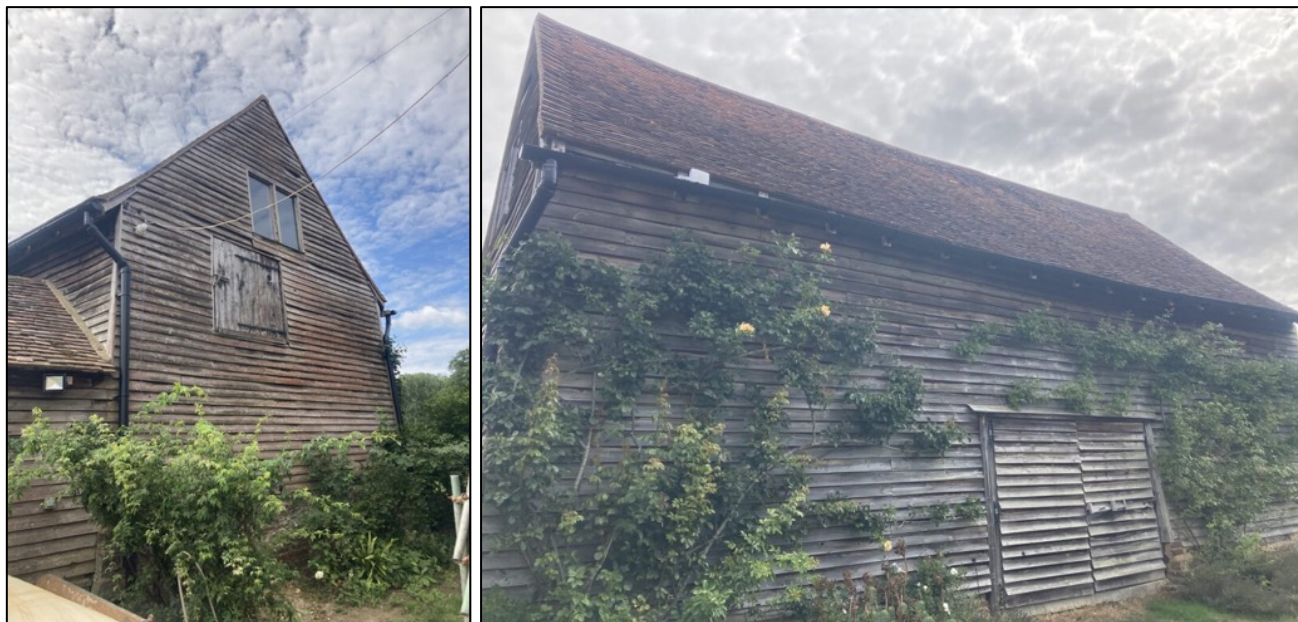
**Photograph 2a & 2b.** Views of the northern (left) and western (right) elevations of the barn at Town House Farm.

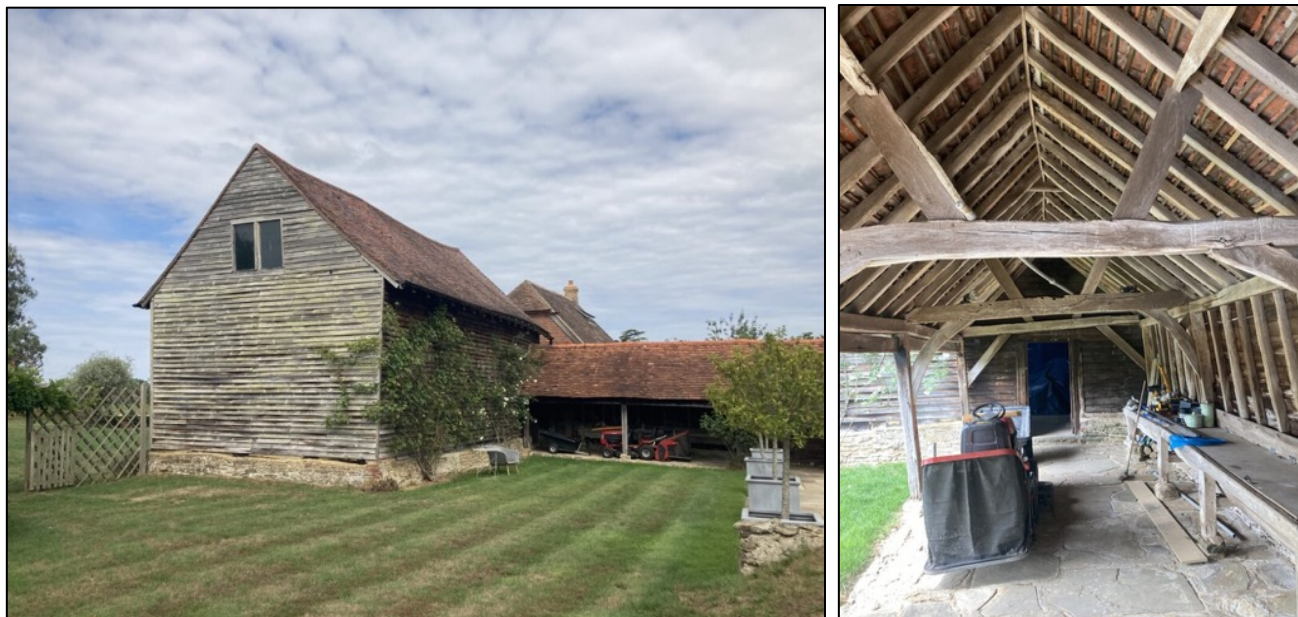
**Photograph 3a & 3b.** The southern and eastern elevations of the barn (left) where the covered walkway attaches, with a view of the open section within this walkway (right).

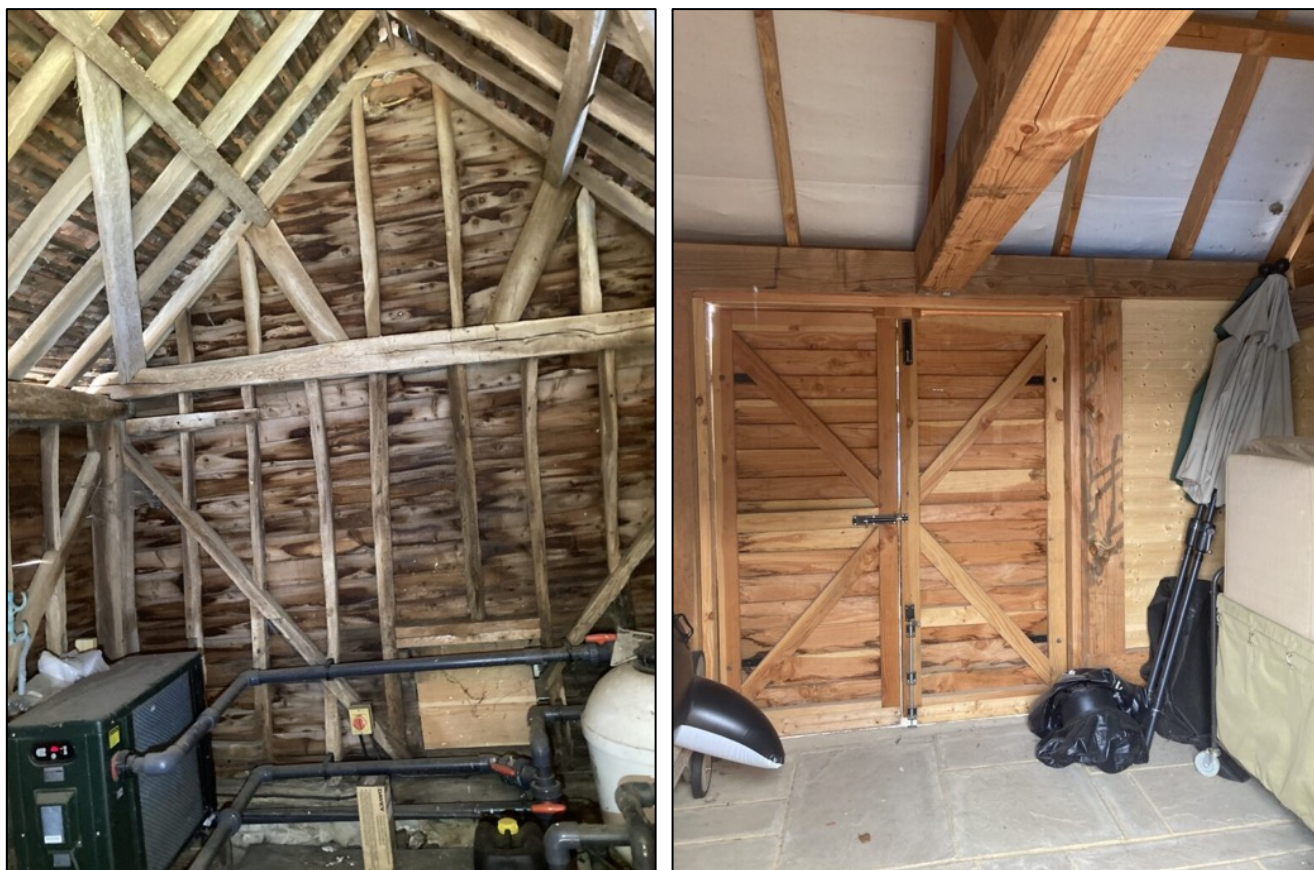
A covered walkway extends from the eastern elevation of the barn, with an open front to the south and a single wall of timber weather boarding to the north, ending in a shed housing an air conditioning unit. The roof of this section is unlined, with the remains of old swallow *Hirundo rustica* nests identified at the ridge, with several individuals identified flying around the site during the visit. No evidence of bats was identified in the shed. Another more recent storage shed has been built on the eastern end of the storage section, with plastic sheet lining the underside of the roof and spray foam insulation in between. This shed is regularly used for storage and was relatively clean at the time of the site visit, with no evidence of bats identified. On the eastern end of the newer storage shed, approximately 1-2 gaps were identified under lifted weather boarding. The roof of the walkway is double-pitched and covered in machine-made clay tiles; there are open eaves across the whole of the original build, with the more recent storage shed having timber soffits at the eaves. Multiple gaps were identified on the northern and southern roof pitches (approximately 50 on each side), with approximately 1-2 gaps additionally observed under ridge tiles on the northern elevation. The storage section holds an air conditioning unit, with no evidence of bats found.

**Photograph 4.** Interiors of the two store sheds within the covered walkway, including the original shed housing the air conditioning unit (left), and the newer build used for storage (right).

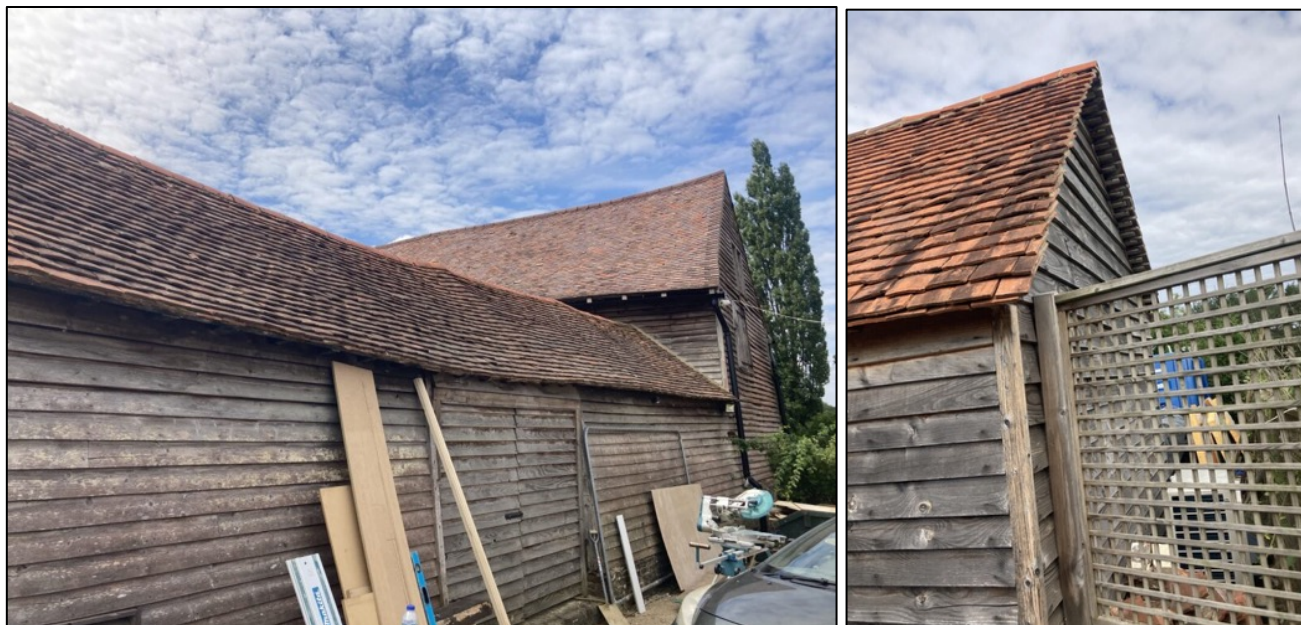
**Photograph 5a & 5b.** The northern pitch (left) and eastern gable (right) of the covered walkway at Town House Farm.

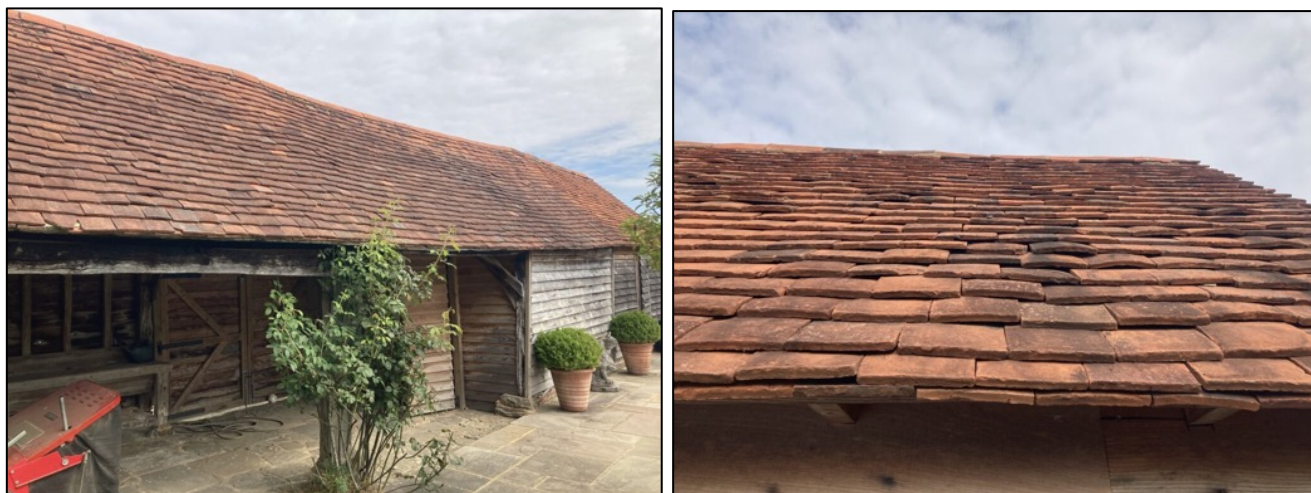
Overall, the barn was confirmed as having a confirmed bat roost, with further potential for bats identified as high. The zone of impact however is limited to the covered walkway, and this was assessed to have moderate suitability for bats.

**Photograph 6a & 6b.** The southern pitch (left) of the covered walkway at Town House Farm, with examples of the gaps under the roof tiles on this section (right).

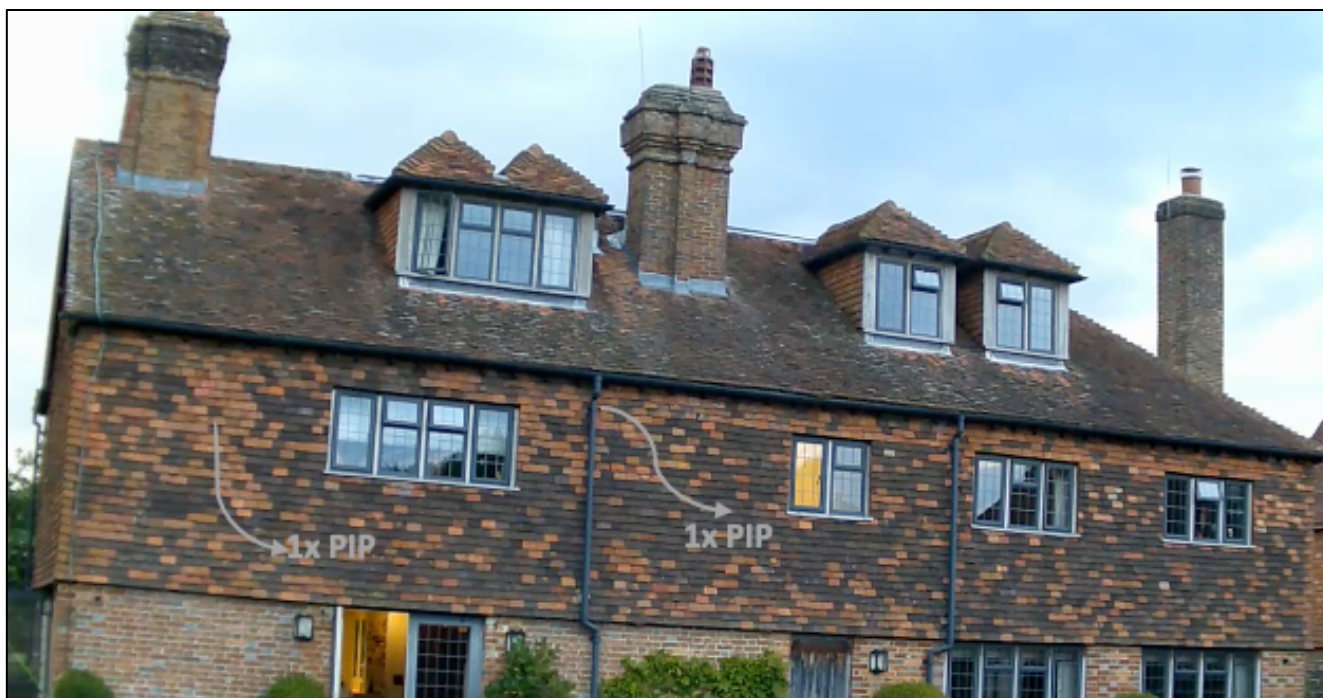
**Figure 9.** Emergence points and flight paths of two unidentified pipistrelle bats (marked in grey) on the southern elevation of the house at Town House Farm during the survey on 11<sup>th</sup> August 2025.

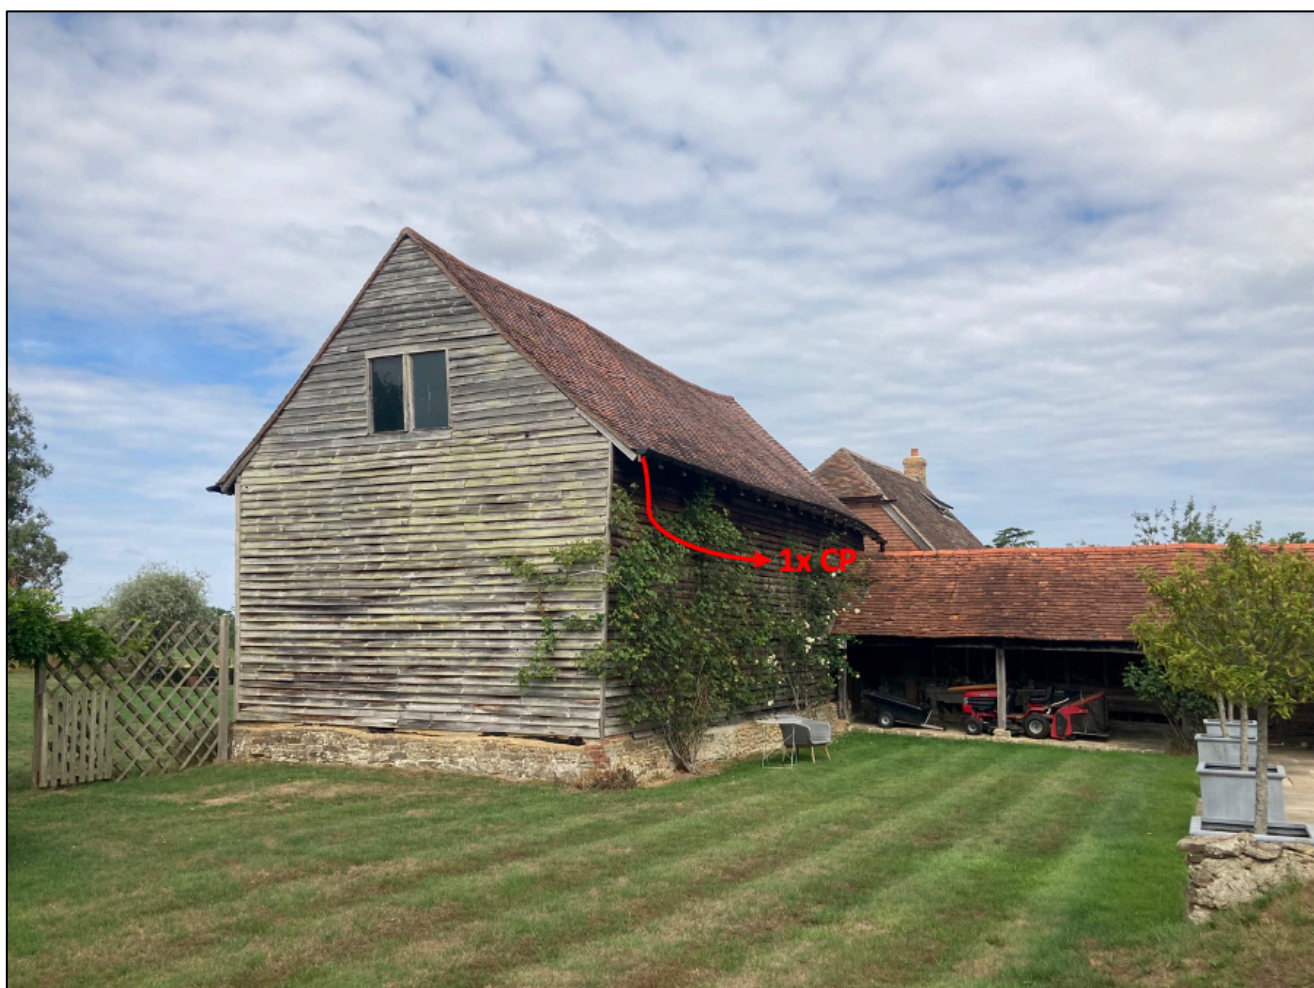
**Figure 10.** Emergence points and flight paths of a common pipistrelle (marked in red) on the eastern elevation of the barn at Town House Farm during the survey on 11<sup>th</sup> August 2025.

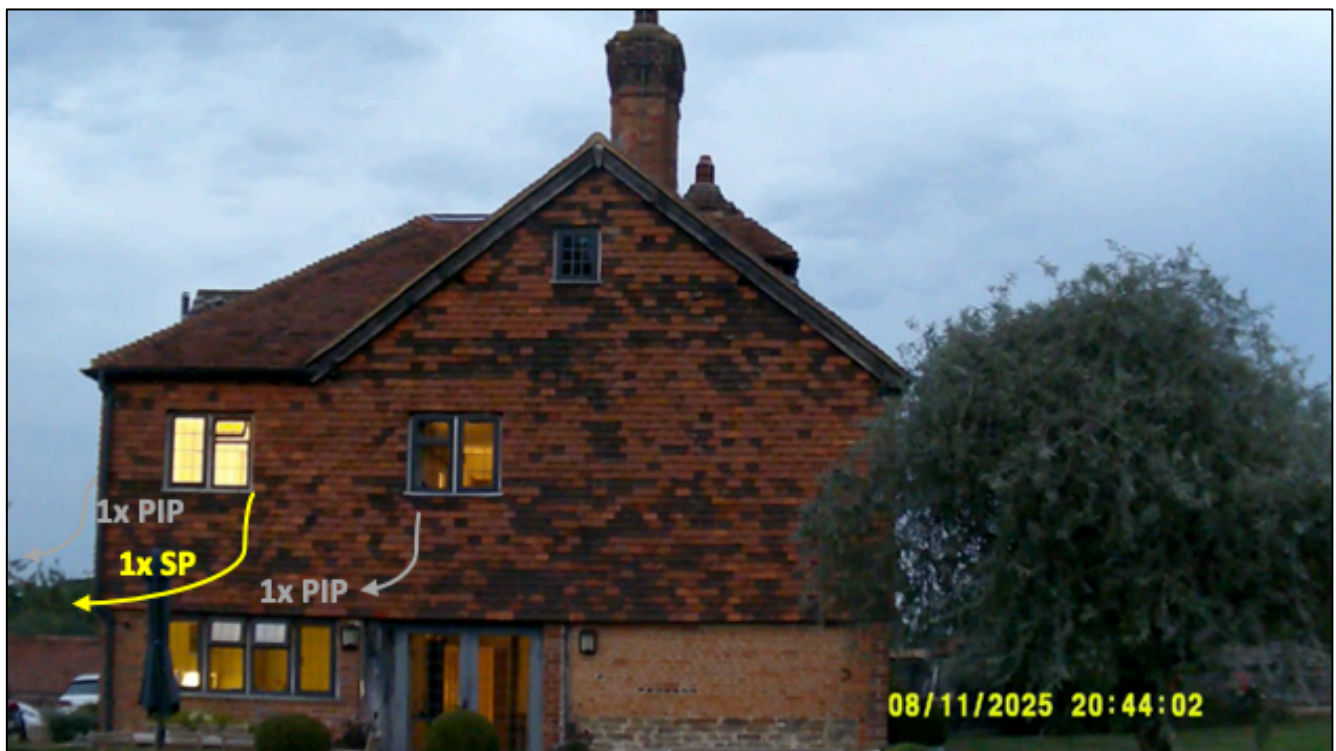
Seven emergences were recorded during this survey, all from the house on site (Figures 11 and 12). A soprano pipistrelle emerged from under a hanging tile on the western elevation at 20:05, with two pipistrelle bats also emerging from under hanging tiles on this elevation at 20:09 and 20:13. A common pipistrelle was recorded emerging from under a hanging tile on the southern elevation at 20:08, with two soprano pipistrelles also emerging from under hanging tiles on this elevation at 20:11 and 20:14. Another unidentified bat was also recorded emerging from under hanging tiles on the northern elevation at 20:10.

**Figure 11.** Emergence points and flight paths of a soprano pipistrelle (marked in yellow) and two unidentified pipistrelle bats (marked in grey) on the northern and western elevations of the house at Town House Farm during the survey on 1st September.

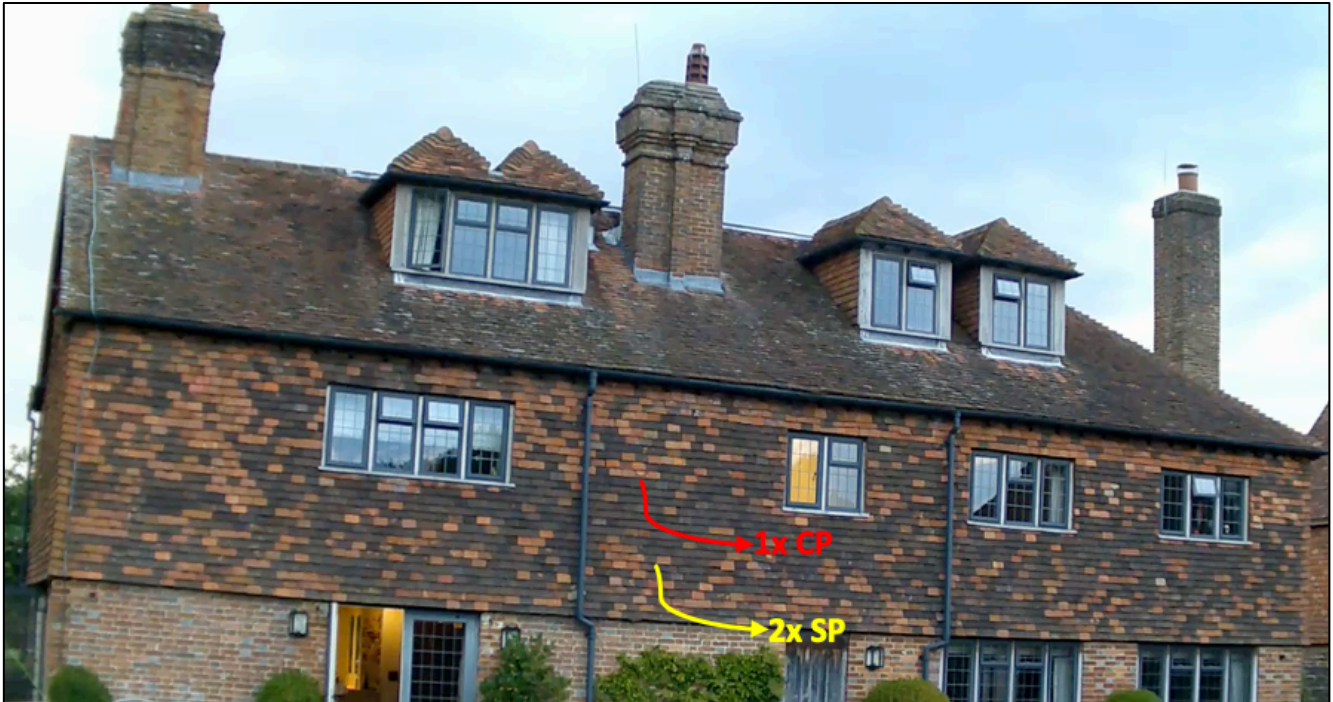
**Figure 12.** Emergence points and flight paths of one common pipistrelle (marked in red) and two soprano pipistrelle (marked in yellow) bats on the southern elevation of the house at Town House Farm during the survey on 1<sup>st</sup> September 2025.

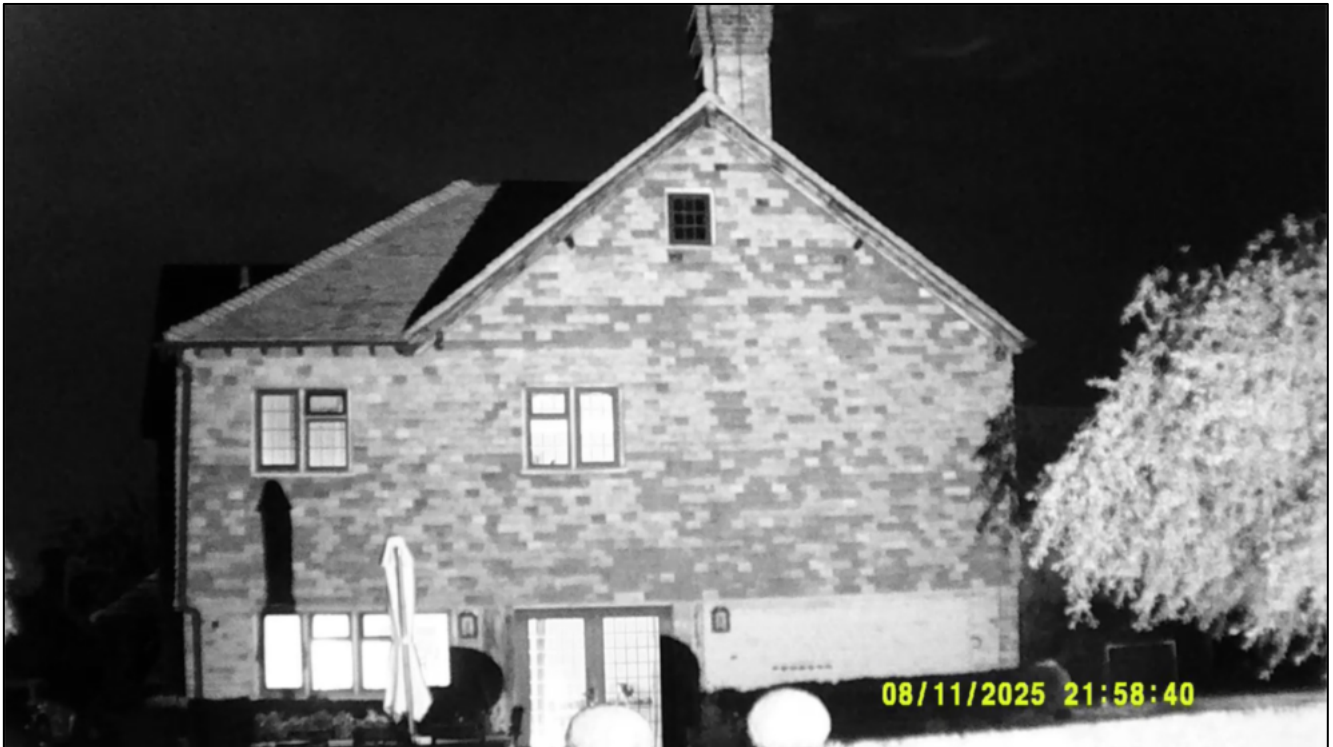
**Figure 1.** Darkest point of the night vision camera covering the western elevation of the house at Town House Farm during the survey on 11<sup>th</sup> August 2025.

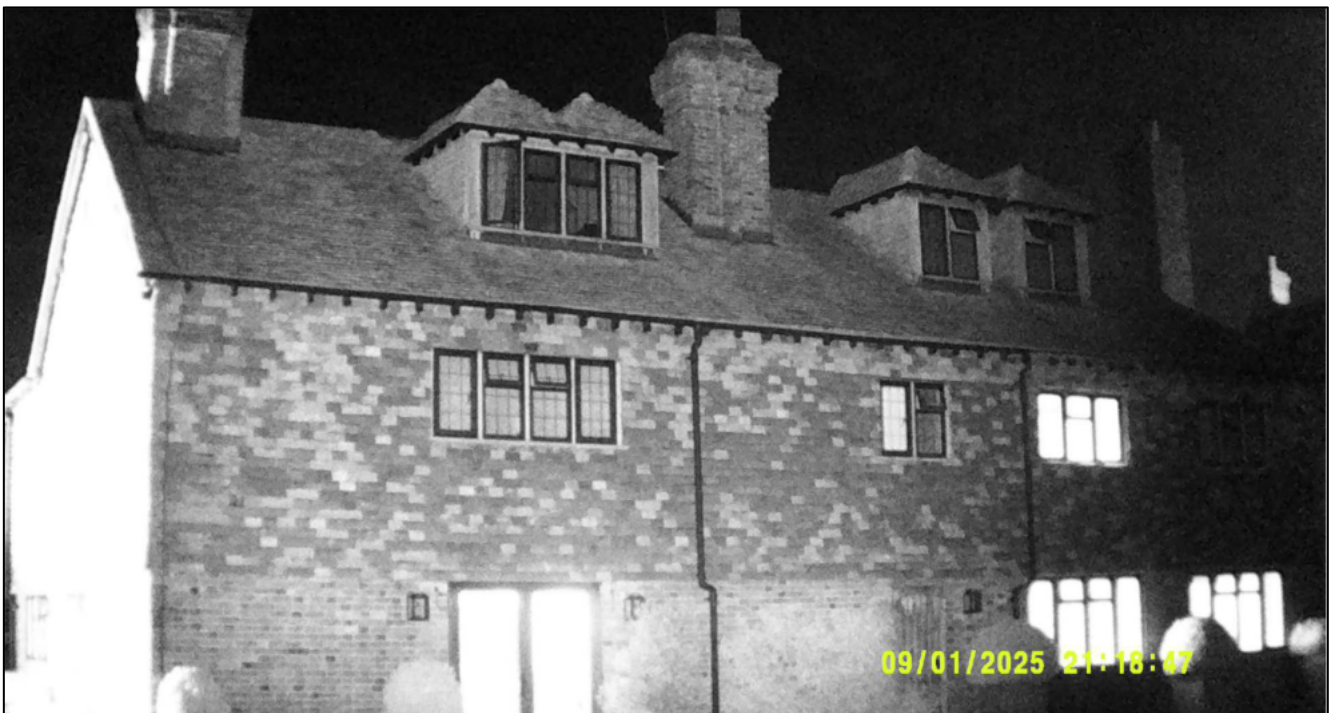
**Figure 2.** Darkest point of the night vision camera covering the southern elevation of the house at Town House Farm during the survey on 11<sup>th</sup> August 2025.

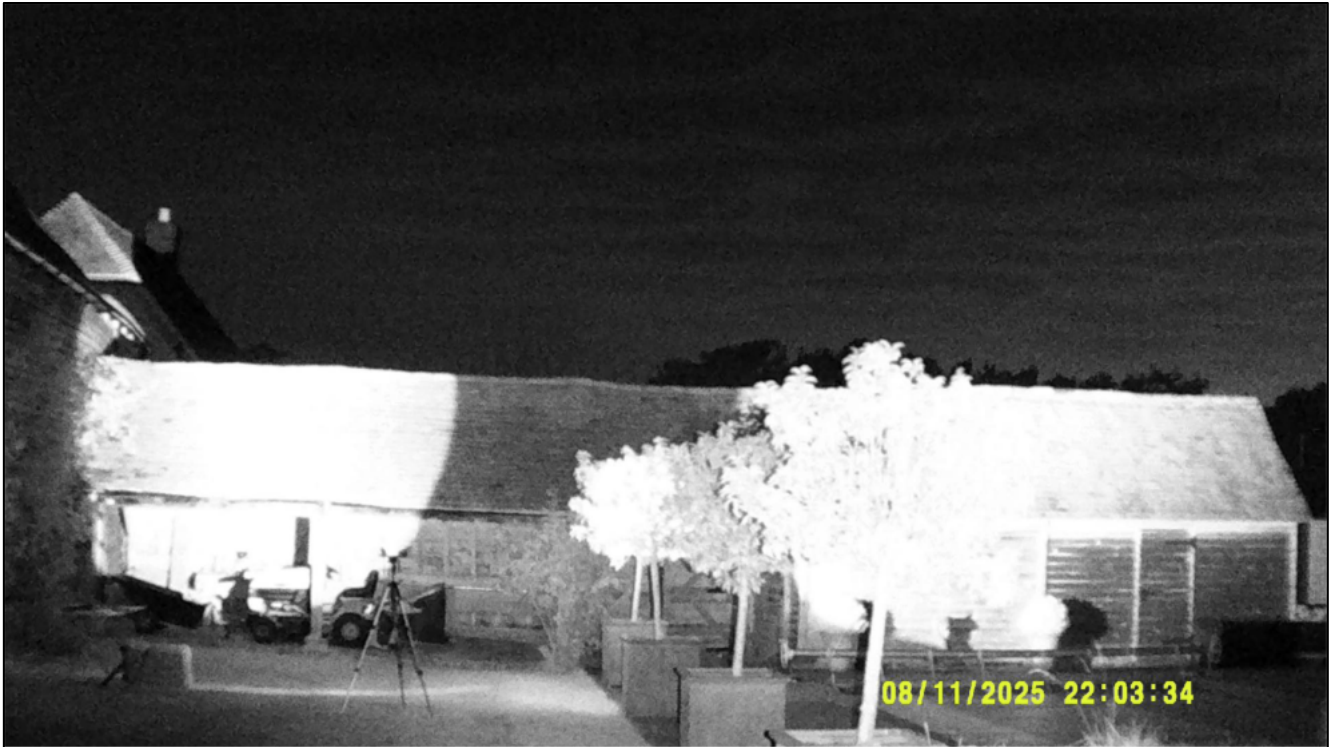
**Figure 3.** Darkest point of the night vision camera covering the southern pitch of the covered walkway on the barn at Town House Farm during the survey on 11<sup>th</sup> August 2025.

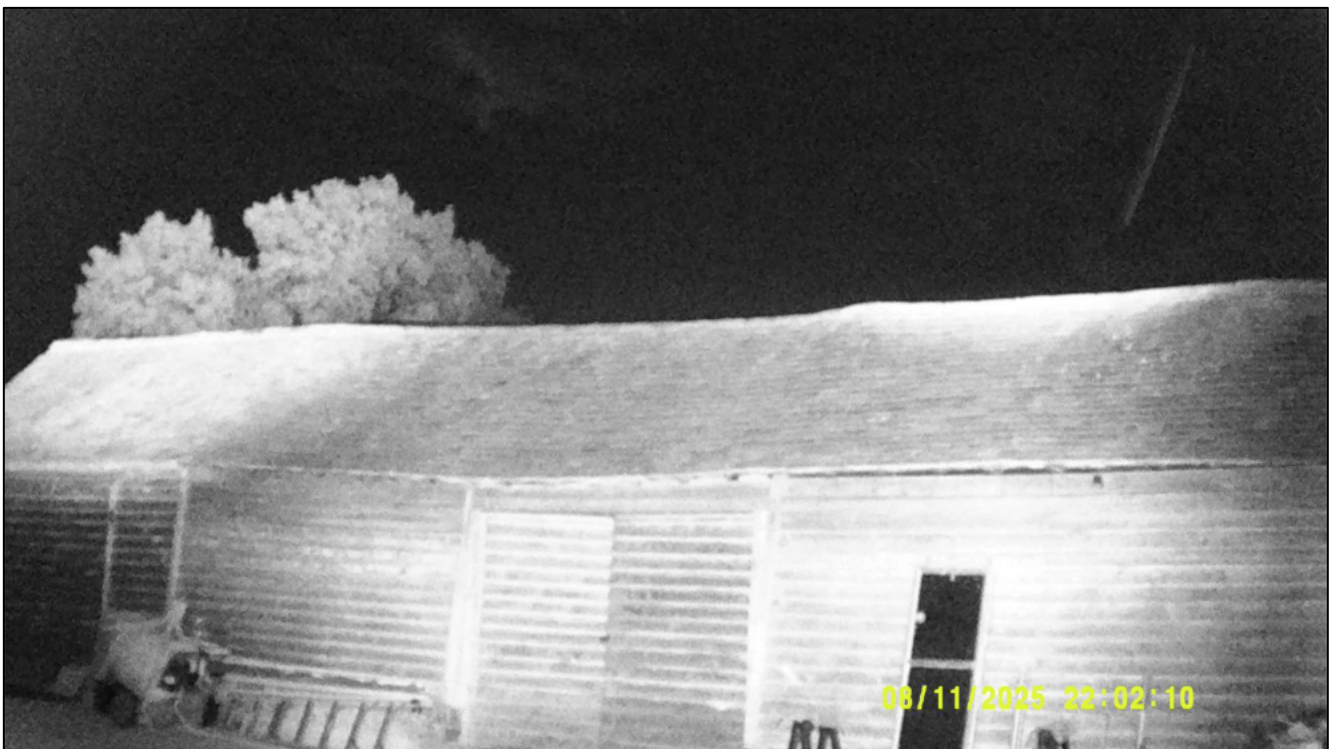
**Figure 4.** Darkest point of the night vision camera covering the northern pitch of the covered walkway on the barn at Town House Farm during the survey on 11<sup>th</sup> August 2025.

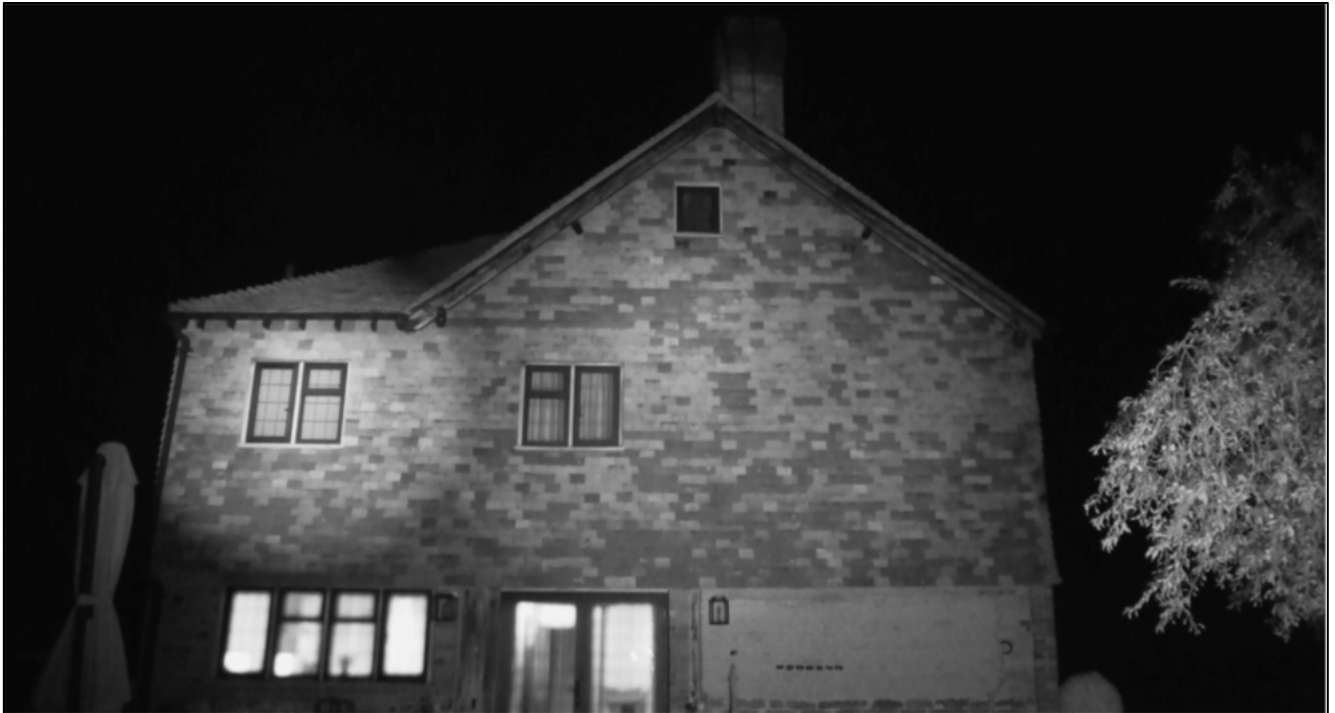
**Figure 5.** Darkest point of the night vision camera covering the western elevation of the house at Town House Farm during the survey on 1<sup>st</sup> September 2025.

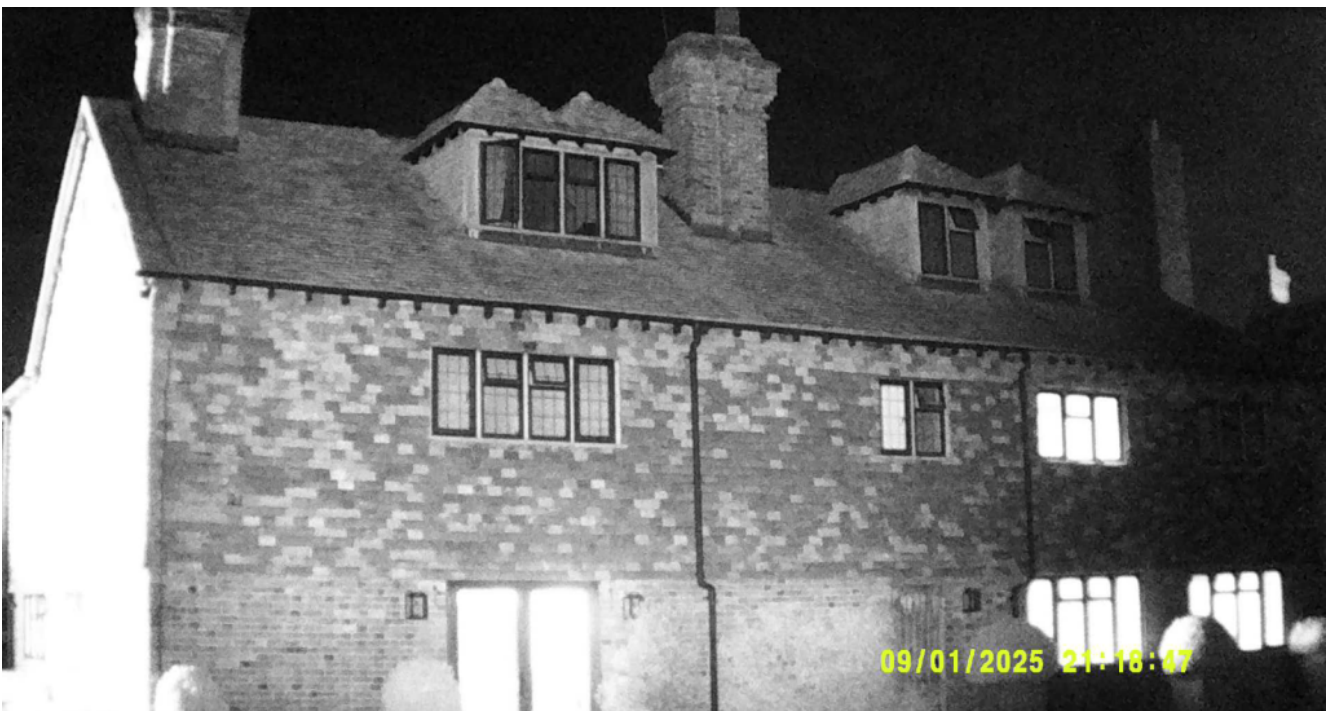
**Figure 6.** Darkest point of the night vision camera covering the southern elevation of the house at Town House Farm during the survey on 1<sup>st</sup> September 2025.

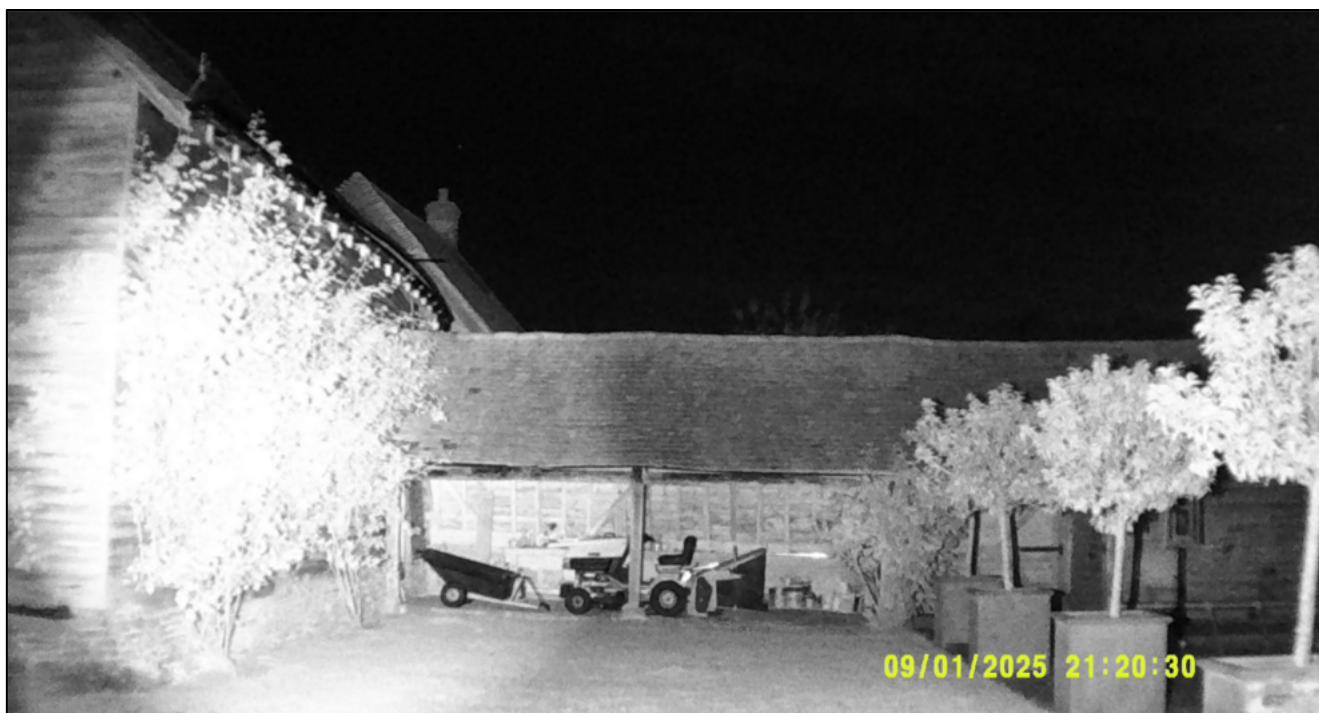
**Figure 7.** Darkest point of the night vision camera covering the western section of the southern pitch of the covered walkway on the barn at Town House Farm during the survey on 1<sup>st</sup> September 2025.

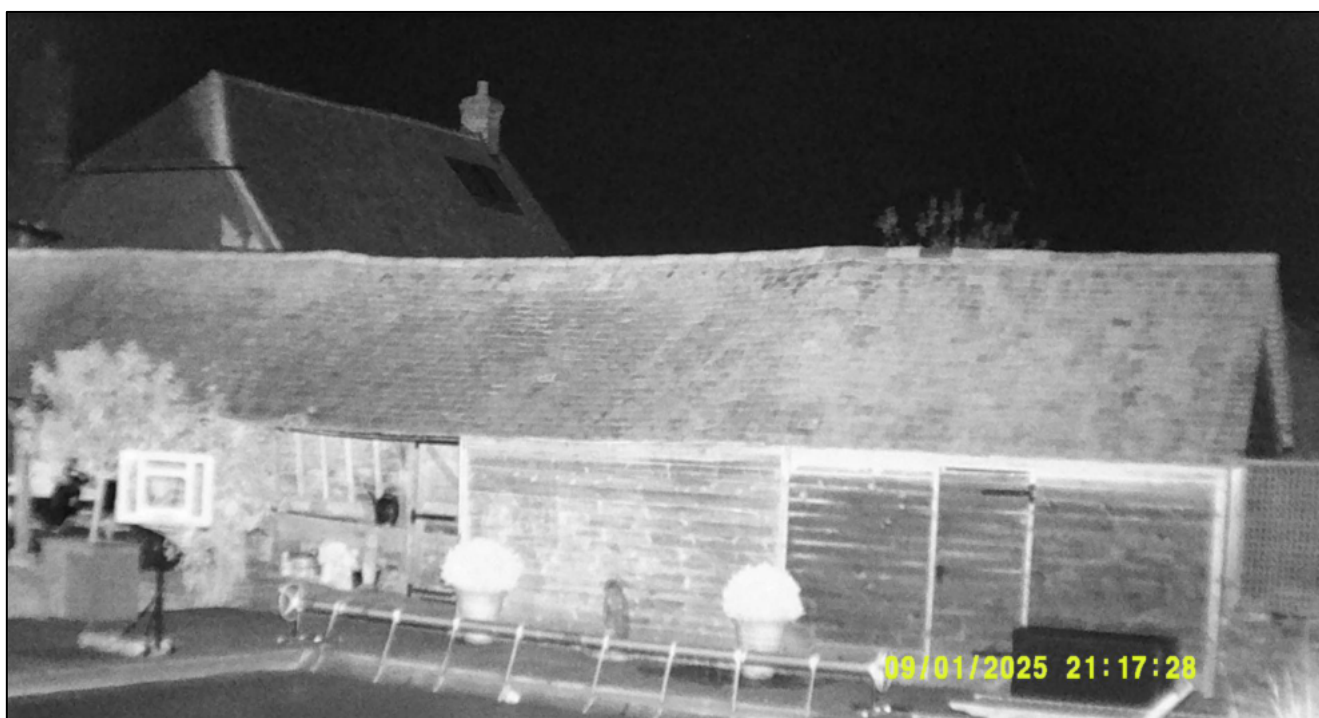
**Figure 8.** Darkest point of the night vision camera covering the eastern section and eastern gable end of the southern pitch of the covered walkway on the barn at Town House Farm during the survey on 1<sup>st</sup> September 2025.

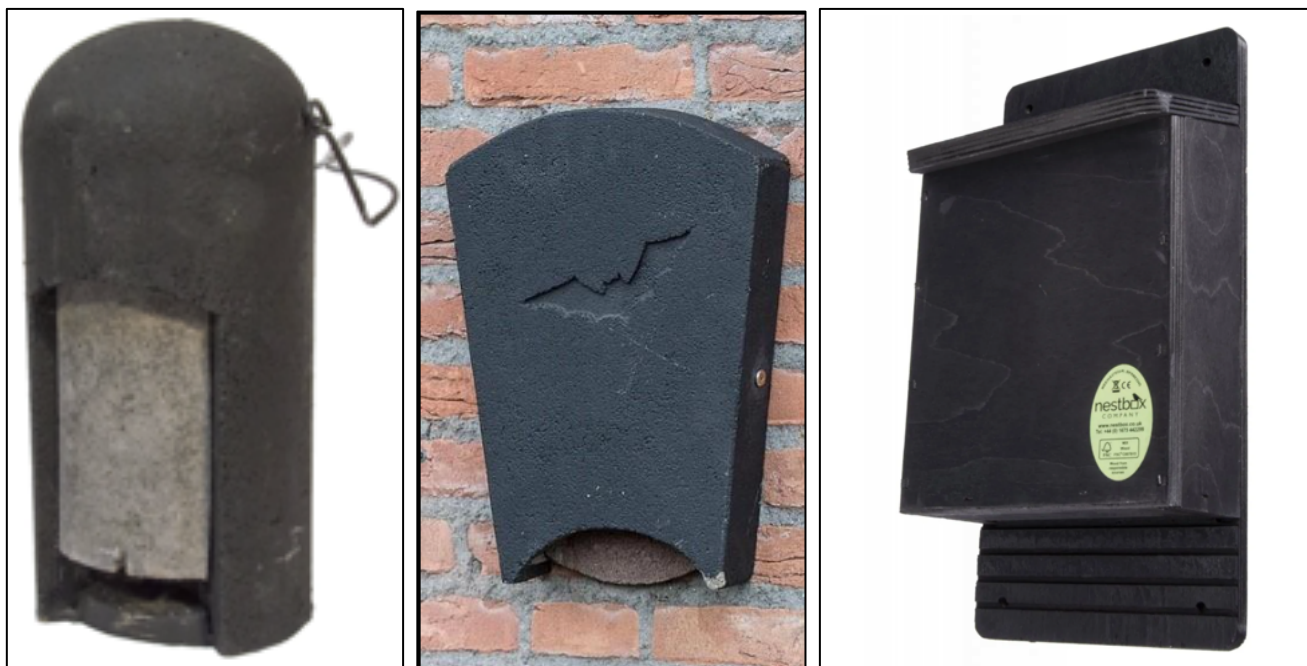
**Figure 1.** Left to right, the 2FN Schwegler bat box, Beaumaris Woodstone Bat Box and Improved Crevice Bat Box, with other brands available at many on-line wildlife stores. The Schwegler and Beaumaris boxes are constructed of 'woodcrete' (a mixture of cement and woodchip) and are designed to be durable and replicate the stable thermal properties of trees and buildings (with the Improved Crevice box comprising treated plywood). They may be attached to trees or buildings.

- **Replacement roost site**  
Replacement roosting opportunities must be incorporated into the proposed replacement building. Suitable crevice features for soprano pipistrelle bats must be re-instated post-development, either achieved through at least one bat tube such as the 2FR Schwegler Bat Tube on the walls of the building, or through the use of bat access tiles or wooden wedges beneath individual hanging tiles. The wooden wedges would create a gap of approximately 15mm allowing access to roosting bats whilst ensuring the feature will remain watertight. These should be positioned on the southern elevation of the property to replace the lost roost. Some recommended examples of integrated features are shown in Appendix 3.
