# Tree survey & report

Thistledown Cottage,  
Harbolets Road, West  
Chiltington, Pulborough RH20  
2LG

Jonathan Rodwell Cert Arb L4(ABC); TechArborA

December 2024

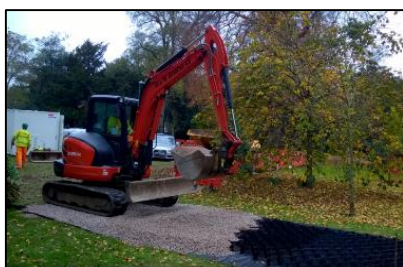
- Extend the width of the Geoweb to 2.6m wide, and secure each corner
  - Ensure the panel is secured at 6.6m x 2.6m, as this will achieve the 259mm by 224mm cell diameter required.

4. **Connection of the panels to create one single mattress**
  - All panels must be adjoined to one another both side by side and end to end
  - Simply connect the Geoweb with the supplied ATRA® keys, through the aligned slots
