# **Barns Green Horsham**

## **Flood Risk Assessment and Surface Water Drainage Statement**

**April 2026**

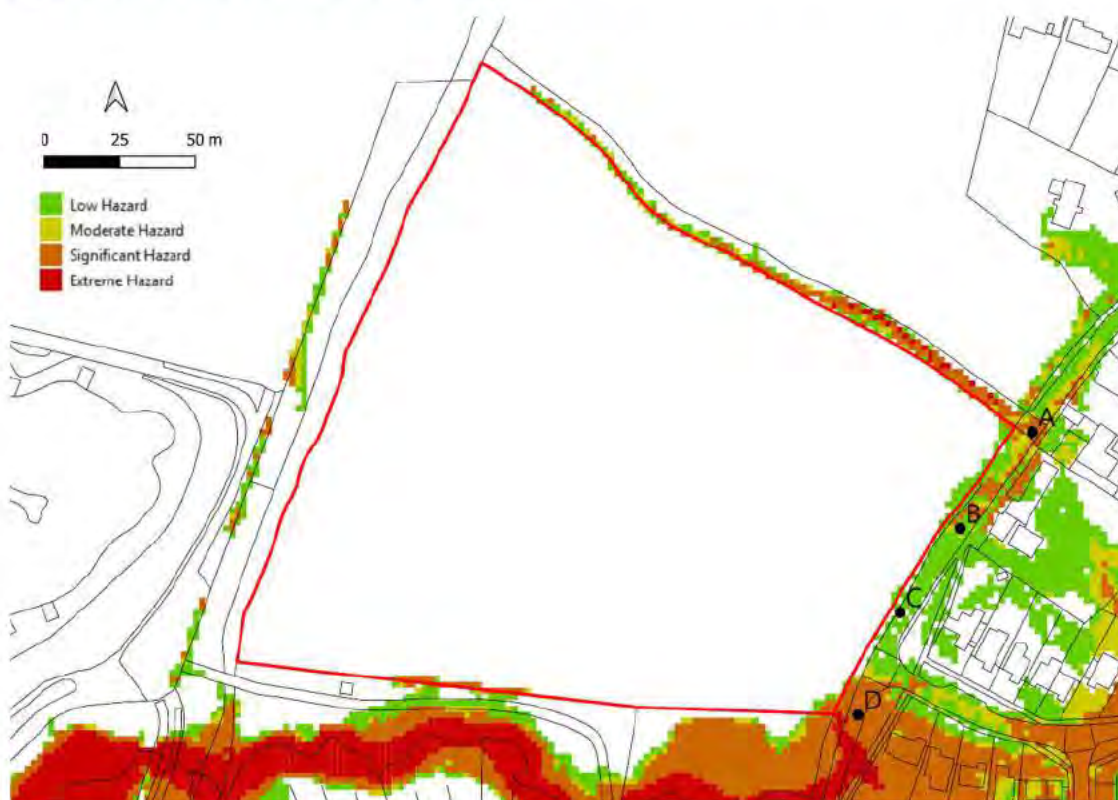
**Figure 11:** 1%AEP+cc Modelled Hazard Rating

- 5.10.3 A varying conservative debris factors has been applied which is defined as 0.5 for depths less than 250mm and 1.0 for depths in excess of 250mm or velocities in excess of 2m/s.
- 5.10.4 The Hazard Rating thresholds are presented in **Table 4**.
- 5.10.5 A plan showing the 1 in 100-year plus climate change hazard rating for the existing situation is presented as **Figure 11**.

- 5.10.6 Representative hazard at 4 node locations which represent the FD2331 rating within the carriageway of Chapel Road at; [A] the proposed northern pedestrian crossing near the junction of Smugglers' Way and Chapel Road; [B] the location of the proposed access into the site; [C]

5.10.7 Figure 11 and Table 5 demonstrate that the hazard rating at Node [B], the location of the proposed access, for the 1 in 100-year plus climate change surface water hazard rating is 0.722 'Low Hazard'.

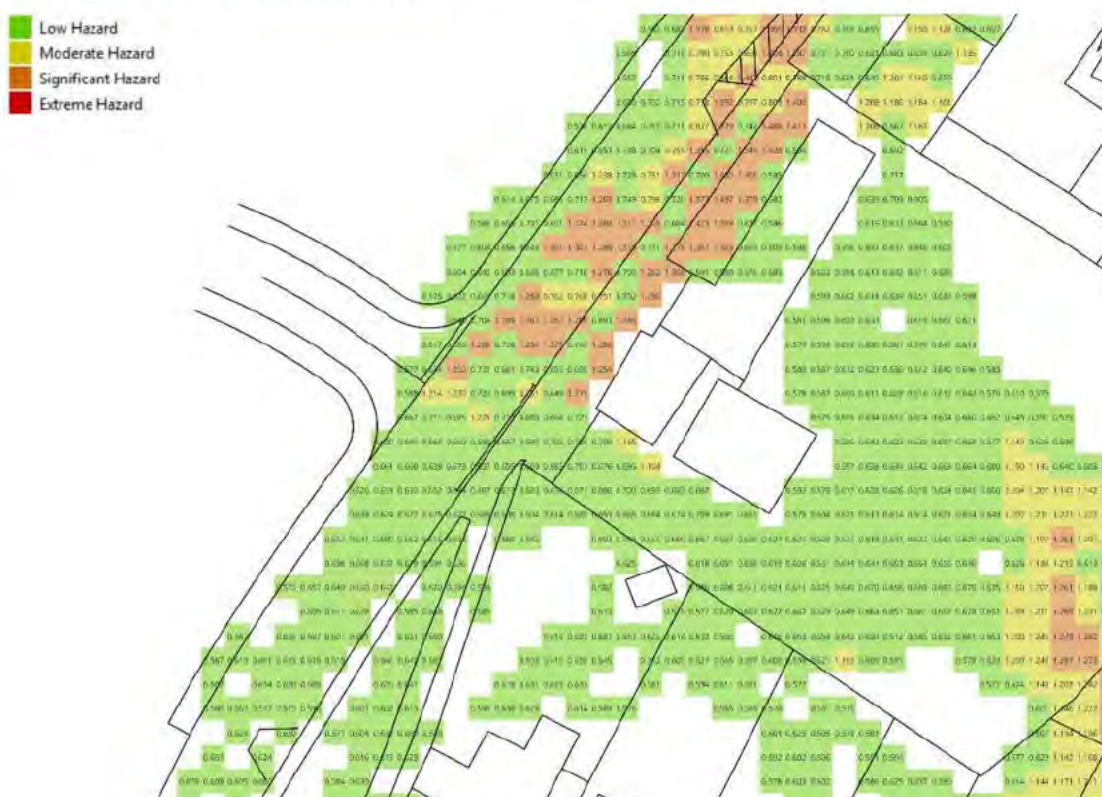
**Figure 12:** 1%AEP+cc Modelled Hazard Rating

5.10.9 When overlaid with the proposed site access, and prior to any further mitigation, it is clear that the proposed access is located in an area of 'No Hazard' to 'Low Hazard' for the majority of Chapel Road with the new footways associated with the access being located entirely within the 'No Hazard' to 'Low Hazard' category. **Figure 12** refers.

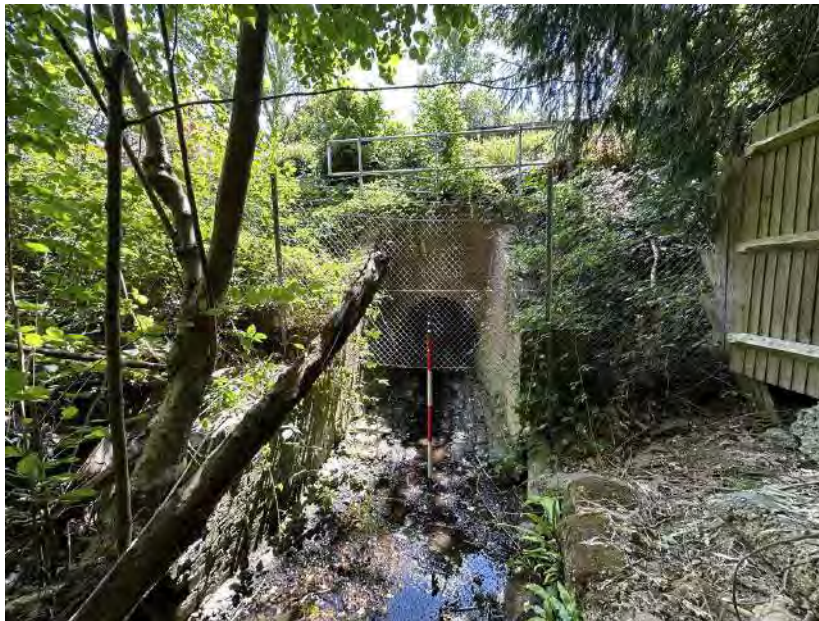
*Fig.2 - Crossing fence cross section MUNT01\_00049 upstream of MUNT01\_00046.*

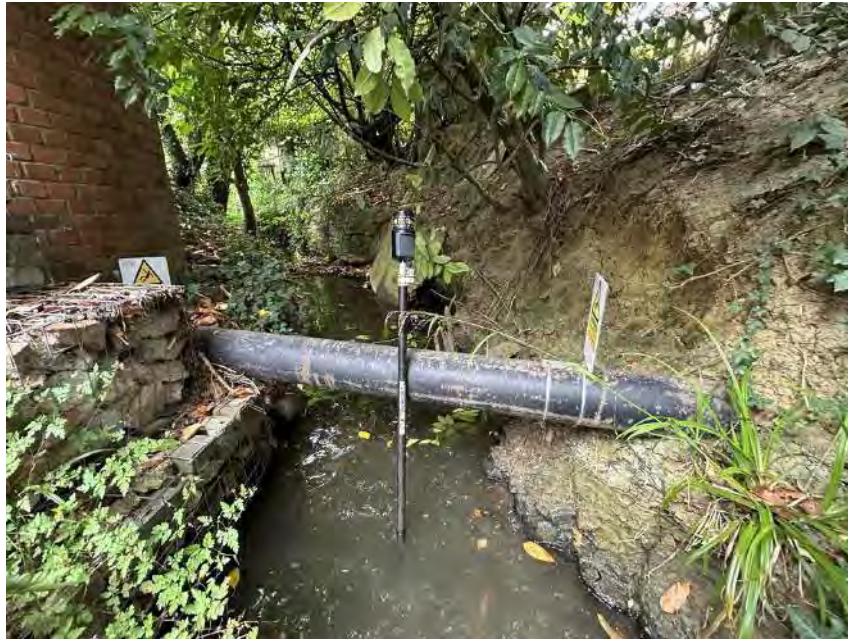
*Fig.3 – Crossing pipe upstream of cross section MUNT01\_00151.*

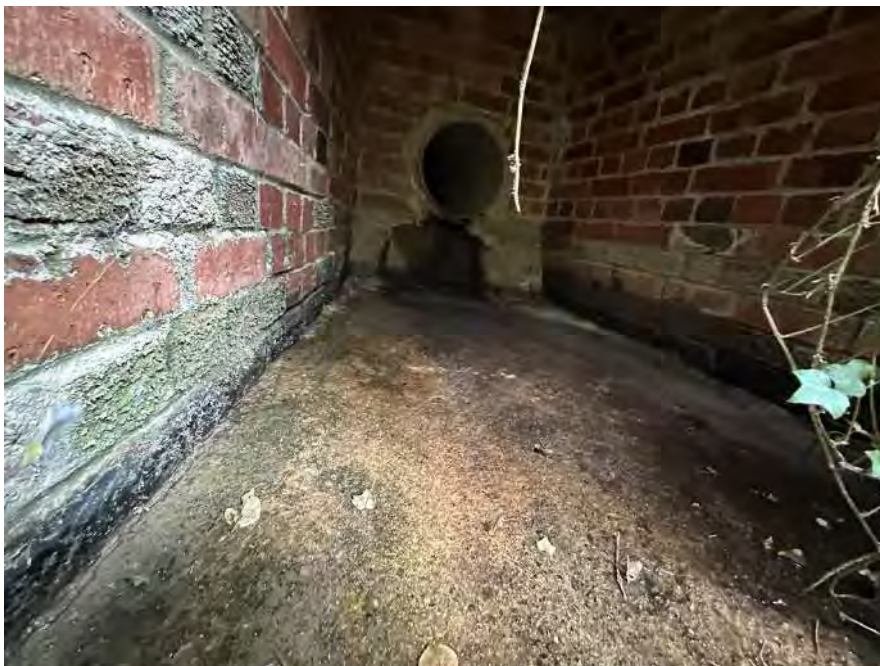
- 6.6 We have been informed by a resident that the only recent flooding to have occurred in the area was due to water flowing back up a large incoming pipe (shown below) found on the left bank upstream of cross section MUNT01\_00216. The pipe has been surveyed with long section points and highlighted on the long section.

*Fig.4 – Large left bank incoming pipe upstream of cross section MUNT01\_00216.*

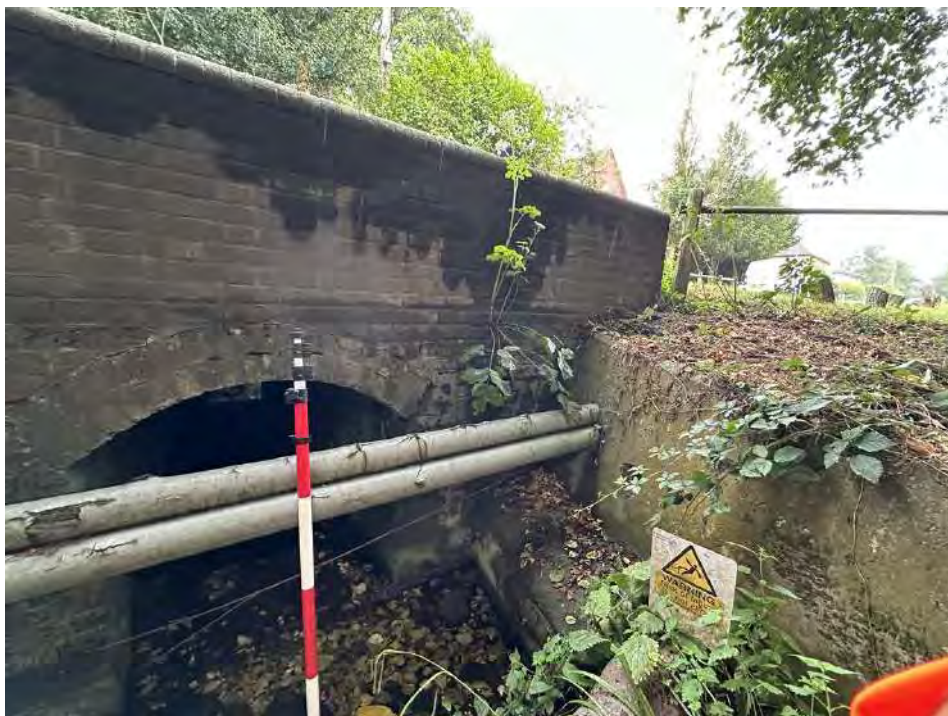
*Fig.5 – Crossing pipe on structure face at cross section MUNT01\_000365.*

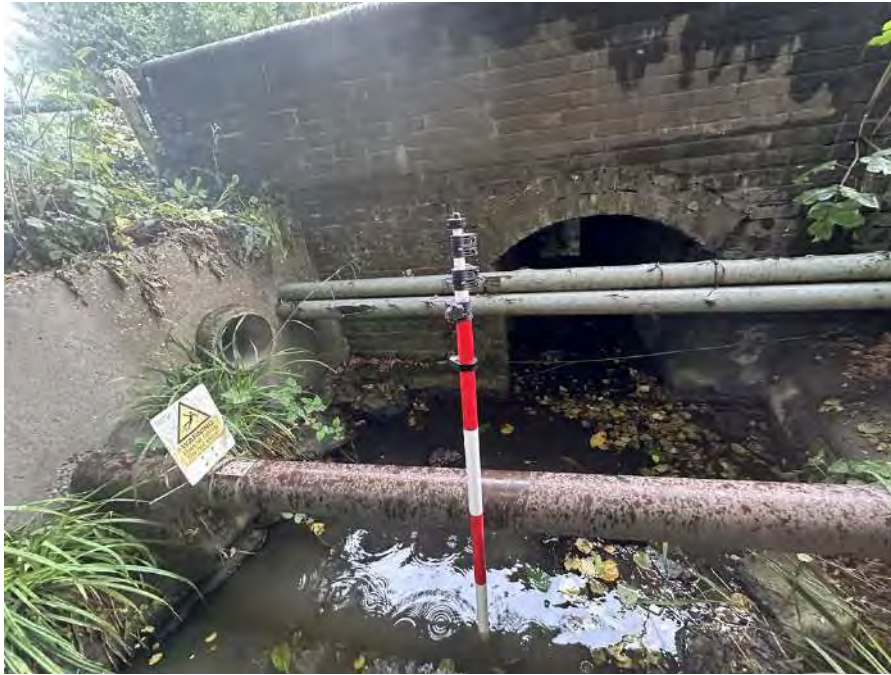
*Fig.6 – Crossing pipe upstream of cross section MUNT01\_00365.*

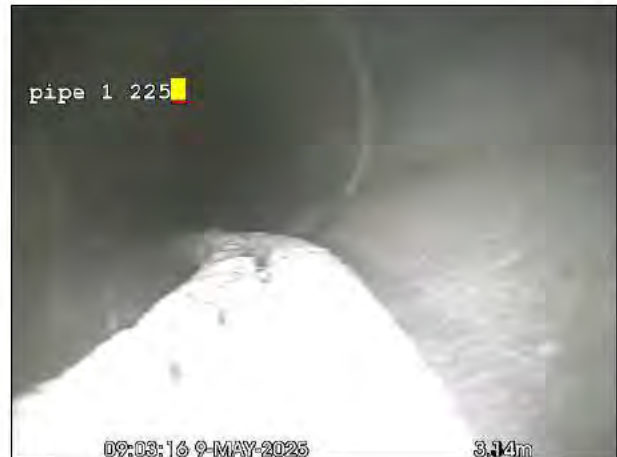
Photo: 4\_4a, 00:00:00  
3.2m, Obstruction, 15 % height/diameter loss

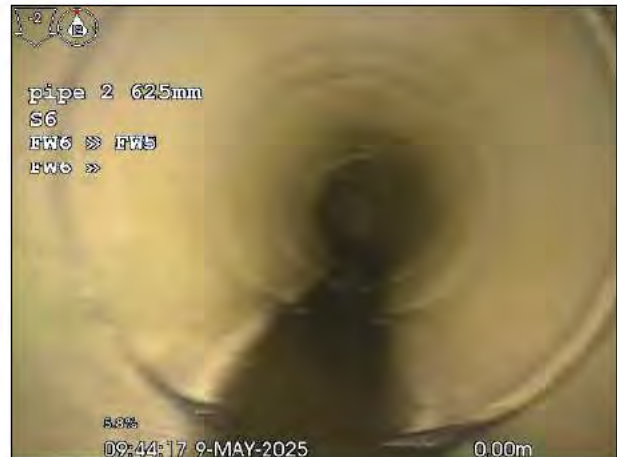
Photo: 2\_5a, 00:00:00  
0.4m, Joint displaced. Medium

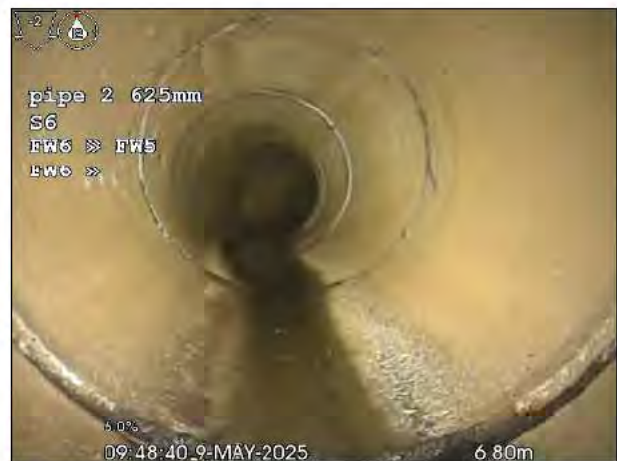
Photo: 2\_8a, 00:00:00  
7.1m, Joint displaced. Medium

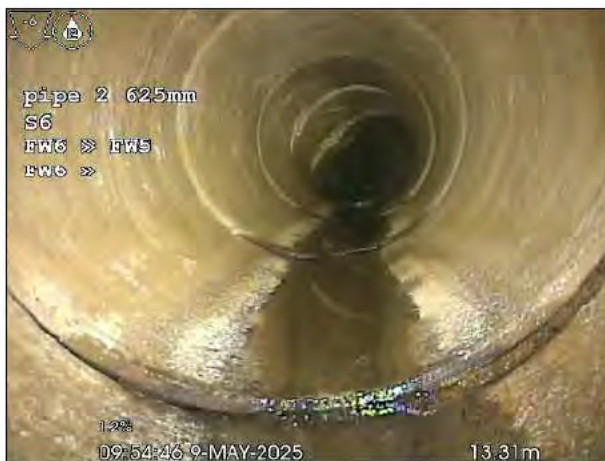
Photo: 26\_12a, 00:00:00  
13.6m, Joint displaced. Medium

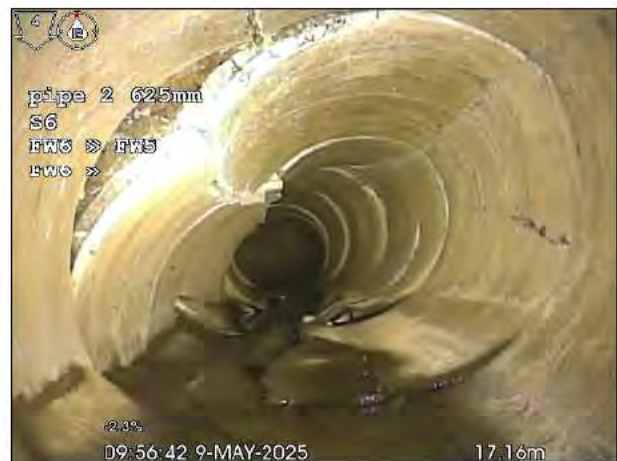
Photo: 28\_13a, 00:00:00  
17.25m, Circumferential Crack, from 06 to 11 o'clock

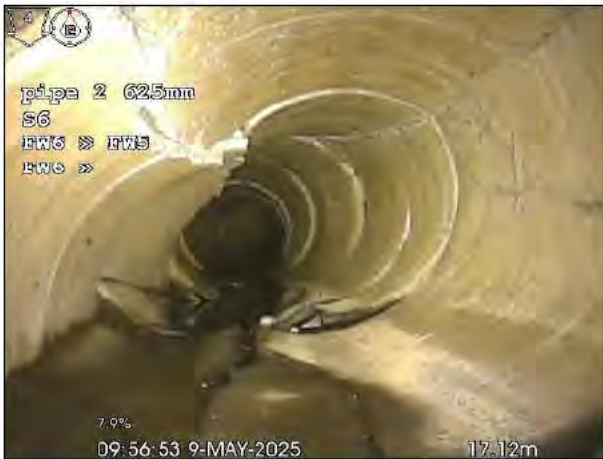
Photo: 28\_13b, 00:00:00  
17.25m, Circumferential Crack, from 06 to 11 o'clock

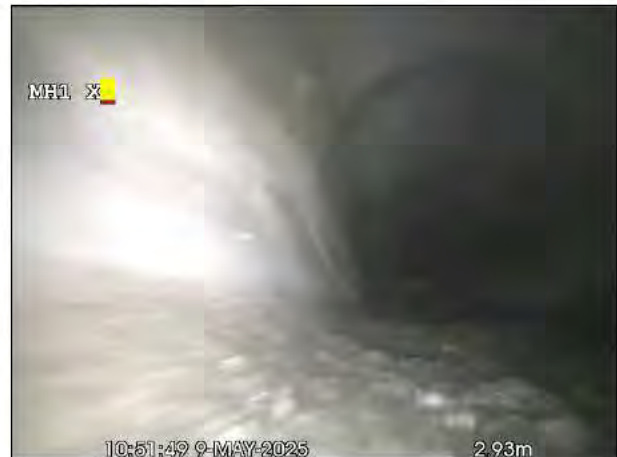
Photo: 33\_5a, 00:00:00  
3m, Debris silt, 10 % cross-sectional area loss

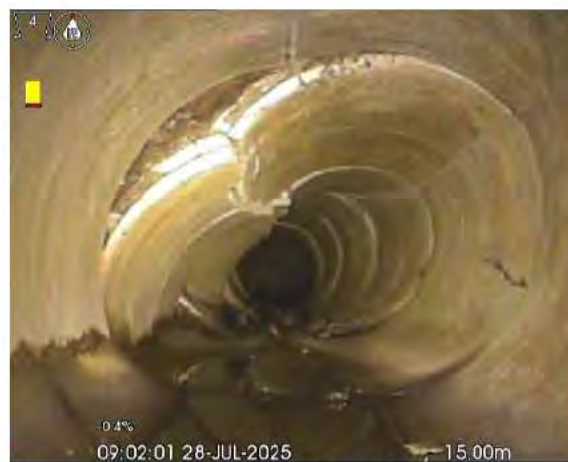
8, 00:01:49, 15.00 m  
Broken pipe from 12 o'clock to 12 o'clock, start
