Land adj. to 5 Muntham Drive  
Barns Green  
Horsham  
RH13 0PT

25-129.01  
Version 2

Aviron Associates Limited

| Report Quality Management | | | |
|---|---|---|---|
| <b>Project Title</b> | Preliminary Risk Assessment | | |

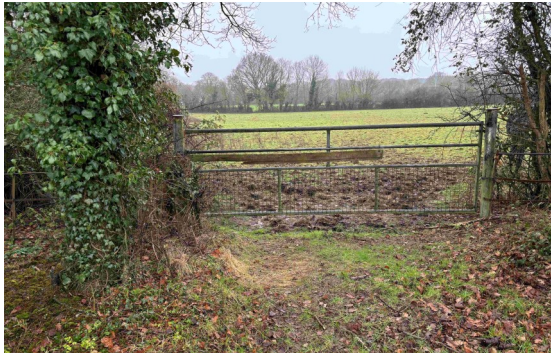
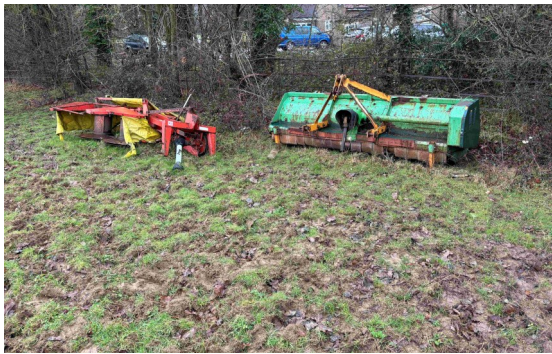
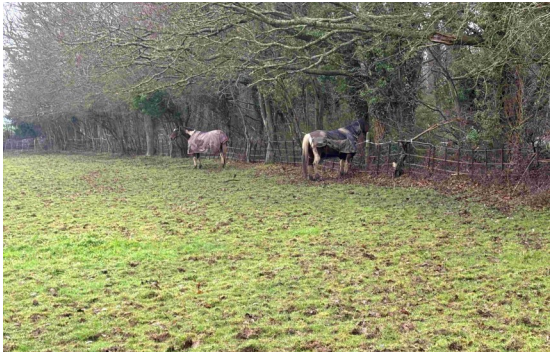
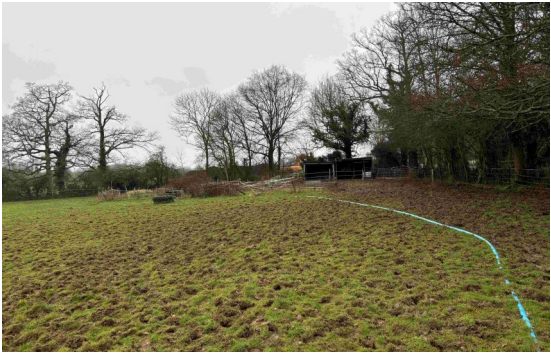
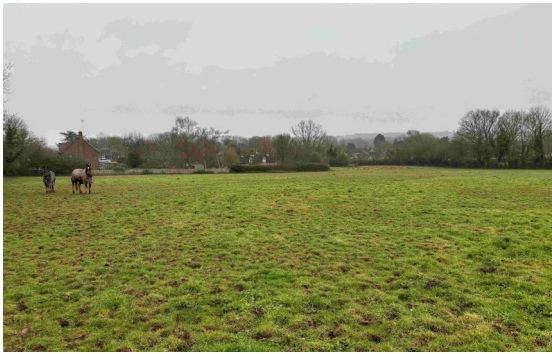
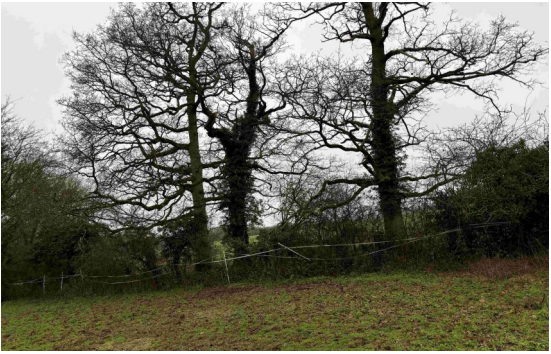
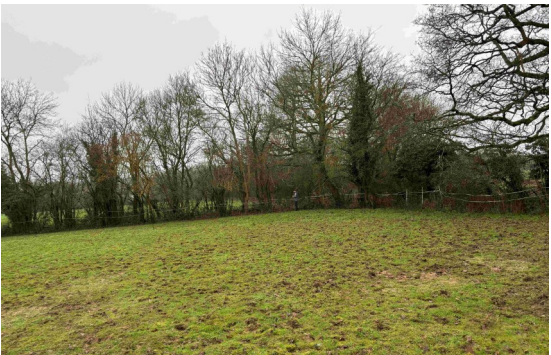
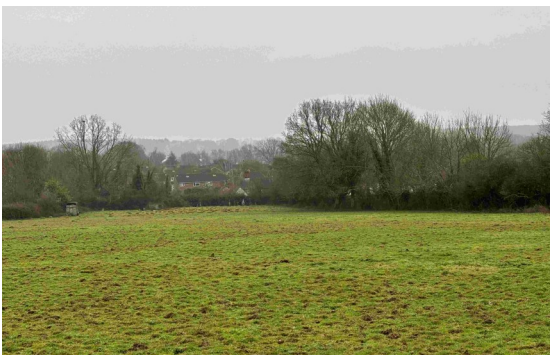
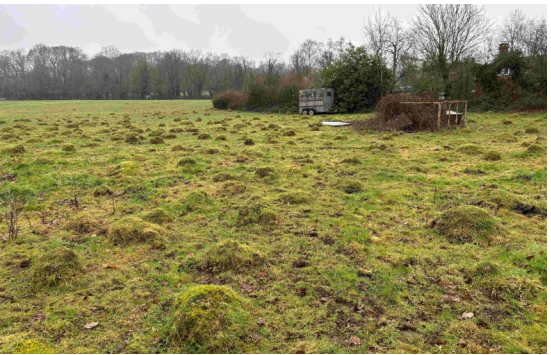
| Table 1.2: Site Details | |
|---|---|
| <b>Current Land Use</b> | <p>The site currently comprises pasture with small, dilapidated stable buildings and animal pens located within the north-western corner. Discarded farming equipment and a horse box are located inside the site entrance and in the south-east of the site respectively.</p> <p><b>Figure 2</b> is presented as the Existing Site Layout Plan.</p> <p><b>Figure 3</b> is presented as the Site Photographs.</p> |

| Physical Site Characteristics | |
|---|---|
| <b>Existing Structures</b> | Small, dilapidated buildings (stables) of corrugated sheet metal construction in the north-western corner of the site. Various animal pens and discarded vegetable plots also at this location. |

| <b>Contaminative Characteristics</b> | |
|---|---|
| <b>Asbestos Containing Materials (ACMs)</b> | <p>Possibility of ACMs as part of the existing or former building materials to the buildings in the north-western corner.</p> <p>An asbestos survey is recommended prior to the redevelopment works.</p> |
