**MR N FRANCIS**

**AMIESMILL FARM, KERVES LANE, HORSHAM,  
WEST SUSSEX, RH13 6RL**

**April 2025**

| Requirement | Data |
|---|---|
| Report type | Preliminary Contamination Risk Assessment |

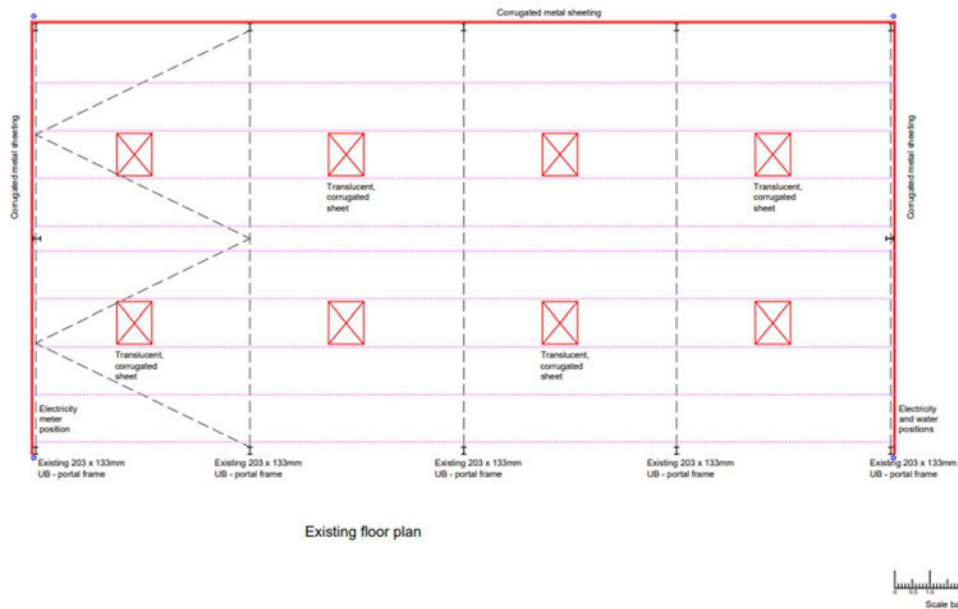
FIGURE 2: **Existing Site Layout**

- 5.3 The site is approximately 0.06 ha and comprises of a modern agricultural barn together with a narrow strip of land surrounding the barn. The narrow strip of land includes part of a loop access track to the north, a further access track to the east, part of a storage area to the west and a field boundary to the south.

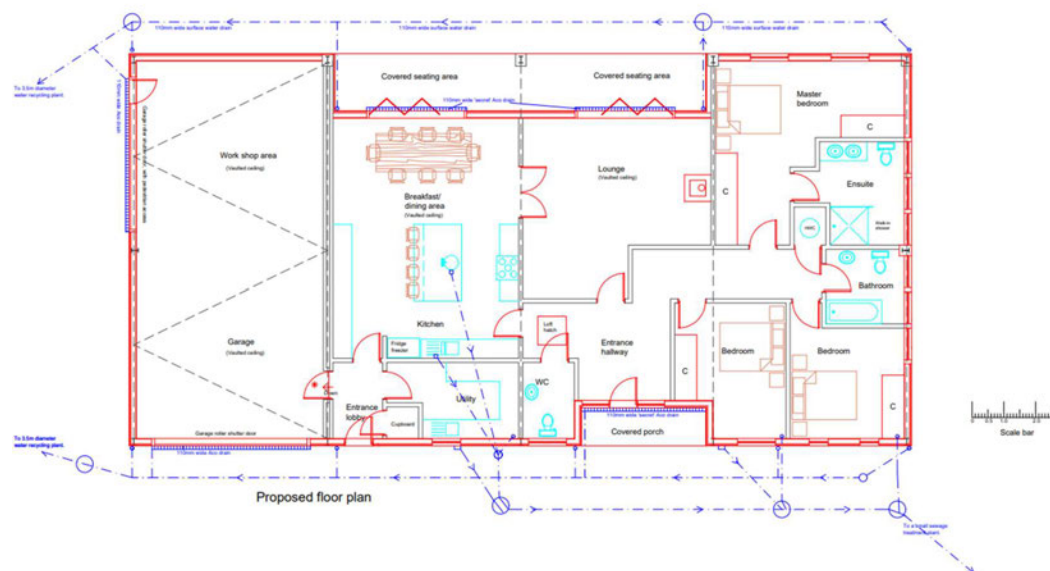
FIGURE 3: **Proposed Site Layout**

- 8.3.1 It is proposed to redevelop the site for residential use. There is a narrow strip of external land within the redline boundary which surrounds the building. This is to be developed as permanent hard standing to provide access into and around the building. There is no garden or soft landscaping area proposed in association with the redevelopment of the barn for residential use. In this case, potential *receptors* may include future site users (which may include adults and children), site workers (during the development of the site), buildings and services (including underground water mains).

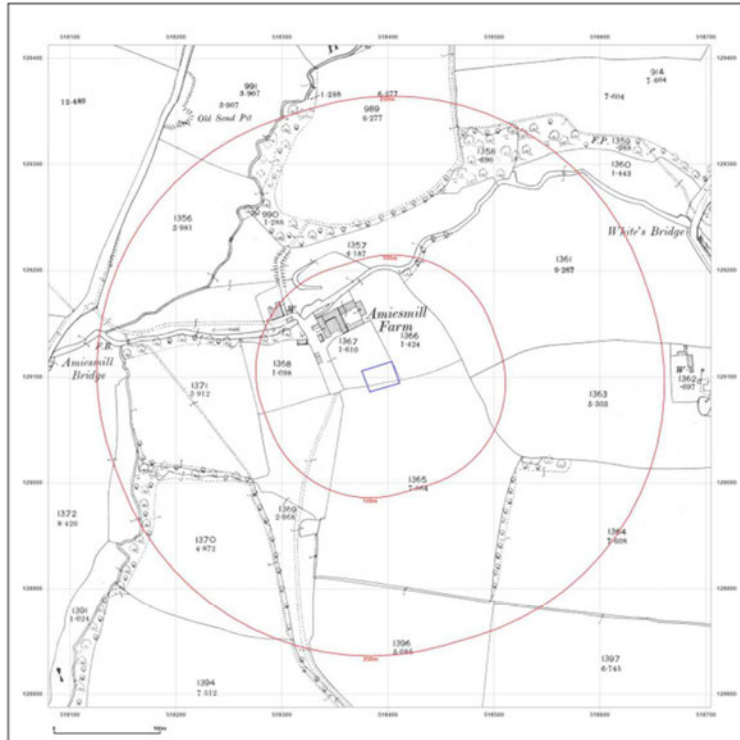
**Map Name:** County Series  
**Map date:** 1897  
**Scale:** 1:2,500  
**Printed at:** 1:2,500

| Map date<br>(Scale) | Features on site | Features within<br>surrounding area (<250 m) |
|---|---|---|
| 1897<br>(1:2,500) | The field in which the site lies has been divided and the track is no longer shown to be present along the northern boundary of the site. | Amiesmill Farm has been further developed with additional buildings to the northwest. A small building previously noted to the west has been removed. |

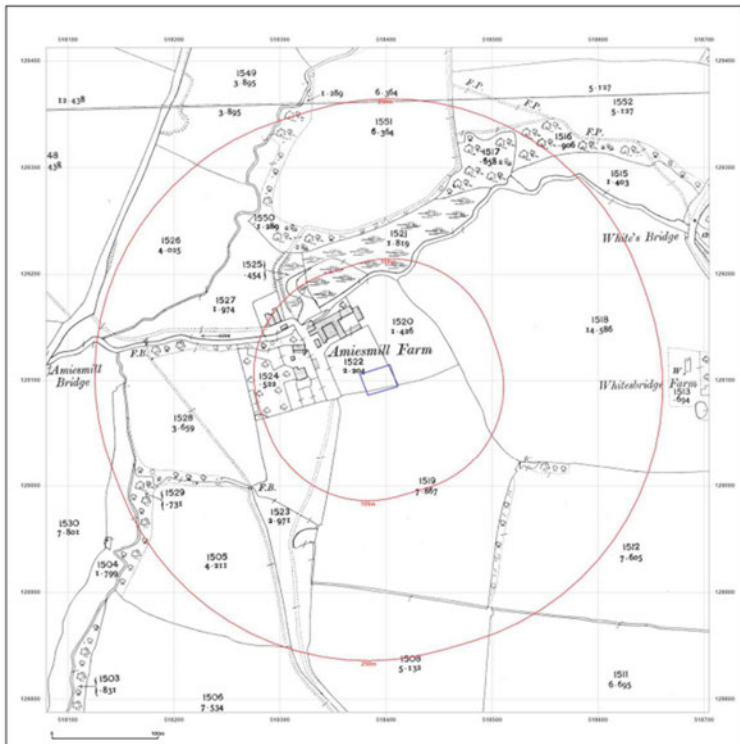
**Map Name:** County Series  
**Map date:** 1911  
**Scale:** 1:2,500  
**Printed at:** 1:2,500

| Map date<br>(Scale) | Features on site | Features within<br>surrounding area (<250 m) |
|---|---|---|
| 1911<br>(1:2,500) | The site remains an undeveloped plot of land to the south of the Amiesmill Farm buildings. | A dwelling with surrounding gardens has been developed on the plot to the west of the site. |

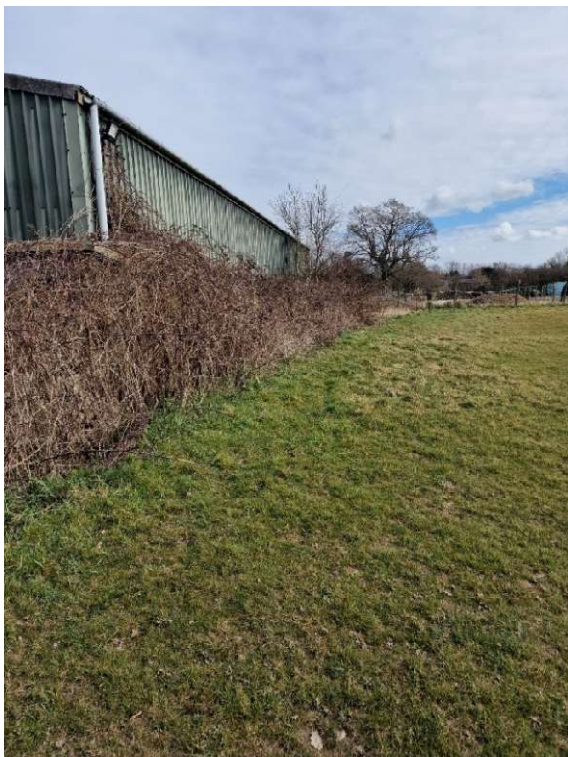
**Photograph 1**  
Southern façade, adjacent to paddock

- 5.6 The field boundary to the south of the barn included within the site is presently overgrown with brambles, adjacent to which is grazing land. That we are aware, this field has never been developed and has been used for crops and pasture only.

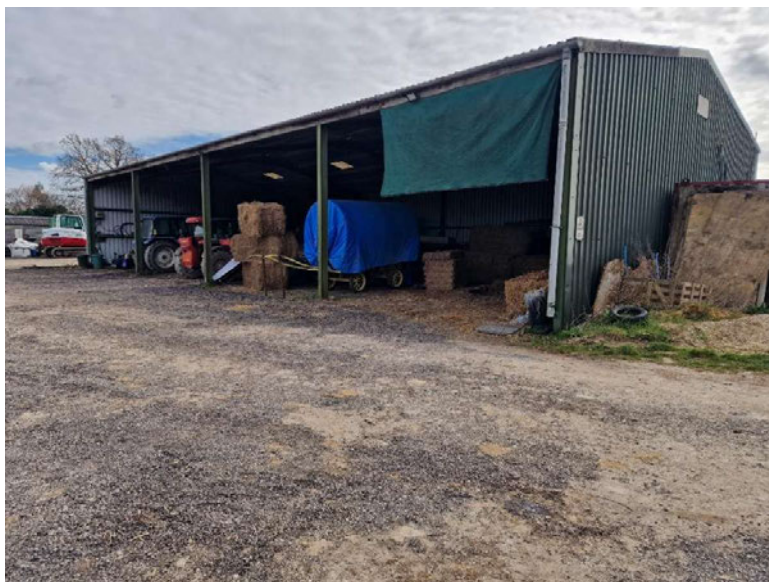
**Photograph 2**  
North façade and access.

- 5.4 The track to the north of the site comprises loose surfacing including road planings. This is an old track likely to have other layers of reinforcement. The area to the north of the track is used for storage of miscellaneous items associated with the farm.

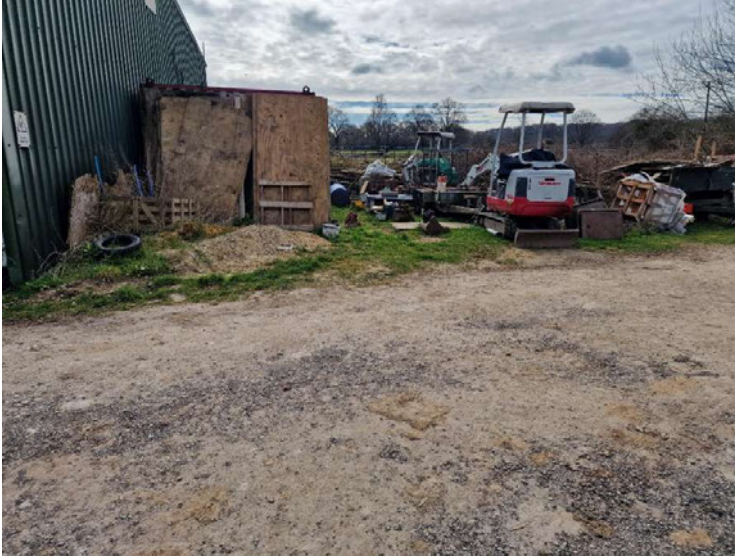
**Photograph 3**  
Western façade and adjacent  
land used for storage.

- 5.5 The area to the east of the barn is mainly clear track with a few stored items, limited to an excavator bucket and a few other metal items. The area to the west of the barn includes two shipping containers (one green, one blue) and an old wooden shed used for the storage of building materials (including pipework, paving, metal and wood). Further west, beyond the redline boundary of the site, other stored items include machinery (including two excavators), trailers, building materials, scrap wood and scrap metal (mainly a pile of drain covers).

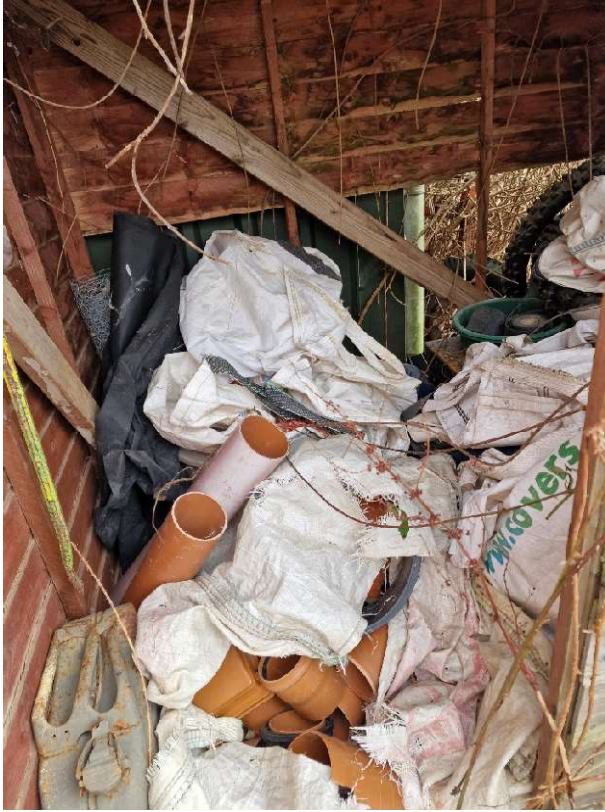
**Photograph 5**

Plastic pipework stored in a wooden shed adjacent to the southwest corner of the barn.

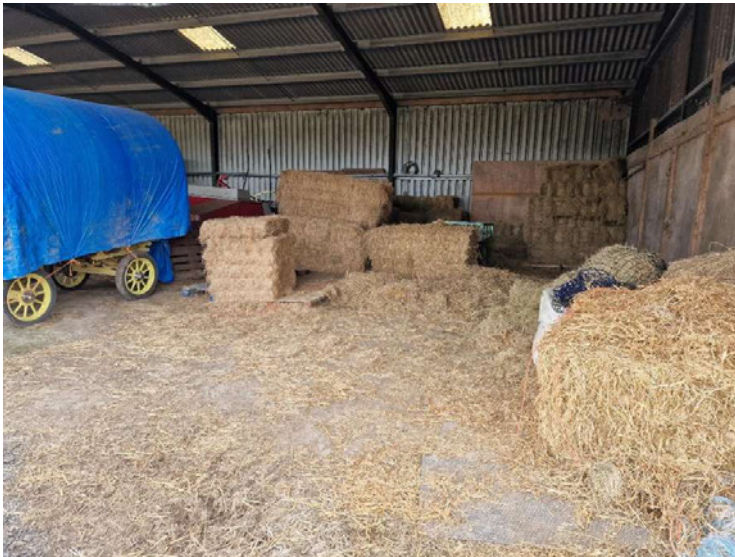
**Photograph 6**

- 5.7 The modern barn is of metal frame construction, clad in profiled metal sheets. The flooring within the barn comprises of compressed road gravel. At the time of our visit, the western third of the barn was being used to store hay and a wooden cart. The eastern two thirds of the barn were being used to store tractors and a horse box, and the northeast corner included a small amount of maintenance equipment and products including oils and batteries. There were no obvious signs of any significant leaks or spills within or adjacent to the barn.

Hay stored within the western third of the barn.

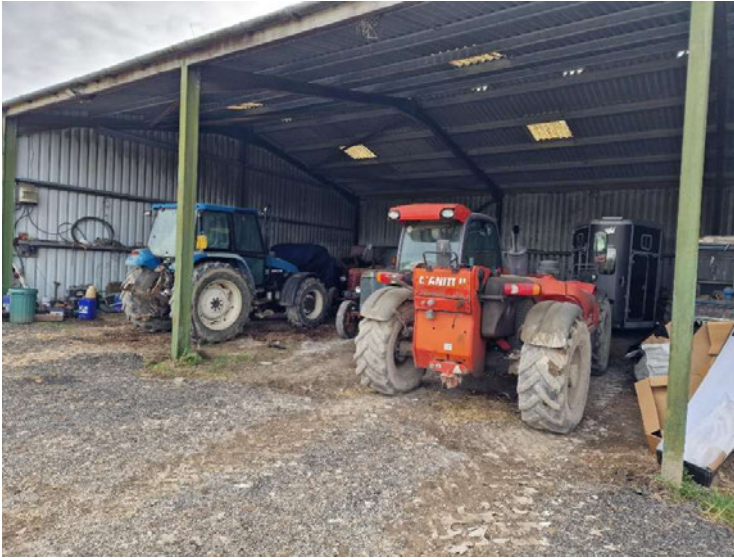
**Photograph 7**  
Tractors stored within the eastern two thirds of the barn.

### 7.3 The western end of the building is being used to store hay and a wooden cart, while the eastern end is being used to store tractors, a horse box and a small amount of maintenance equipment and products, including oils and batteries, within the northeast corner of the site. There is some potential contamination risk associated with the storage of machinery and maintenance activities within the eastern section of the barn.

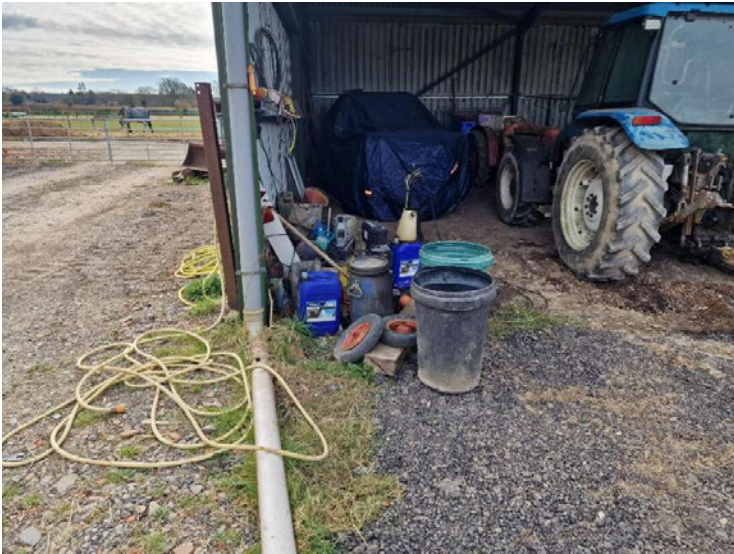
**Photograph 8**  
Maintenance fluids and equipment located within the northeast corner of the barn.

- 8.4.4 Petrol, diesel and some fuel additives (such as MTBE) are highly mobile and may cause contamination of the wider area. The proposed development will result in the removal of surfacing materials potentially impacted by any leaks or spills associated with the storage and use of fuels and maintenance fluids on

- 10.1 The existing surfacing and any underlying natural ground which has obviously been impacted by past land use (i.e. areas of staining) are to be removed and/or capped by permanent hard cover. Should any unexpected contamination be identified during the development phase, the Council are to be notified and any necessary remediation work carried out as required.
- 10.2 Should any garden or soft landscaping areas be associated with the proposed development in the future, soil testing should be completed in order to confirm the soil is fit for use. At present we are not aware of any such plans to provide a garden area associated with the proposed development. Adjacent land is to
