**Barn at High Beech Farm, Horsham,  
West Sussex RH13 6PE**

**Biodiversity Enhancement Plan**

**June 2026**

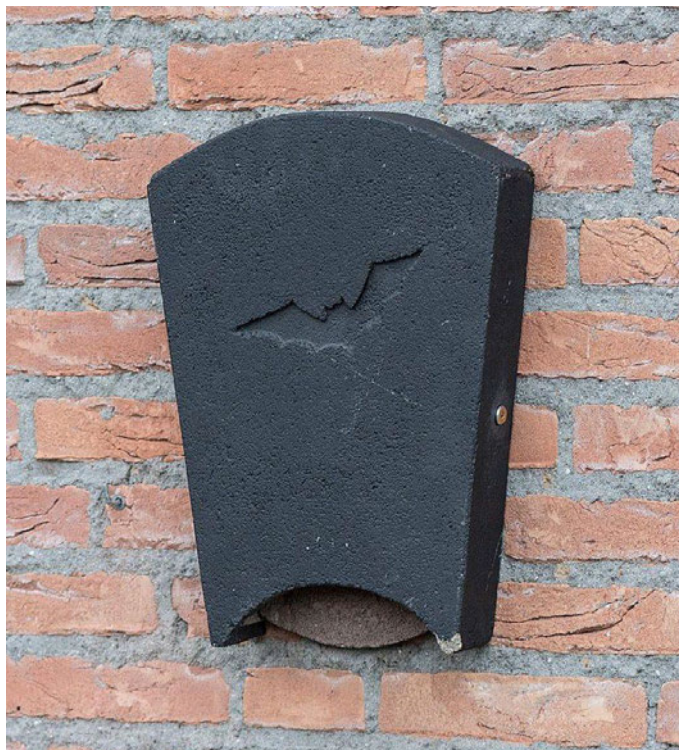
Figure 1. Beaumaris Woodstone Bat Box. Source: [www.nhbs.com](http://www.nhbs.com).

of different designs. A Beaumaris Woodstone Bat Box, or similar (see Figure 1) is recommended for mounting on the external walls of buildings. This box should be installed as high as possible on the southern elevation to provide a warmer microclimate within the box.

Considering the location of the site, it is hoped that bats navigating along the newly created area of trees along the site boundary will be able to find and colonise this box with relative ease. This type of box would be suitable for crevice-dwelling species of bat, such as the common pipistrelle, soprano pipistrelle, Nathusius's' pipistrelle, Brandt's bat and whiskered bat.

The bat box will be checked annually in the period May to August to determine its condition. If it is found to be damaged or blocked, it will be fixed/replaced or unblocked.

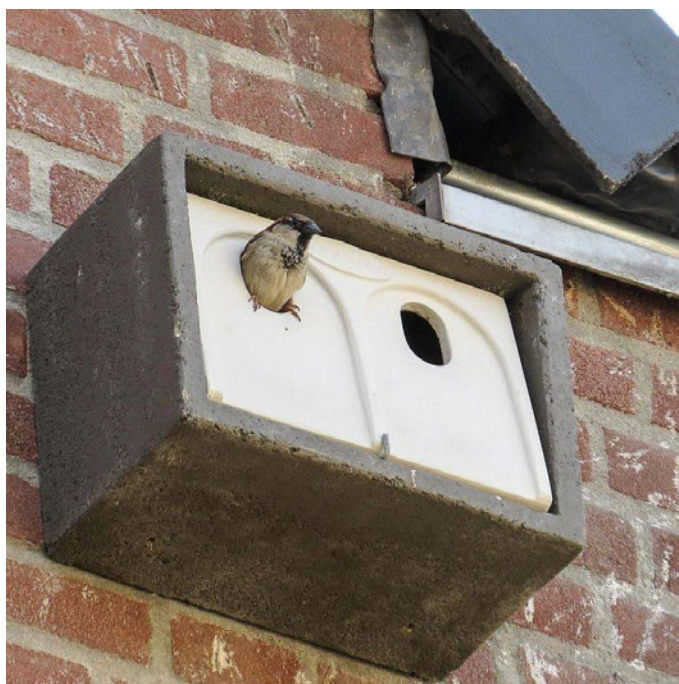
Figure 2. Vivara Pro WoodStone House Sparrow Nest Box. Source: [www.nhbs.com](http://www.nhbs.com).

Bird boxes can be obtained pre-fabricated in a number of different designs. A Vivara Pro WoodStone House Sparrow Nest Box, or similar (see Figure 2) is recommended for mounting on the external walls of buildings. This box should be installed near to vegetation and at a minimum of 2m above ground. Unless there are trees or buildings which shade the box during the day, boxes should be

faced between north and east, thus avoiding strong sunlight and the wettest winds. In this case the box should be installed on the northern elevation of the proposed building.

The bird nest box will be surveyed once a year in May. The survey will be a daytime inspection to look for active birds' nests within the box.

Annual cleaning of the box is recommended to remove any parasites and material built up from the previous occupants. Annual cleaning is best carried out in October and November when there is no chance of disturbing the previous occupants. The bird nest box will be cleaned in the following way:

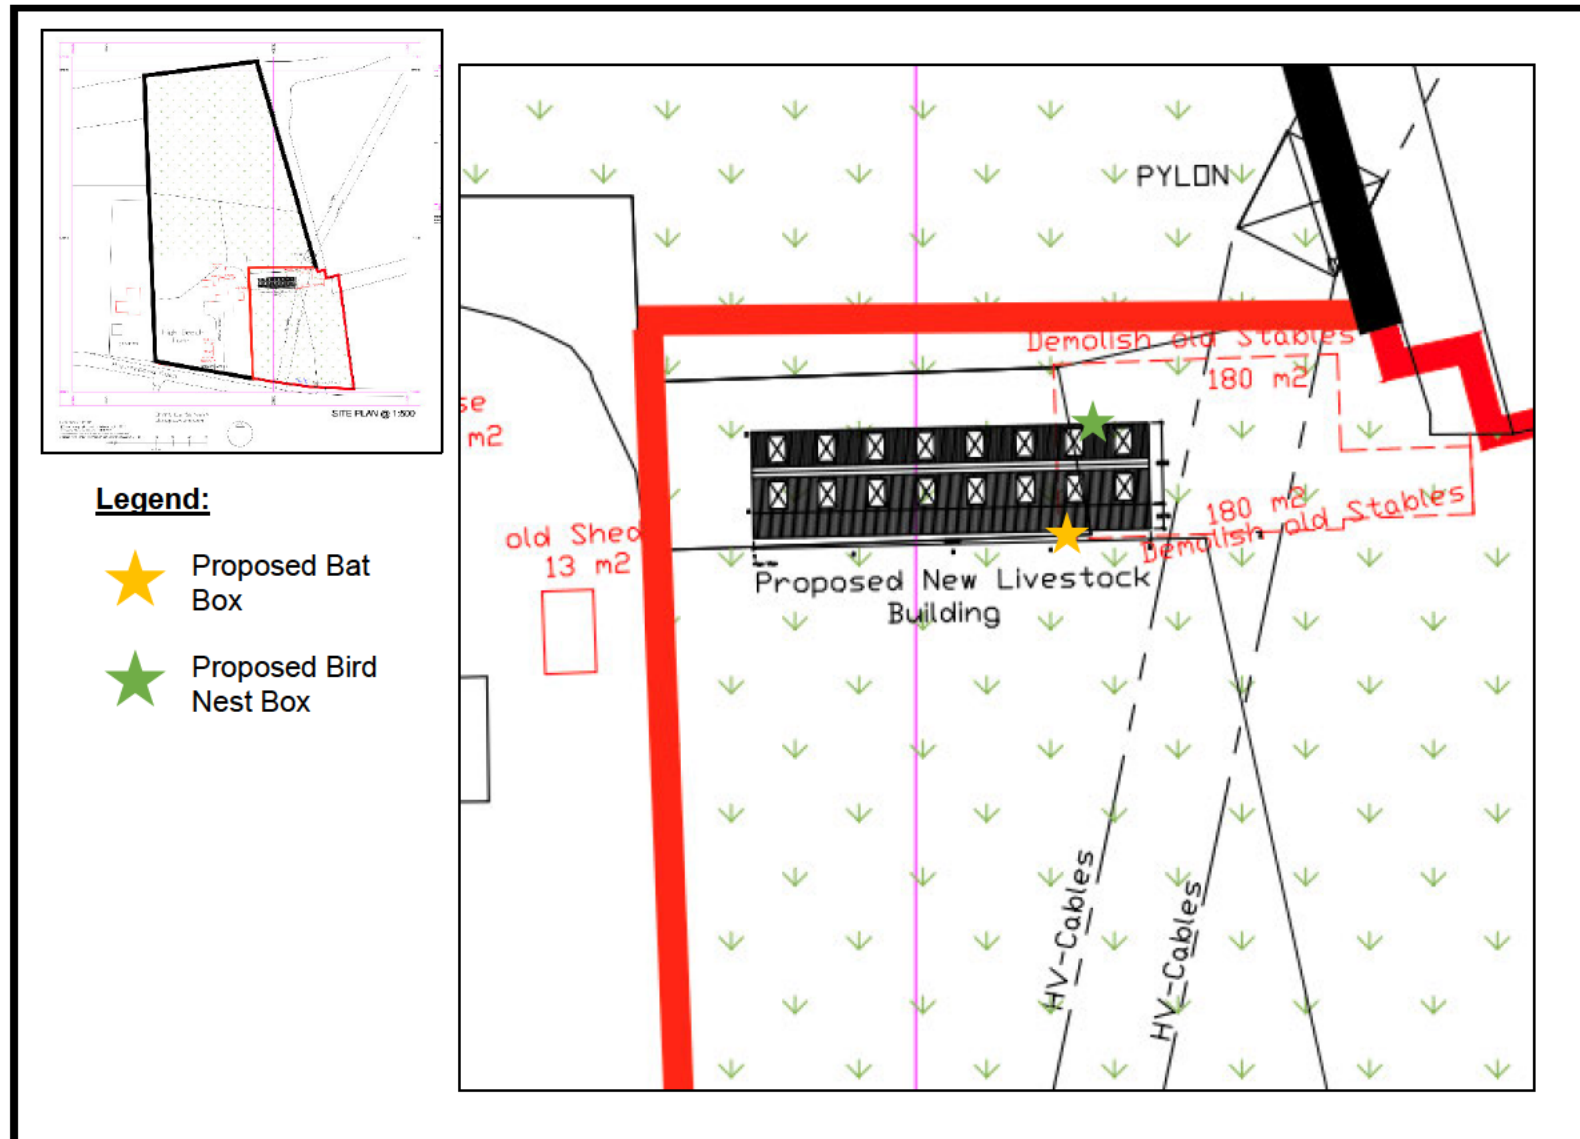
### 3 Appendix 1. Biodiversity Enhancement Plan

Please see Appendix 1 for the locations and elevations of the proposed species-specific biodiversity enhancement measures.
