| Project: | High Barn Farm |
| Document Ref: | 31066TN1 High Barn Farm addendum |

### HIGH BARN FARM – ADDENDUM

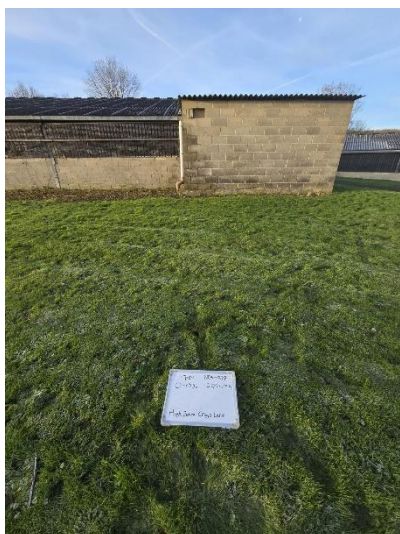
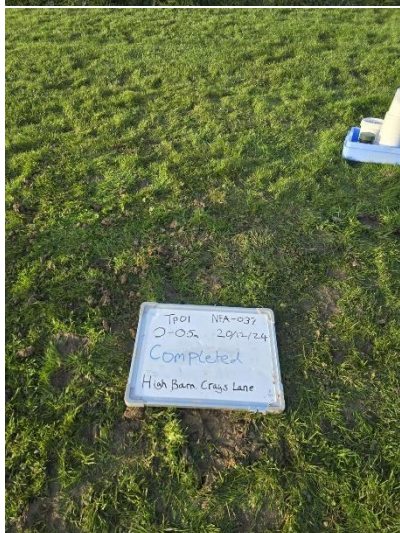
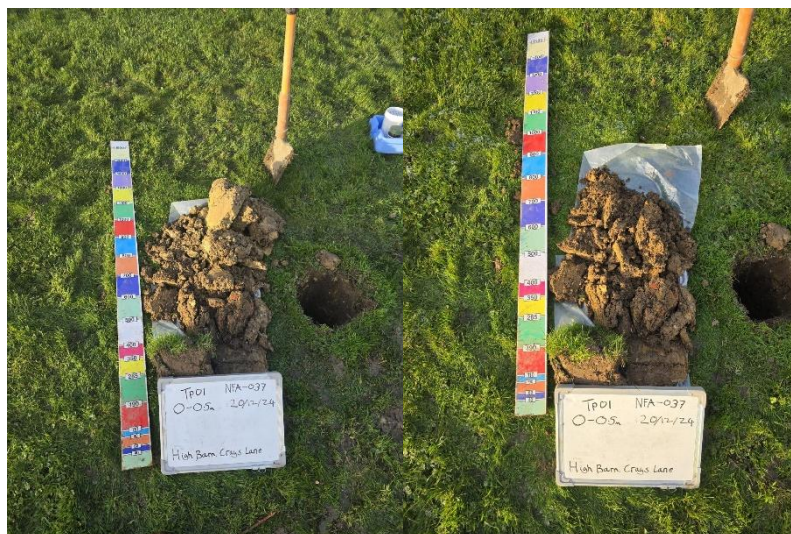
### TP01

- TP01 light to mid brown clayey soil and stones with some brick inclusions possibly indicating reworked ground
- TP02 Dark to mid brown soil and stones with some inclusions from the overlying slab, an artefact of trial pitting
- TP03 light to mid brown clayey soil and stones
- TP04 light to mid brown clayey soil and stones
- TP05 Dark to mid brown soil and stones
- TP06 Dark to mid brown soil and stones
