## GEOTECHNICAL INVESTIGATION – HIGH BARN, CRAYS LANE, GOOSE GREEN PULBOROUGH RH20 2LR

Jolliff Developments Limited

Report Number: YEX2150, Date: May 2021

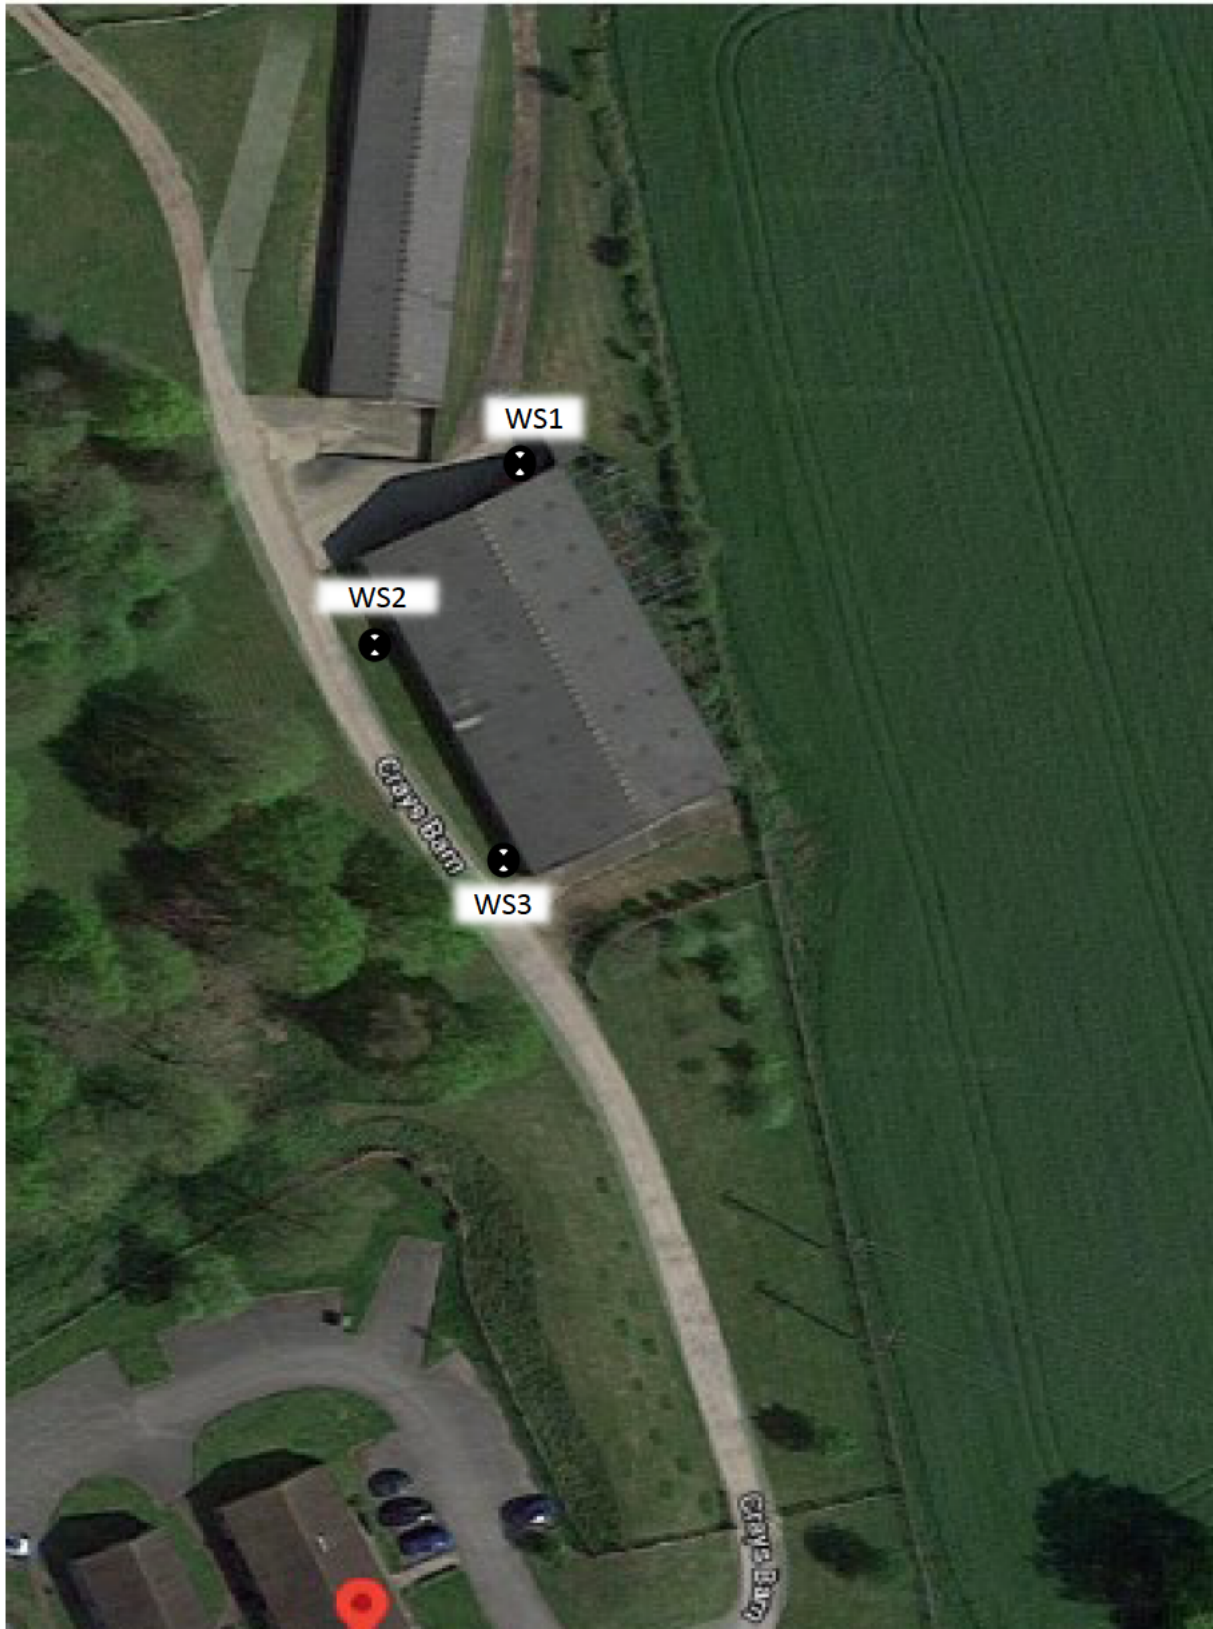
Title: **Investigation Location Plan**

The positions of exploratory holes in relation to the existing site layout can be reviewed within [Appendix B](#). Exploratory mini percussive borehole logs are located in [Appendix C](#).

- Three (3no.) mini percussive boreholes (WS01 to WS03) were completed to a maximum depth of 5.45mbgl.
- The boreholes were logged with any groundwater conditions noted and representative soil samples removed in accordance with current guidelines.
