## Partridge Green, Horsham Preliminary Risk Assessment

Job Number  
**LKC251626**

Client  
**Wain Estates (Land) Ltd**

| <b>Report Title</b> | Phase 1 Preliminary Risk Assessment |

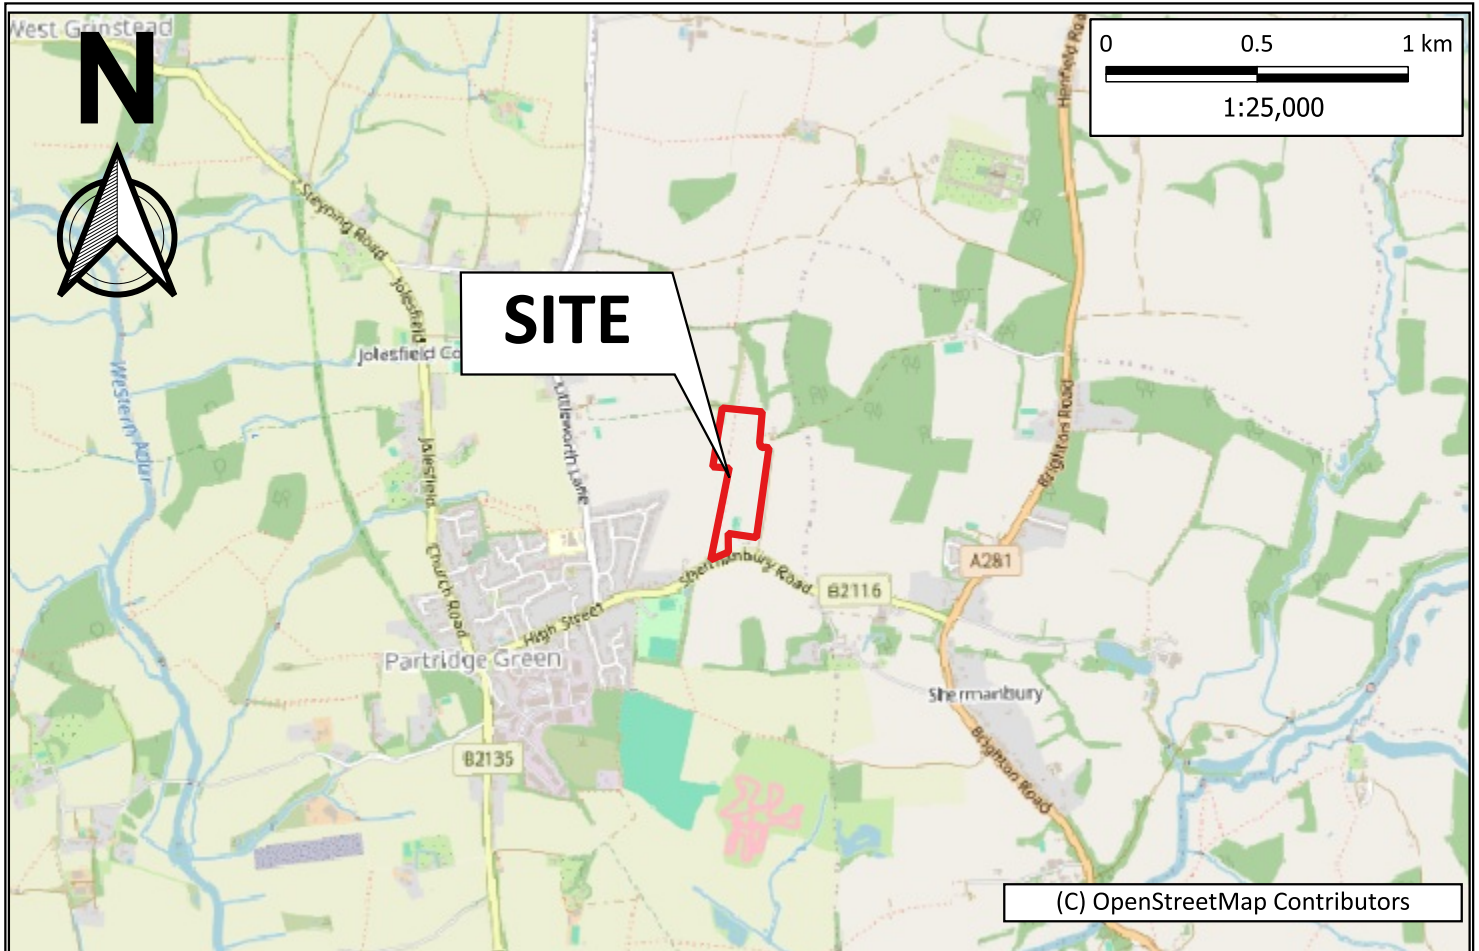
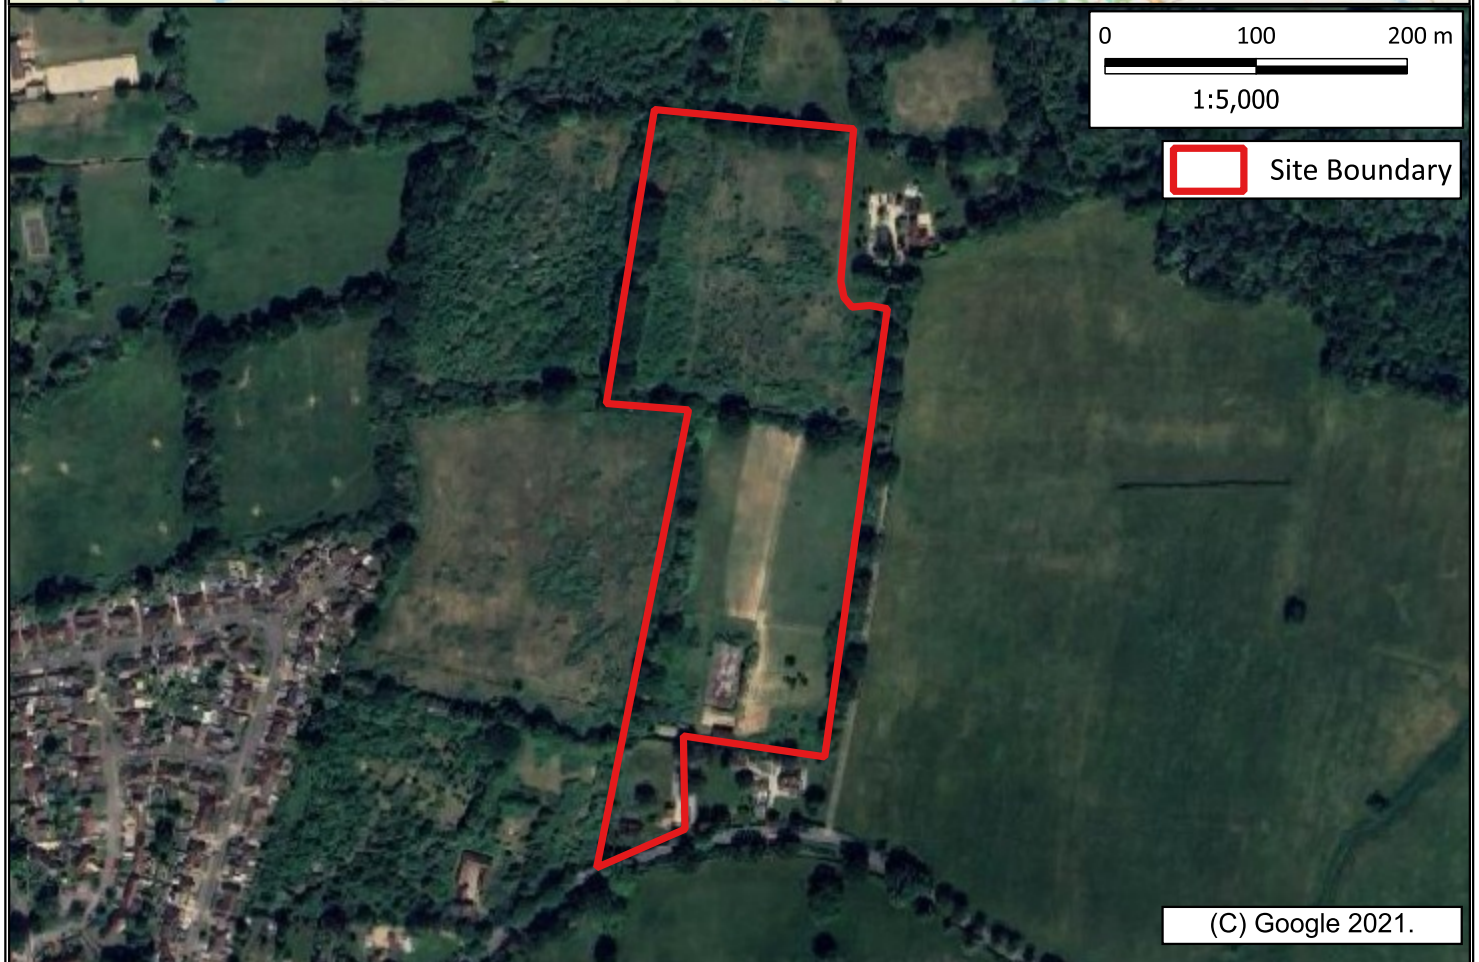
Figure 1 – Site Location and Boundary Plan

A summary of the site details is presented in Table 1-1. Figure 1 indicates the site location and boundary plan.
