**OREHAM MANOR FARM, OREHAM COMMON, HENFIELD,  
WEST SUSSEX, BN5 9SB**

**Preliminary Contamination Risk Assessment**

February 2023

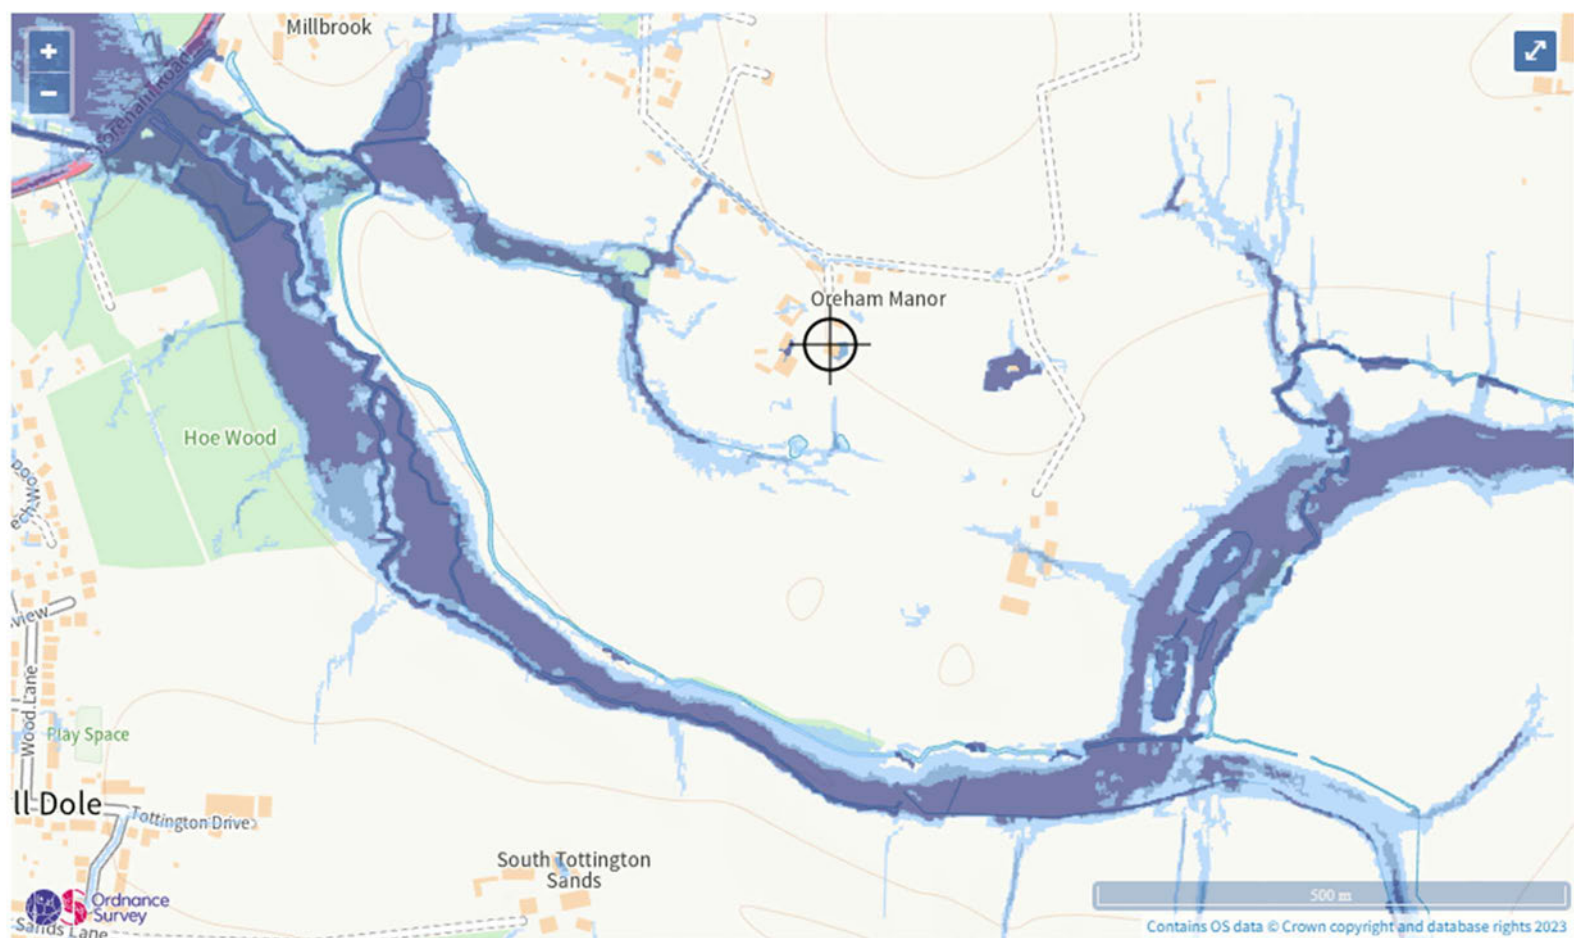
Extent of flooding from surface water

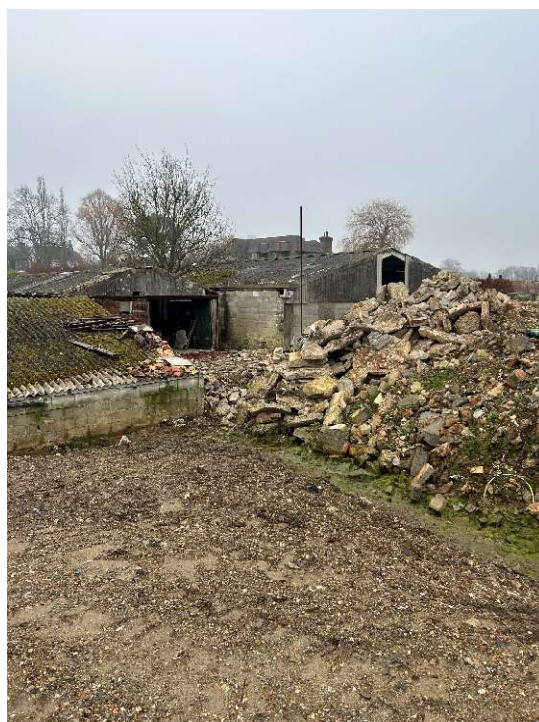
Photo 1: View of workshop building from former yard to the south, with reprofied soil and piled hardcore.

- 5.11 The area to the south of the site was previously a yard area under hardstanding. The hardstanding has been removed and retained on site as piled hardcore, intended to be crushed and used as recycled aggregate. The underlying soil has been reprofiled and the ground level raised.

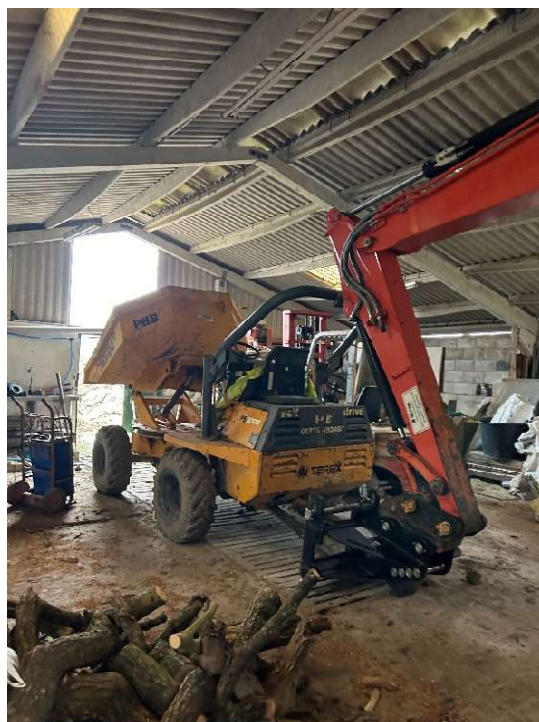
Photo 2: Dumper and excavator stored within the eastern section of the warehouse.

- 5.5 The eastern section of the building is larger and is used predominately for storage of materials and vehicles/machinery. This includes two excavators, a dumper, a sit-on mower, a forklift, and several motorcycles. This area is used for storage of bulk bags of wood and a table saw, plus various building materials, vehicle parts and equipment, some of which are stored in wooden crates. There is storage of various small quantities of fluids (generally associated with vehicle maintenance), a number of 25 litre containers, and a universal bulk container, which is currently empty but was previously used for storage of diesel.

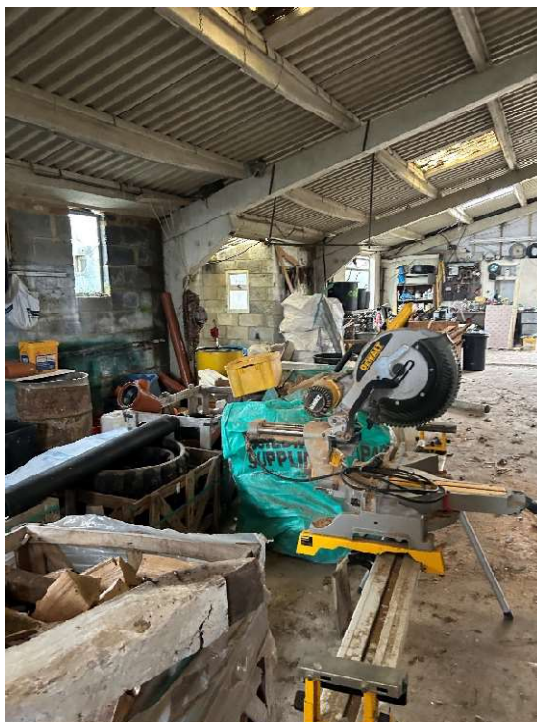
Photo 3: Table saw and storage of wood and various materials within the eastern warehouse section.

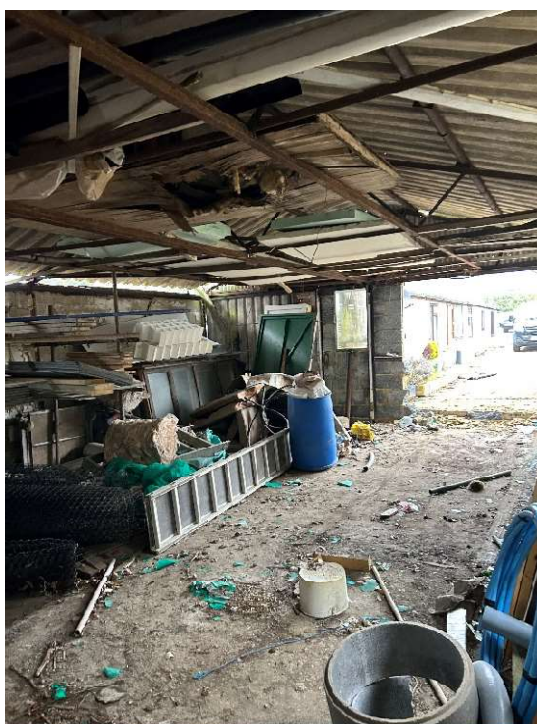
Photo 4: Northern room of the western warehouse section.

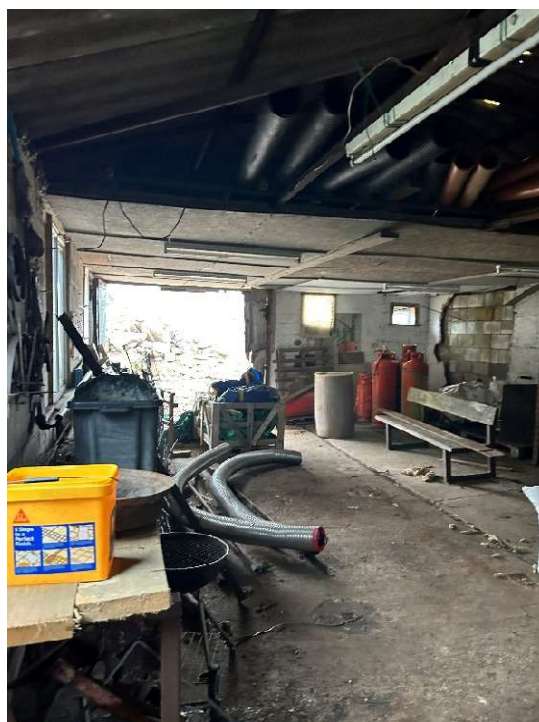
Photo 5: Storage within southern room of western warehouse section.

- 5.6 The eastern and western sections of the building are connected internally. A trailer and tubing are stored within this area.
- 5.7 The western section is divided into two rooms. The northern room is used for storage of timber planks and plastic pipes on shelving. This previously housed an old car which has been removed from the room via the removal of the northern external wall. This car now sits within the parking area to the north. The southern room is used for further storage including several large gas canisters.

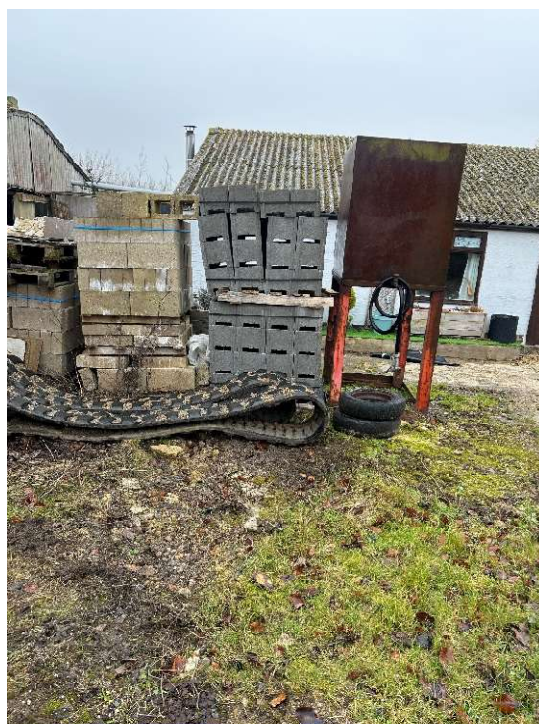
Photo 6: Redundant fuel tank, concrete blocks and excavator tread stored within soft landscaping adjacent to workshop.

- 5.8 There is a small area of soft landscaping to the north and east of the eastern section of the barn, comprising mown grass and shrubs. This is used for storage of concrete blocks, excavator treads and a redundant fuel tank. This tank has been moved from its original location which was previously situated, when in use, on the concrete.

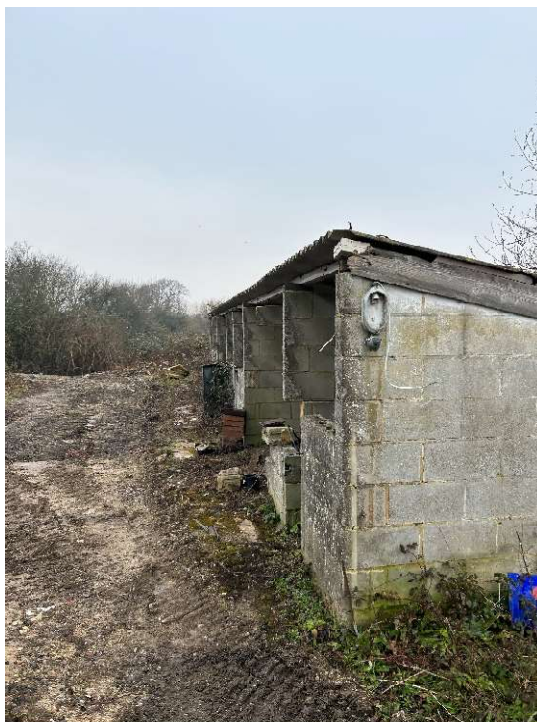
Photo 7: Redundant pigstie to the west of the workshop.

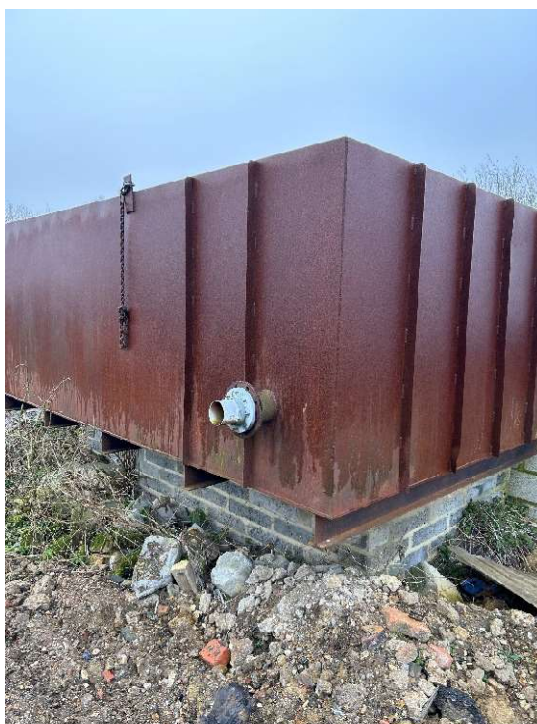
Photo 8: Redundant tank adjacent to pigstie.

- 5.10 The yard area to the west of the workshop building is laid to concrete and is in current use for materials storage. This includes pallets and bulk bags of bricks and tiles, corrugated metal, stone, concrete blocks, and scaffolding. A modern oil tank sits adjacent to the building at the north of the yard. There is a central skip which appears to be full of scrap metal, and a bonfire area to the east which was smoking during the site walkover. There are redundant pigsties to the south of this area adjacent to the bulk of the stored materials. There is a disused tank to the south which is thought to have been associated with keeping of pigs, likely slurry, but the exact former use is unknown.

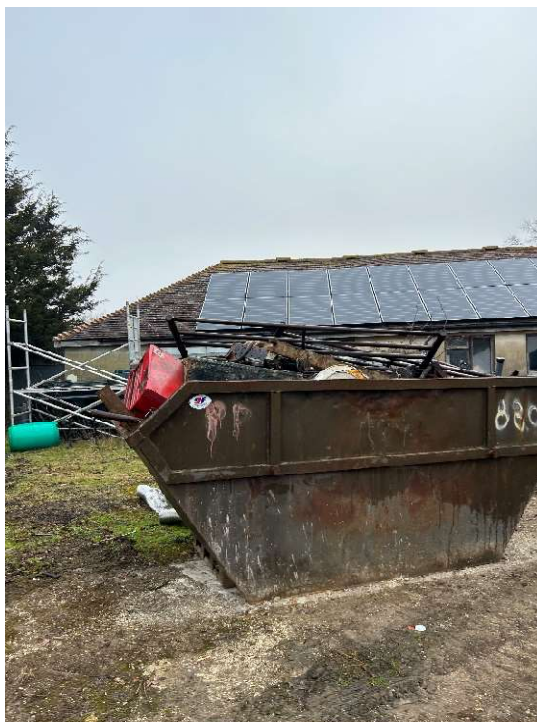
Photo 9: Scrap metal skip within the western yard.

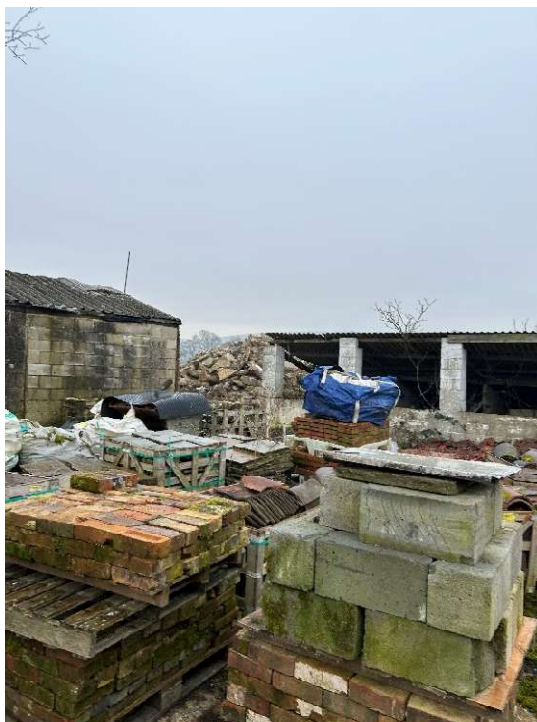
Photo 10: Materials storage within the western yard.
