**OREHAM MANOR FARM, OREHAM COMMON, HENFIELD,  
WEST SUSSEX, BN5 9SB**

**Contamination Risk Assessment**

July 2023  
(Revised August 2024)

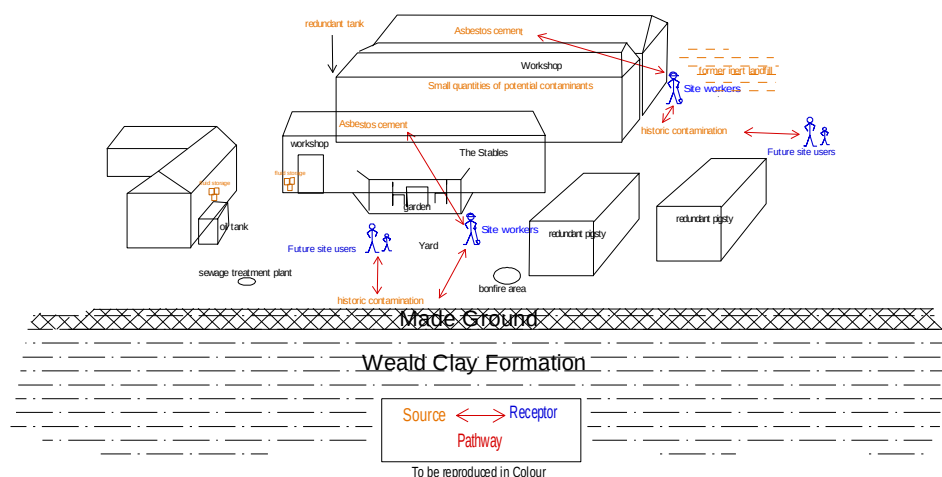
FIGURE 4  
CONCEPTUAL MODEL

- 8.1 The contamination risk assessment has been prepared in accordance with the recommendations given in the Defra/EA publication “Model Procedures for the Management of Land Contaminated – Contaminated Land Report 11” 2004.
- 8.2 For contamination to be significant, there must be three elements present: *Contamination* (a substance that has the potential to cause harm or cause pollution of controlled waters), a *receptor* (something that could be adversely affected by a contaminant) and a feasible *pathway* (route or means) between substance and receptor. See Figure 4 below.

- 8.3 In this case, the model may be applied to three cases:
- Construction workers engaged in the redevelopment of the site and exposed to contamination. The receptor assumed to be an adult.
  - Future residents on the site after the redevelopment is complete and exposed to contact with soil in any garden areas plus, possibly, eating produce grown in a garden. The receptor assumed to be a child.
  - Post-redevelopment impacts on the wider environment. Includes off-site contamination migration, contamination of watercourses, etc.

In this case evidence of contamination appears to be limited to the upper soil samples with the exception of the lower sample at TP1 (which is suspected to be cross-contamination from the overlying made ground) and contamination is minor – moderate. Contamination does not appear to have penetrated or otherwise affected the underlying clay, except in the case of TP10, where some evidence of soil mixing at the top of the clay layer was apparent.

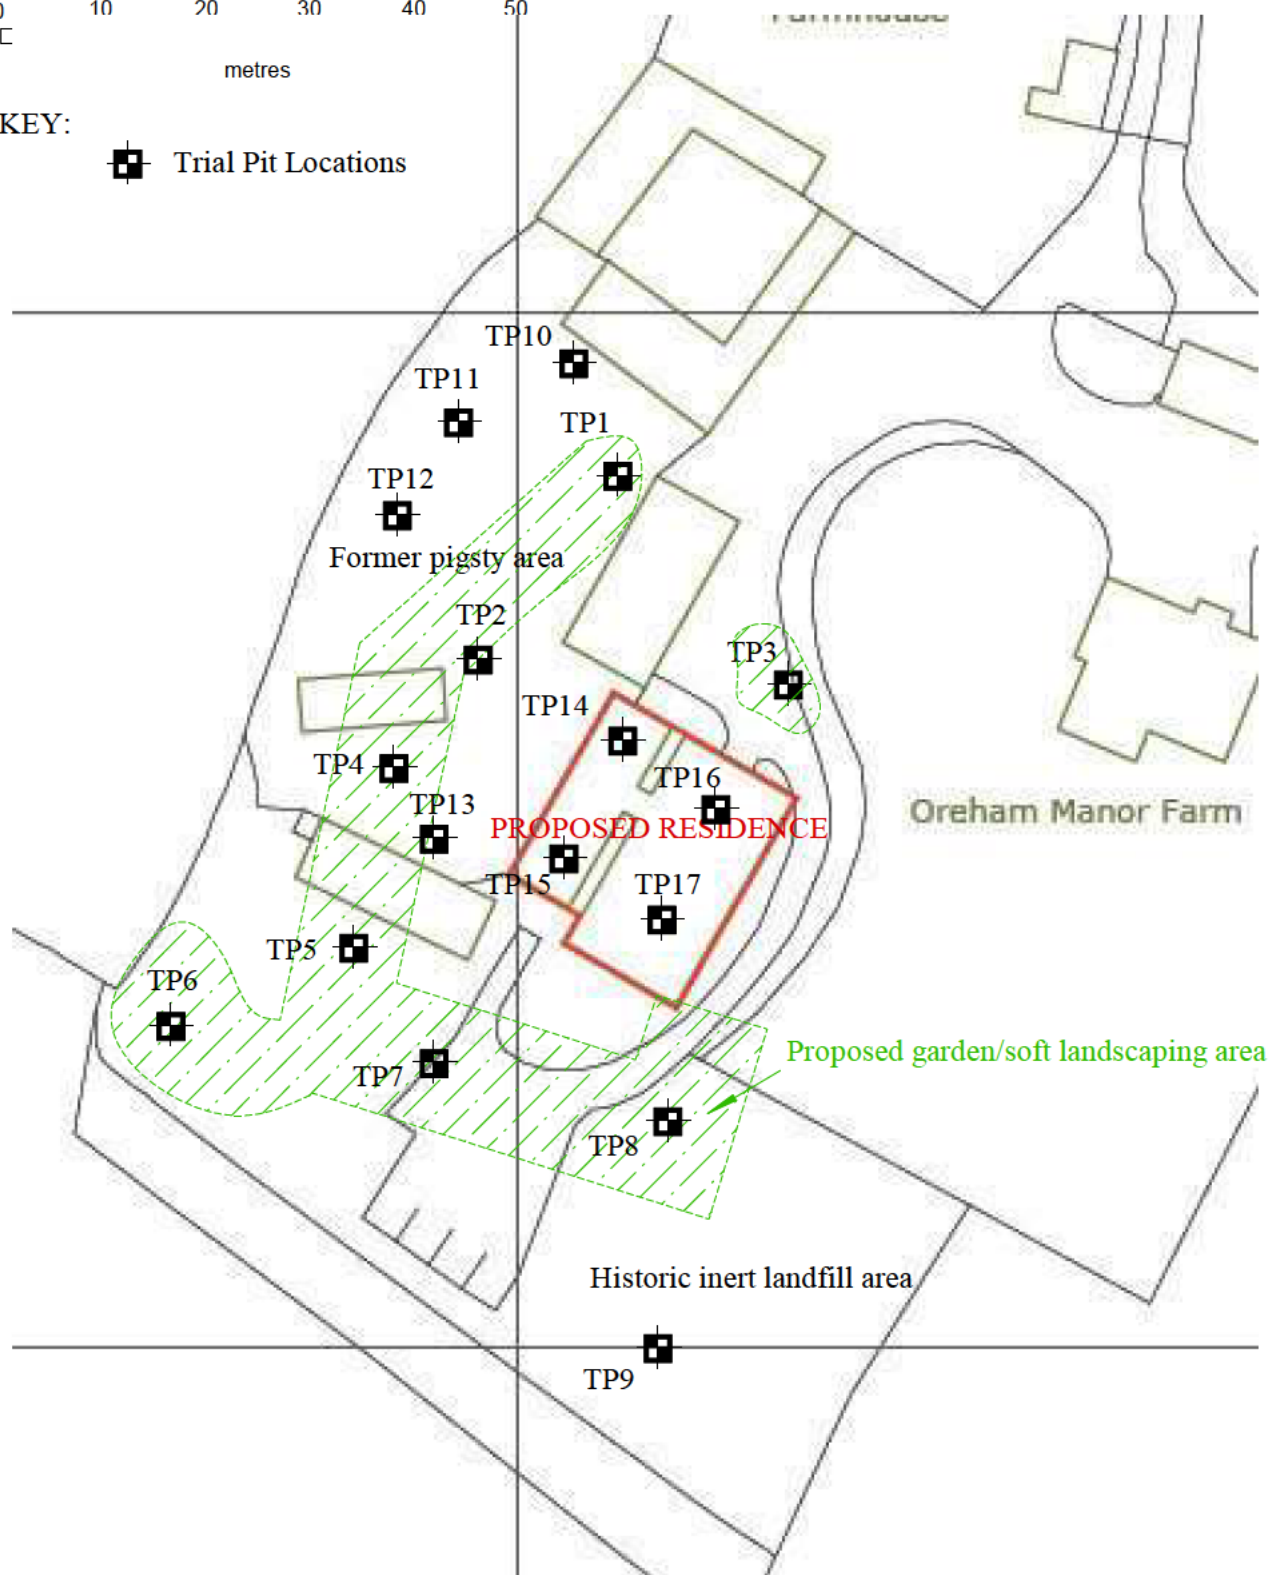
- 5.3 The existing site layout is given in Figure 2 and the proposed development plus trial pit locations are shown on Figure 3. The trial pit logs are given in Appendix B. In most cases the trial pits encountered made ground of soil mixed with brick and concrete gravel or hardcore over stiff grey/brown/ blue clay.

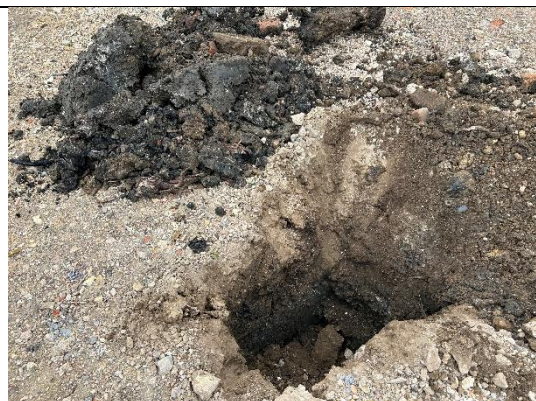
Photo 5: TP5

| Sample identity | | Nature of contamination | Significance |
|---|---|---|---|
| TP 5 | 0.25 m | PAHs, Heavy Metal | Minor - Moderate |

Crocidolite fibre (blue asbestos) was also identified at TP5, this is a more harmful type of asbestos. This sample was sent for quantification analysis which revealed through hand picking / weighing that asbestos within the sample was present but fell below the reporting limit of detection. Thus, no additional recommendations are made.

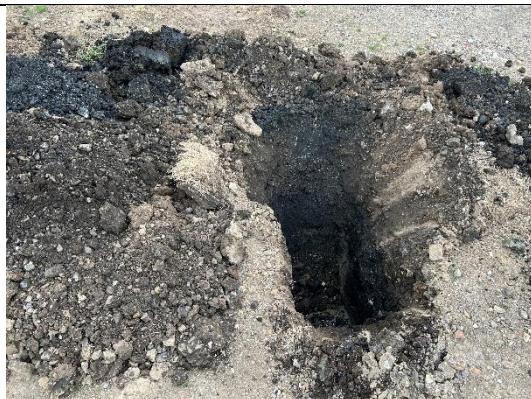
Photo 8: TP8

Apparent oil staining, unusual colouring, odour and other superficial indications of significant contamination were noted within the made ground in TP8.

| Sample identity | | Nature of contamination | Significance |
|---|---|---|---|
| TP 8 | 0.3 m | PAHs, Heavy Metals | Minor - Moderate |

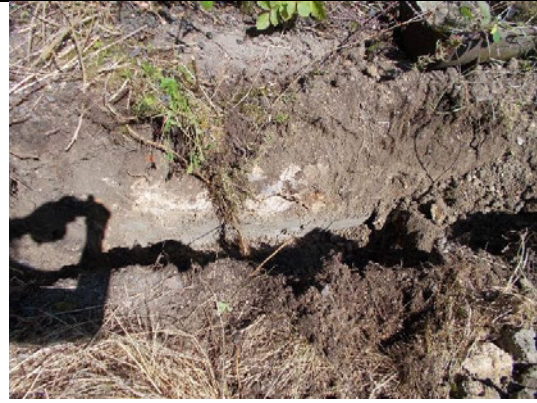
Photo 10: TP10

| Sample identity | | Nature of contamination | Significance |
|---|---|---|---|
| TP 10 | 0.2 m | PAHs, TPH | Moderate - High |
| TP 10 | 0.6 m | PAHs | Moderate |

- 10.2 The made ground in the former pond area (which exhibited the highest PAH concentrations) should be excavated down to the underlying clean clay, stockpiled, subject to Waste Acceptance Criteria (WAC) testing and disposed of to a suitably licenced landfill. The resulting void may be backfilled with clean soil or crushed recycled concrete, depending on the proposed future use.

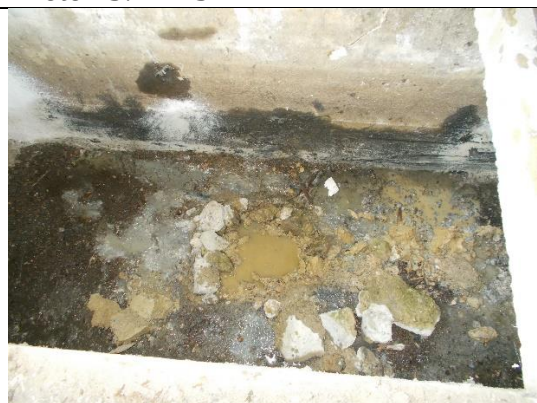
Photo 17: TP17

- 6.2 No groundwater was encountered in any of the trial pits during the site investigation, apart from TP17, where the hole was saturated. It is suspected that represented a lens of perched water trapped beneath the inspection pit floor.

| Sample identity | | Nature of contamination | Significance |
|---|---|---|---|
| TP 17 | 1.5 m | PAHs | Minor |
