# Contamination Assessment & Updated Remediation Strategy

## Millfields Farm, Rusper

**BRD4518-OR3-C**

**March 2026**

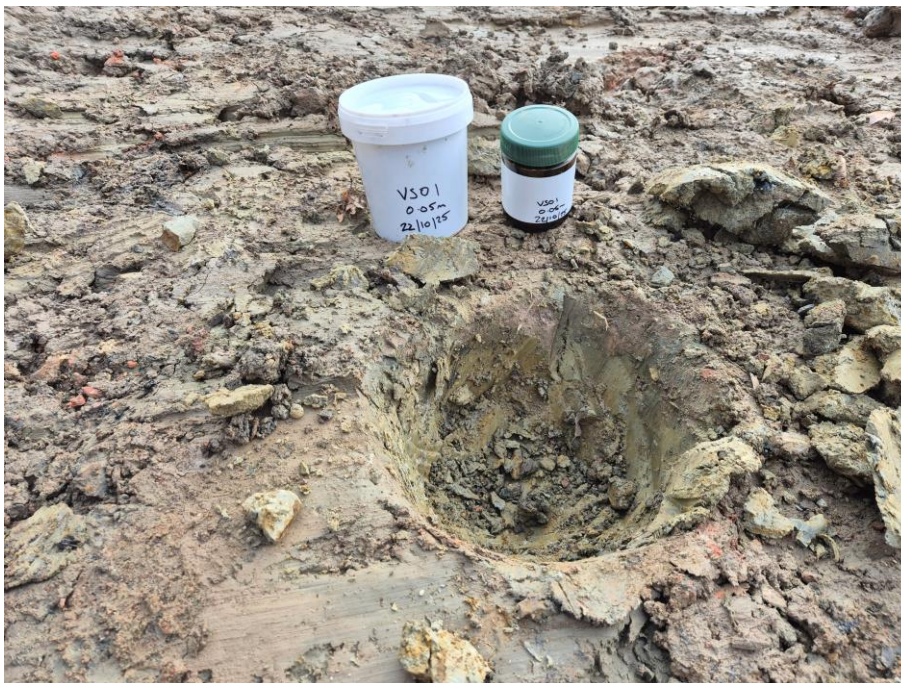
VS01

Made Ground was noted to be absent from beneath the northern most building (VS01 to VS02) following the removal of the concrete floor slab to this building. The natural clay subsoils were exposed directly beneath.

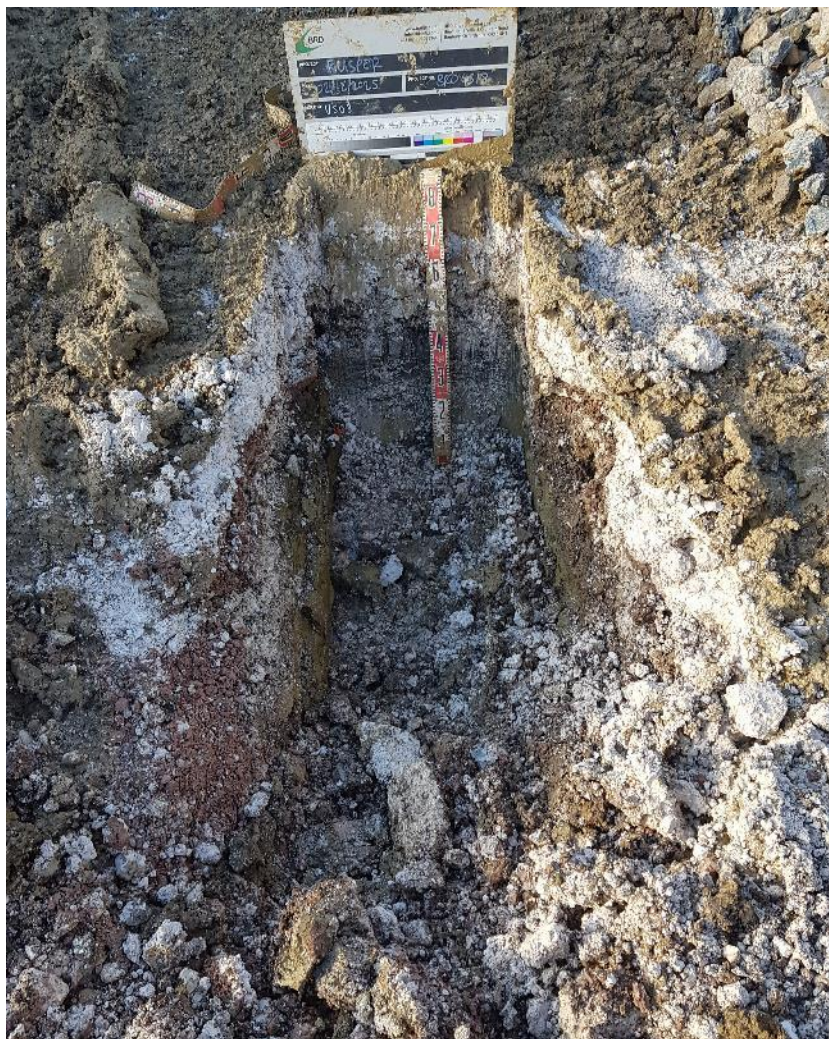
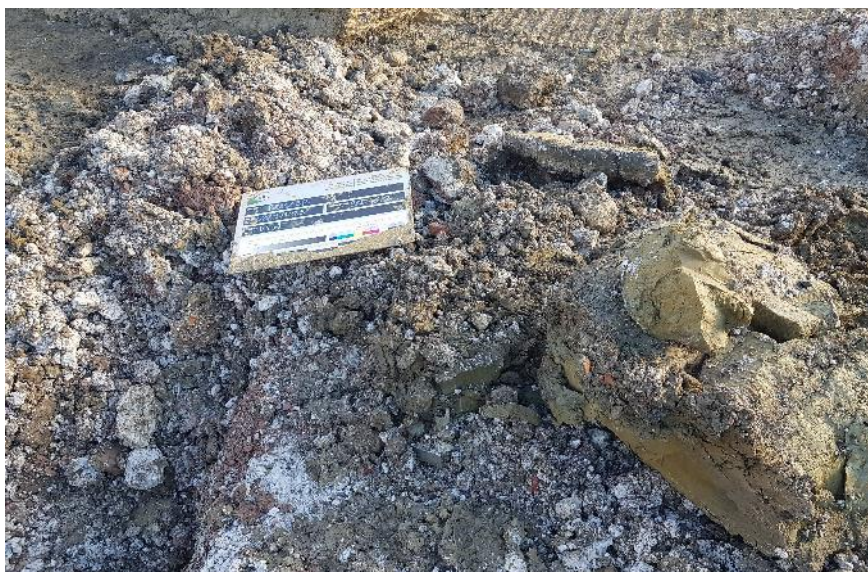
Moving south, VS03 (next building to the south) and VS04 and VS05 (western end of third building to the south) all encountered similar Made Ground strata with broken out concrete to 0.13m (VS04 and VS05 only) then a cover of reworked chalk material to depths of between 0.20m to 0.25 described as *'Off-white, slightly sandy, silty gravel of fine to coarse, angular chalk'*. Beneath this, a distinct strata of *'dark red brown, gravelly sand. Gravel of fine to medium, angular to subrounded brick, clinker and rare flint'* was encountered and extending to depths in the range 0.35m to 0.40m and overlying the natural soils. This is also consistent with an upper layer of material previously identified in the area between the farm buildings (TP112).

The thin band of dark red brown, gravelly sand Made Ground beneath the thin chalk layer (VS03 to VS05) was noted to contain clinker fragments and therefore may be at risk of containing elevated PAHs as has previously been recorded at the site.

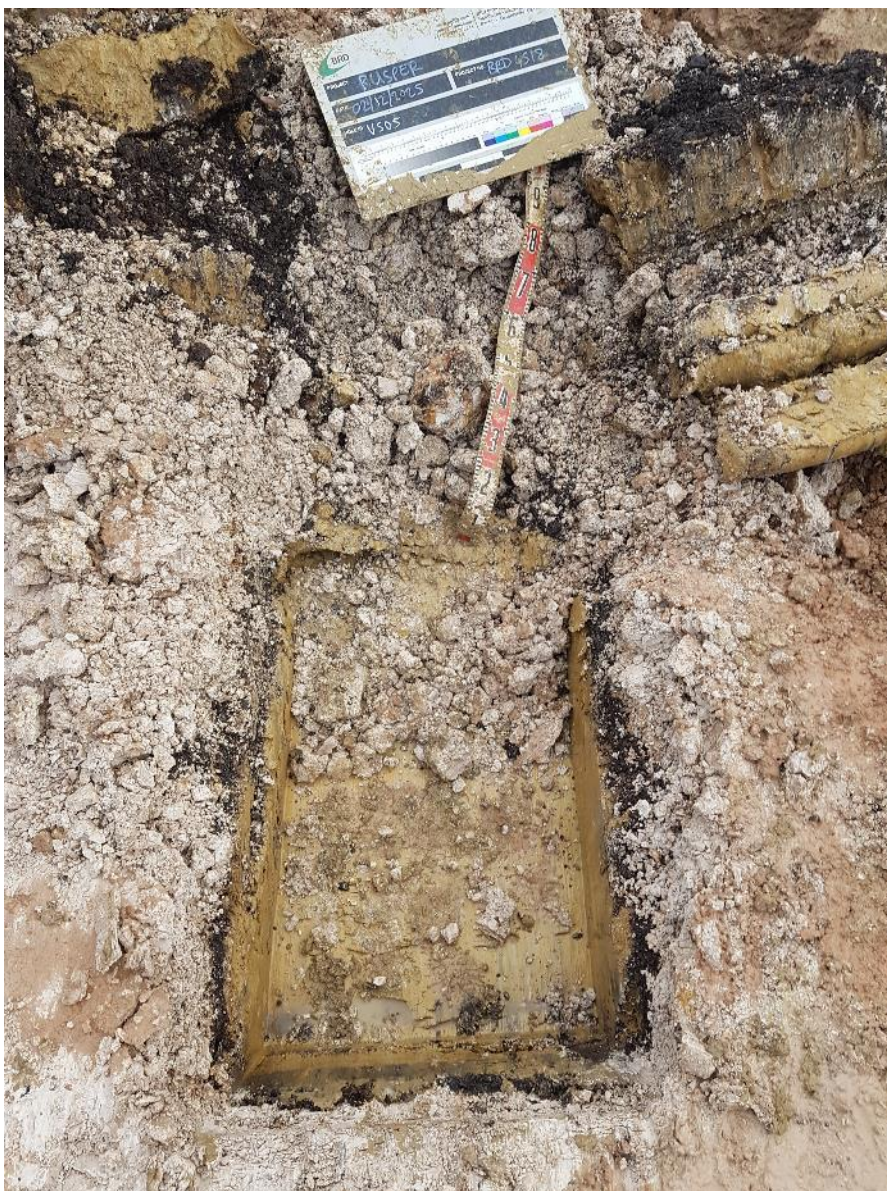
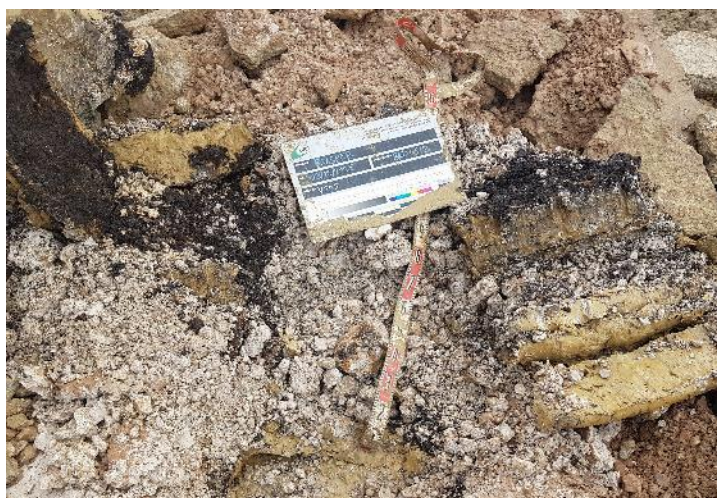
The exception is a localised area at VS05 where the concentrations of copper in the Made Ground render it as hazardous waste. This area should be segregated and the waste soil disposed of separately as 17 05 03 'Soil and Stones, containing dangerous substances'

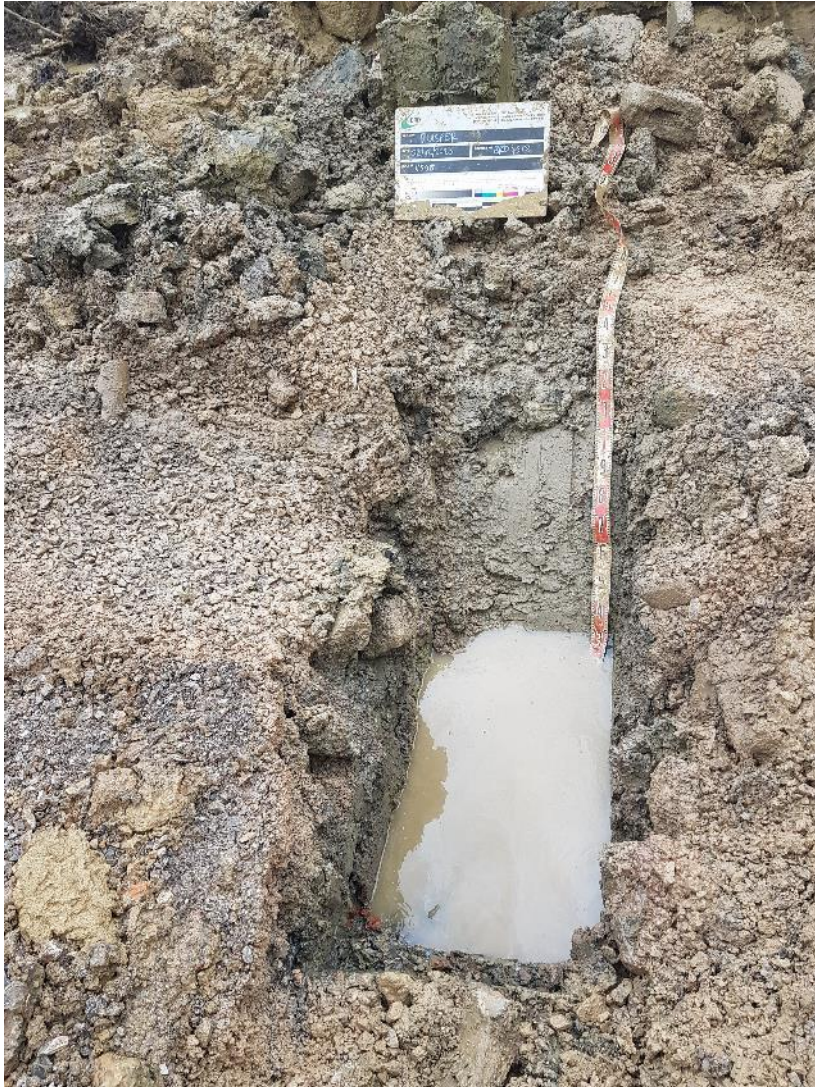
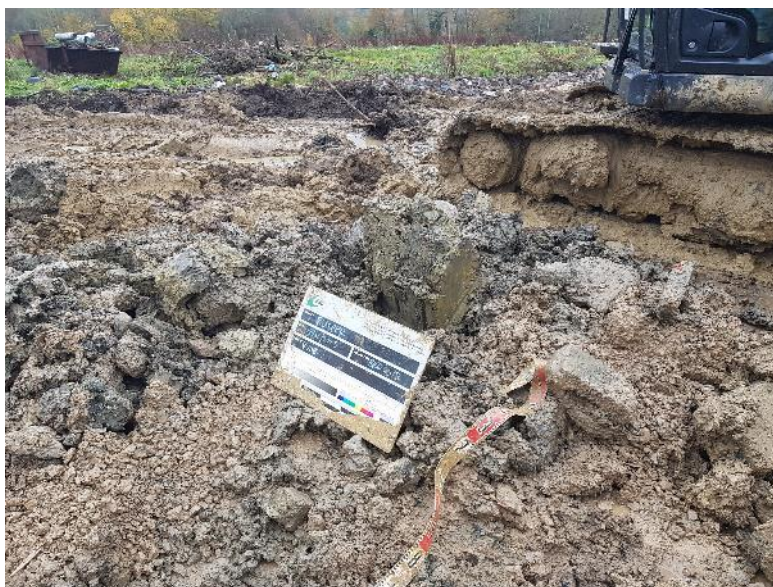
VS06

Elsewhere, moving south, beneath the eastern end of the third building and the area between the third and fourth buildings (VS6 to VS8), Made Ground to between 0.60m and 0.80m was encountered. This Made Ground generally consisted of two strata with an upper layer comprising *'Red brown to brown, slightly clayey in parts, sandy gravel of fine to coarse, angular granite, flint, brick and concrete'*. Underlying this was a *'Dark brown, very sandy, gravelly clay with decaying plant remains. Gravel of fine to coarse, angular brick, flint and concrete with occasional plastic fragments and rare asbestos cement fragments'*. This is consistent with the previously encountered deeper Made Ground material between the farmyard buildings.

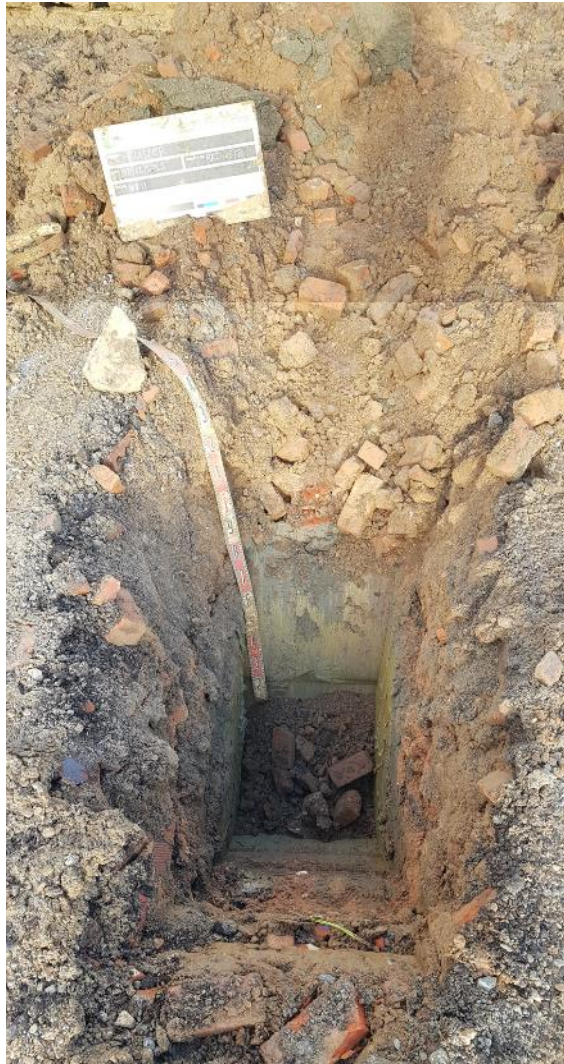
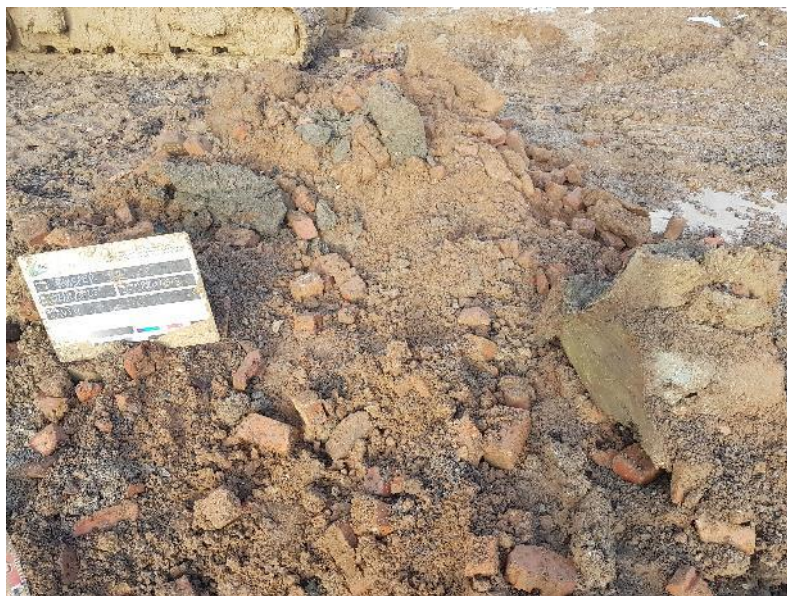
VS11

| <b>PAH</b> | <p>The deeper Made Ground in VS11, beneath the southerly farm building, recorded a marginally elevated concentration of dibenzo(a)anthracene at a concentration of 0.26mg/kg compared to the GAC of 0.24mg/kg. Given the lack of any other PAH compounds exceeding their respective GAC in all of the samples in the area, coupled with the fact it is only a marginal exceedance of what is already a very low screening levels, it is not considered that this presents any significant cause for concern for this specific soil.</p> <p><u>Previously Investigated Northern Farmyard</u></p> <p>The previous BRD investigation has recorded several elevated PAH compounds within the near surface soils in trial pits TP106 and TP107. The BaP concentrations at these locations were 11.8mg/kg and 7.29mg/kg, respectively.</p> |
