| Continuous Gas Monitoring Record | | | | | | | | |
| Project No | LP2441 | Temp °C | 2 | | | | | |
| Site | Novartis | Ambient Pressure | 1025 | | | | | |

## **APPENDIX J – DRAINAGE PLANS AND CCTV**

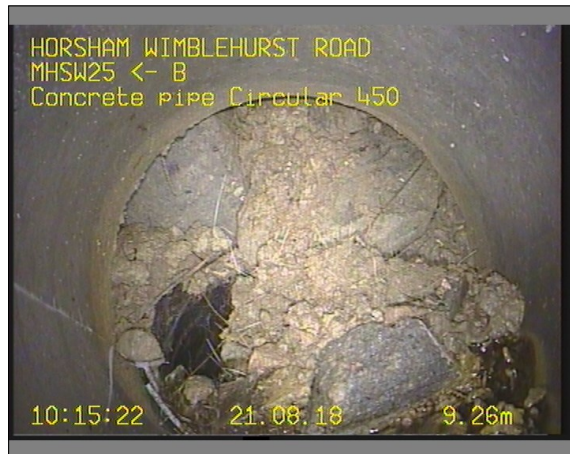
| 1:75 | Position | Code | Observations and Remarks | MPEG | Photo | Grade |
|---|---|---|---|---|---|---|
| | | 9.26 | DEC | Settled deposits, hard or compacted, 95% cross-sectional area loss Remarks: POSSIBLE COLLAPSE | 00:01:03 | (Serv) 5 |

Photo: 3\_3\_9\_A.JPG  
9.26m, Survey abandoned Remarks: POSSIBLE COLLAPSE

) Grade 5: Best practice suggests an immediate repair schedule as the risk of collapse or further structural damage is very high.

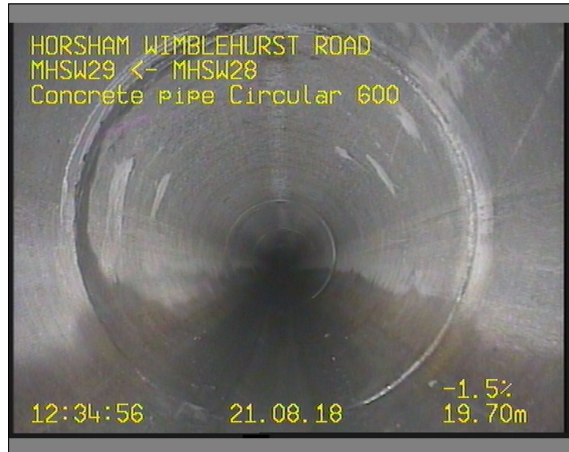
| 1:435 | Position | Code | Observations and Remarks | MPEG | Photo | Grade |
|---|---|---|---|---|---|---|
| | 19.70 | ISJ | Infiltration, seeping at joint, from 6 to 12 o'clock | 00:01:29 | 7_7_27_A.JP<br>G | (Serv) 0 |

Photo: 7\_7\_27\_A.JPG  
19.7m, Infiltration, seeping at joint, from 6 to 12 o'clock

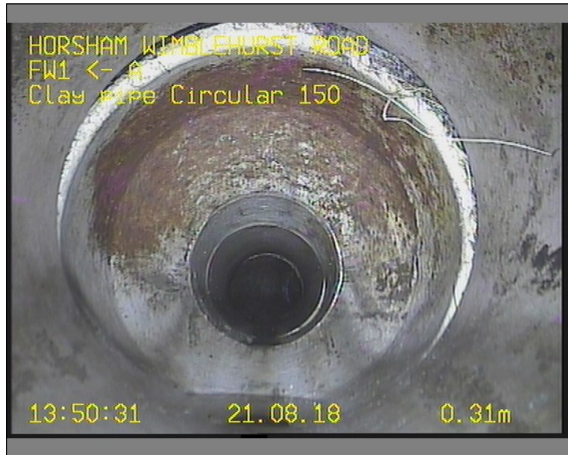
Photo: 9\_9\_35\_A.JPG  
0.31m, Joint displaced, medium

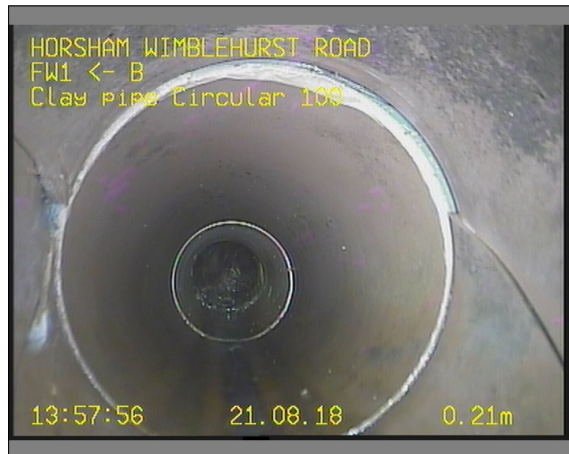
| 1:50 | Position | Code | Observations and Remarks | MPEG | Photo | Grade |
|---|---|---|---|---|---|---|
| | 0.21 | FLJ | Fracture, longitudinal at joint, at 8 o'clock | 00:00:24 | 10_10_45_A.J PG | (Struct) 3 |

Photo: 10\_10\_45\_A.JPG  
0.21m, Fracture, longitudinal at joint, at 8 o'clock

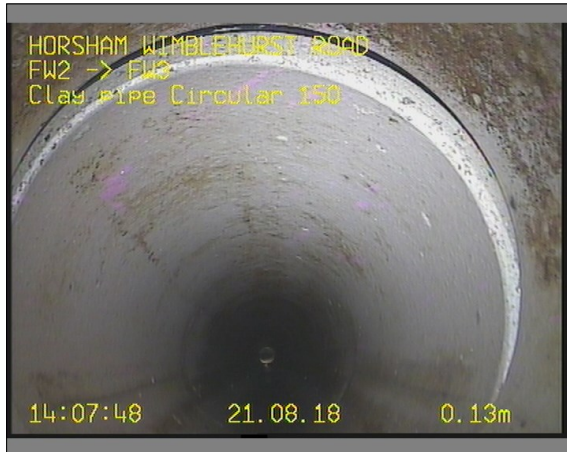
Photo: 12\_12\_53\_A.JPG  
0.13m, Joint displaced, medium

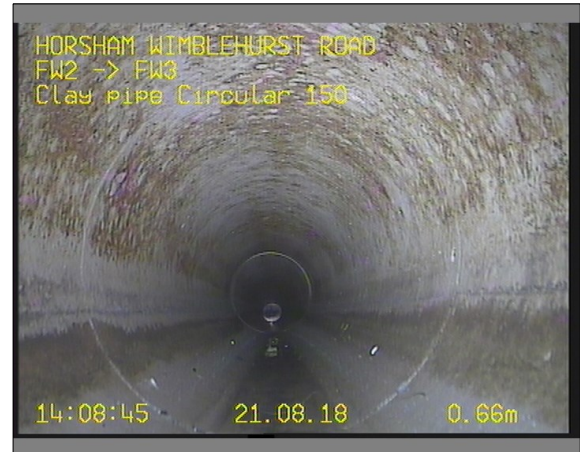
| 1:50 | Position | Code | Observations and Remarks | MPEG | Photo | Grade |
|---|---|---|---|---|---|---|
| | 0.66 | CC | Crack, circumferential, from 12 to 12 o'clock | 00:00:58 | 12_12_54_A.J<br>PG | (Struct) 2 |

Photo: 12\_12\_54\_A.JPG  
0.66m, Crack, circumferential, from 12 to 12 o'clock

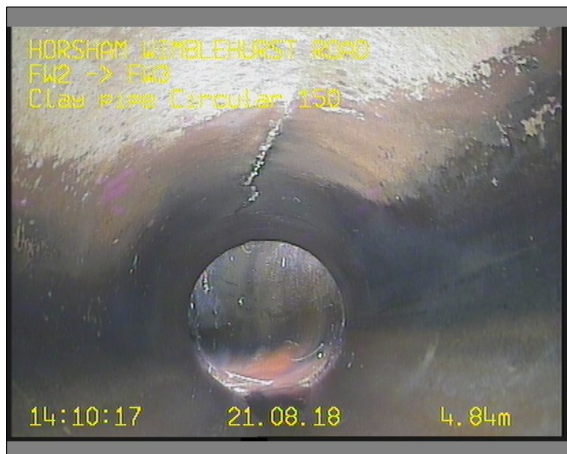
| 1:50 | Position | Code | Observations and Remarks | MPEG | Photo | Grade |
|---|---|---|---|---|---|---|
| | 4.84 | CL | Crack, longitudinal, at 12 o'clock | 00:02:13 | 12_12_55_A.J<br>PG | (Struct) 2 |

Photo: 12\_12\_55\_A.JPG  
4.84m, Crack, longitudinal, at 12 o'clock

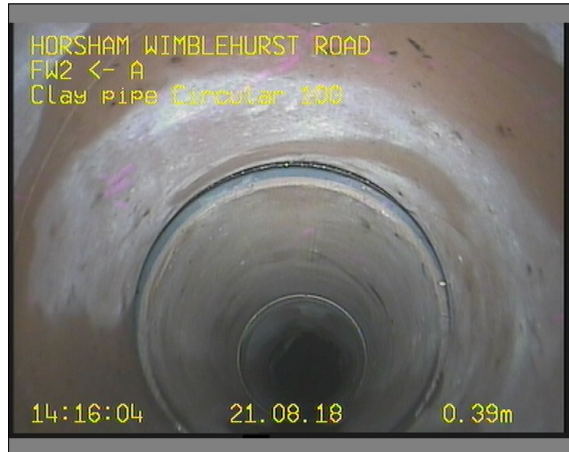
| 1:60 | Position | Code | Observations and Remarks | MPEG | Photo | Grade |
|---|---|---|---|---|---|---|
| | 0.39 | CC | Crack, circumferential, from 6 to 12 o'clock | 00:00:38 | 13_13_60_A.J PG | (Struct) 2 |

Photo: 13\_13\_60\_A.JPG  
0.39m, Crack, circumferential, from 6 to 12 o'clock

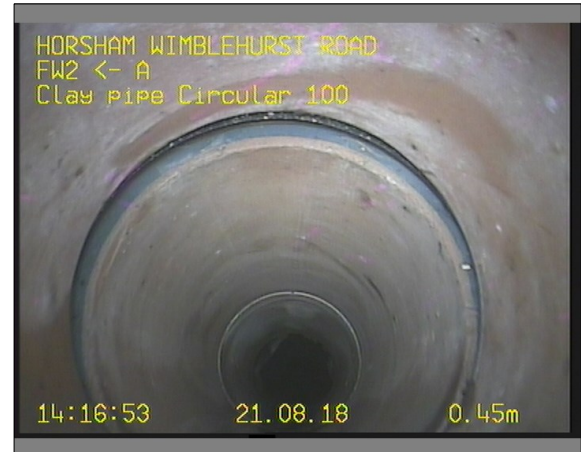
Photo: 13\_13\_61\_A.JPG  
0.45m, Joint displaced, medium

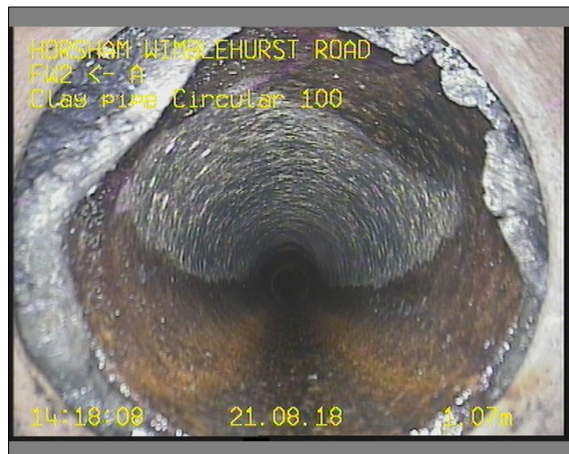
Photo: 13\_13\_62\_A.JPG  
1.07m, General remark Remarks: CONCRETE AROUND JOINT

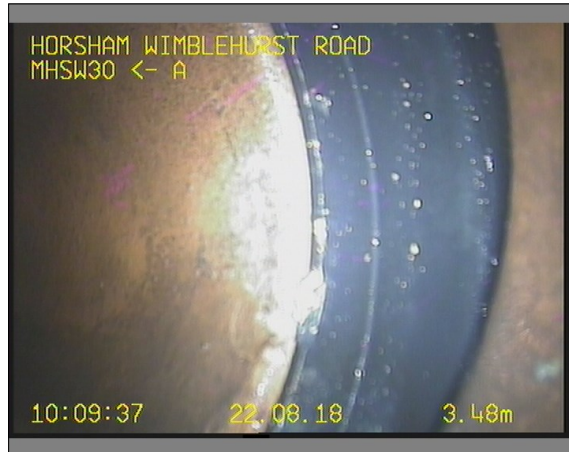
Photo: 14\_14\_70\_A.JPG  
3.48m, Joint displaced, medium

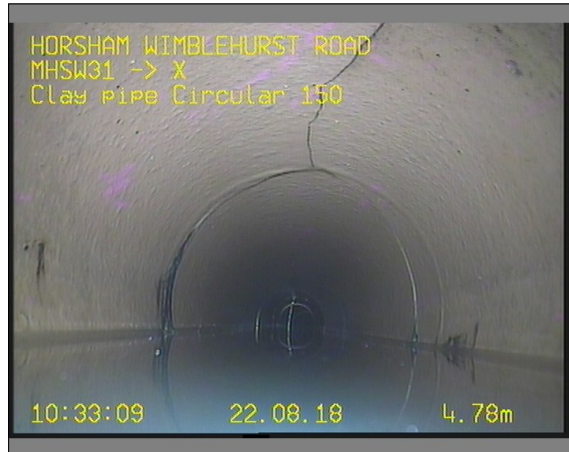
| 1:135 | Position | Code | Observations and Remarks | MPEG | Photo | Grade |
|---|---|---|---|---|---|---|
| | | 4.76 | FL | Fracture, longitudinal, at 12 o'clock | 00:00:56 | 16_16_84_A.J PG (Struct) 3 |

Photo: 16\_16\_84\_A.JPG  
4.76m, Fracture, longitudinal, at 12 o'clock

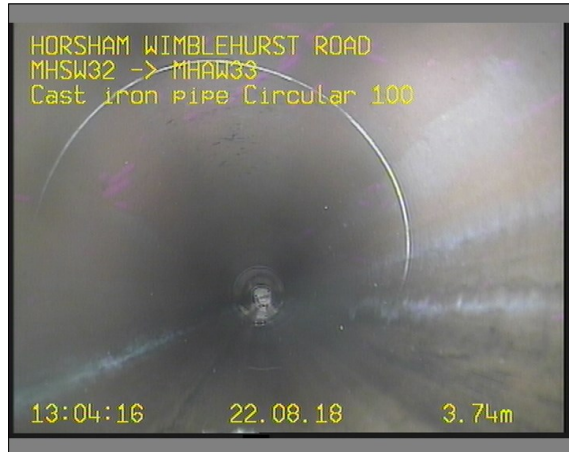
| 1:60 | Position | Code | Observations and Remarks | MPEG | Photo | Grade |
|---|---|---|---|---|---|---|
| | 3.76 | CC | Crack, circumferential, from 12 to 12 o'clock | 00:01:23 | 21_21_118_A.JPG | (Struct) 2 |

Photo: 21\_21\_118\_A.JPG  
3.76m, Crack, circumferential, from 12 to 12 o'clock

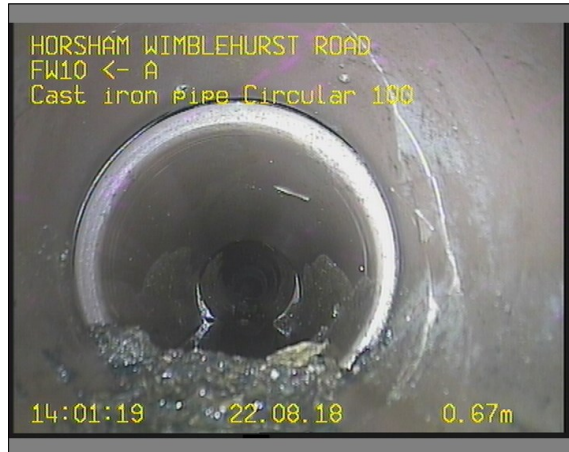
| 1:75 | Position | Code | Observations and Remarks | MPEG | Photo | Grade |
|---|---|---|---|---|---|---|
| | 0.67 | CC | Crack, circumferential, from 12 to 5 o'clock | 00:00:22 | 22_22_122_A.JPG | (Struct) 2 |

Photo: 22\_22\_122\_A.JPG  
0.67m, Crack, circumferential, from 12 to 5 o'clock

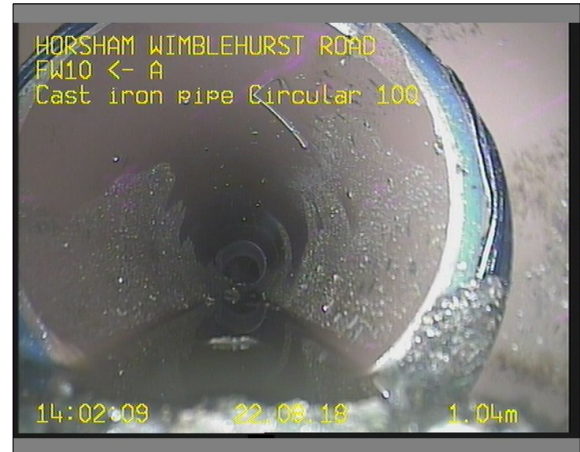
Photo: 22\_22\_124\_A.JPG  
1.04m, Open joint, medium

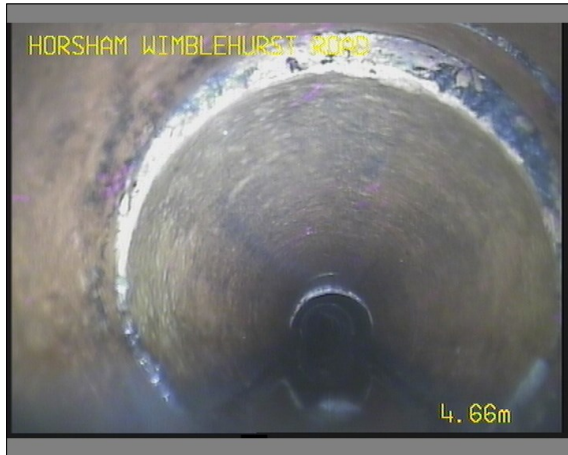
| 1:75 | Position | Code | Observations and Remarks | MPEG | Photo | Grade |
|---|---|---|---|---|---|---|
| | 4.66 | FC | Fracture, circumferential, from 12 to 6 o'clock | 00:01:09 | 29_29_167_A.JPG | (Struct) 3 |

Photo: 29\_29\_167\_A.JPG  
4.66m, Fracture, circumferential, from 12 to 6 o'clock

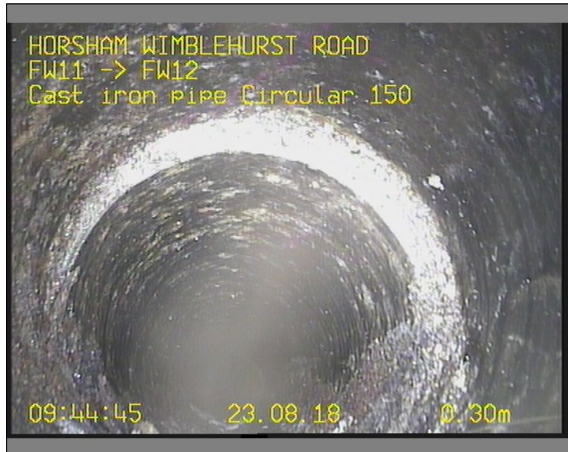
Photo: 31\_31\_179\_A.JPG  
0.3m, Joint displaced, medium

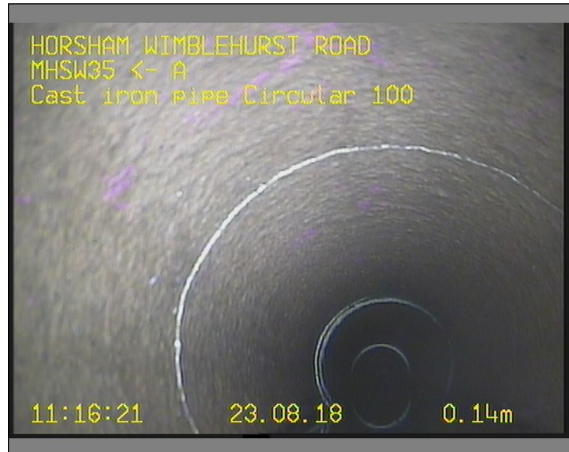
| 1:135 | Position | Code | Observations and Remarks | MPEG | Photo | Grade |
|---|---|---|---|---|---|---|
| | 0.16 | CC | Crack, circumferential, from 12 to 12 o'clock | 00:00:18 | 33_33_190_A.JPG | (Struct) 2 |

Photo: 33\_33\_190\_A.JPG  
 0.16m, Crack, circumferential, from 12 to 12 o'clock

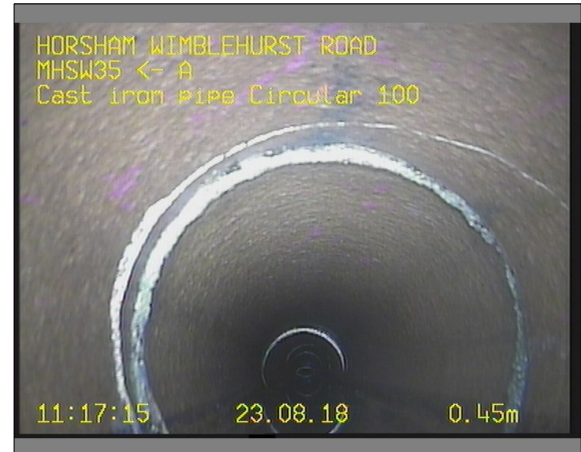
| 1:135 | Position | Code | Observations and Remarks | MPEG | Photo | Grade |
|---|---|---|---|---|---|---|
| | 0.45 | FCJ | Fracture, circumferential at joint, from 6 to 3 o'clock | 00:00:44 | 33_33_191_A.JPG | (Struct) 3 |

Photo: 33\_33\_191\_A.JPG  
 0.45m, Fracture, circumferential at joint, from 6 to 3 o'clock

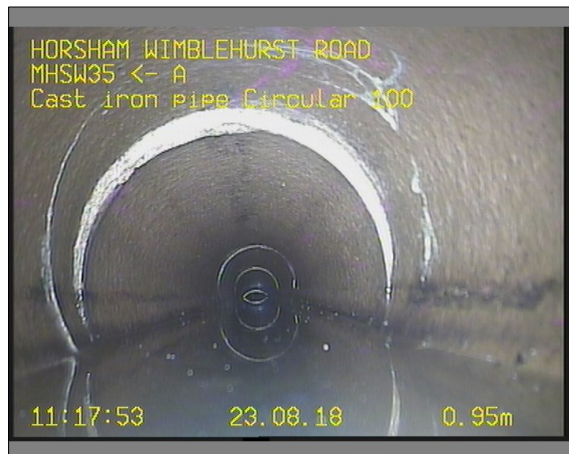
| 1:135 | Position | Code | Observations and Remarks | MPEG | Photo | Grade |
|---|---|---|---|---|---|---|
| | 0.95 | CCJ | Crack, circumferential at joint, from 12 to 12 o'clock | 00:01:01 | 33_33_192_A.JPG | (Struct) 2 |

Photo: 33\_33\_192\_A.JPG  
 0.95m, Crack, circumferential at joint, from 12 to 12 o'clock

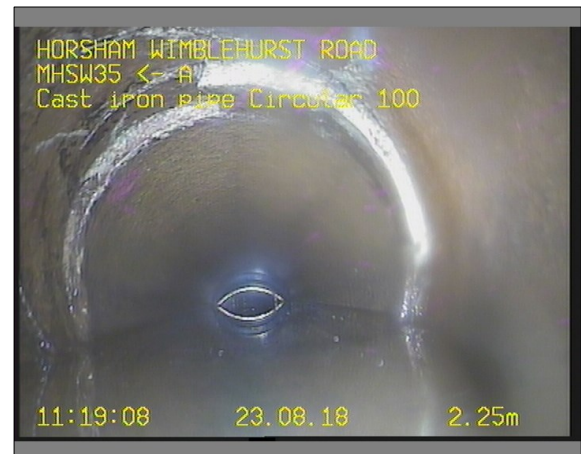
| 1:135 | Position | Code | Observations and Remarks | MPEG | Photo | Grade |
|---|---|---|---|---|---|---|
| | 2.25 | B | Broken pipe, from 12 to 12 o'clock | 00:01:39 | 33_33_194_A.JPG | (Struct) 4 |

Photo: 33\_33\_194\_A.JPG  
 2.25m, Broken pipe, from 12 to 12 o'clock

) Grade 4: Best practice suggests a repair schedule is planned in the short term to avoid potential collapse or increased damage.

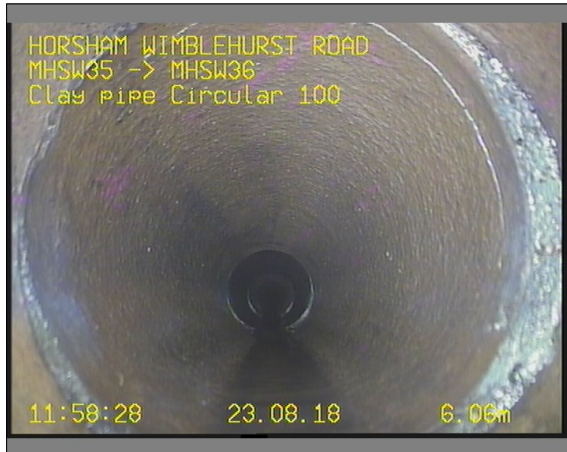
| 1:210 | Position | Code | Observations and Remarks | MPEG | Photo | Grade |
|---|---|---|---|---|---|---|
| | 6.06 | CCJ | Crack, circumferential at joint, from 11 to 3 o'clock | 00:01:41 | 35_35_217_A.JPG | (Struct) 2 |

Photo: 35\_35\_217\_A.JPG  
6.06m, Crack, circumferential at joint, from 11 to 3 o'clock
