# Addendum Site Investigation Report

at Horsham Enterprise  
Park, land off Parsonage  
Road, Horsham,  
West Sussex,  
RH12 4AN

for West Sussex County  
Council

Report Reference : LP2575

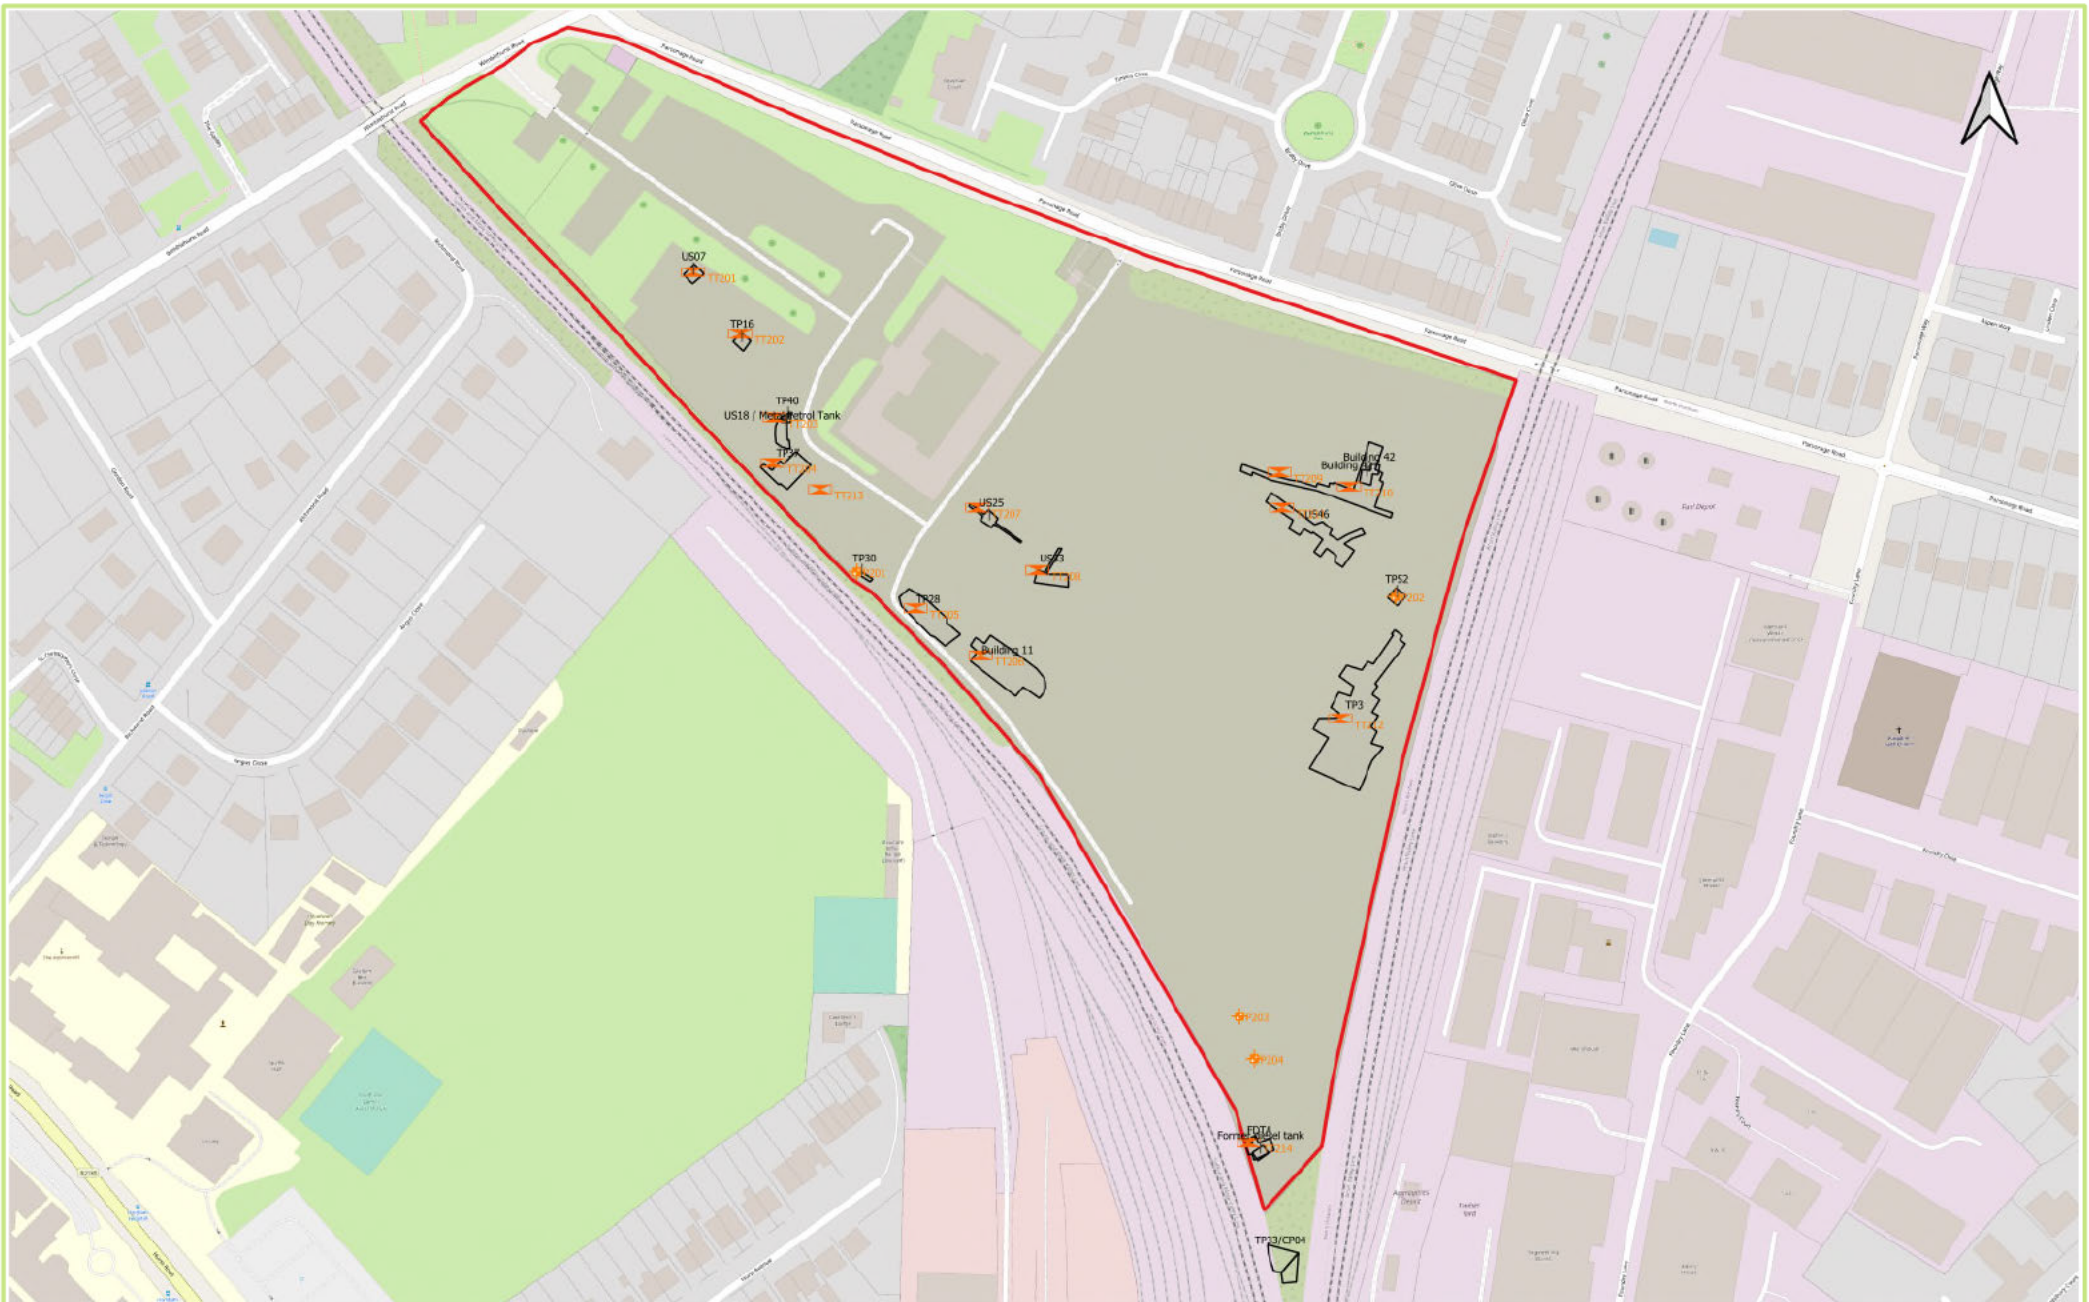
| Project: | Horsham Enterprise Park | Date: | 06/07/21 | Figure No. | 05 |

Basemap: © OpenStreetMap contributors  
 & Client supplied.  
 Exploratory hole locations and remediation areas estimated

KDC Remediation Areas
  Trial-trenches
 + Trial Pits
