**LITTLE PADDOCK  
HURSTON LANE  
STORRINGTON  
PULBOROUGH RH20 4HH**

**Remedial Action Plan**

**Report No. 6120 v3**

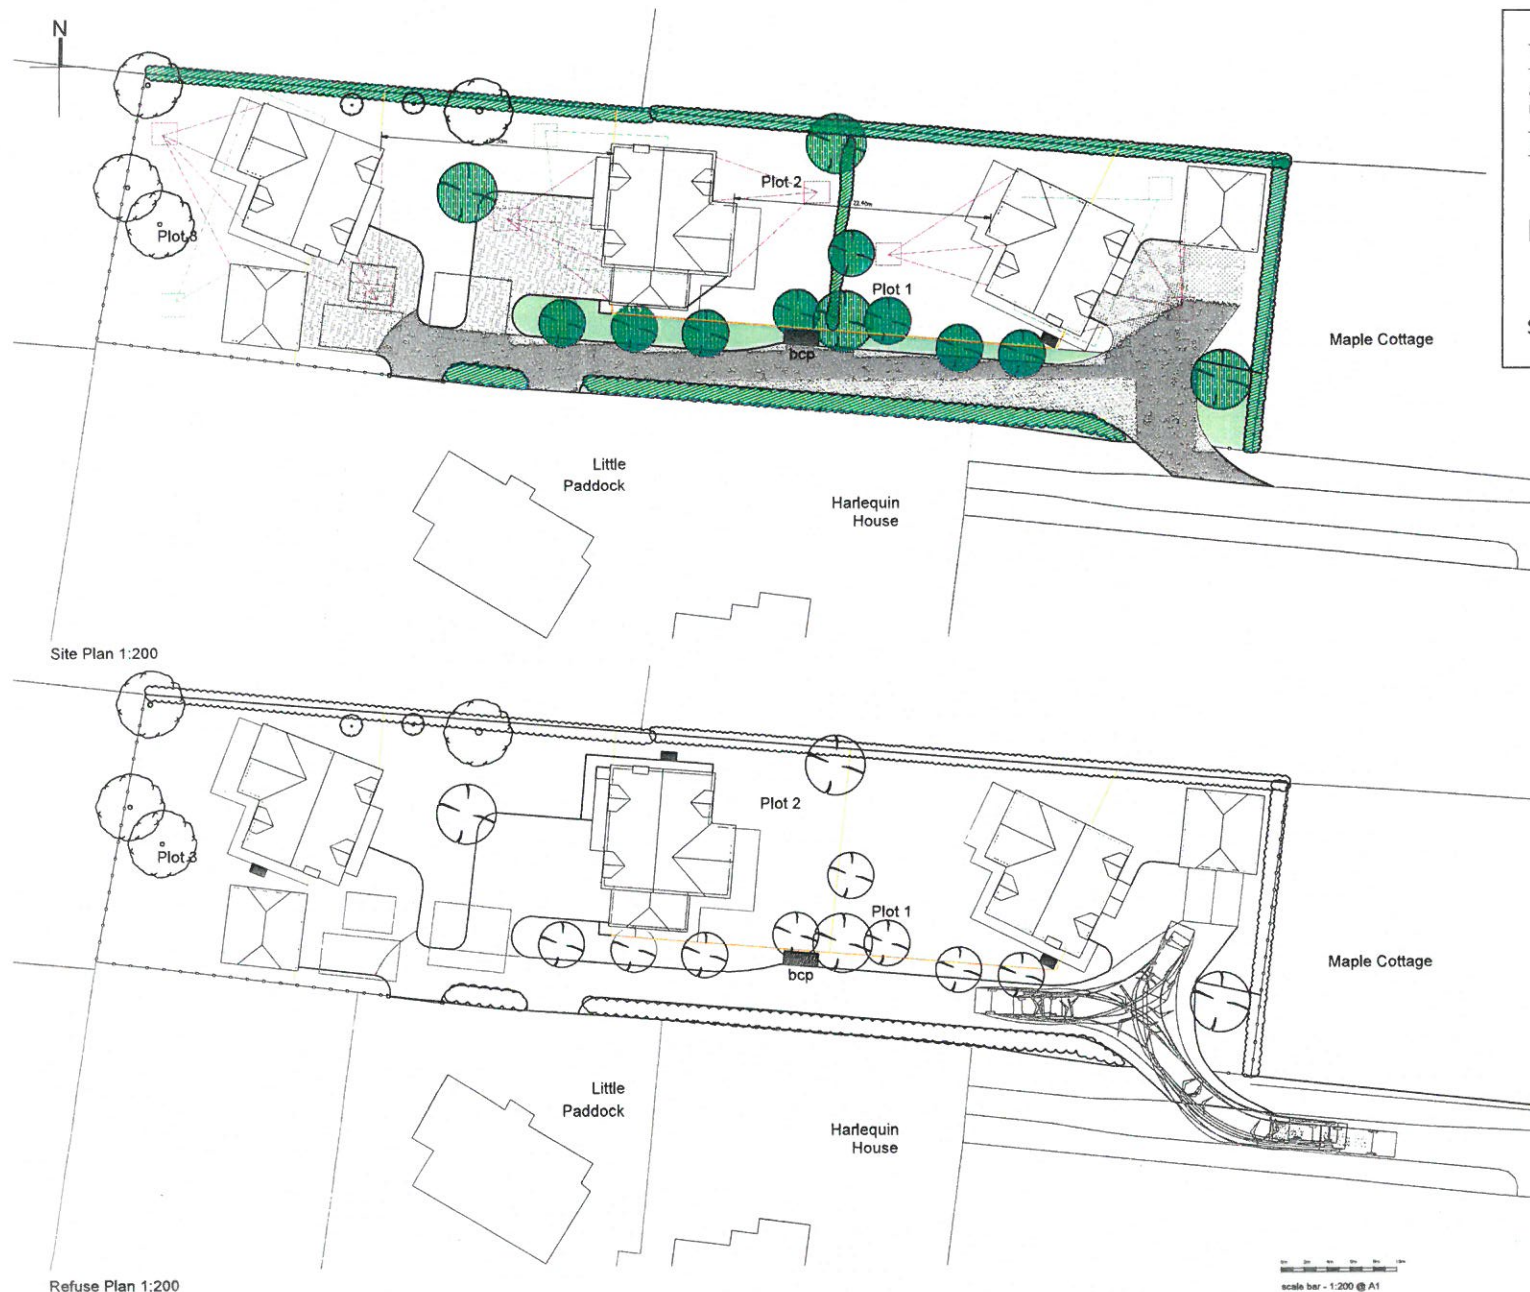
# Proposed Development

It is intended to construct three detached houses on site with associated gardens, landscaping and parking.

The proposed general arrangement is given at Figure 2 of Appendix A.

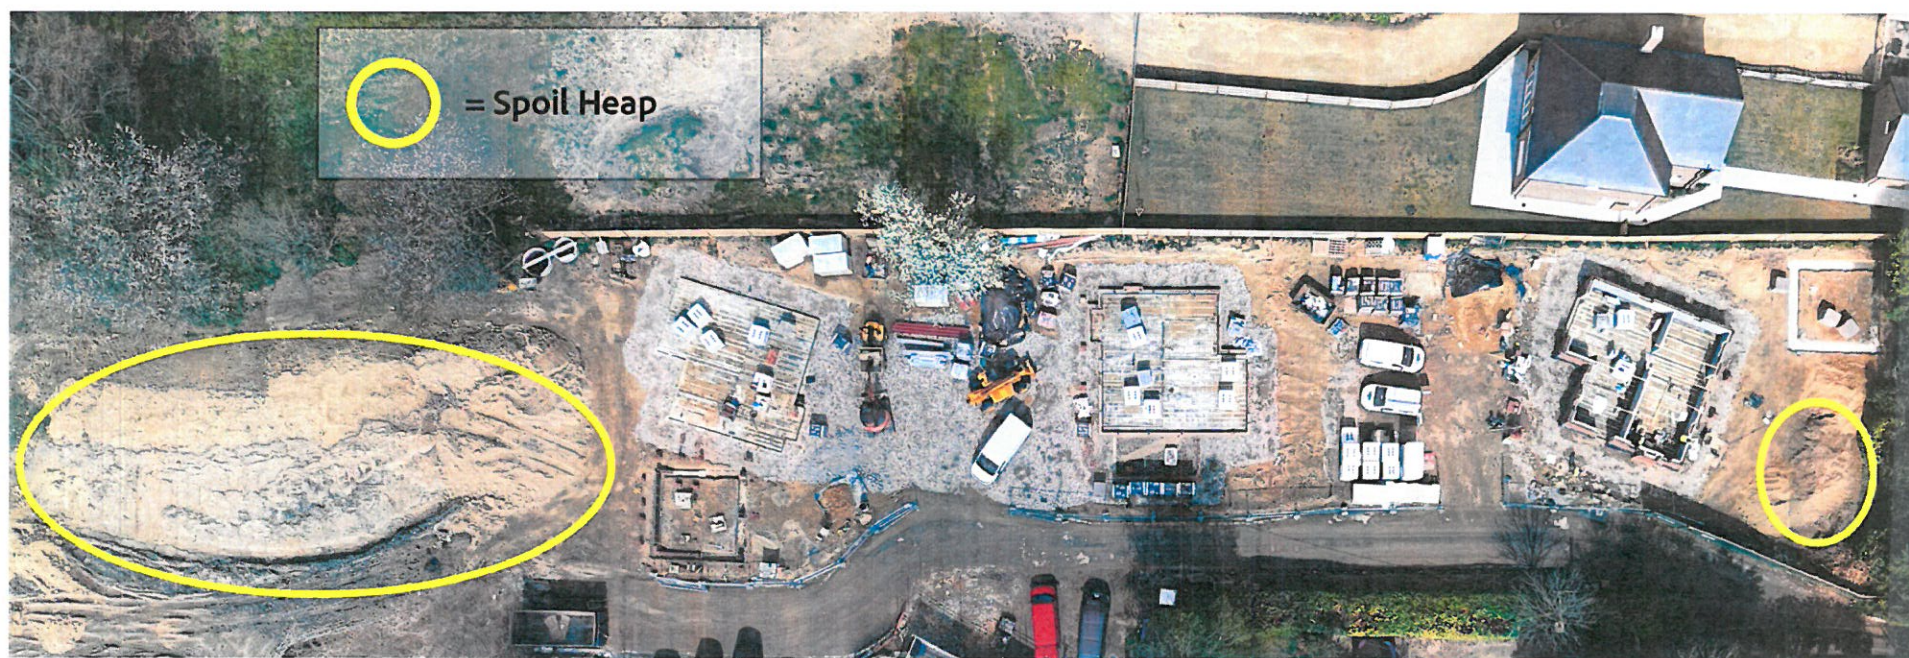
### Spoil Heap Locations

Due to very wet conditions at the start of the development, some 200 - 300 mm of soil was removed from the locations of the proposed properties to aid vehicle movement. The soil has been stockpiled on site. In addition, foundation arisings have also been stockpiled on site. Figure 3 at Appendix A is a recent drone shot showing the location of the two spoil heaps. The site won material is to be reused in garden and soft landscaping areas.
