**Preliminary Risk Assessment, site Investigation  
and Groundwater Risk Assessment** | Residential Development

Former Sandgate Nurseries  
West End Lane  
Henfield  
West Sussex  
BN5 9RD

22-200.03  
Version 2

| Report Quality Management | | | |
|---|---|---|---|
| <b>Project Title</b> | Preliminary Risk Assessment, Site Investigation and Groundwater Risk Assessment | | |

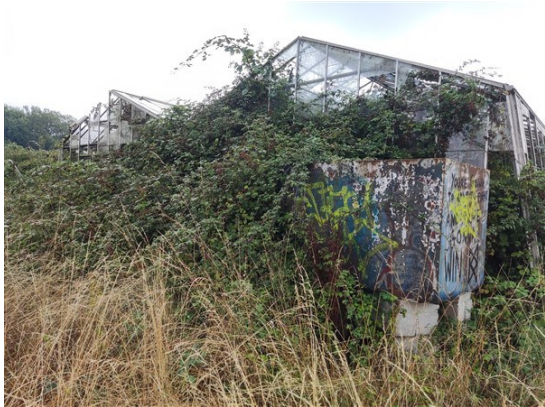
| <b>Above or Underground Storage Tanks and Drums</b> | <p>There is an above ground storage tank (AST) outside the north-west corner of the glasshouses. The AST is a metal tank that is supported on breeze blocks and partially covered with brambles, as shown in Photo 4 in <b>Figure 3</b>.</p> <p>Details of the content of the AST could not be obtained but it is speculated that it contained heating oil which would have been used to heat the glasshouses. Given the age of the tank, it is thought to be of single-skin construction with no integral bund. It is not known whether the tank is empty. The vegetation was too dense to determine whether there were any stains to the ground surface underneath the tank.</p> |
